SITE NUMBER AND NAME: S061 Hwy 762 Embankment Erosion North of Junction 549		HIGHWAY & KM: 762:02, 0.346	PREVIOUS INSPECTION DATE: May 16, 2022	INSPECTION DATE: May 9, 2023
LEGAL DESCRIPTION: 09-03-21-04 W5M	NAD 83 COORDINATES: UTM Northing Easting 11 5626018 678916		RISK ASSESMENT: PF: 8 CF: 3 TOTAL: 24	
AVERAGE ANNUAL DAILY TRAFFIC (AADT): 700 (north) & 1320 (south) (Reference No. 65170 & 60180)			CONTRACTOR MAINTENANCE AREA (CMA): 27

PROJECT SOUTHERN REGION GEOHAZARD RISK MANAGEMENT PROGRAM		
TITLE Site Plan S061 - Hwy 762 Embankment Erosion N of Junction 549 Hwy 762:02, km 0.346		
SCALE 1:1,250	PROJECT No. A05116A03	FIG No. 1

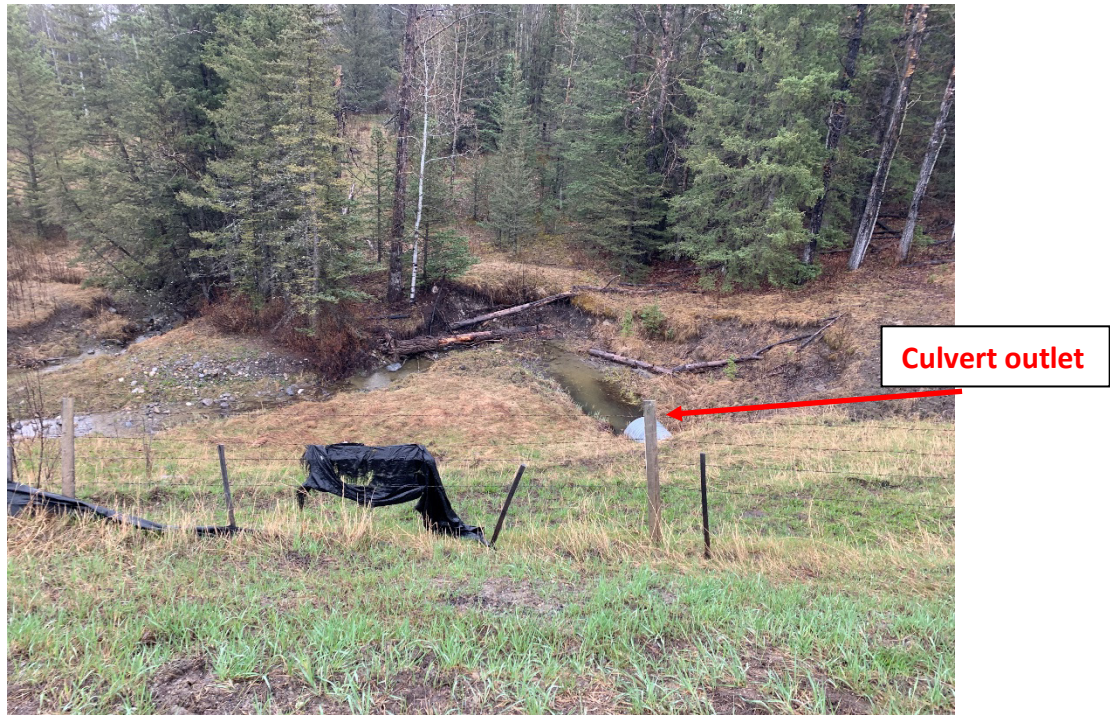
The creek flow entering the culvert appears to be flowing faster than discharge from the outlet of the culvert (i.e., backing up). The culvert is corroded and may be partially blocked. Corrosion of the invert may be leading to leakage from the culvert into embankment fill beneath highway, increasing the groundwater level and destabilizing the embankment.

Photo 1 Erosion at downstream end of culvert (east side). Culvert outflows are deflected back towards the highway embankment. Photo taken facing northeast on May 9, 2023.

- A camera inspection should be completed to assess the condition of the 900 mm diameter CSP culvert. If irreparable, the culvert could be sealed and a new culvert could be built with an alignment that outlets further downstream, away from the meandering stream where the current outlet is.
- The embankment could be stabilized by reconstructing the embankment with geogrid reinforced granular fill.

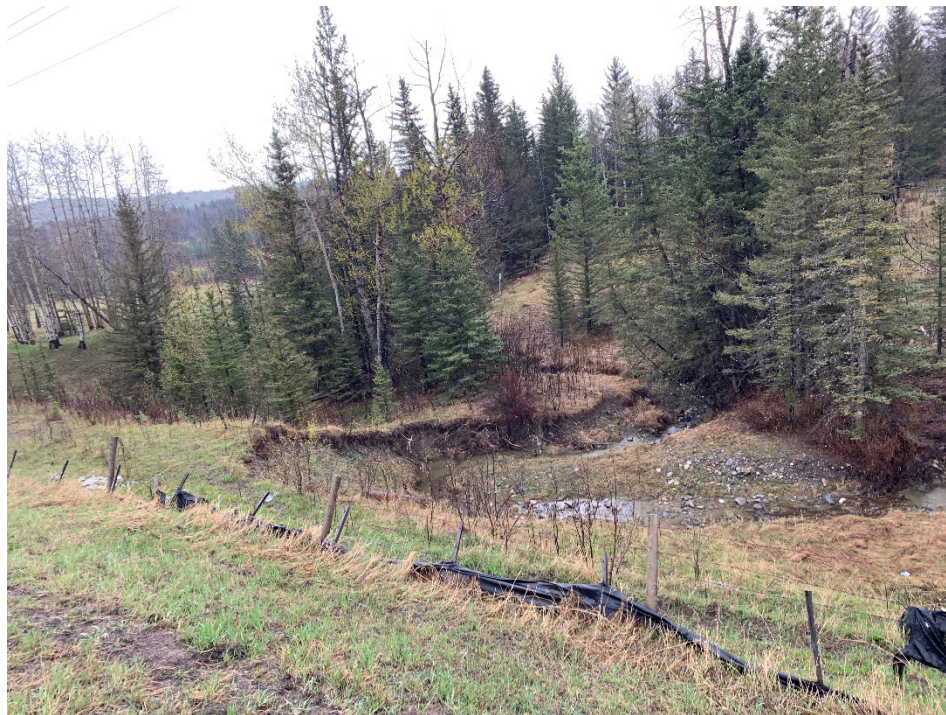
COMMENTS
The site was previously inspected as part of the S008 Fisher Creek Pile Wall site and referred to as "South of S008". In 2021, the site was numbered and named "S061 Hwy 762 Embankment Erosion North of Junction 549".
The highway embankment is in a creek valley and downslope of a hill.
The highway embankment slopes are well vegetated.
High flow water comes out of the culvert on the west side of highway during periods of heavy rainfall. The water hits the bank directly downstream of the culvert and is eroding the west highway embankment toe. Standing water was observed at the culvert outlet during the 2023 inspection.
The fence on the west side of the embankment has deflected and is leaning towards the toe of the highway

embankment.

Photo 2 Toe erosion and fence deflection on embankment slope. Photo taken facing northeast on May 9, 2023.

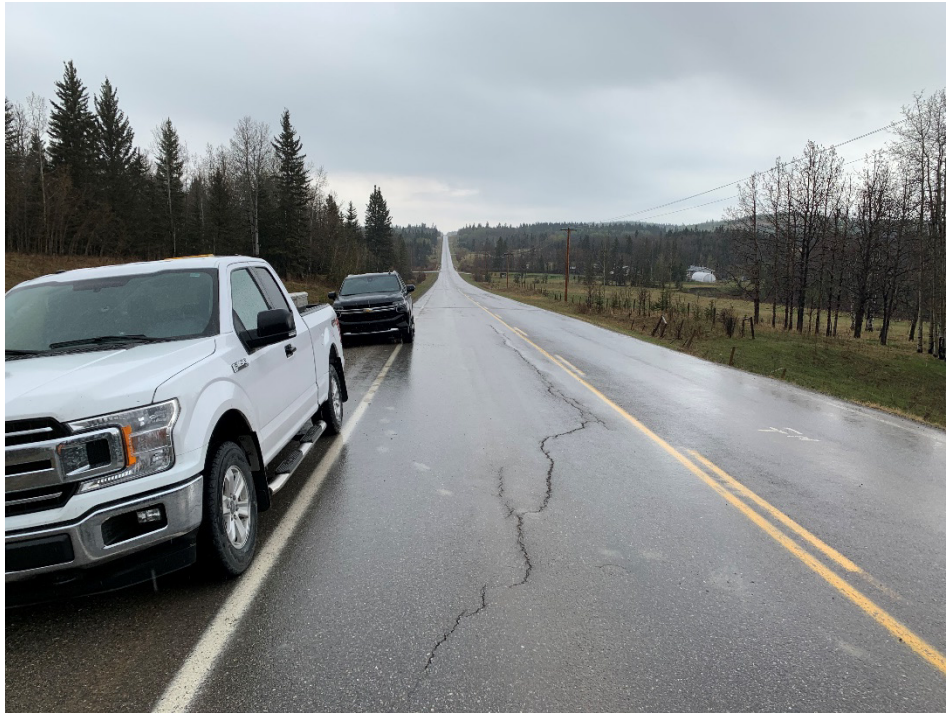
The pavement cracking appears to have lengthened since the 2022 inspection and the transverse pavement cracking has widened to approximately 30 mm to 40 mm. The pavement cracking (believed to be caused by settlement in the west (southbound) lane) has dropped by approximately 20 mm to 25 mm over its 23 m length and could suggest that the slide is moving to the west.

Photo 3 **Pavement cracking extends to centreline. Photo was taken facing north on May 9, 2023.**
