SITE NUMBER AND NAME: S008 Fisher Creek Pile Wall		HIGHWAY & KM: 762:02, 2.125	PREVIOUS INSPECTION DATE: July 8, 2020	INSPECTION DATE: July 5, 2021
LEGAL DESCRIPTION: 09-10-021-04 W5M	NAD 83 COORDINATES: UTM Northing Easting 11 5627342 678866		RISK ASSESSMENT: PF: 10 CF: 5 TOTAL: 50 (New cracking north of previously slide)	
AVERAGE ANNUAL DAILY TRAFFIC (AADT): 720 (north) (Ref No. 65170), 1420 (south) (Ref. No. 60180)			CONTRACTOR MAINTENANCE AREA (CMA): 27

PROJECT SOUTHERN REGION GEOHAZARD RISK MANAGEMENT PROGRAM		
TITLE Site Plan S008 - Fisher Creek Hwy 762.02, km 2.125		
SCALE 1:1,300	PROJECT No. A05116A03	FIG.No. 1

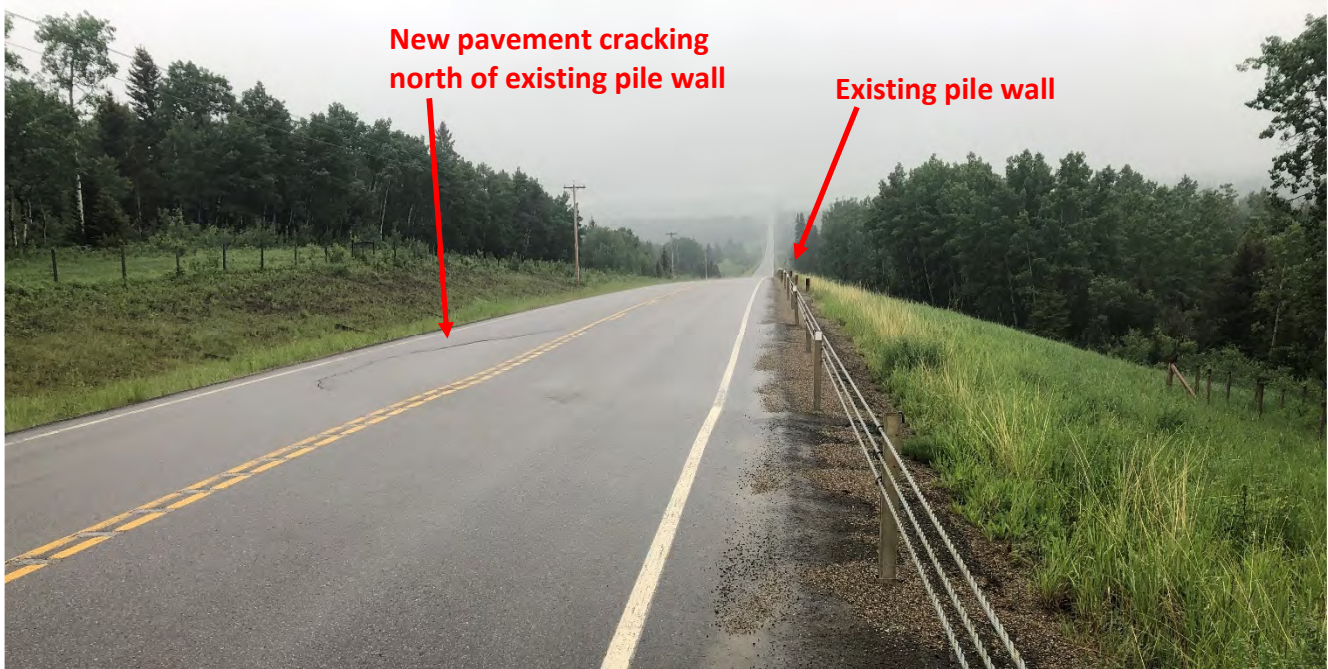
COMMENTS
Recorded movements in the existing pile-wall are negligible, but new pavement cracking and a dip in the northbound lane to the north of the pile wall was observed in 2020, indicating possible outflanking of the wall. Pavement cracking was noted approximately 24 m north of the existing pile wall (approximately 15 m north of the HTCB terminal). Movement is to the west.
In 2021, the extent of pavement cracking was larger than in 2020. The crack was estimated as approximately 11 m long and up to 22 mm wide. Cracking was within 0.8 m of the white line on the east side of the highway (northbound lane).

Photo 1 New pavement cracking north of the pile wall. Possible outflanking of pile wall. Photo taken facing south on July 5, 2021.

- Short-Term
 - Continue reading pile wall instruments at least once a year (current reading frequency is twice a year).
 - Continue annual inspections.
 - Drill a borehole near the pavement cracking north of existing pile wall and install a SI to monitor slope movements.
- Long-Term
 - Extend the pile wall to the north, or excavate and replace embankment fill with geogrid reinforced gravel to stabilize west embankment slope.

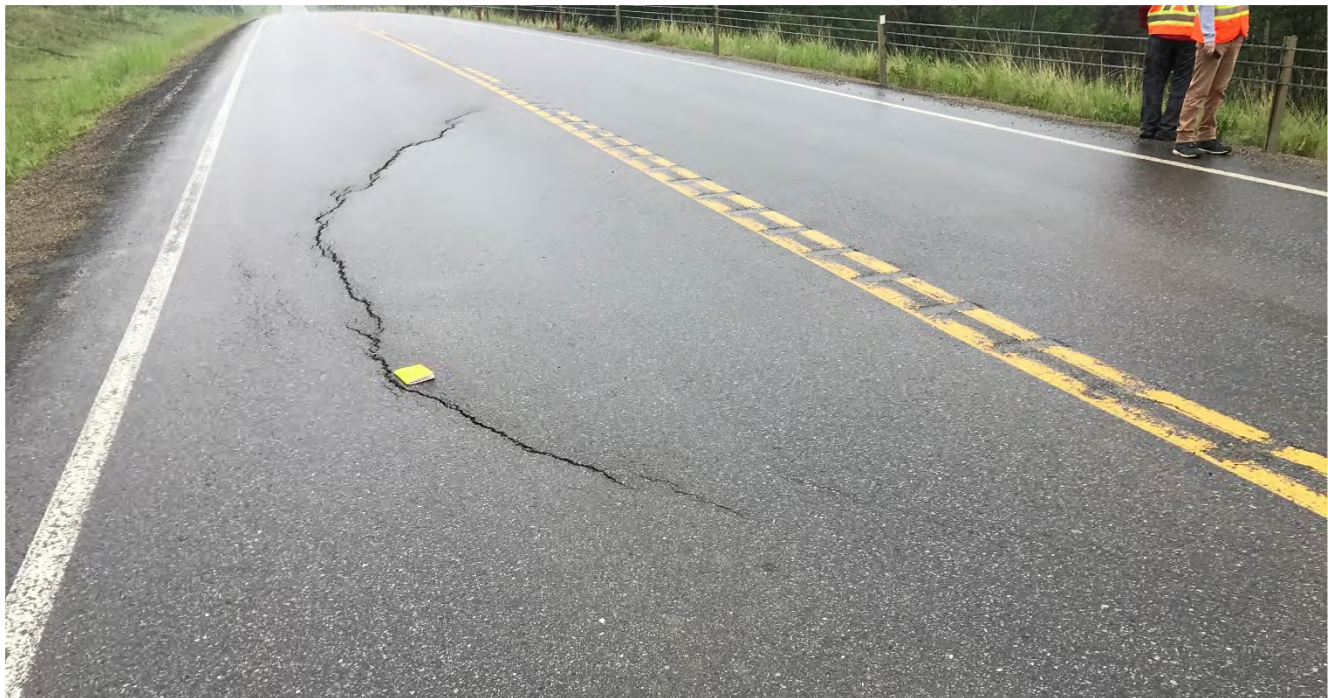
Photo 2 Pavement cracking in the northbound lane, north of the existing pile wall. Photo taken facing south on July 5, 2021.

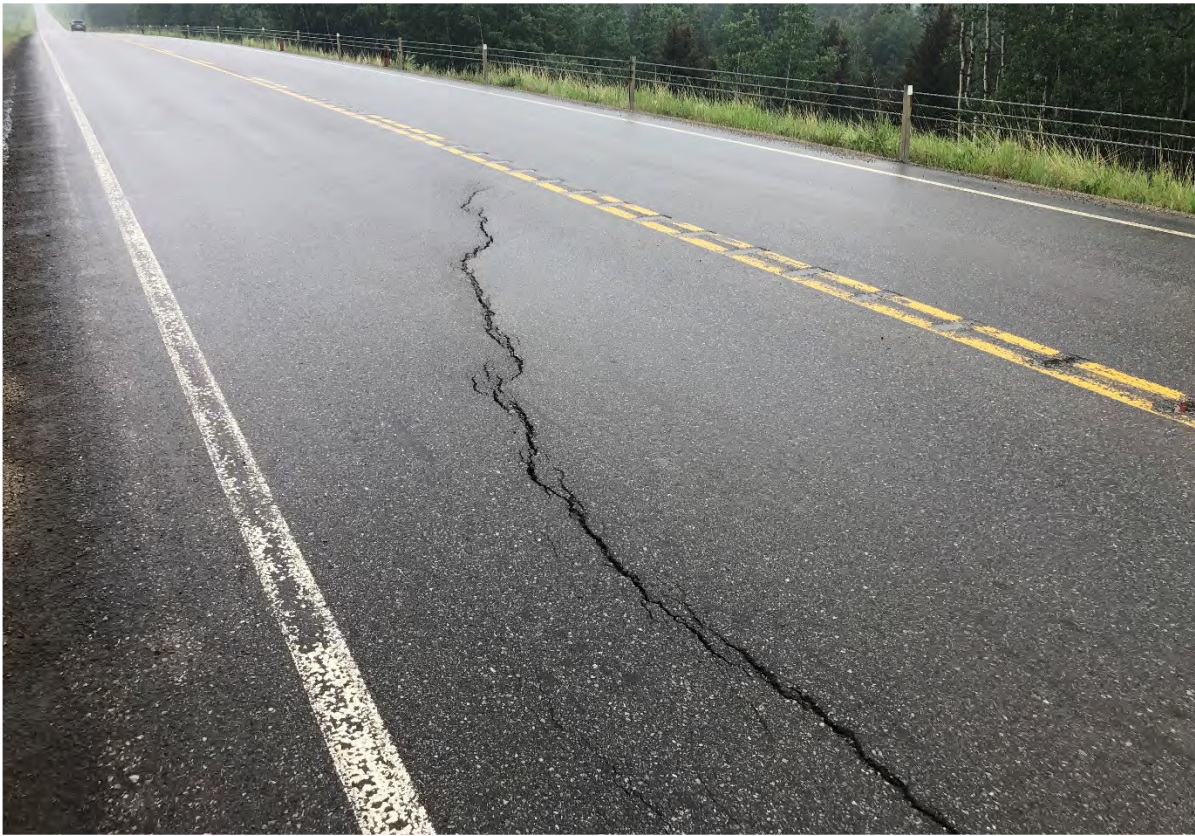
Photo 3 Pavement cracking has enlarged when compared to 2020 inspection. Photo taken facing southwest on July 5, 2021.

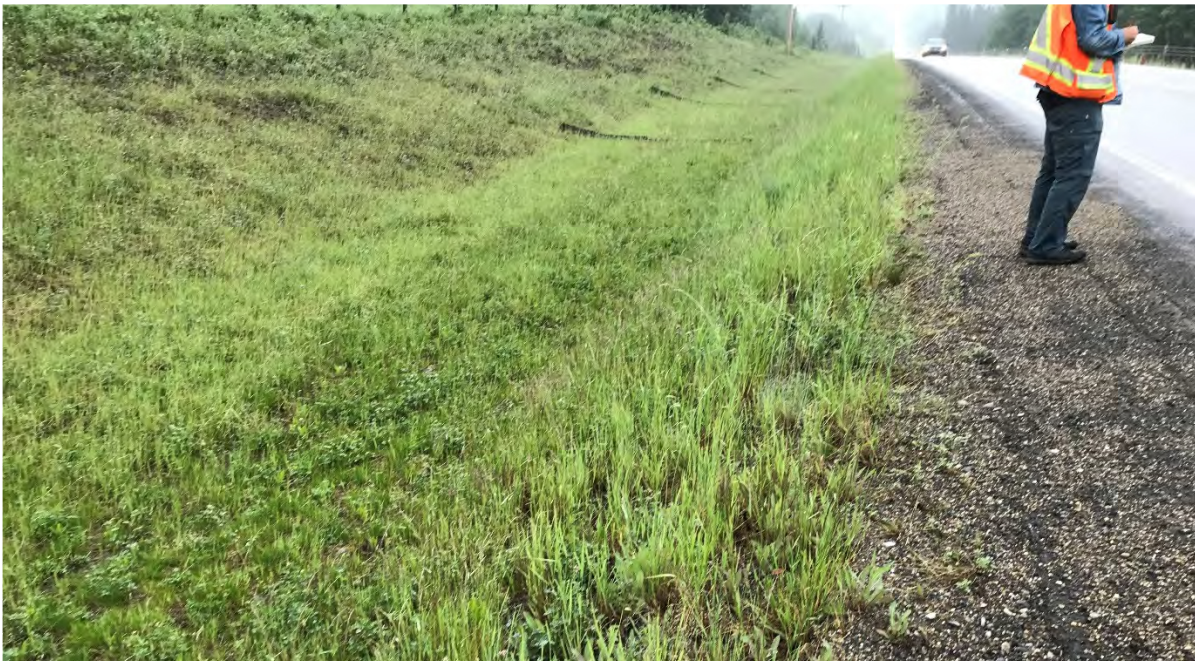
The ditch on the uphill side was experiencing rill erosion in 2018 due to lack of rolled erosion control product in the ditch bottom. At the time of the 2021 site visit, the ditch was well vegetated and in good condition.

Photo 4 View south along east ditch. Photo taken on July 5, 2021.
