November 30, 2022

Alberta Transportation
2nd Floor, 803 Manning Road N.E.
Calgary, Alberta
T2E 7M8

**CON0022161 Southern Region GRMP Instrumentation Monitoring
Site S008; H762:02, km 2.125 Fisher Creek Pile Wall
Section C – 2022 Fall Readings**

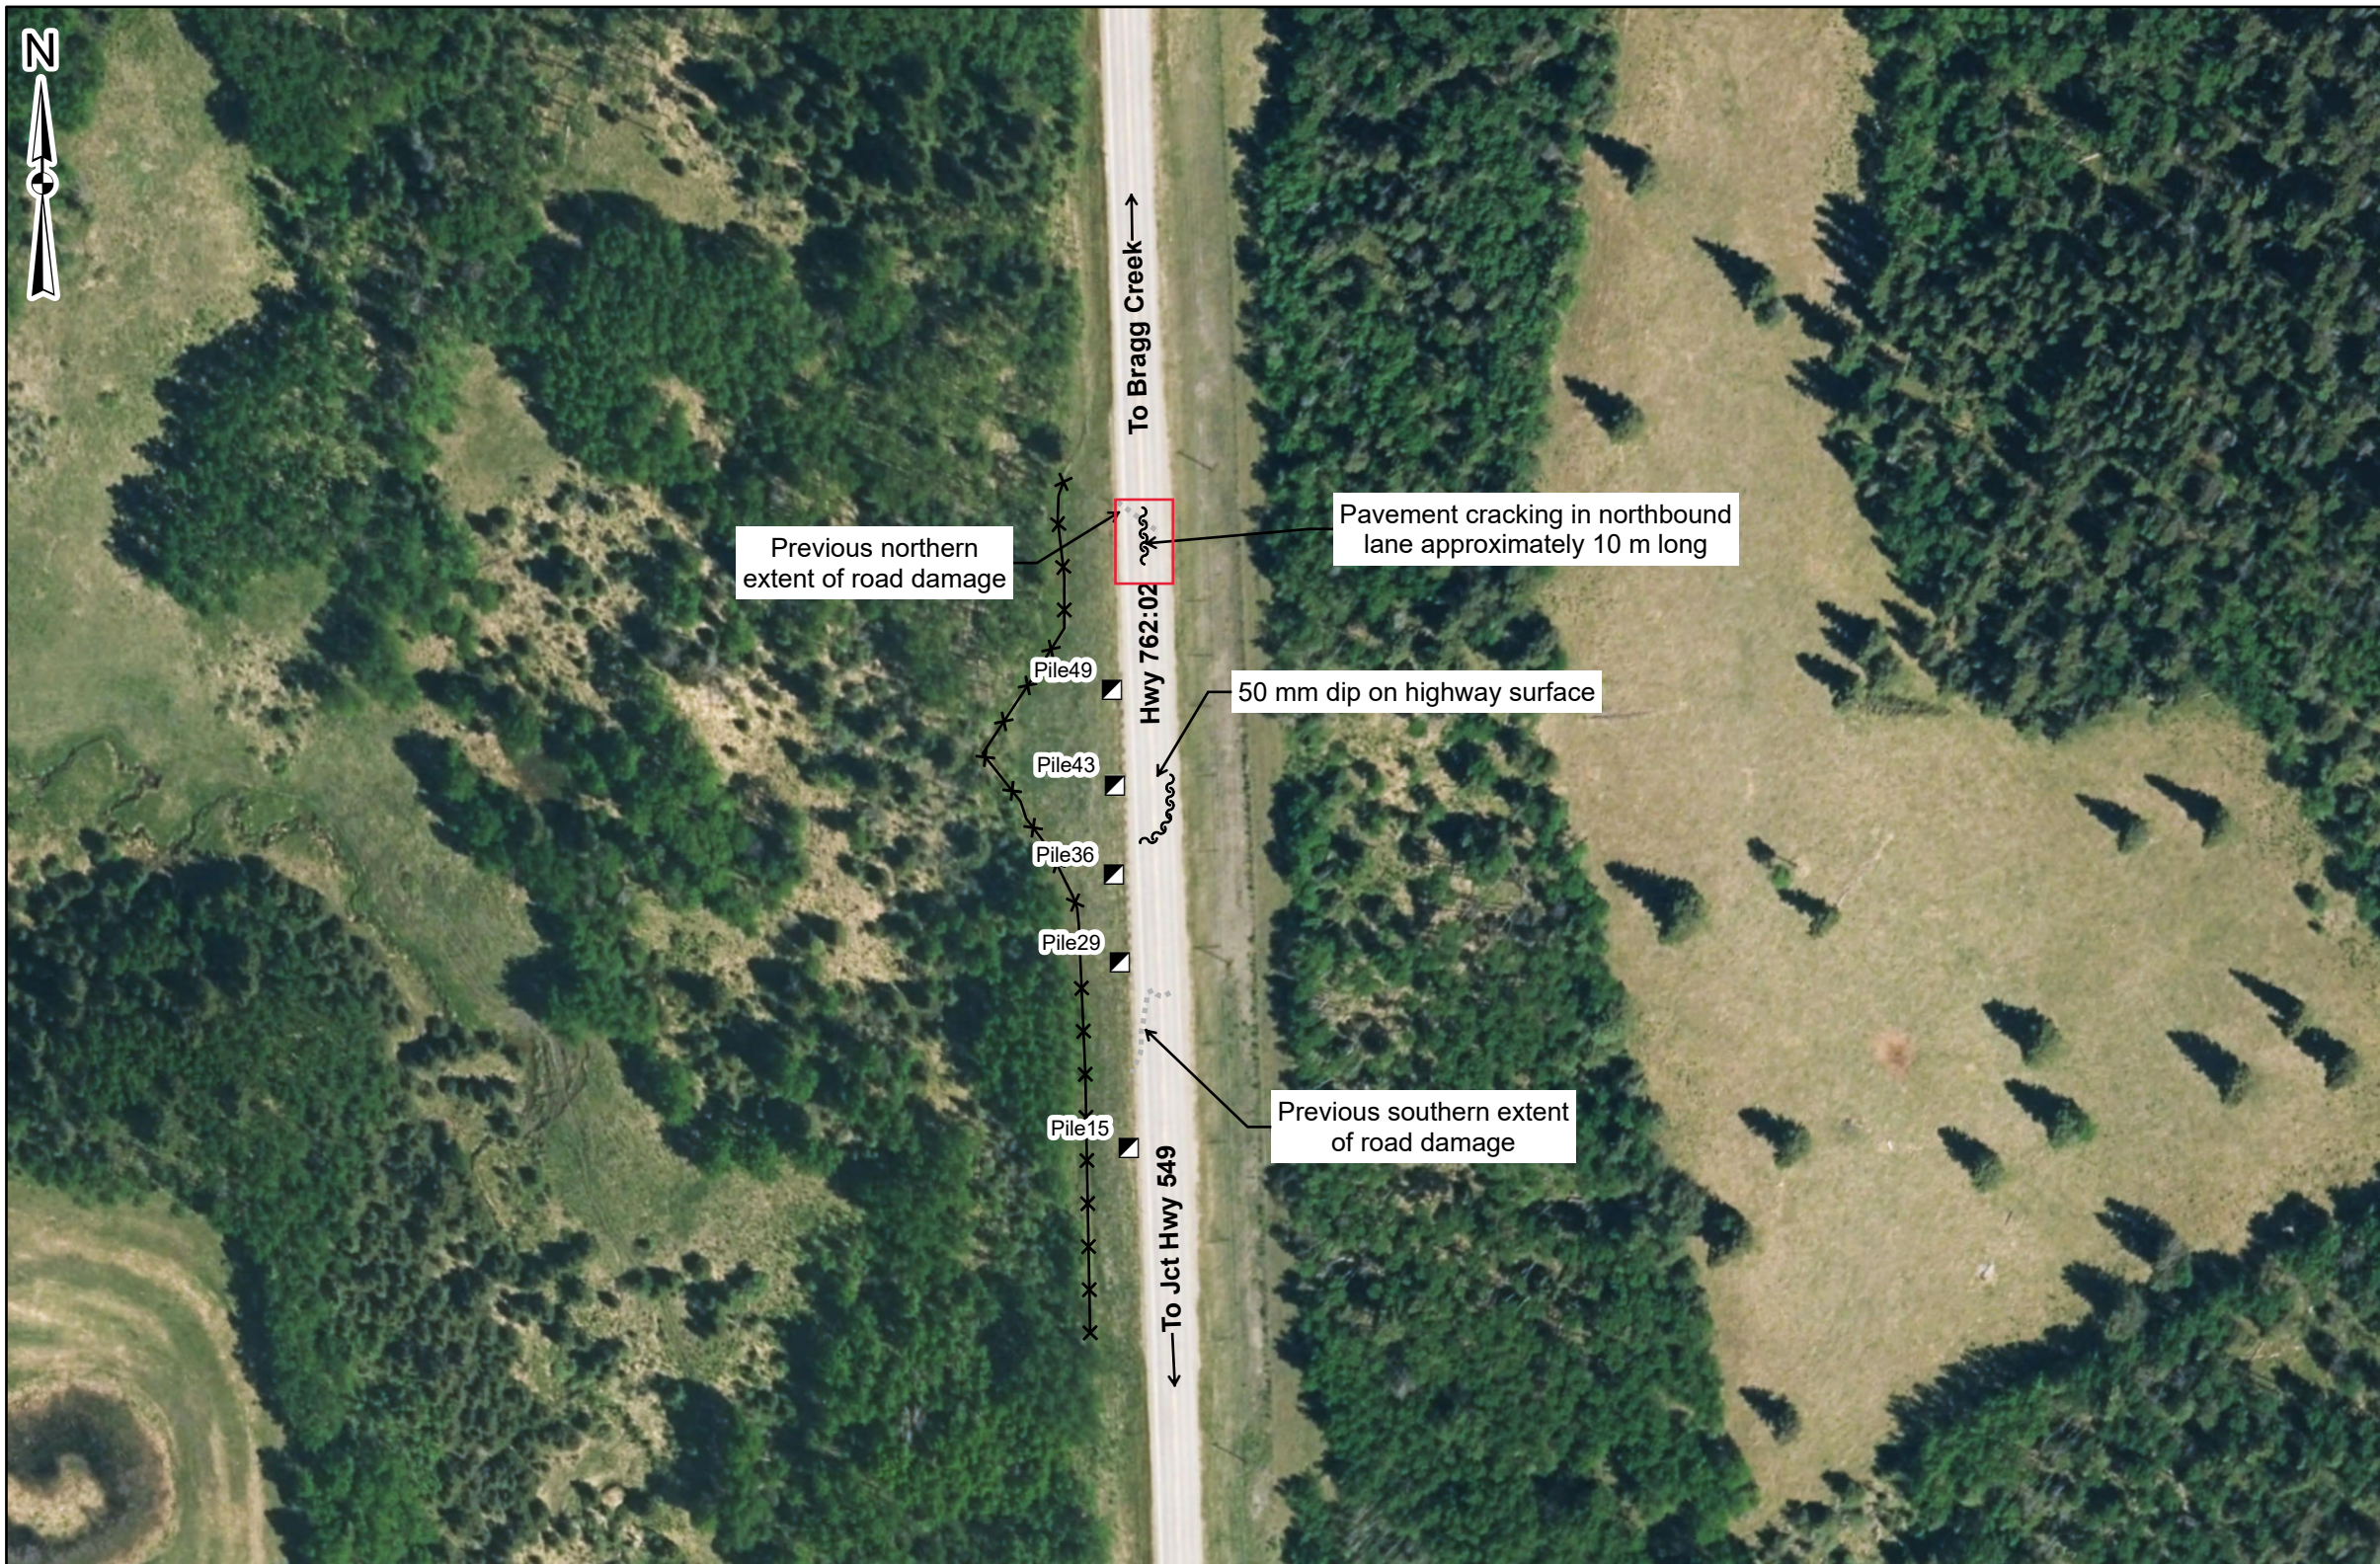
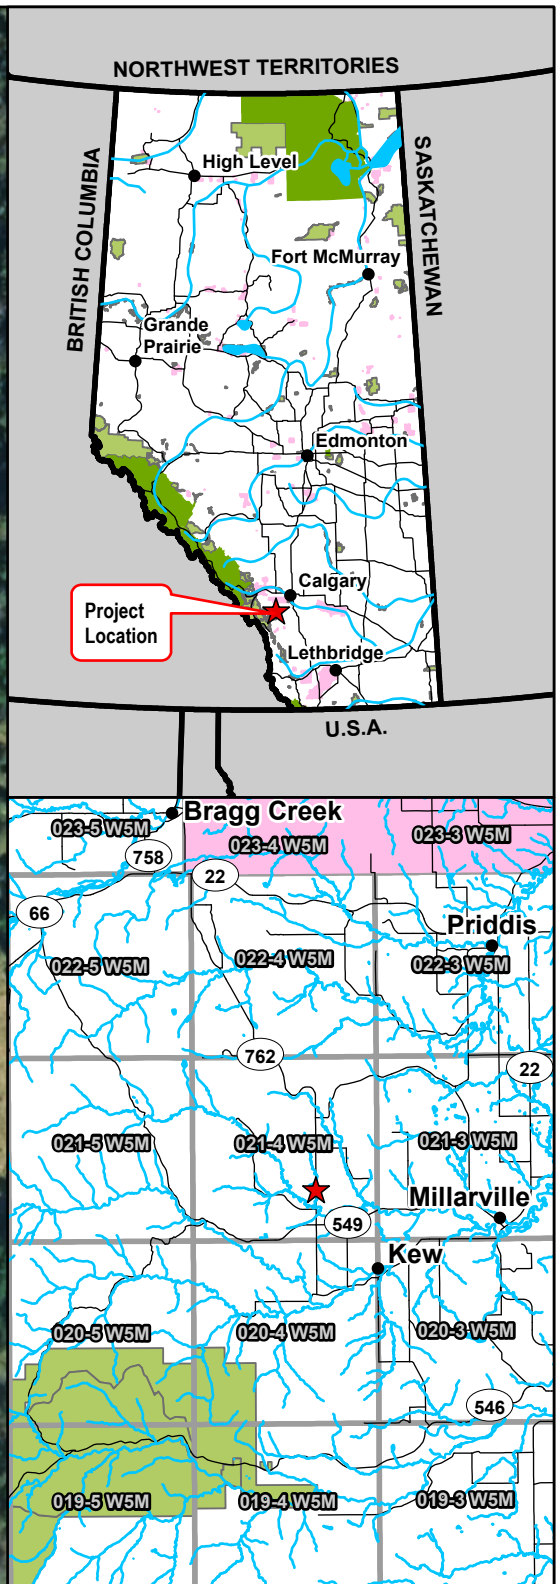
PROJECT SOUTHERN REGION GEOHAZARD RISK MANAGEMENT PROGRAM		
TITLE Site Plan S008 - Fisher Creek Pile Wall Hwy 762:02, km 2.125		
SCALE 1:1,500	PROJECT No. A05116A03	FIG No. 1

The geohazard at the S008 site consists of a landslide approximately 130 m in length on the west slope of the highway embankment. In January 2017, a cast-in-place pile wall consisting of fifty-seven (57) 1.2-m-diameter piles was installed to a depth of 16 m to 18 m below ground surface and anchored in bedrock. In the fall of 2017, a high-tension-cable-barrier (HTCB) was installed along the west (southbound lane) shoulder of the highway. A pavement patch was placed north of the pile wall between the spring and fall 2022 readings.

The pavement distress north of the pile wall could indicate the slide is outflanking the pile wall at its north extent. Between the spring and fall 2022 readings, a new pavement patch was placed north of the pile wall, in the area where pavement cracks were observed during the previous three Section B inspections.

KCB recommends that a borehole be drilled approximately 24 m north of the existing pile wall where pavement distress is observed. A SI should then be installed in the borehole to monitor movement at this location.

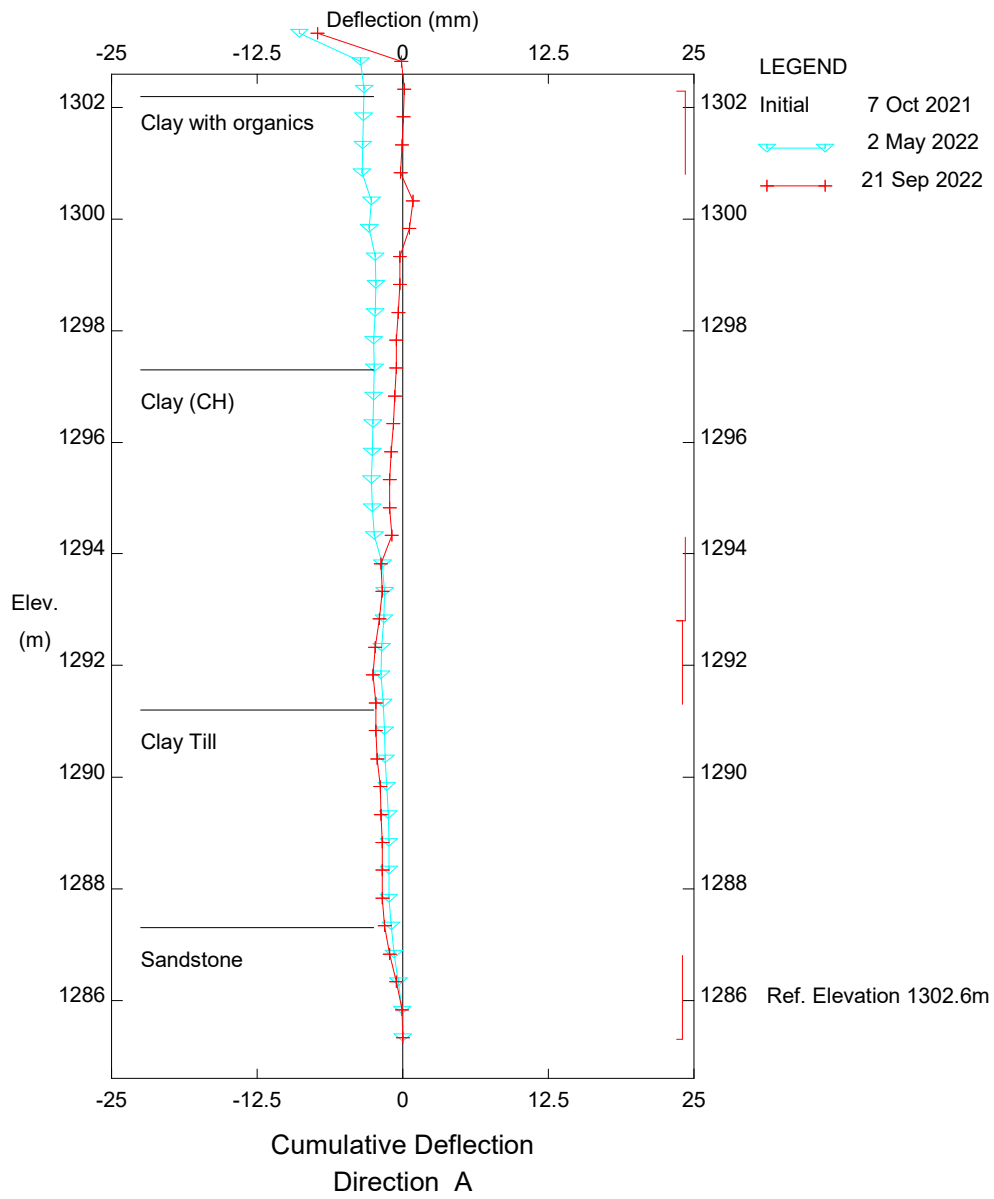
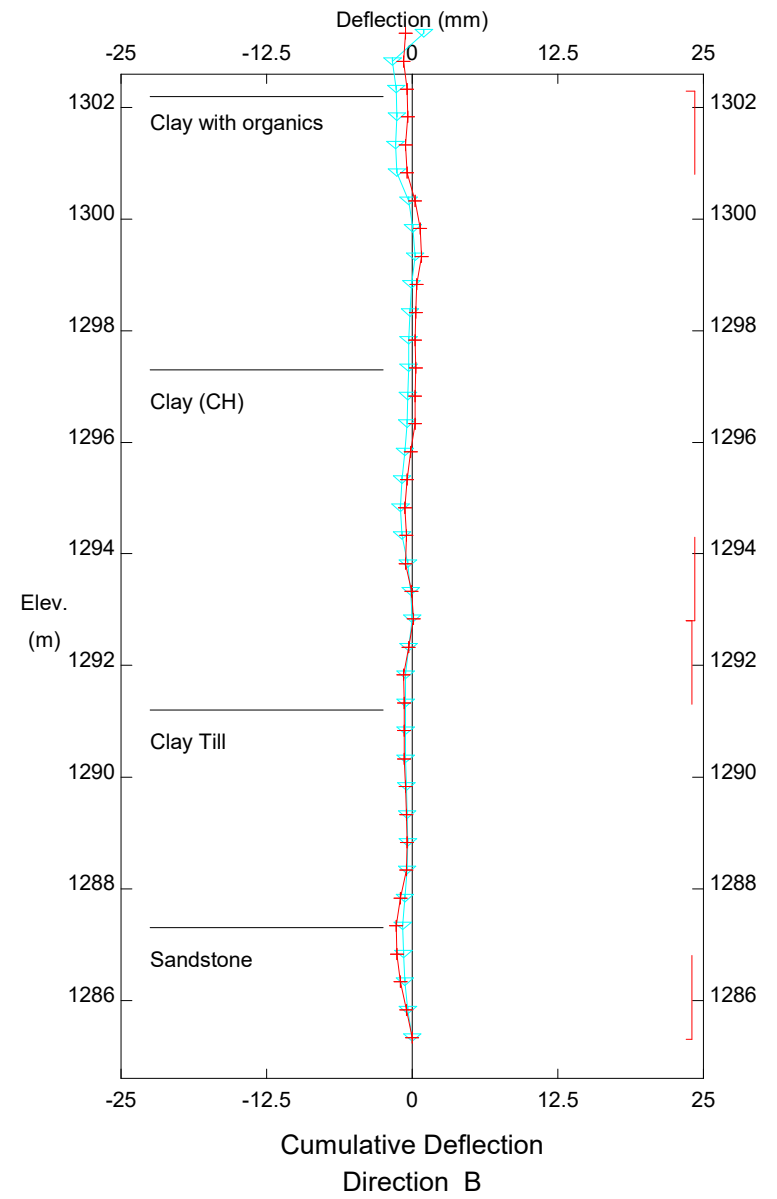
S008; H762:02, Fisher Creek, Inclinator PILE15
 Alberta Transportation

- 9.8 m below ground surface in Pile 15 with some minor deflection (less than 10 mm) being recorded to an approximate depth of 17.3 m below ground surface (i.e., bottom of casing);
- 10.7 m below ground surface in Pile 29;
- 10.8 m below ground surface in Pile 36 with some minor deflection (less than 5 mm) being recorded to an approximate depth of 17.3 m below ground surface (i.e., bottom of casing);
- 7.8 m below ground surface in Pile 43; and
- 7.8 m below ground surface in Pile 49 with some minor deflection (less than 5 mm) being recorded to an approximate depth of 15.3 m below ground surface (i.e., bottom of casing).

Initial movement (less than 10 mm) was recorded in the base of Pile 15, Pile 36, and Pile 49 in early 2017, within six months of pile wall installation. Those movements have since attenuated and are no longer discernible.

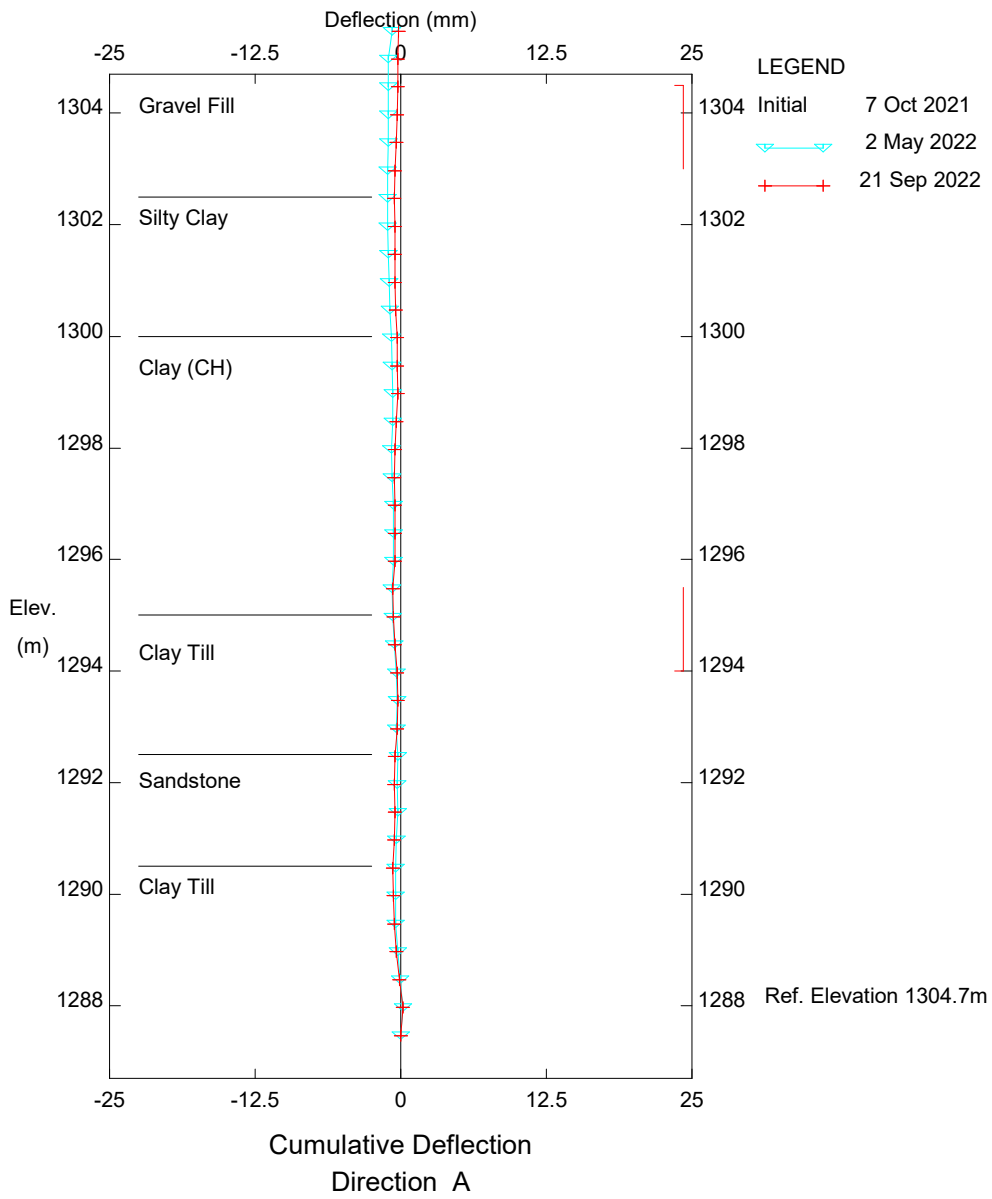
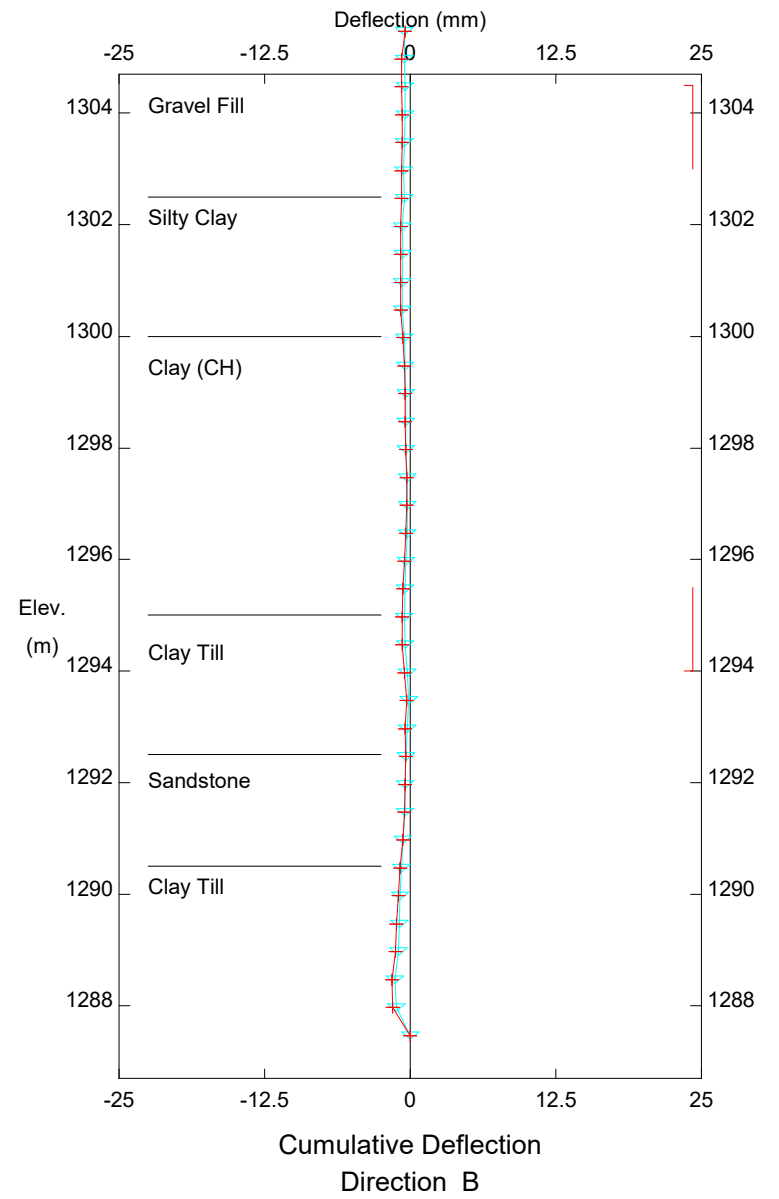
S008; H762:02, Fisher Creek, Inclinator PILE29
 Alberta Transportation

Since being re-initialized to the October 2021 reading, no discernible movement has been recorded in Pile 29, Pile 43, or Pile 49.
