SITE NUMBER AND NAME: S008 Fisher Creek Pile Wall		HIGHWAY & KM: 762:02, 2.125	PREVIOUS INSPECTION DATE: July 5, 2021	INSPECTION DATE: May 16, 2022
LEGAL DESCRIPTION: 09-10-21-04 W5M	NAD 83 COORDINATES: UTM Northing Easting 11 5627342 678866		RISK ASSESSMENT: PF: 11 CF: 6 TOTAL: 66	
AVERAGE ANNUAL DAILY TRAFFIC (AADT): 720 (north) & 1420 (south) (Reference No. 65170 & 60180)			CONTRACTOR MAINTENANCE AREA (CMA): 27

PRIMARY SITE ISSUE: Settlement of the embankment slope downslope of the existing pile wall by up to 0.8 m, and development of a dip in the pavement north of the existing pile wall.

PROJECT SOUTHERN REGION GEOHAZARD RISK MANAGEMENT PROGRAM		
TITLE Site Plan S008 - Fisher Creek Pile Wall Hwy 762.02, km 2.125		
SCALE 1:1,500	PROJECT No. A05116A03	FIG No. 1

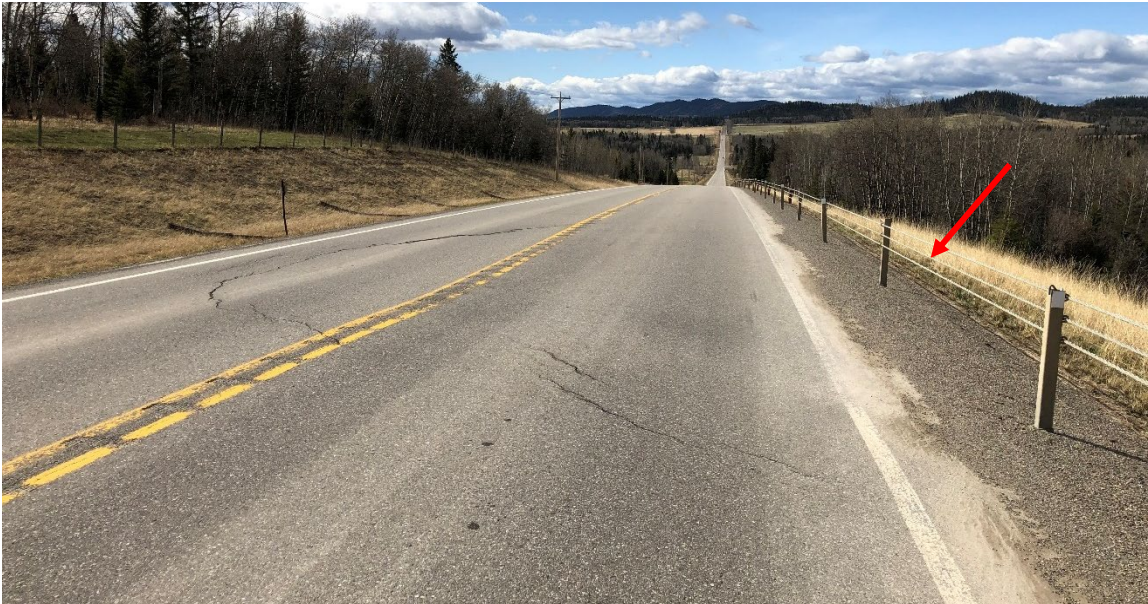
There is negligible movement being recorded in the pile-wall slope inclinometers and no pavement cracking has been observed directly upslope of the pile wall. However, pavement cracking and settlement in the highway approximately 24 m north of the pile wall (15 m north of the HTCB) has been observed since 2020 (Photo 1 and 2). The pavement crack and settlement has increased in severity since 2020 (increased in length from 11 m to 16 m since 2021) and is up to approximately 25 mm wide. The pavement settlement is up to approximately 25 mm in the east (northbound) lane. Pavement cracking was within 400 mm of the white line on the east side of the highway (northbound lane).

The pavement cracking and settlement north of the pile wall could indicate the slide has begun to outflank the pile wall.

- Photo 1** Pavement cracking north of the pile wall (approximate location of the north end indicated by red arrow) crosses both lanes of the highway. The pavement cracking has increased since the 2021 inspection. Photo taken on May 16, 2022, facing south.

- The pavement cracks should be sealed to reduce surface water infiltration.
- The voids between the pile walls should be backfilled to reduce infiltration and potential erosion undermining the east (southbound) lane.
- The site should be regularly inspected as part of the Southern Region Section B inspections and instruments read as part of the Section C instrumentation monitoring.
- A borehole could be drilled through the pavement north of the pile wall and a slope inclinometer and piezometer(s) should be installed to monitor movement and groundwater conditions, respectively.

- The pile wall could be extended the north, so the slide doesn't outflank the existing pile wall; or
- Stabilize the highway embankment by excavating and replacing embankment fill with geogrid reinforced granular fill.

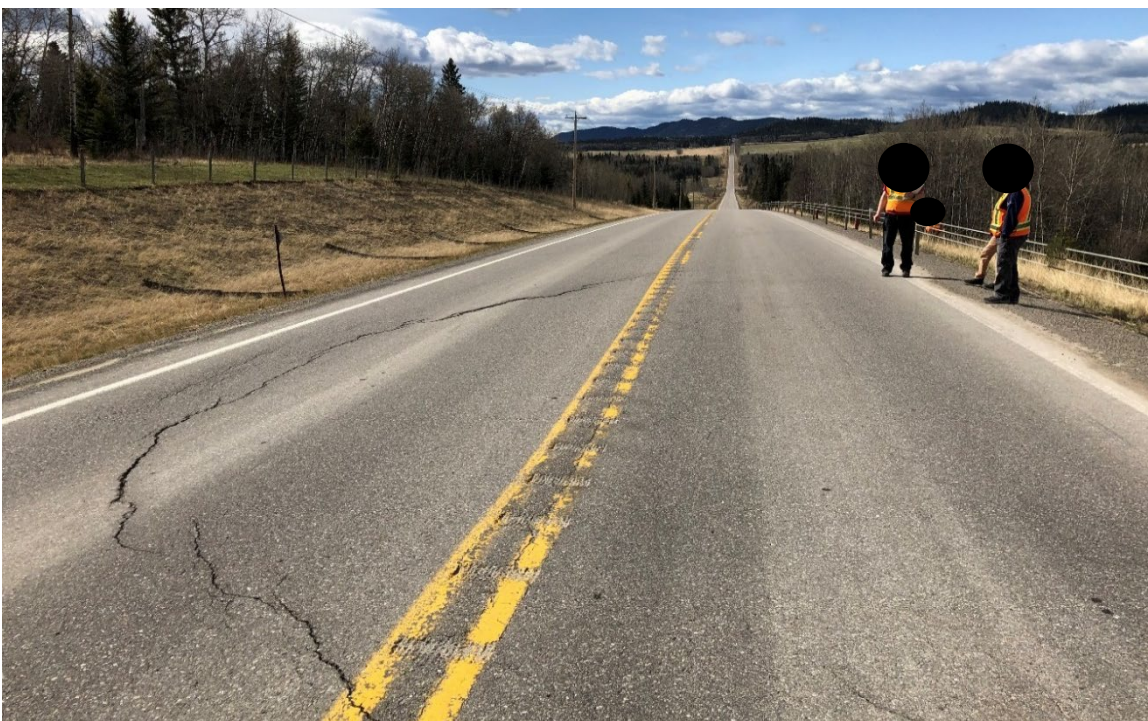
The south extent of pavement cracking is likely to intersect with the north end of the pile wall. Settlement in the southbound lane was estimated to be up to 50 mm (Photo 2).

- Photo 2** Pavement cracking in the northbound lane (WP 85) and pavement settlement (approximately 50 mm) in the west (southbound) lane pavement has increased since the 2021 inspection. Photo taken on May 16, 2022, facing south.

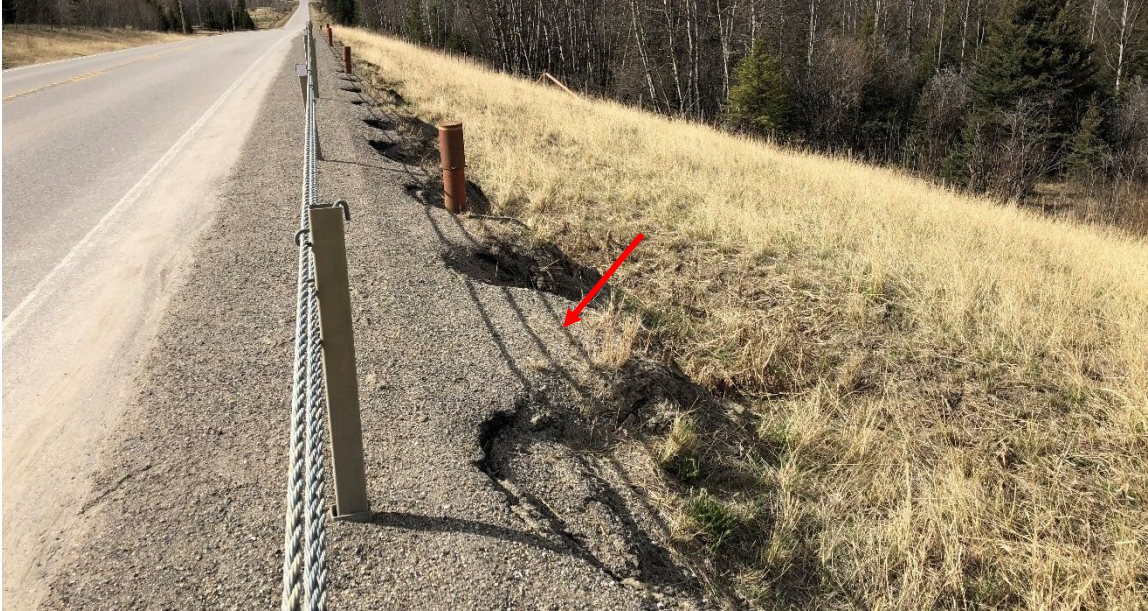
During the 2022 inspection, cracking and settlement of the embankment downslope of the pile wall was visible and the ground surface had dropped by up to 800 mm, creating a ledge that could potentially pond water, leading to increased infiltration (Photo 3 and 4).

Surface water runoff has enlarged existing sinkholes at the pile locations and contributed to embankment settlement downslope of the pile wall.

Photo 3 There has been approximately 800 mm of settlement of embankment fill downslope of the pile wall, which has formed a ledge downslope of the high-tension cable barrier (HTCB) (indicated by red arrow). Photo taken on May 16, 2022, facing south.

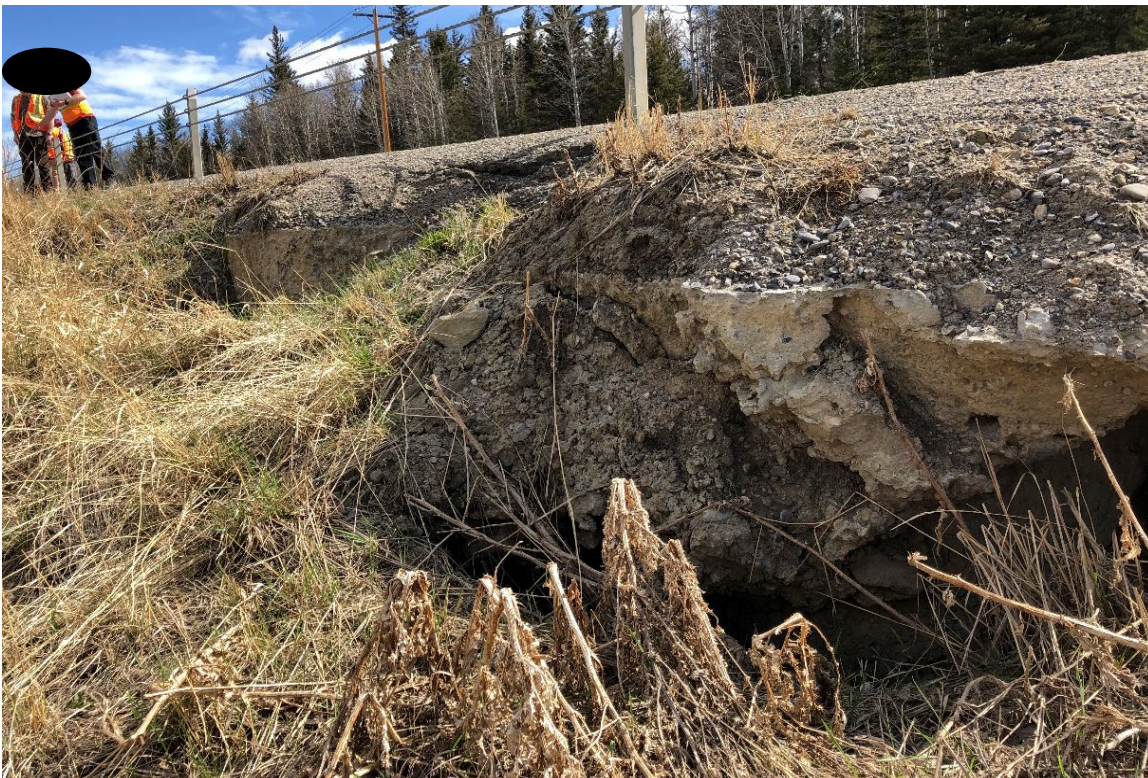
Photo 4 There has been approximately 600 mm of settlement of embankment fill downslope of the pile wall. Photo taken on May 16, 2022, facing north east.
