SITE NUMBER AND NAME: S008 Fisher Creek Pile Wall		HIGHWAY & KM: 762:02, 2.125	PREVIOUS INSPECTION DATE: May 16, 2022	INSPECTION DATE: May 9, 2023
LEGAL DESCRIPTION: 09-10-21-04 W5M	NAD 83 COORDINATES: UTM Northing Easting 11 5627342 678866		RISK ASSESSMENT: PF: 11 CF: 6 TOTAL: 66	
AVERAGE ANNUAL DAILY TRAFFIC (AADT): 700 (north) & 1320 (south) (Reference No. 65170 & 60180)			CONTRACTOR MAINTENANCE AREA (CMA): 27

PRIMARY SITE ISSUE: Settlement of the embankment slope downslope of the existing pile wall by up to 0.85 m, and development of a dip in the pavement north of the existing pile wall.

PROJECT SOUTHERN REGION GEOHAZARD RISK MANAGEMENT PROGRAM		
TITLE Site Plan S008 - Fisher Creek Pile Wall Hwy 762.02, km 2.125		
SCALE 1:1,500	PROJECT No. A05116A03	FIG No. 1

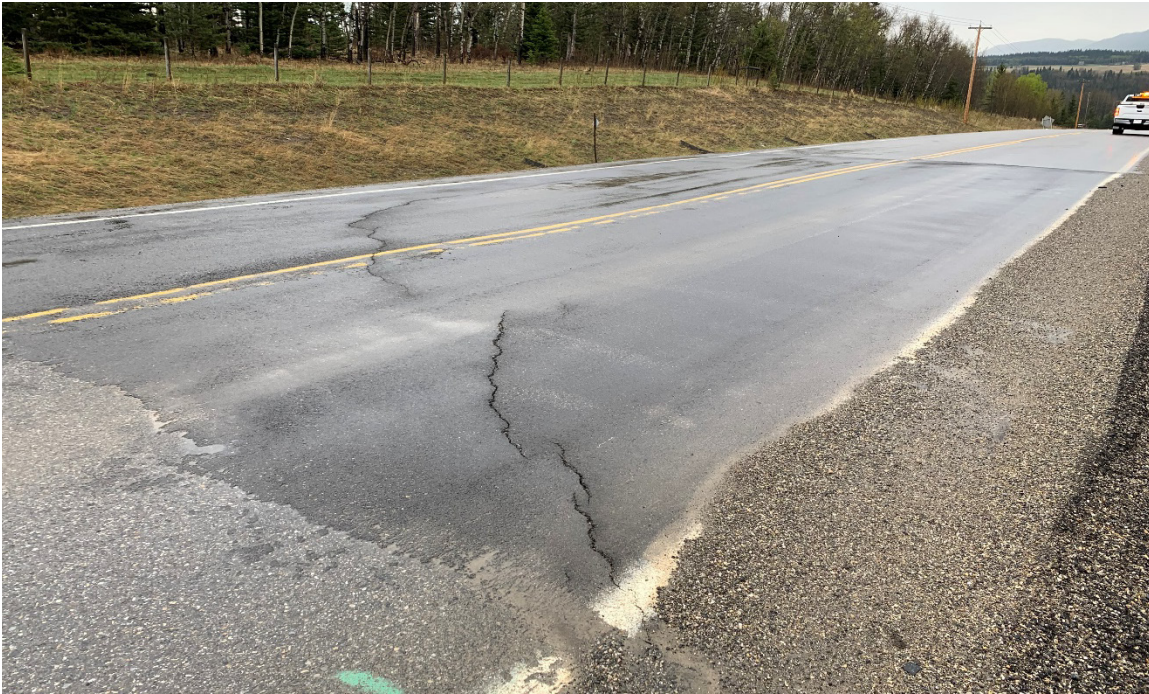
There is negligible movement being recorded in the pile-wall slope inclinometers and no pavement cracking has been observed directly upslope of the pile wall. However, pavement cracking and settlement in the highway approximately 24 m north of the pile wall (15 m north of the HTCB) has been observed since 2020. The previous pavement cracking observed during the 2022 inspection was visible through the asphalt overlay completed in fall 2022.

The pavement cracking and settlement north of the pile wall could indicate the slide has begun to outflank the pile wall.

Photo 1 Pavement cracking north of the pile wall. Cracking through patch installed in 2022. Photo taken facing southeast on May 9, 2023.

- The pavement cracks should be sealed to reduce surface water infiltration.
- The voids between the pile walls should be backfilled to reduce infiltration and potential erosion undermining the east (southbound) lane.
- The site should be regularly inspected as part of the Southern Region Section B inspections and instruments read as part of the Section C instrumentation monitoring.
- A borehole should be drilled through the pavement north of the pile wall and a slope inclinometer and piezometer(s) should be installed to monitor movement and groundwater conditions, respectively. A proposal for this work was submitted on December 15, 2022.

- The pile wall could be extended to the north, so the slide doesn't outflank the existing pile wall; or
- Stabilize the highway embankment by excavating and replacing embankment fill with geogrid reinforced granular fill.

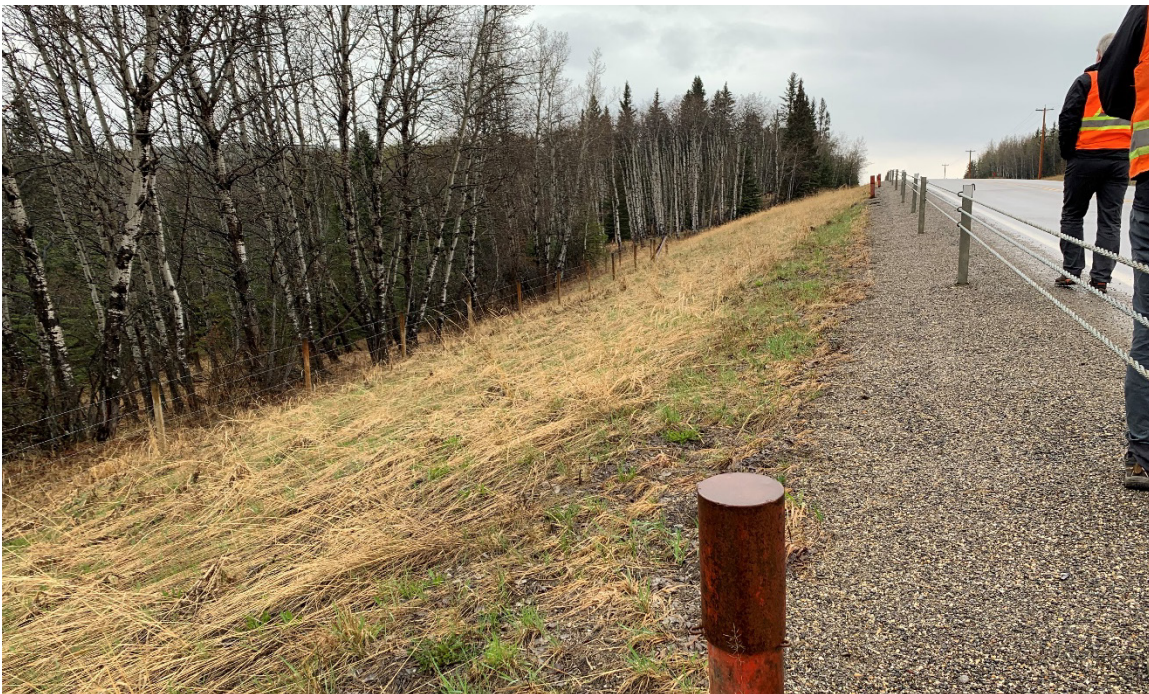
Photo 2 South end of pile wall. No slope movement noted. Photo taken facing north on May 9, 2023.

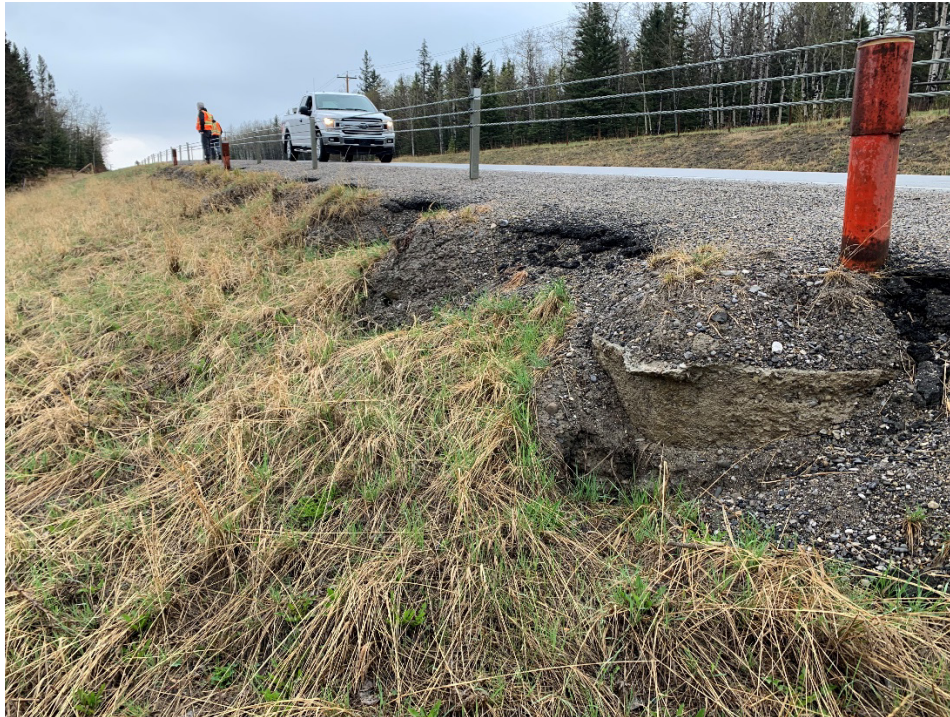
During the 2023 inspection, cracking and settlement of the embankment downslope of the pile wall was visible and the ground surface had dropped by up to 850 mm, creating a ledge that could potentially pond water, leading to increased infiltration.

Surface water runoff has enlarged existing sinkholes at the pile locations and contributed to embankment settlement downslope of the pile wall.

Photo 3 Settlement downslope of pile wall, exposed concrete pile. Photo taken facing north on May 9, 2023.

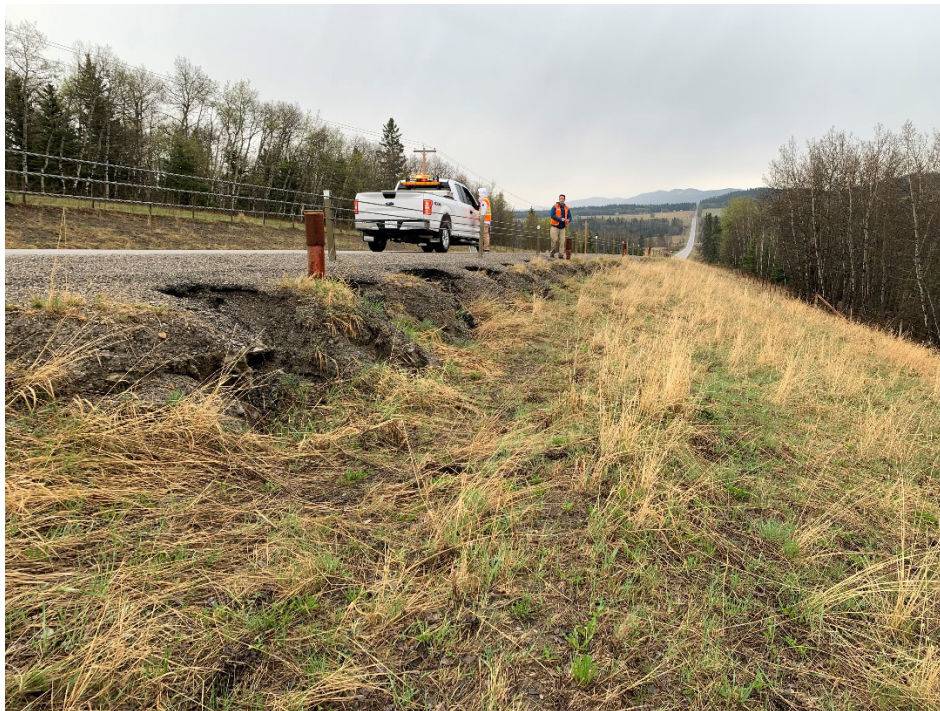
Photo 4 Settlement downslope of pile wall. Photo taken facing south on May 9, 2023.
