November 29, 2024

**CON0022161 Southern Region GRMP Instrumentation Monitoring
Site S008; H762:02, km 2.125 Fisher Creek Pile Wall
Section C – 2024 Fall Readings**

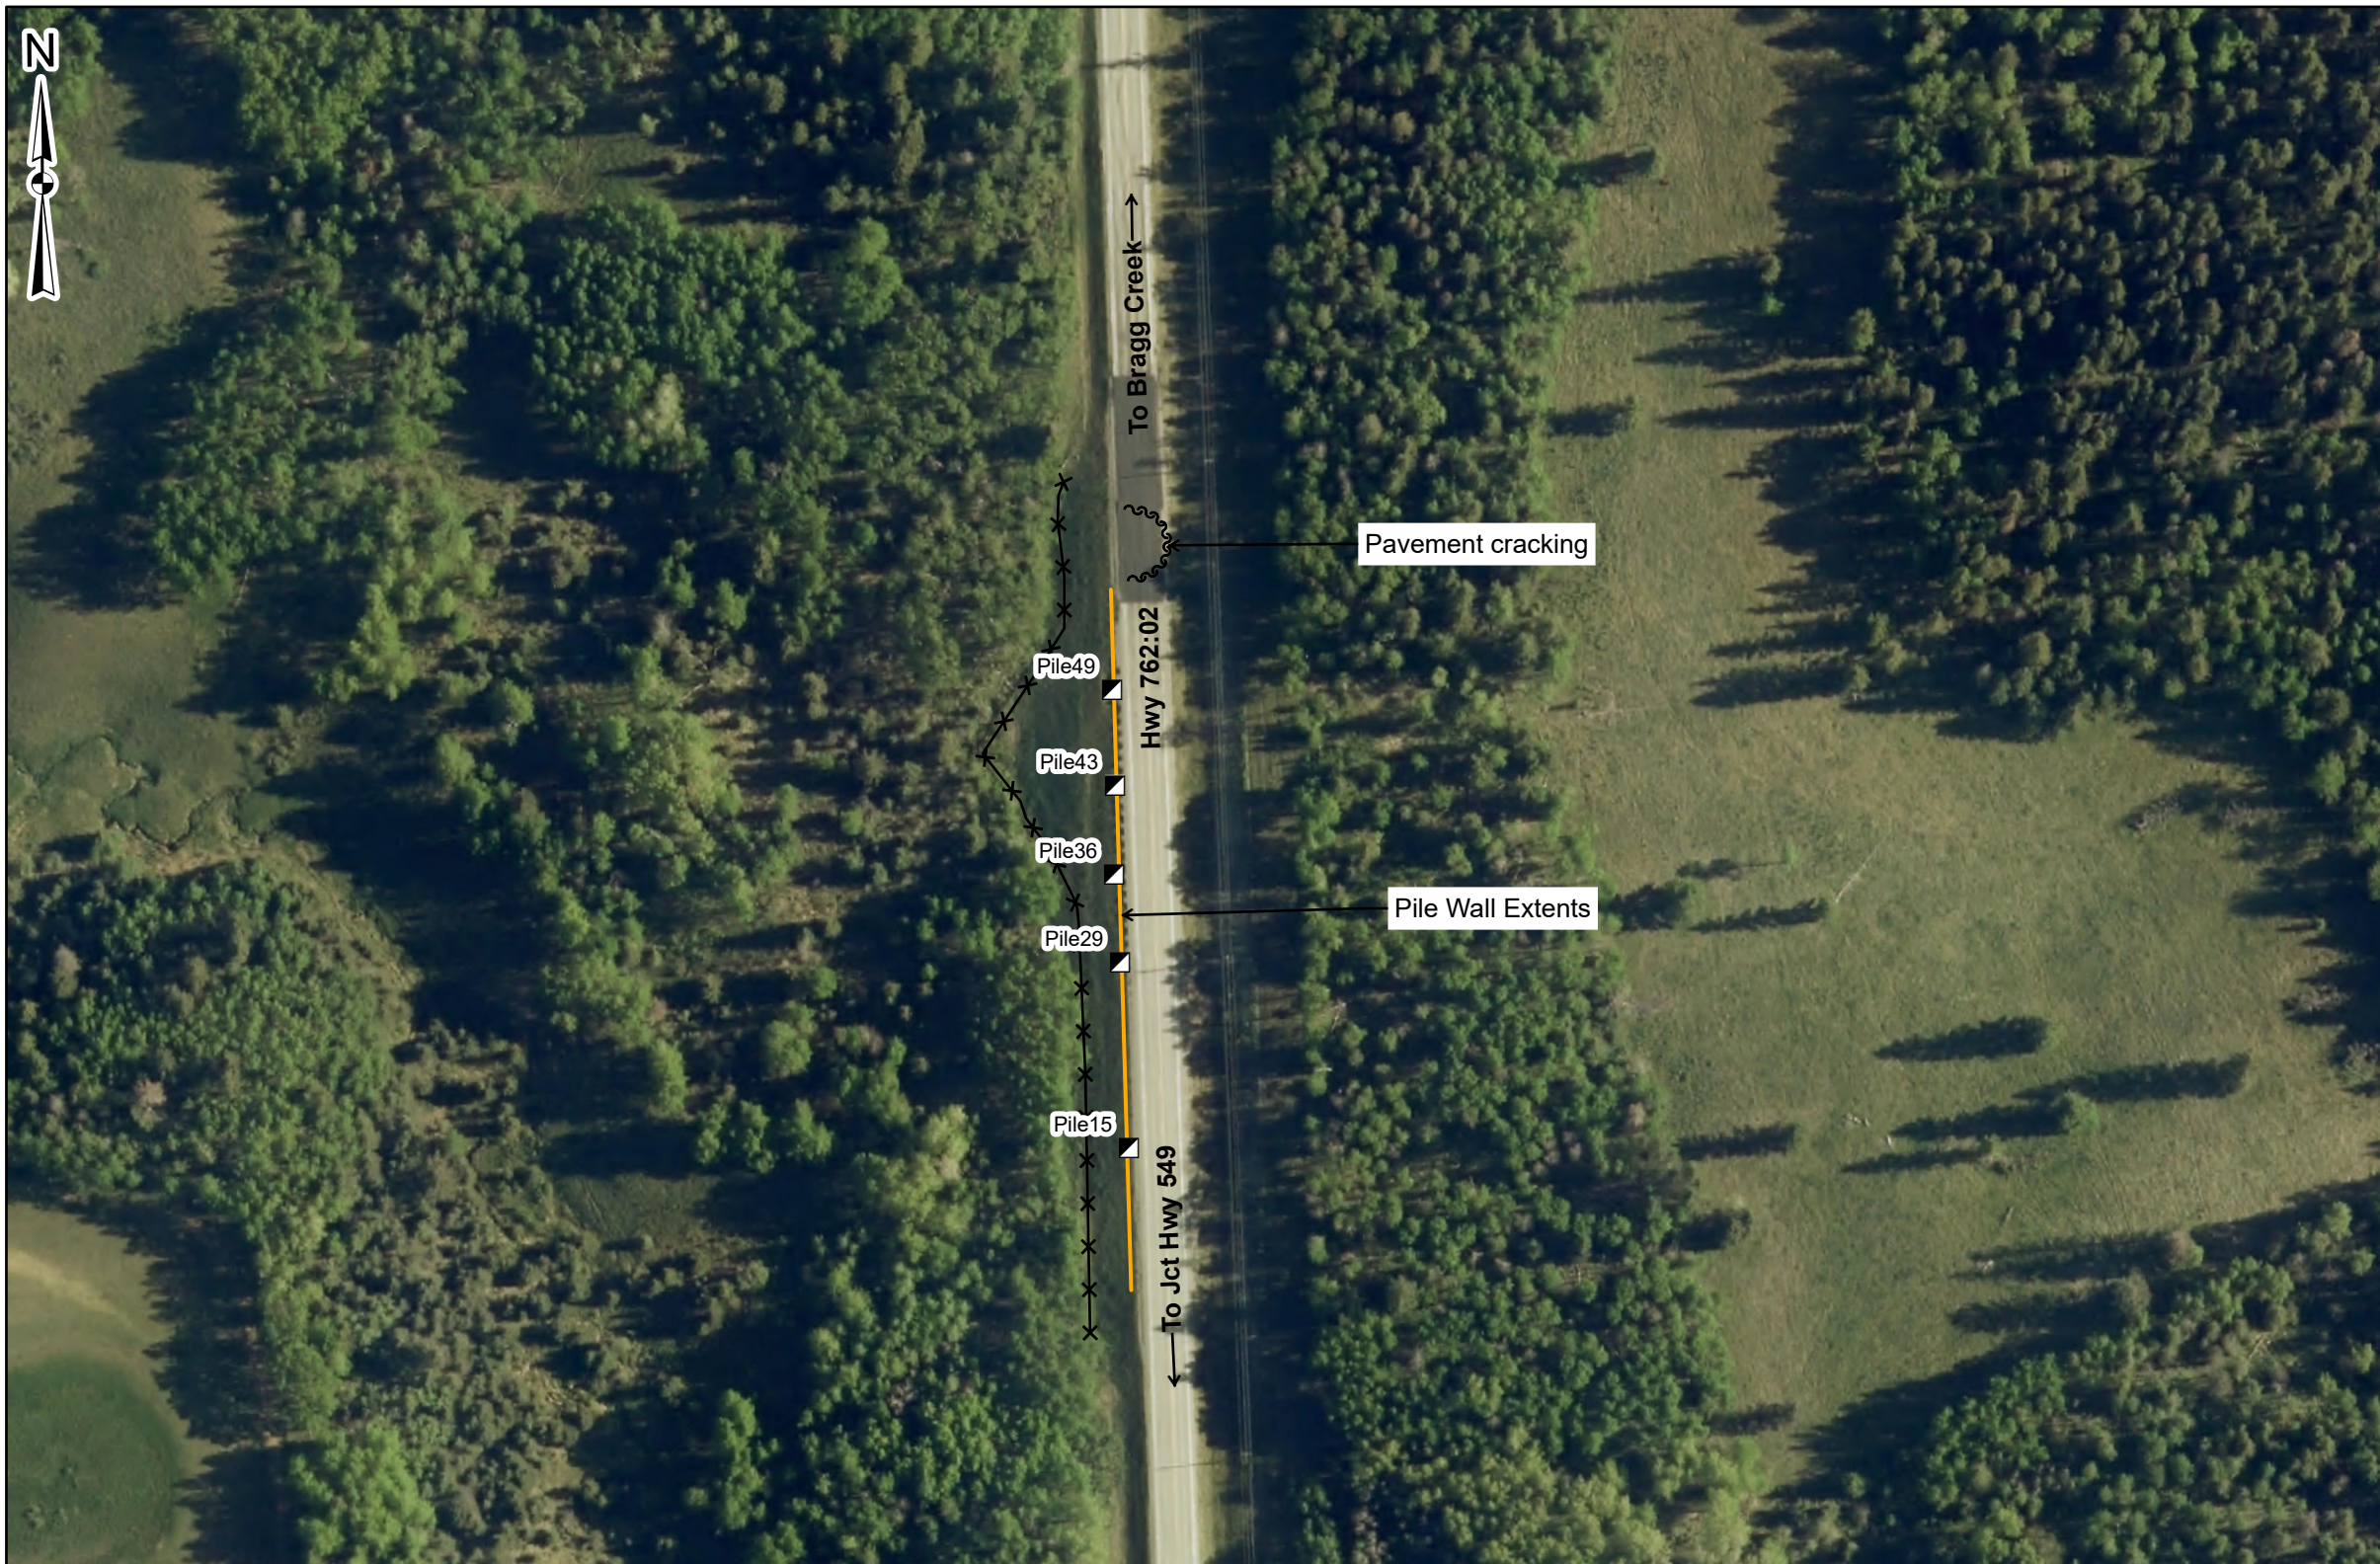
PROJECT SOUTHERN REGION GEOHAZARD RISK MANAGEMENT PROGRAM		
TITLE Site Plan S008 - Fisher Creek Pile Wall Hwy 762:02, km 2.125		
SCALE 1:1,500	PROJECT No. A05116A03	FIG No. 1

The pavement distress north of the pile wall could indicate the slide is outflanking the pile wall at its north extent. No discernable movement has been recorded in Pile 49, the closest SI to the pavement distress, since 2021.

KCB recommends that a borehole be drilled approximately 24 m north of the existing pile wall where pavement distress is observed. A SI should then be installed in the borehole to monitor movement at this location. A proposal for this work was issued in December 2022 and reissued in July 2024. Drilling is expected to be completed in January 2025. KCB is updating the proposal to include design and tendering services to remediate the area north of the pile wall.

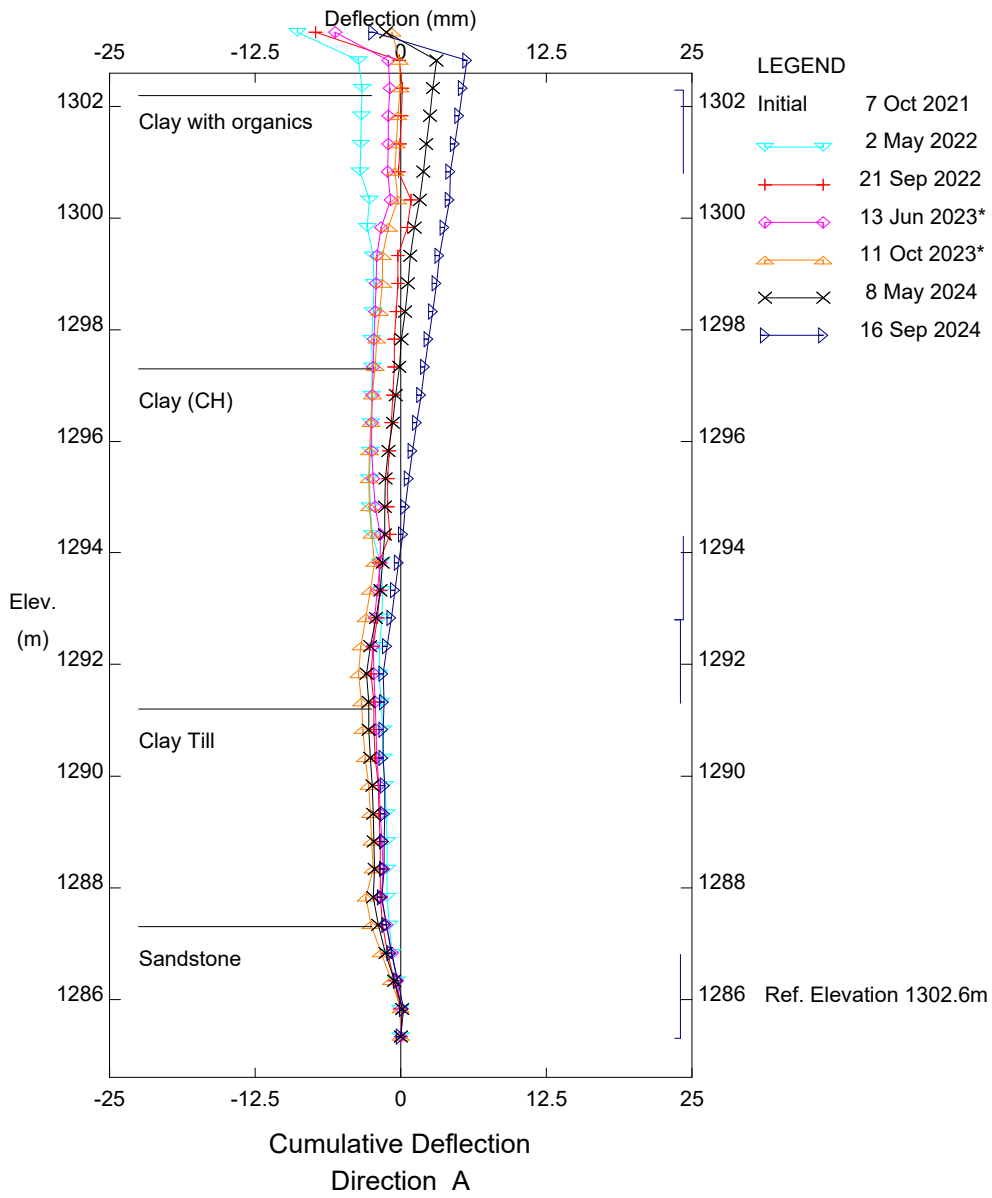
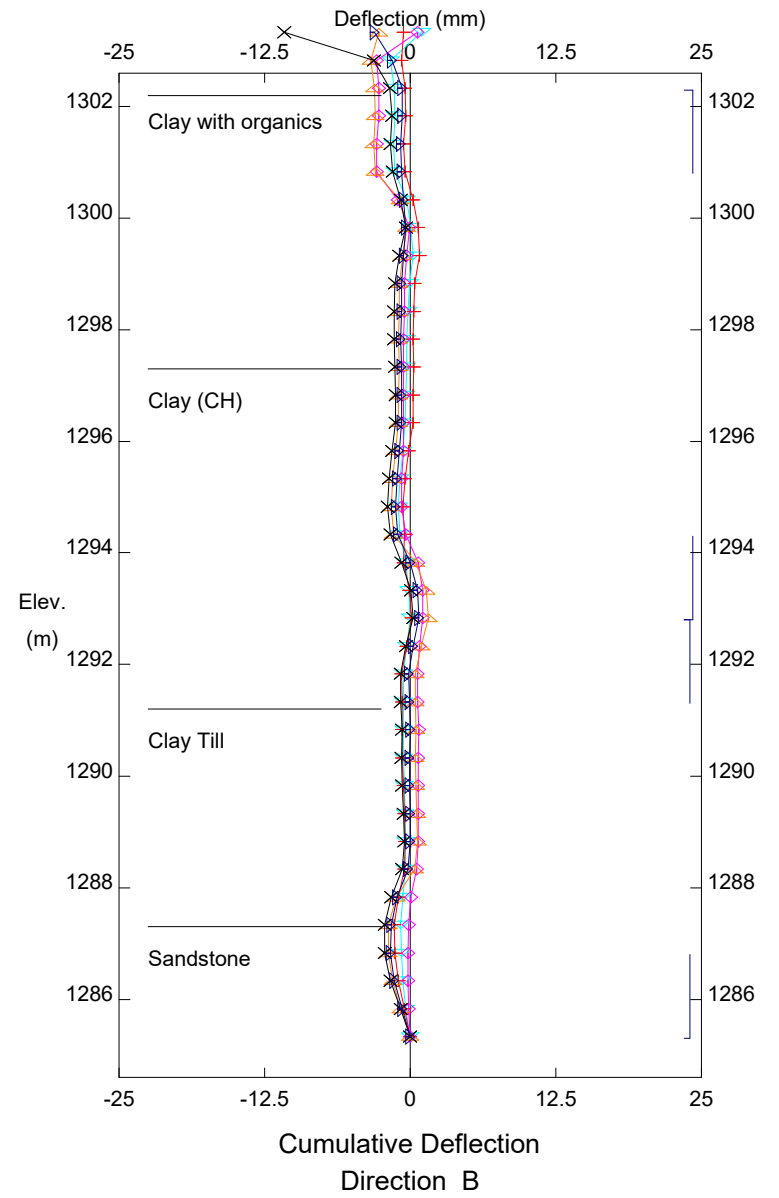
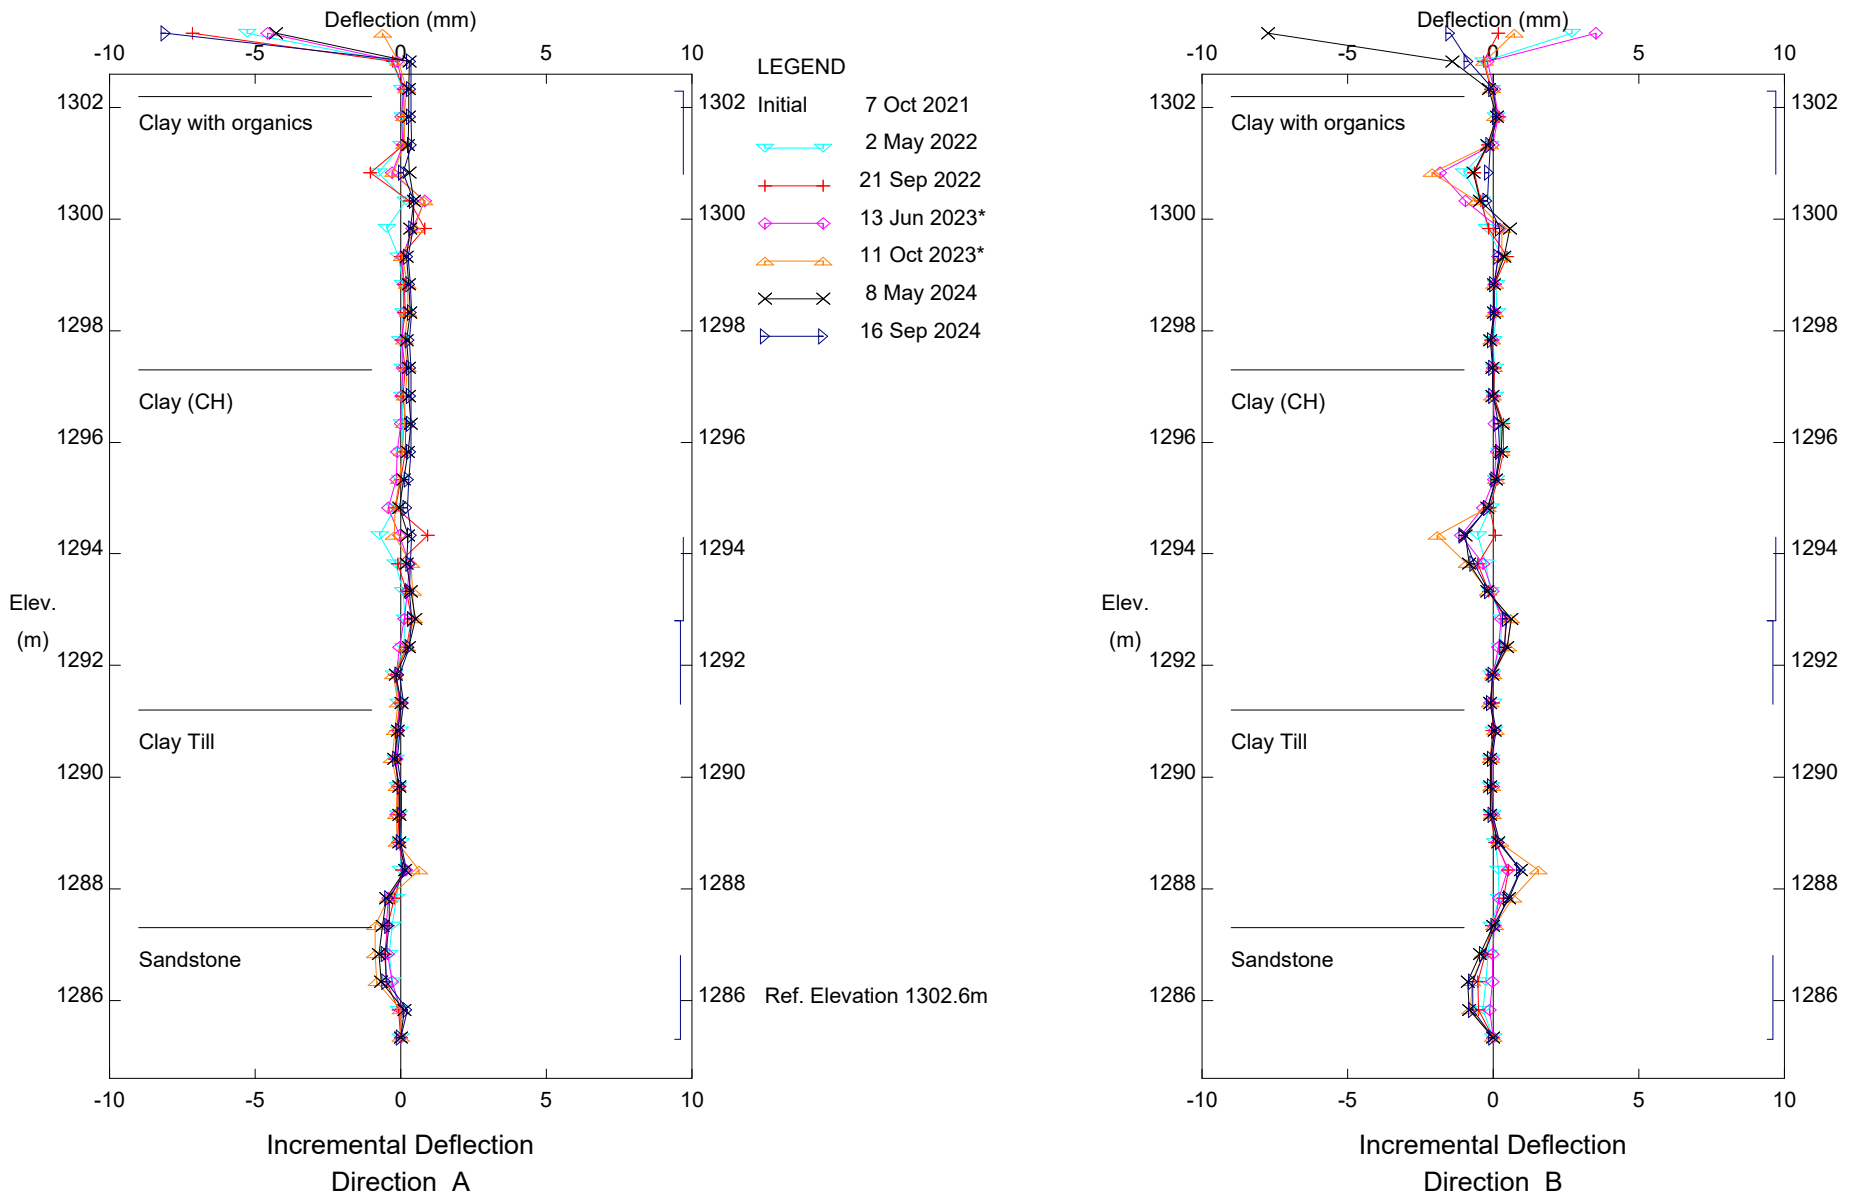
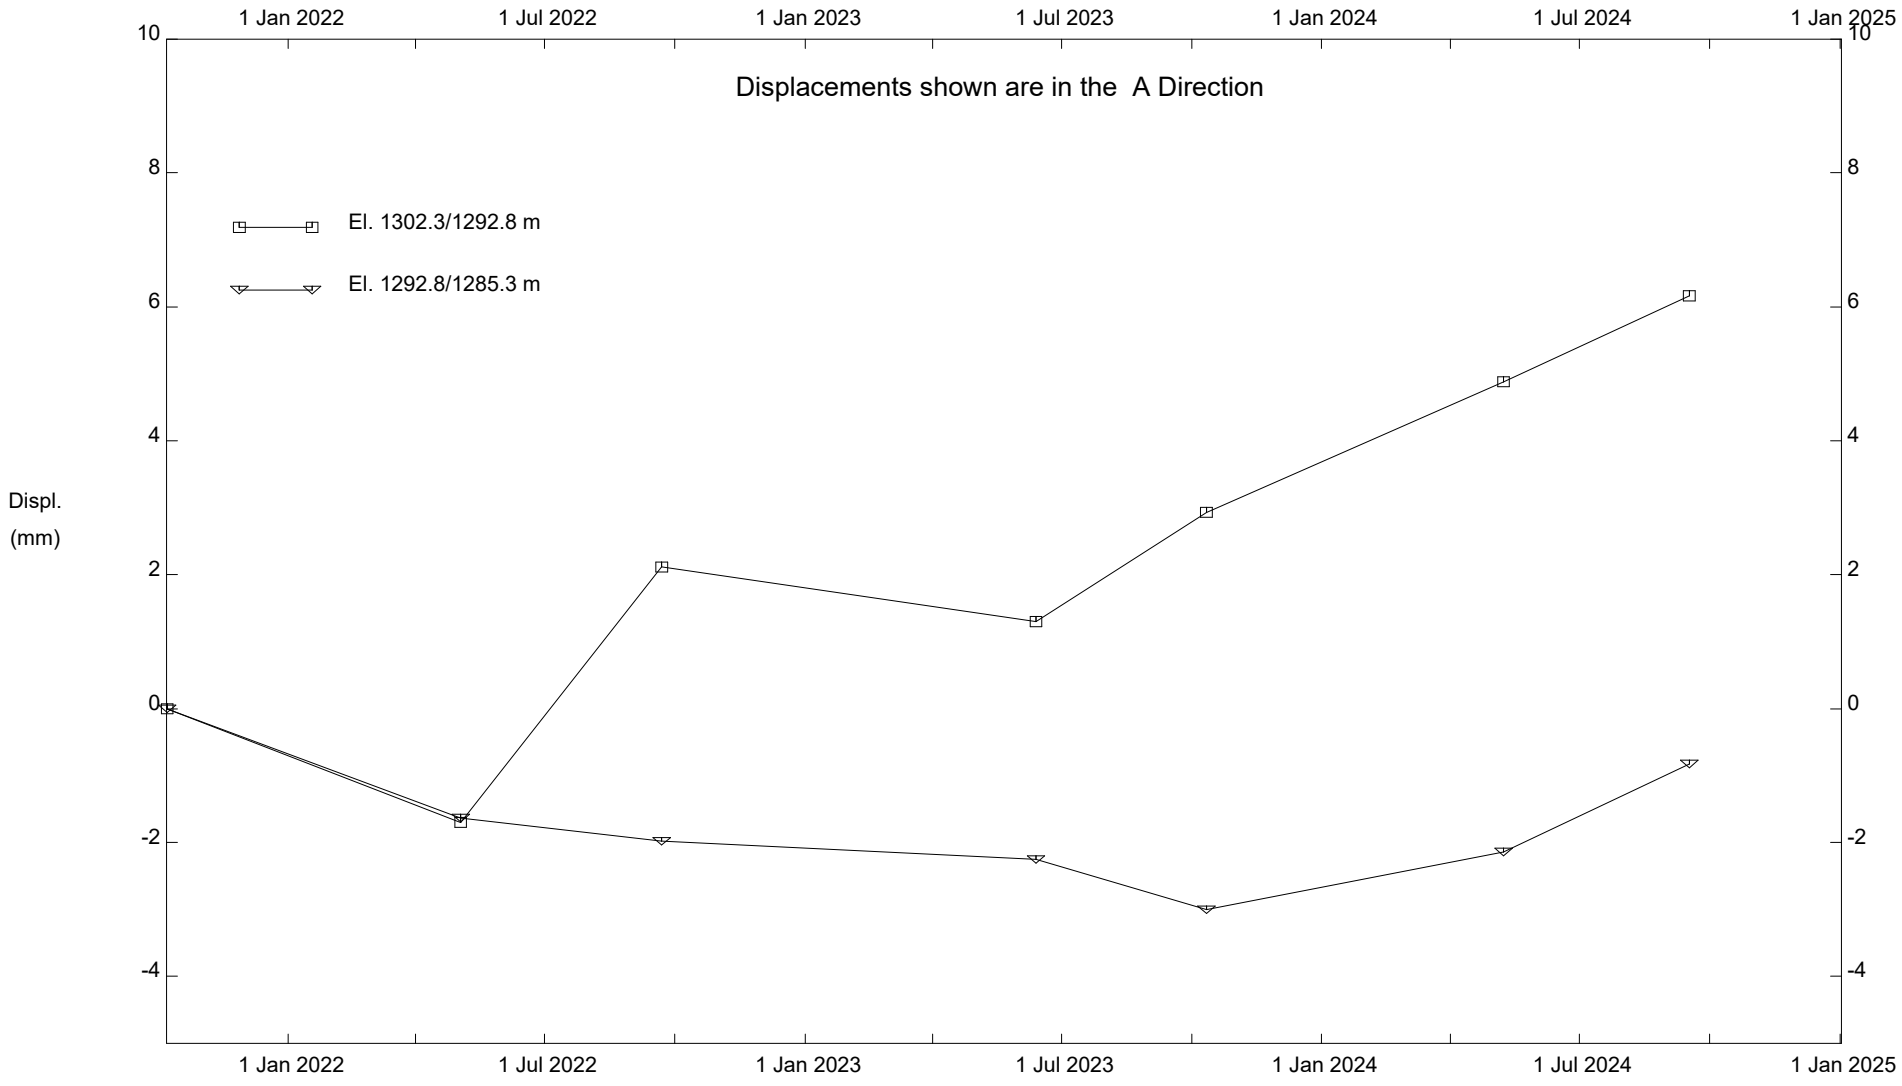
S008; H762:02, Fisher Creek, Inclinator PILE15

Initial movement (less than 10 mm) was recorded in the base of Pile 15, Pile 36, and Pile 49 in early 2017, within six months of pile wall installation. Those movements have since attenuated and are no longer discernible.

Movement has been recorded in Pile 15, located approximately 35 m from the south end of the pile wall, in the B-direction at what appears to be SI casing joints, based on an approximate spacing of 3 m intervals between joints.

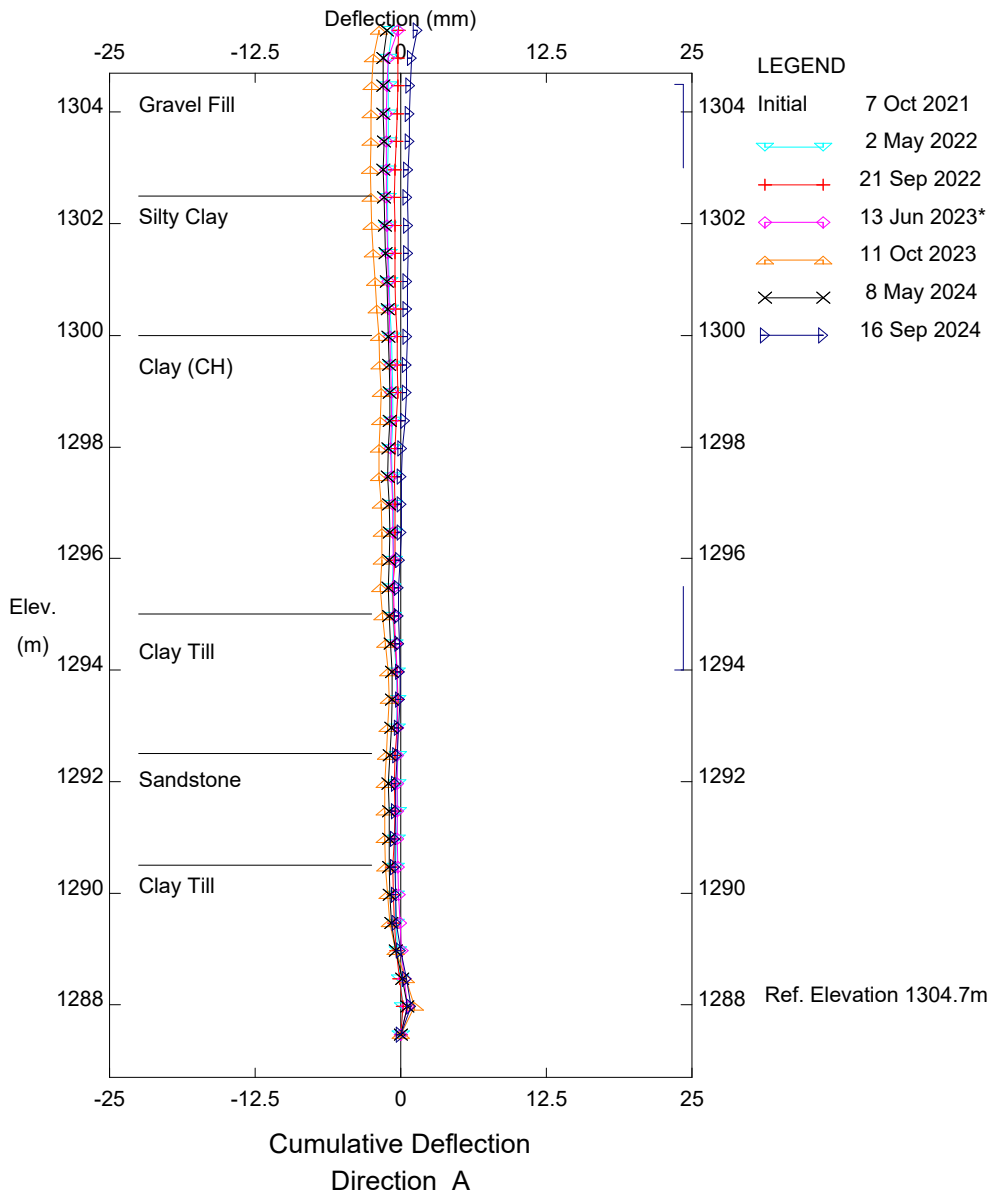
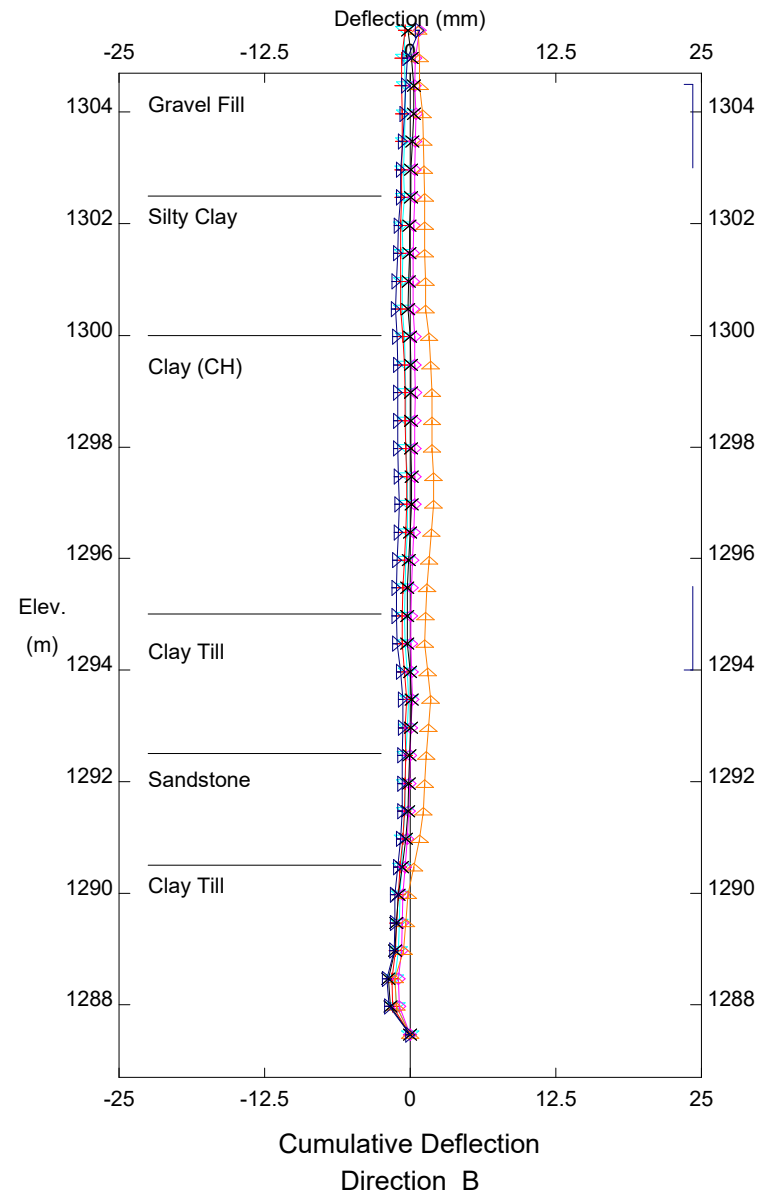
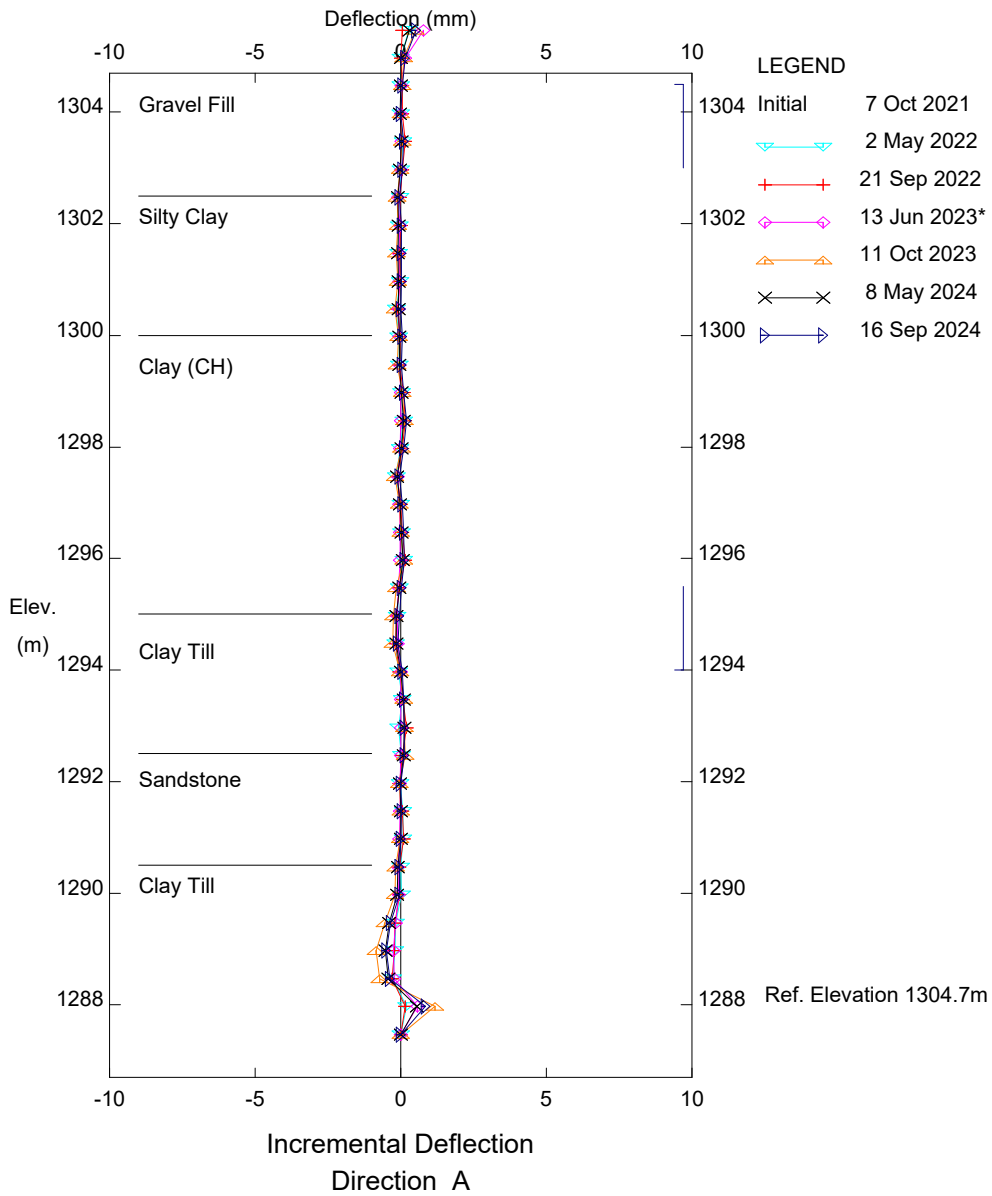
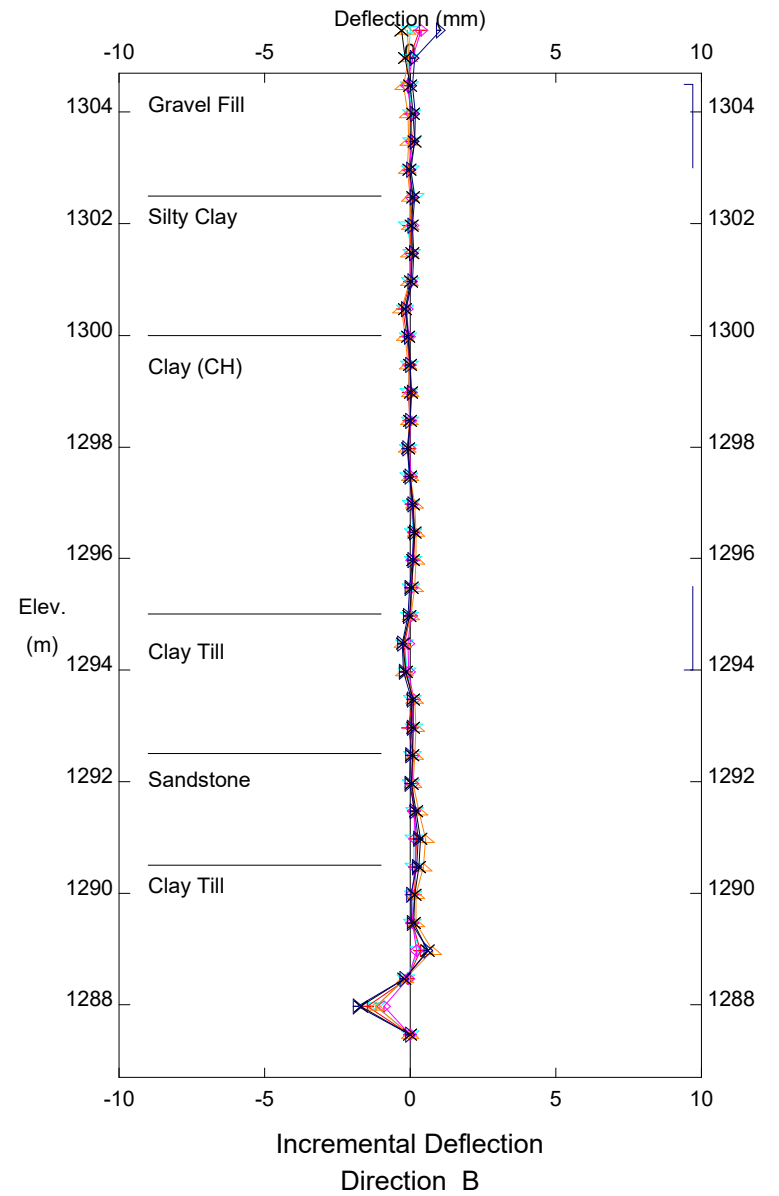
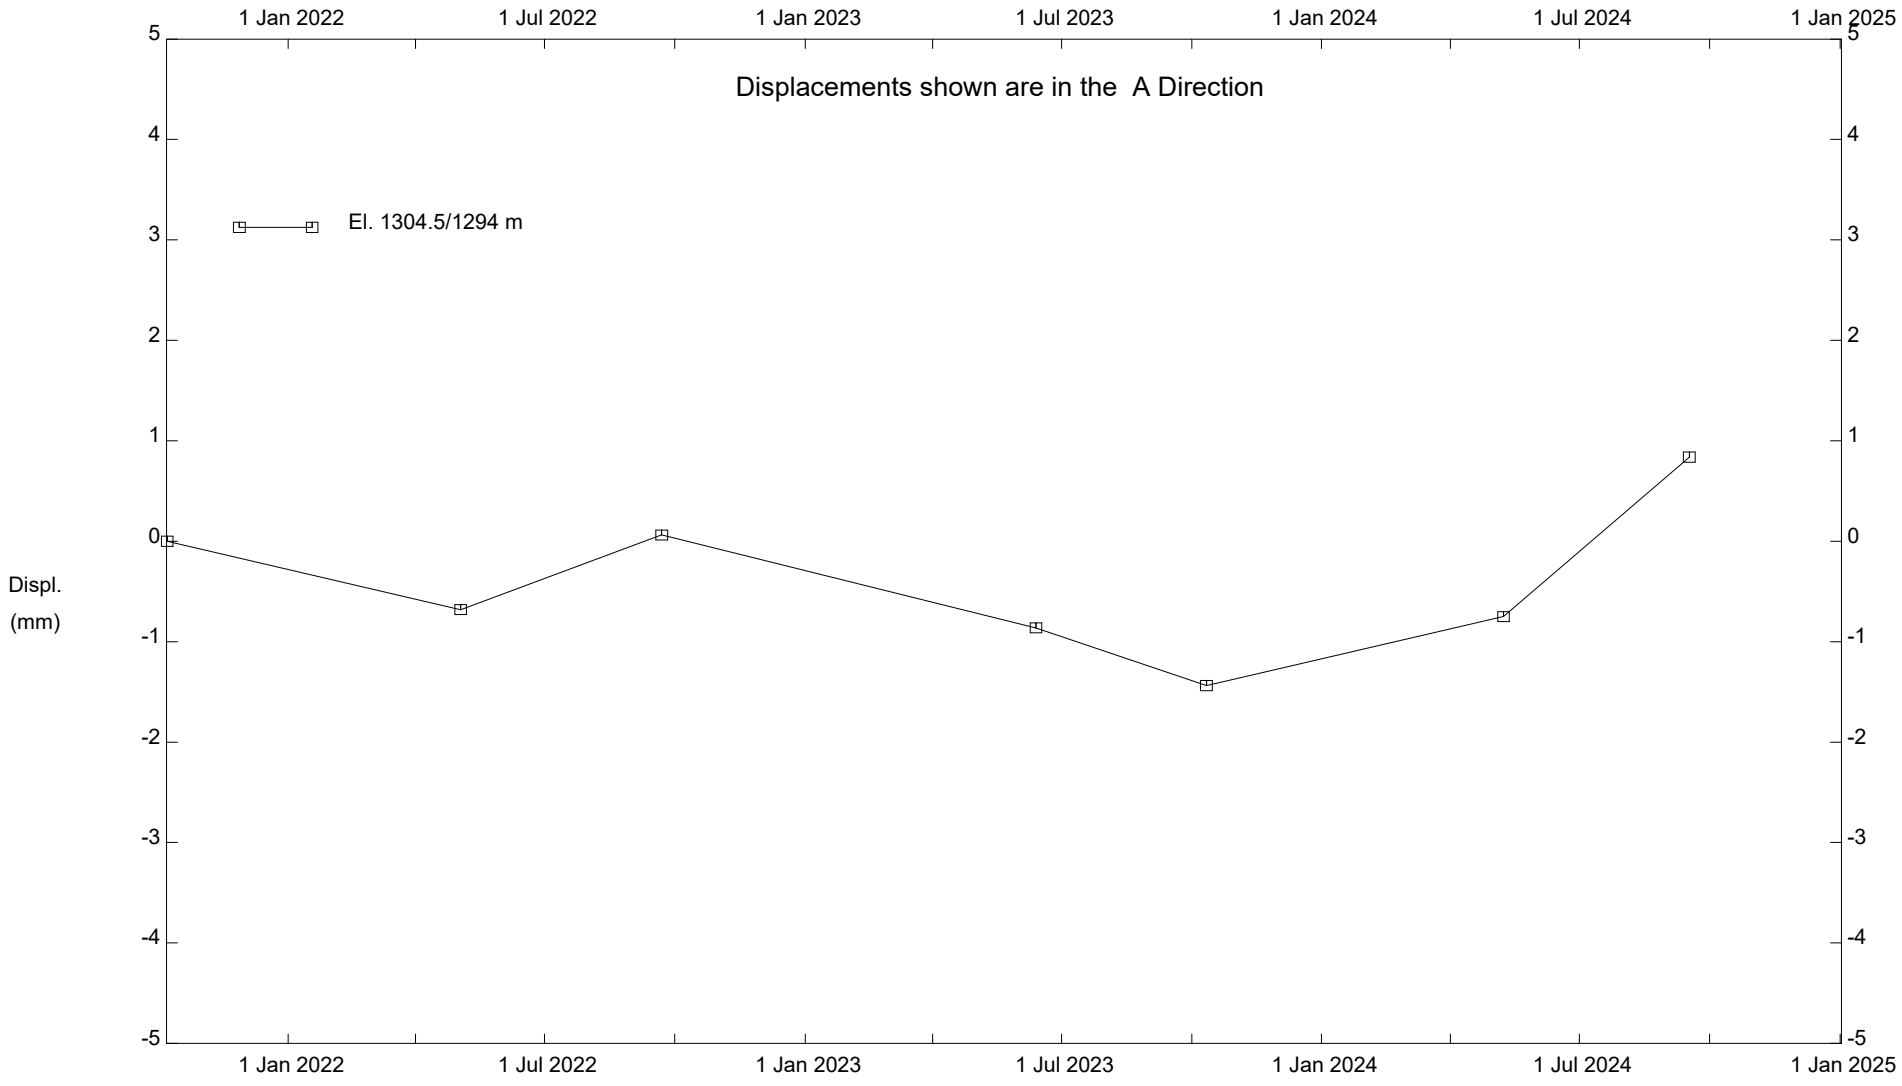
S008; H762:02, Fisher Creek, Inclinometer PILE29

Since being re-initialized to the October 2021 reading, no discernible movement has been recorded in Pile 29, Pile 43, or Pile 49.
