November 29, 2024

**CON0022161 Southern Region GRMP Instrumentation Monitoring
Site S008; H762:02, km 2.125 Fisher Creek Pile Wall
Section C – 2024 Fall Readings**

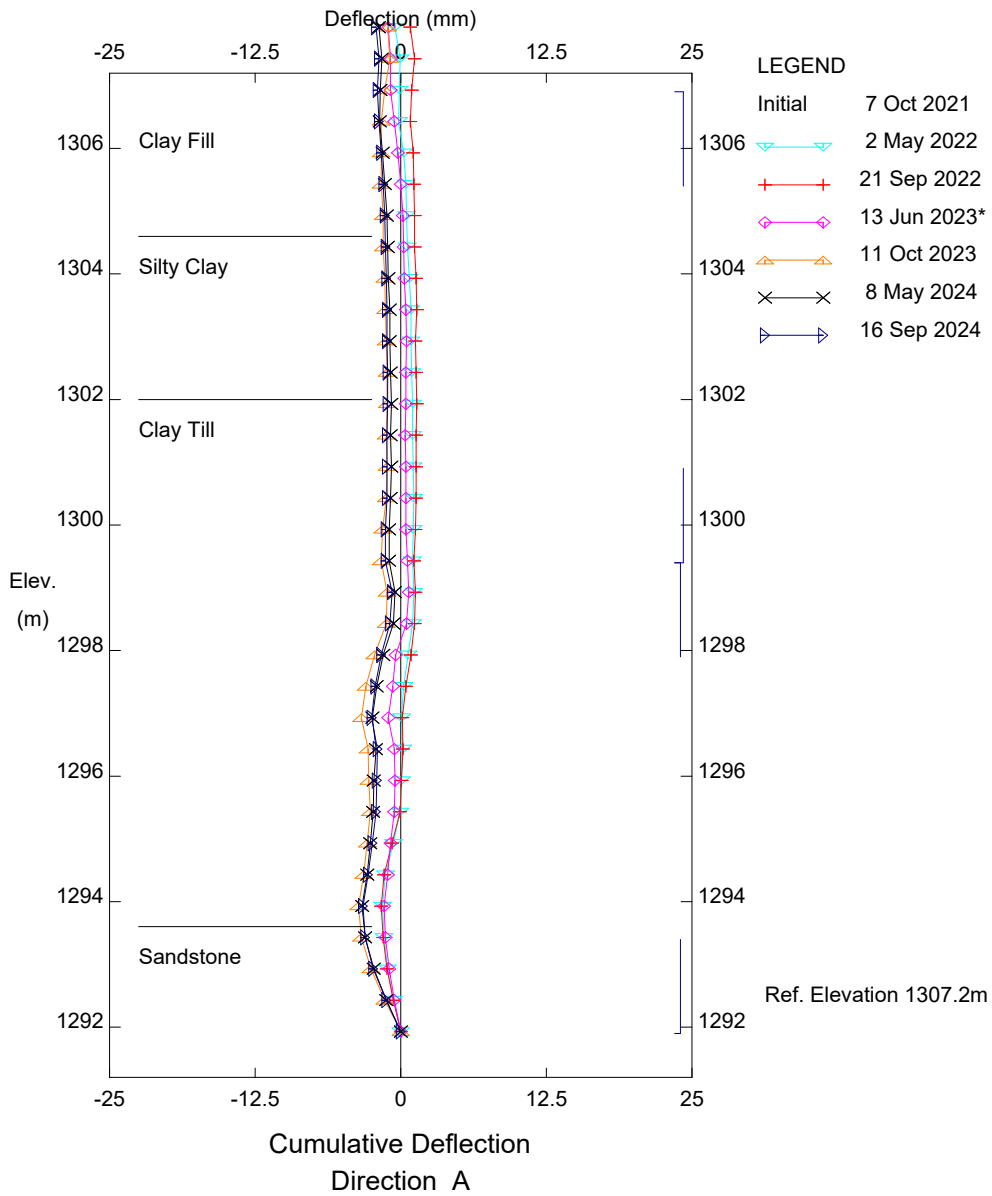
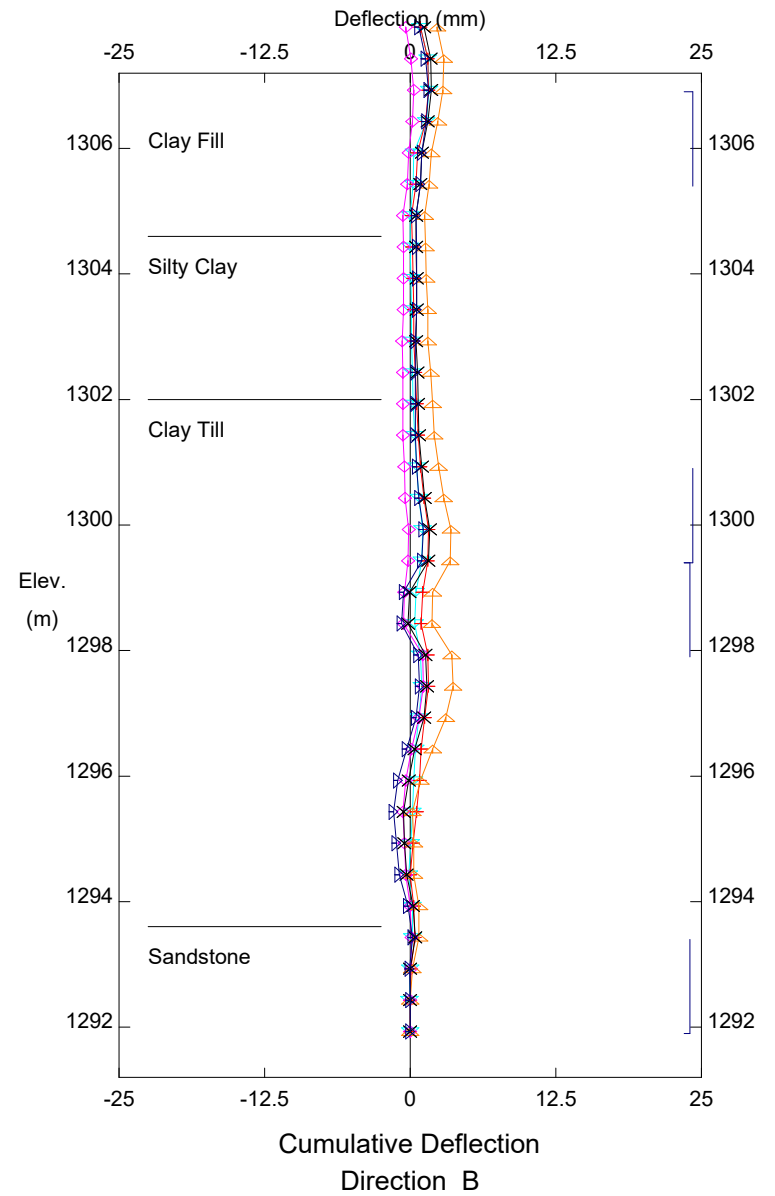
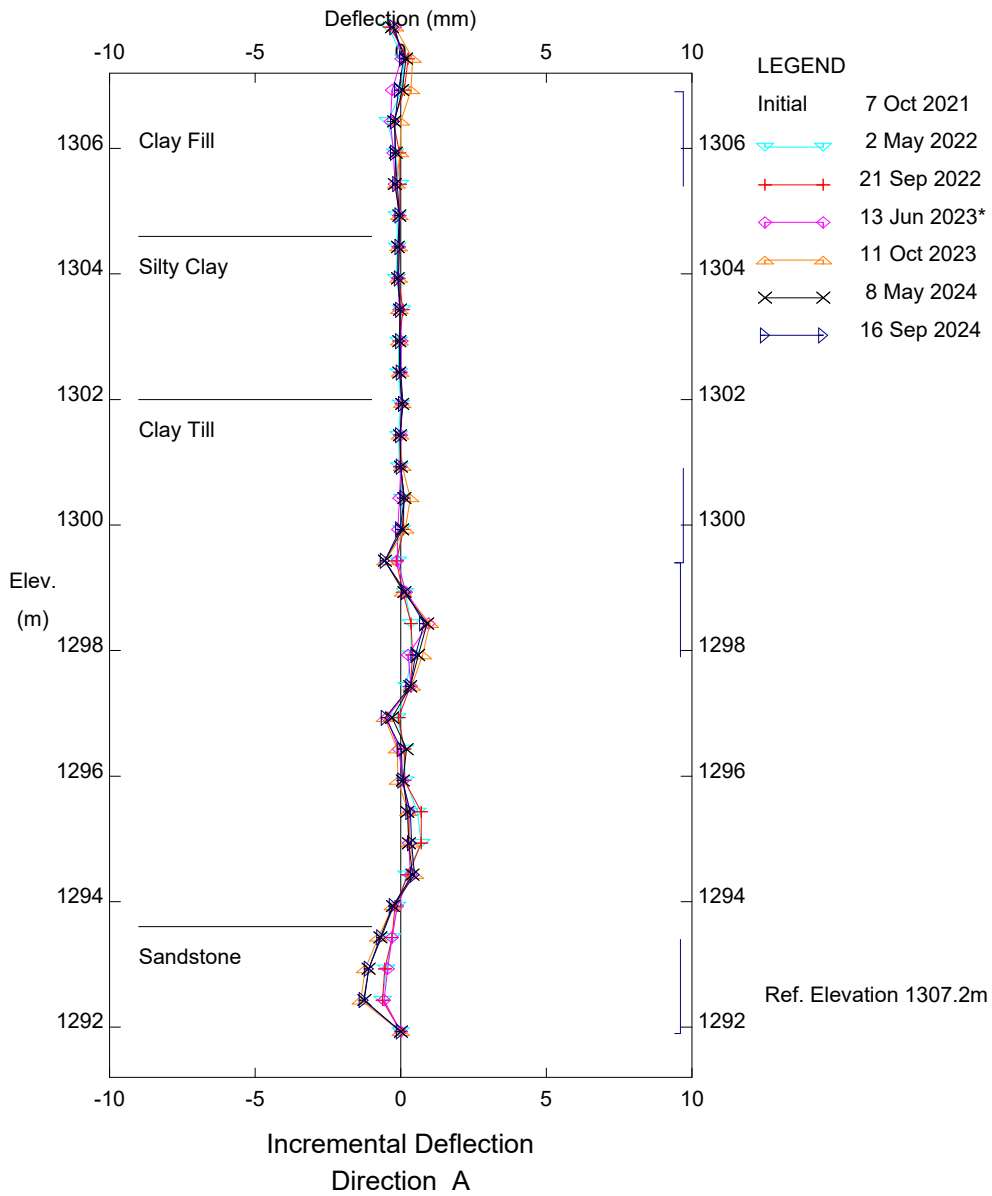
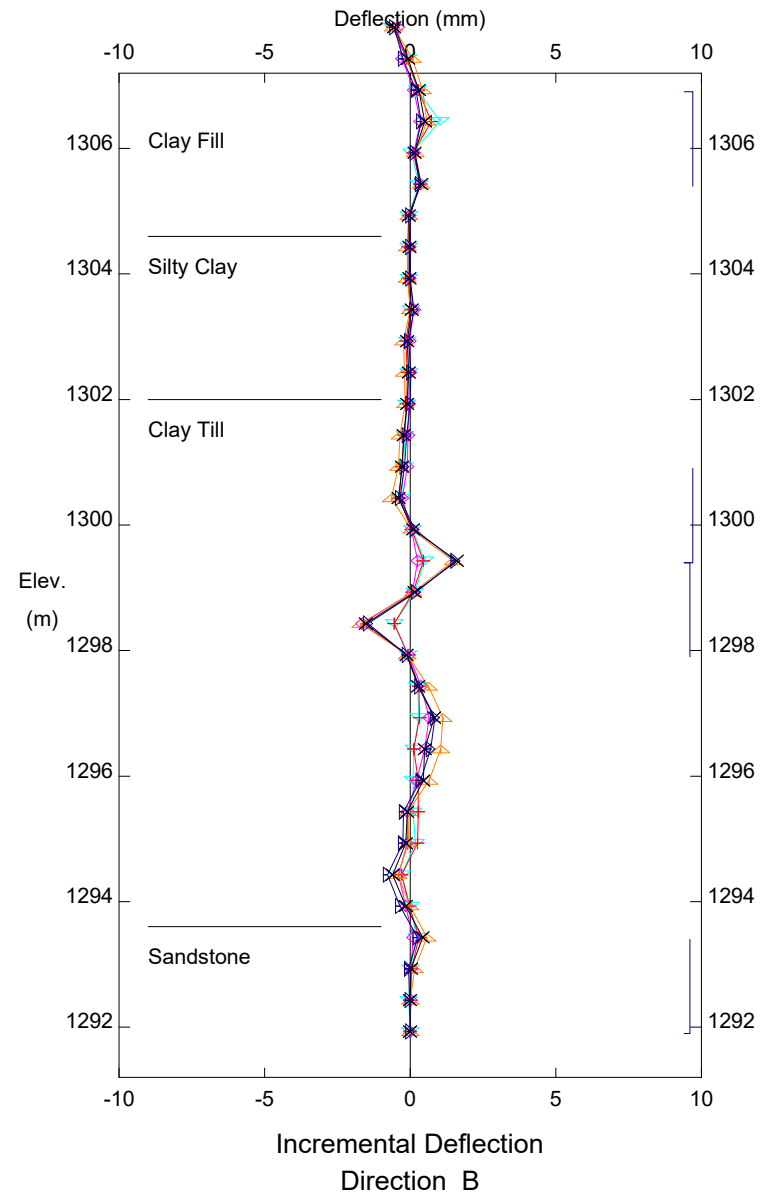
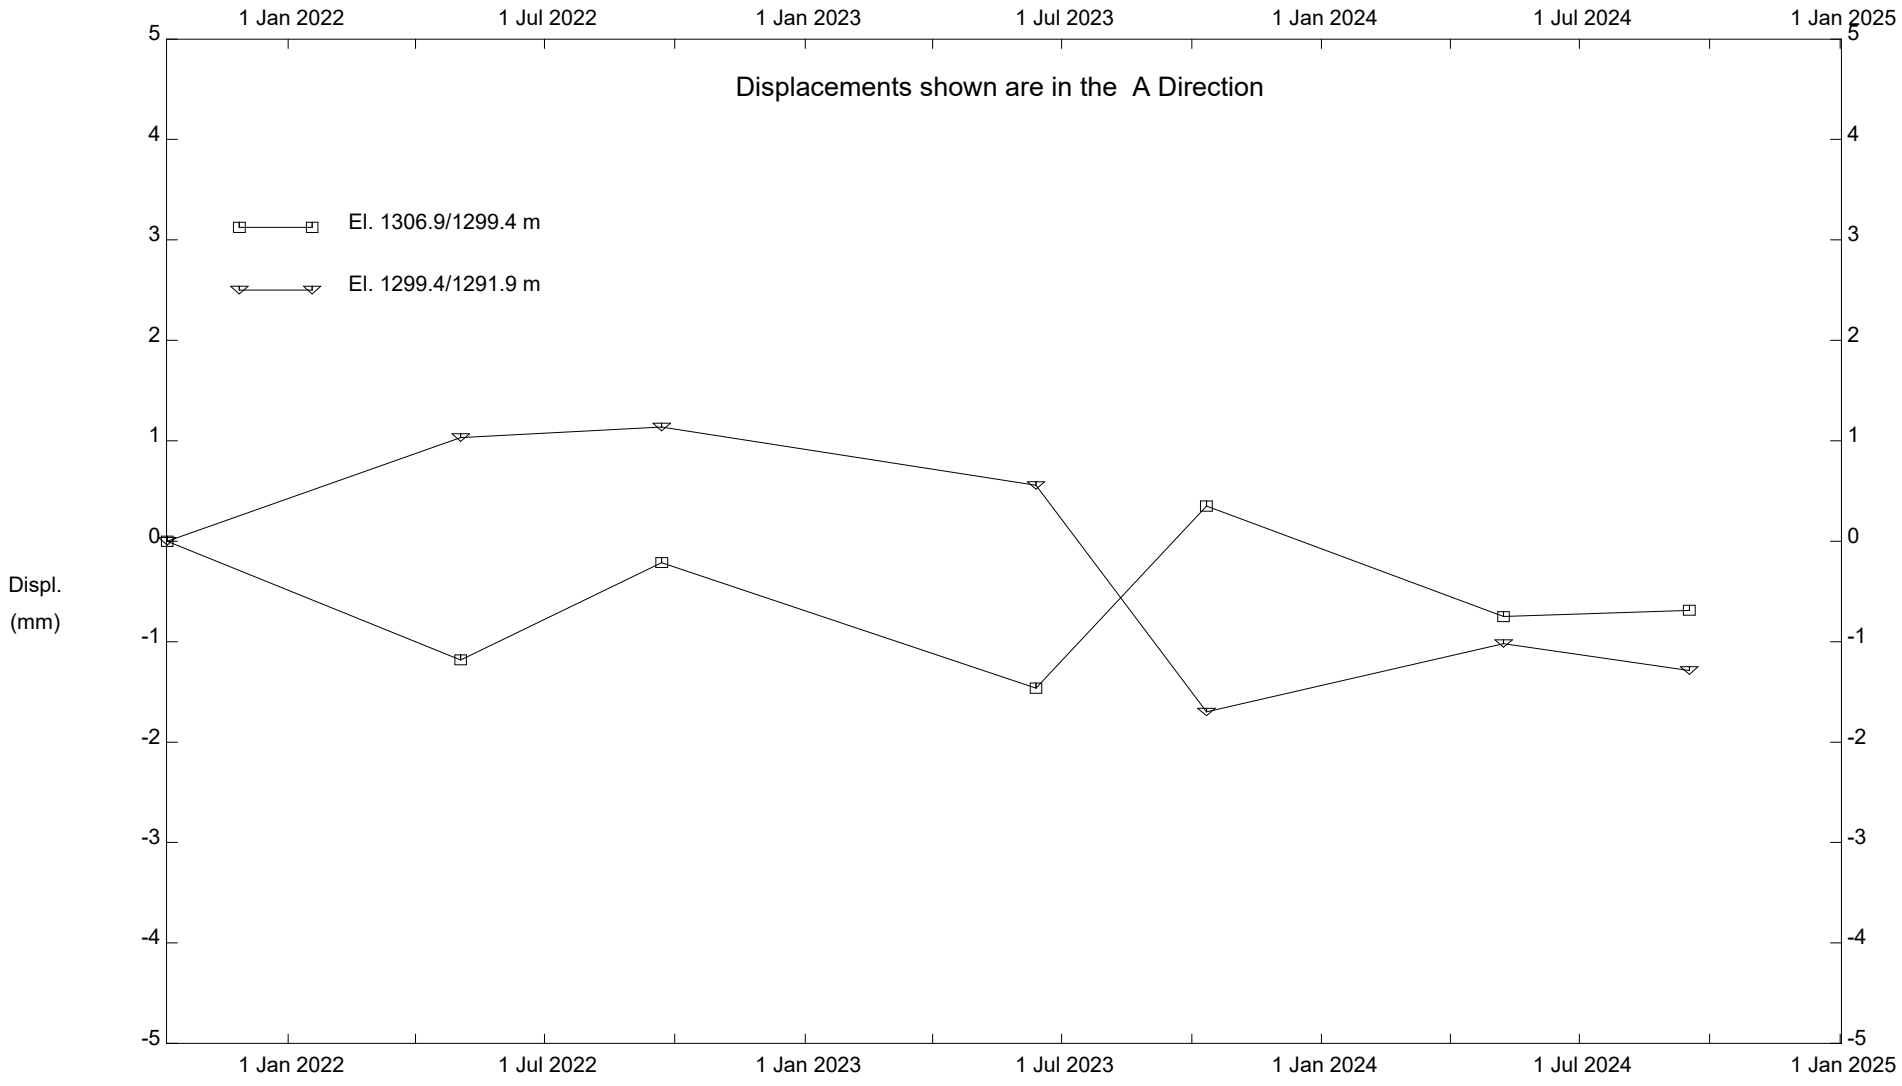
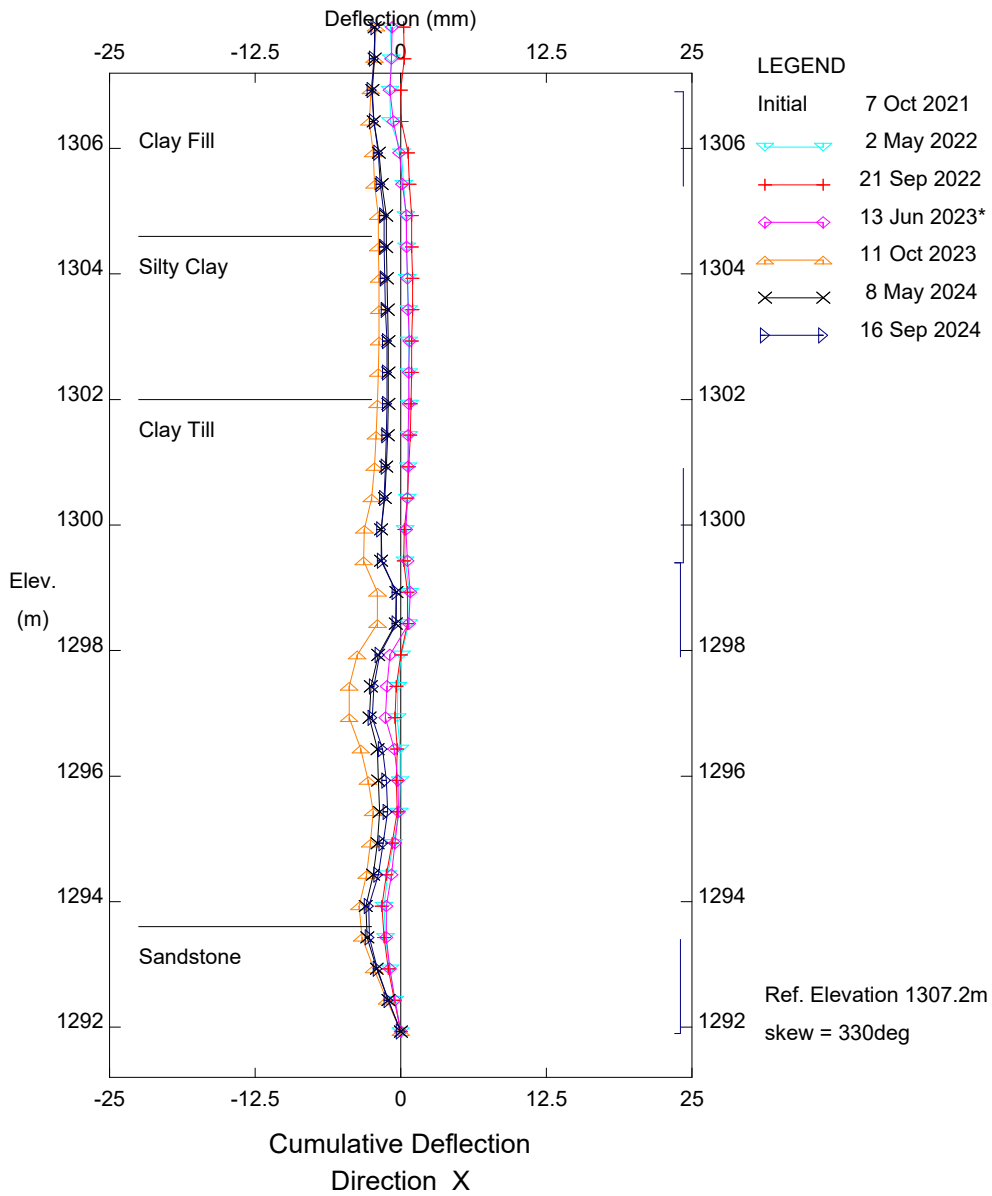
S008; H762:02, Fisher Creek, Inclinator PILE49

The pavement distress north of the pile wall could indicate the slide is outflanking the pile wall at its north extent. No discernable movement has been recorded in Pile 49, the closest SI to the pavement distress, since 2021.
