SITE NUMBER AND NAME: S008 Fisher Creek Pile Wall		HIGHWAY & KM: 762:02, 2.125	PREVIOUS INSPECTION DATE: May 9, 2023	INSPECTION DATE: May 28, 2024
LEGAL DESCRIPTION: 09-10-21-04 W5M	NAD 83 COORDINATES: UTM Northing Easting 11 5627342 678866		RISK ASSESSMENT: PF: 10 CF: 6 TOTAL: 60	
AVERAGE ANNUAL DAILY TRAFFIC (AADT): 1090 (north) & 1380 (south) (Reference No. 65170 & 60180)			CONTRACTOR MAINTENANCE AREA (CMA): 27

PRIMARY SITE ISSUE: Settlement of the embankment slope downslope of the existing pile wall by up to 0.85 m, and development of a dip in the pavement north of the existing pile wall.

PROJECT SOUTHERN REGION GEOHAZARD RISK MANAGEMENT PROGRAM		
TITLE Site Plan S008 - Fisher Creek Pile Wall Hwy 762.02, km 2.125		
SCALE 1:1,500	PROJECT No. A05116A03	FIG No. 1

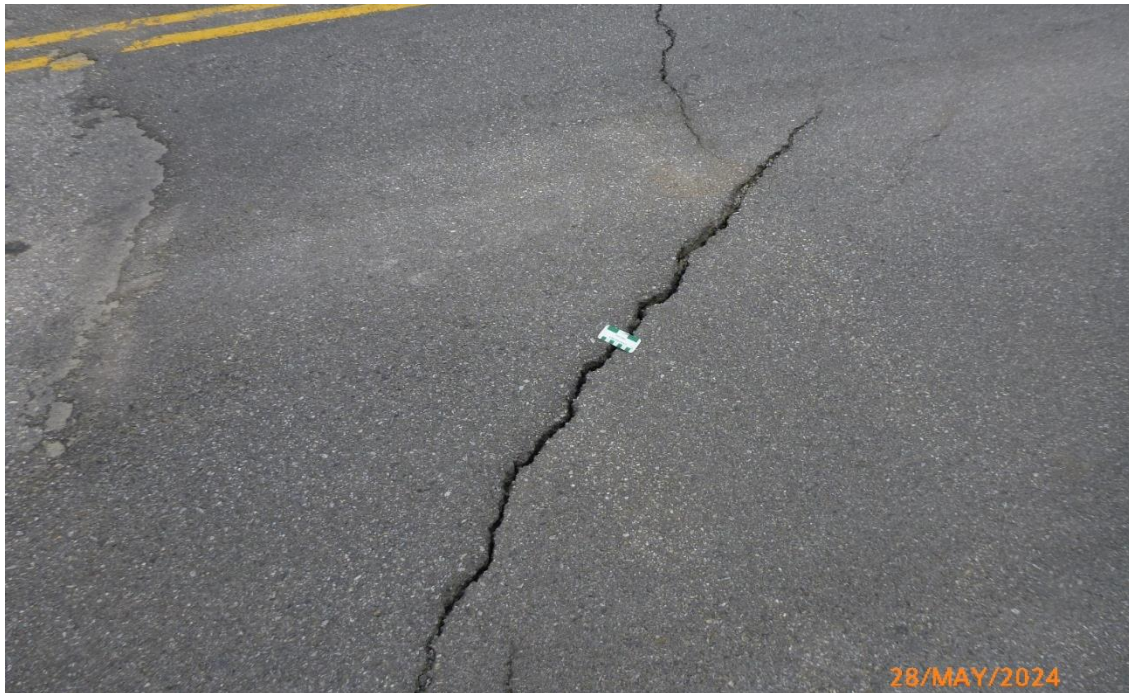
ITEM	CONDITION EXISTS		DESCRIPTION AND LOCATION	NOTICABLE CHANGE FROM LAST INSPECTION	
	YES	NO		YES	NO
Pavement Distress	X		Pavement cracking is 6 m long and up to 15 mm wide in the northbound lane, approximately 24 m north of the existing pile wall. Cracking showing through new overlay completed in 2022	X	
Slope Movement	X		Slope movement downslope of pile wall and sinkholes at individual pile locations.	X	
Erosion	X		Downstream slope is well vegetated with grass. Erosion is visible between the concrete piles where downstream slope has settled.	X	
Seepage		X	N/A – none observed		X
Culvert Distress		X	N/A – none observed		X

Photo 1 Pavement cracking north of the pile wall. Cracking through patch installed in 2022. Photo taken facing southeast on May 28, 2024.

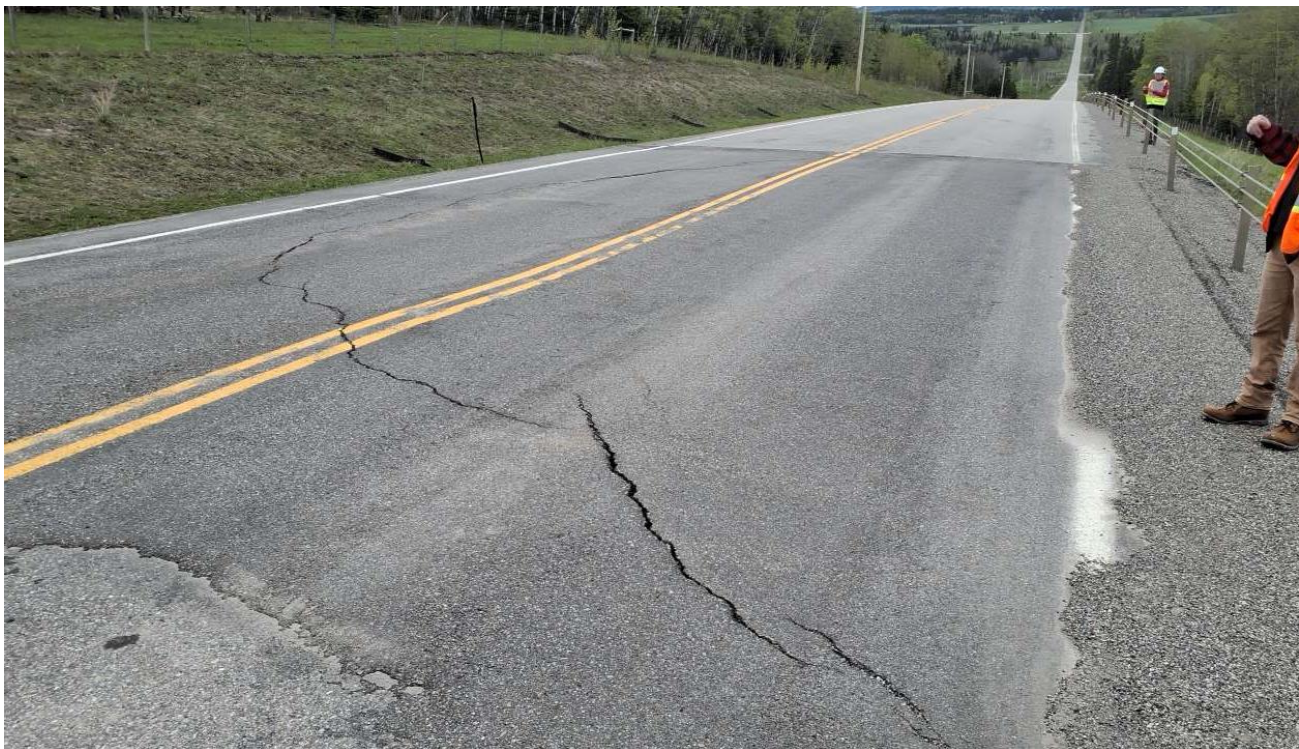
Photo 2 Cracking in the northbound lane. Photo taken facing south on May 28, 2024

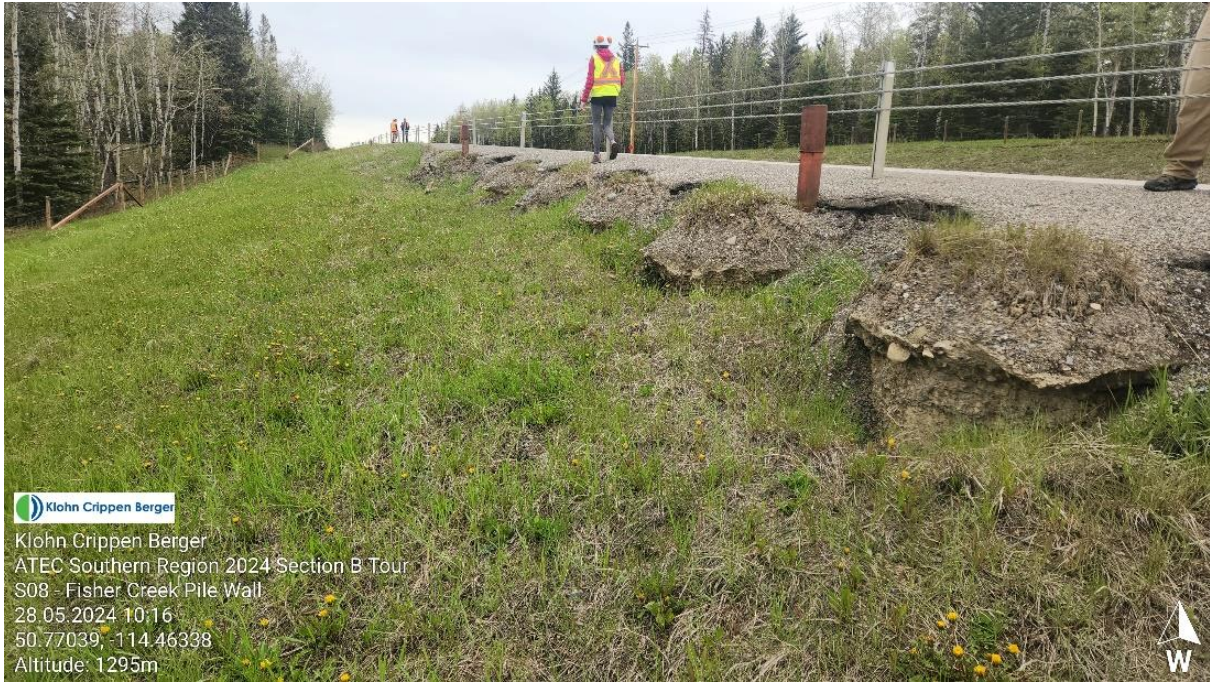
<p>During the 2024 inspection, cracking and settlement of the embankment downslope of the pile wall was visible and the ground surface had dropped by up to 850 mm, creating a ledge that could potentially pond water, leading to increased infiltration.</p>
<p>Surface water runoff has enlarged existing sinkholes at the pile locations and contributed to embankment settlement downslope of the pile wall.</p>
<p><u>Discussed Remedial Actions:</u></p> <p><u>Short-Term</u></p> <ul style="list-style-type: none"> • The pavement cracks should be sealed to reduce surface water infiltration. • The voids between the pile walls should be backfilled to reduce infiltration and potential erosion undermining the east (southbound) lane. • The site should be regularly inspected as part of the Southern Region Section B inspections and instruments read as part of the Section C instrumentation monitoring. • A borehole should be drilled through the pavement north of the pile wall and a slope inclinometer and piezometer(s) should be installed to monitor movement and groundwater conditions, respectively. A proposal for this work was initially submitted on December 15, 2022. A refreshed proposal was submitted on July 16, 2024. <p><u>Long-Term</u></p> <ul style="list-style-type: none"> • The pile wall could be extended to the north, so the slide doesn't outflank the existing pile wall; or • Stabilize the highway embankment by excavating and replacing embankment fill with geogrid reinforced granular fill.

Photo 3 Settlement downslope of pile wall, exposed concrete pilea. Photo taken facing north on May 28, 2024.

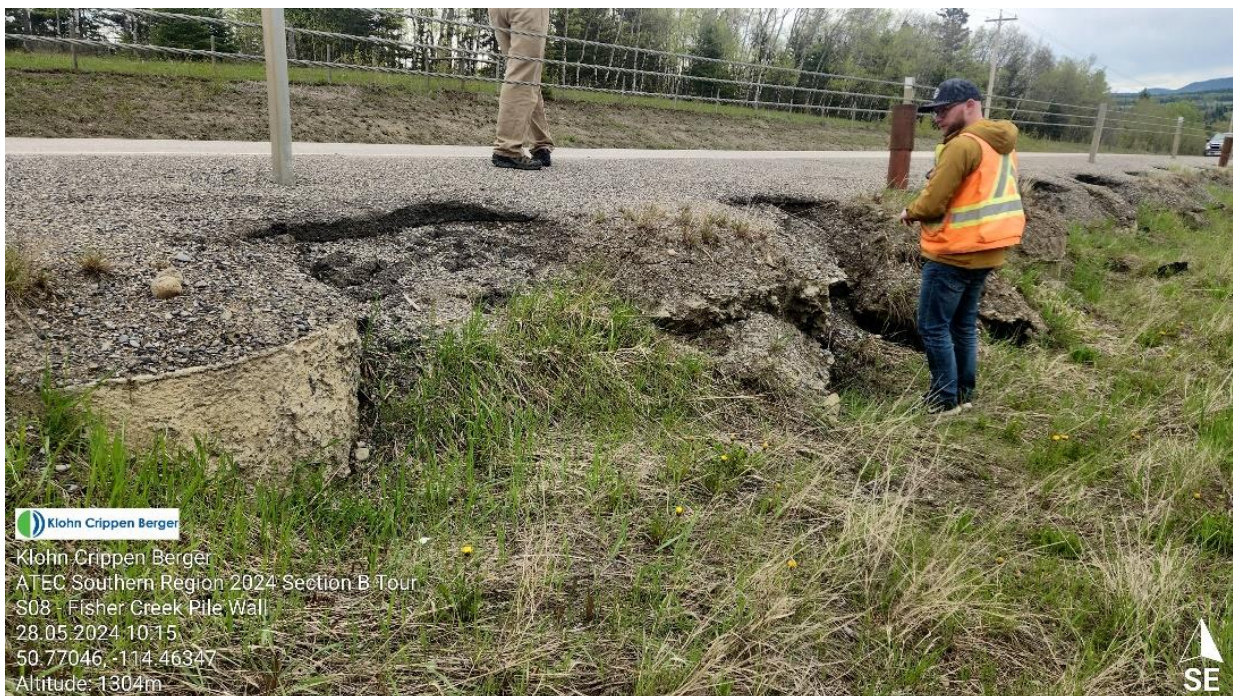
Photo 4 Settlement downslope of pile wall, exposed concrete pilea. Photo taken facing southeast on May 28, 2024.
