July 10, 2024

**CON0022161 Southern Region GRMP Instrumentation Monitoring
Site S008; H762:02, km 2.125 Fisher Creek Pile Wall
Section C – 2024 Spring Readings**

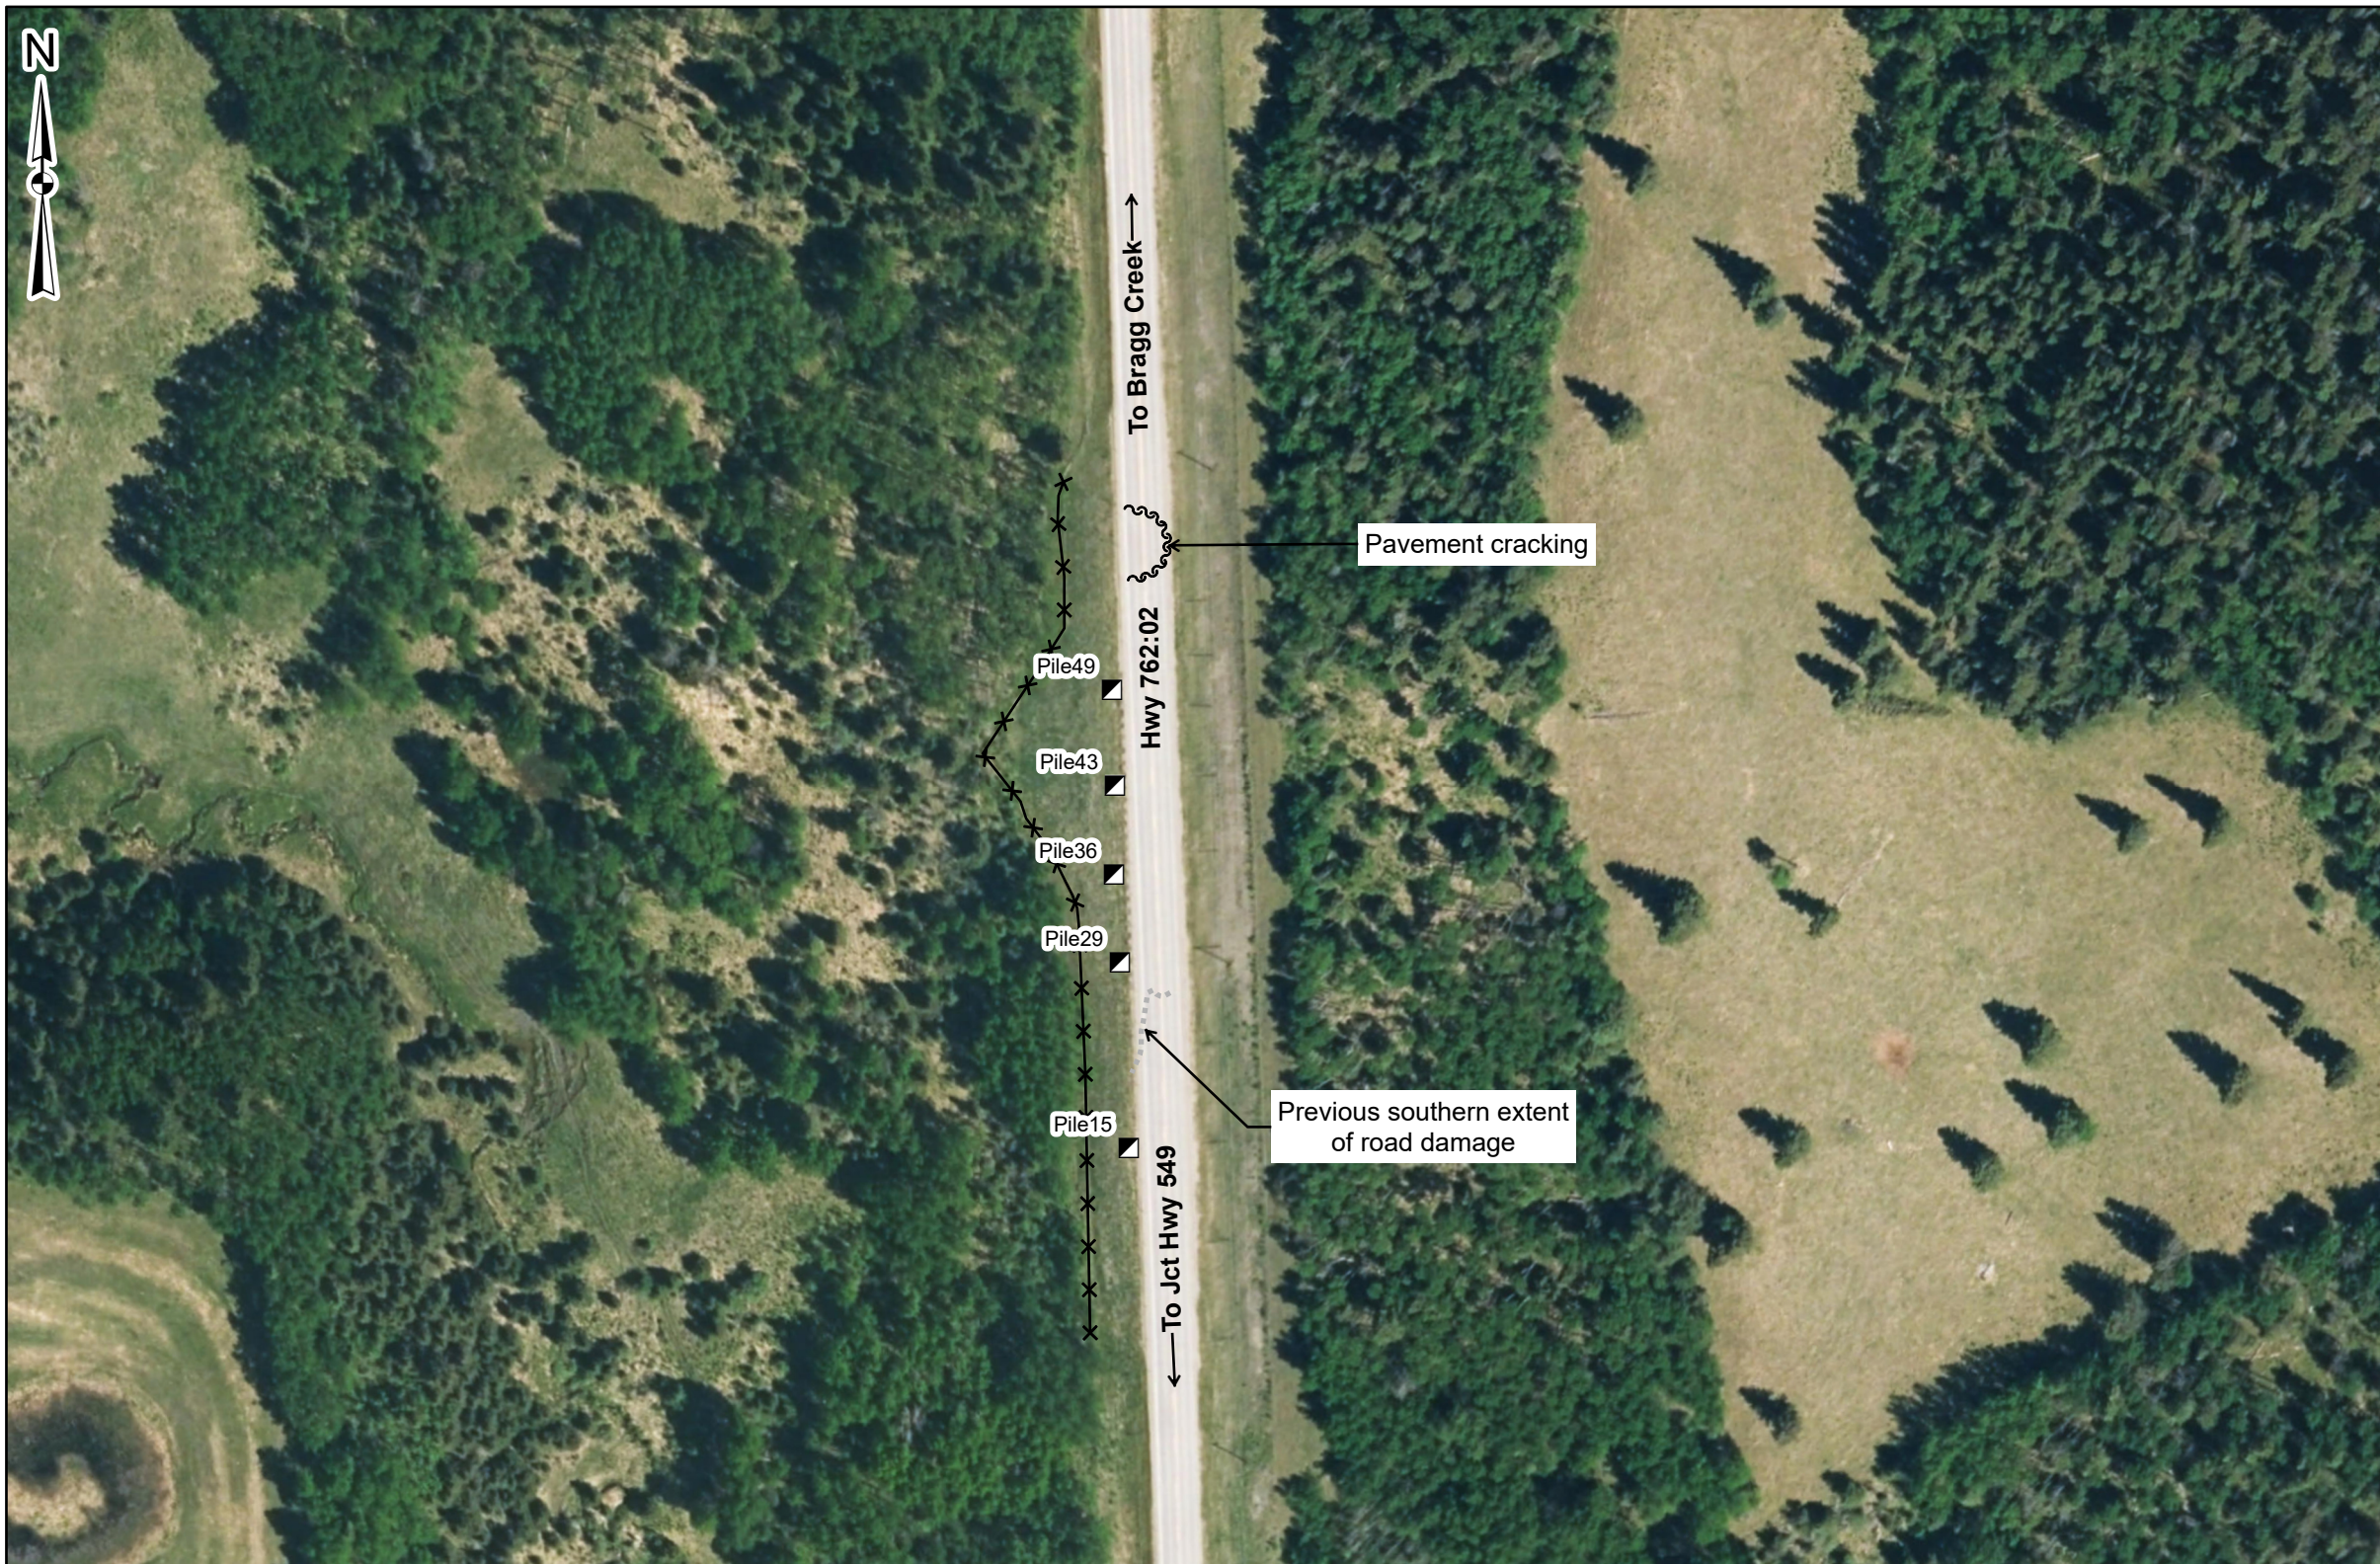
PROJECT SOUTHERN REGION GEOHAZARD RISK MANAGEMENT PROGRAM		
TITLE Site Plan S008 - Fisher Creek Pile Wall Hwy 762:02, km 2.125		
SCALE 1:1,500	PROJECT No. A05116A03	FIG No. 1

The pavement distress north of the pile wall could indicate the slide is outflanking the pile wall at its north extent.

KCB recommends that a borehole be drilled approximately 24 m north of the existing pile wall where pavement distress is observed. A SI should then be installed in the borehole to monitor movement at this location. A proposal for this work was issued in December 2022 and reissued in July 2024.

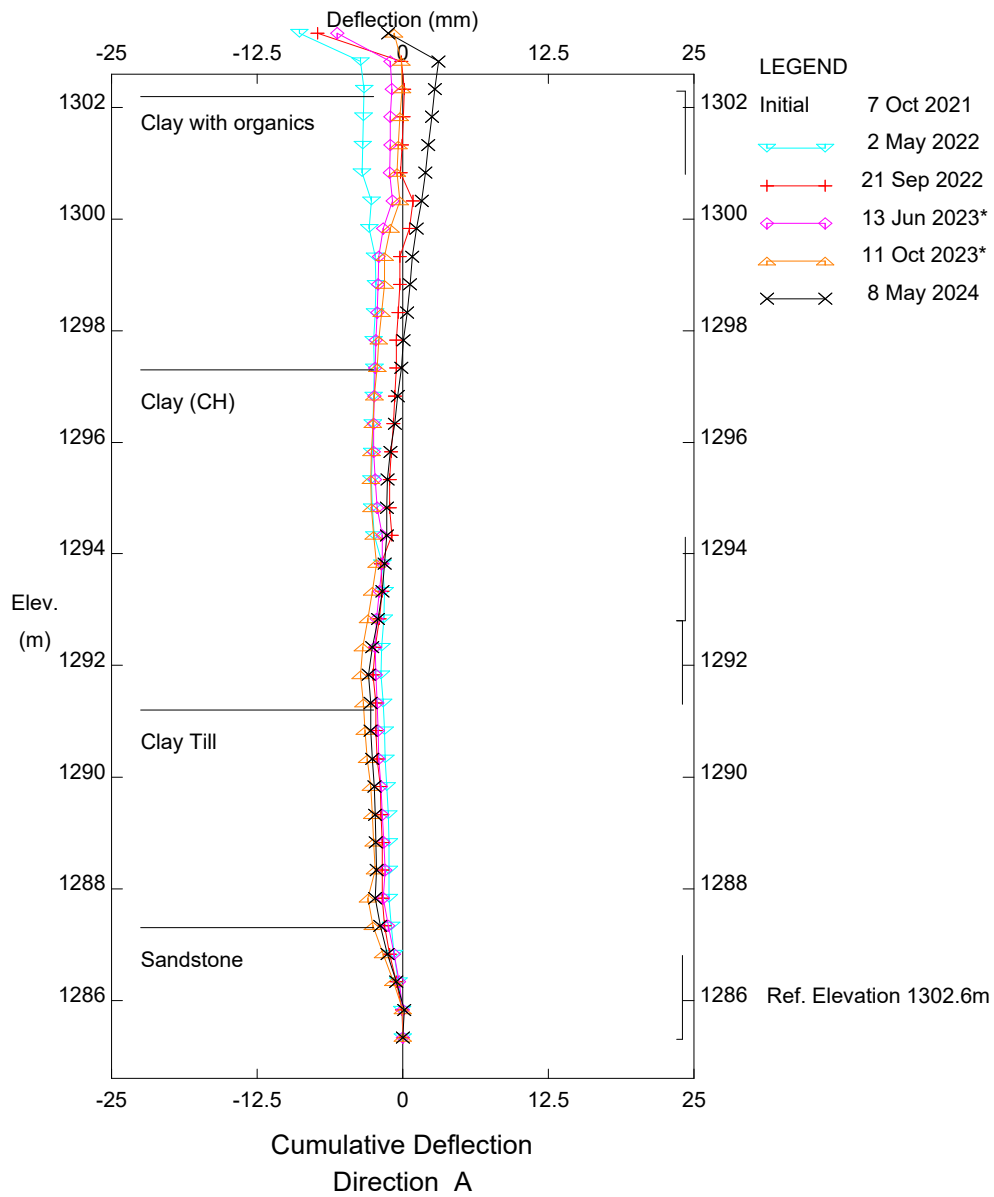
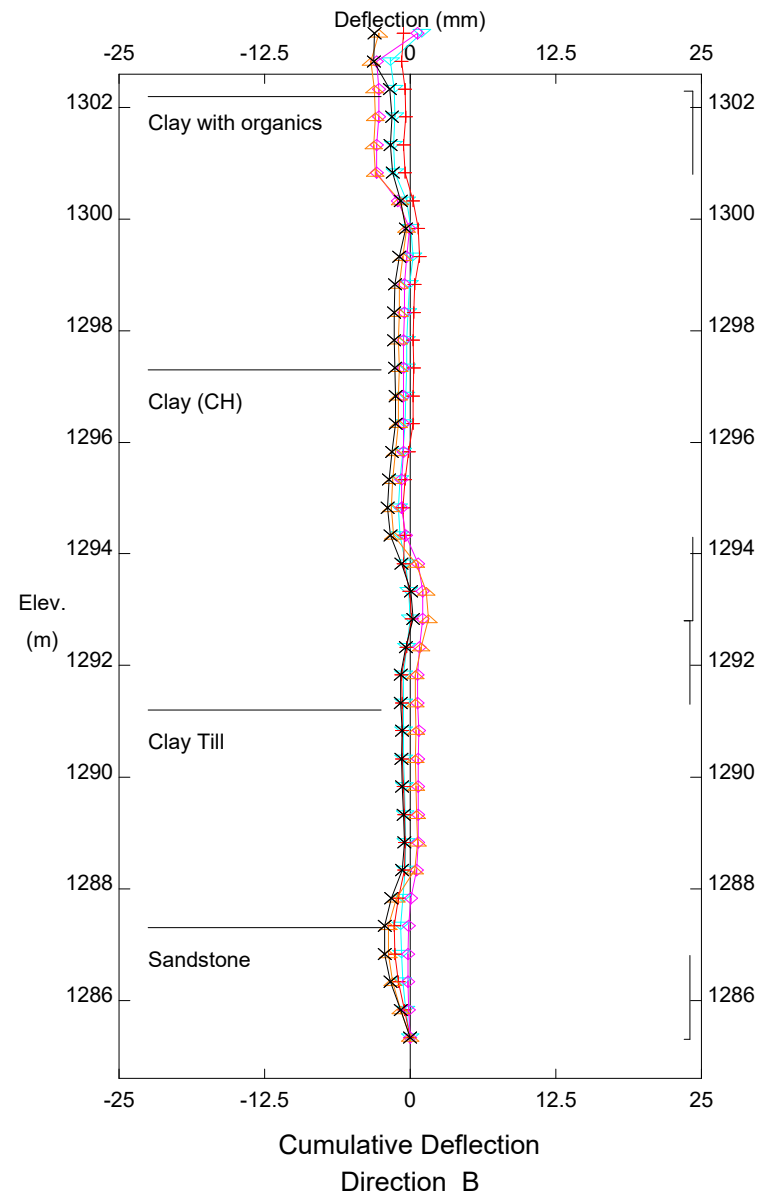
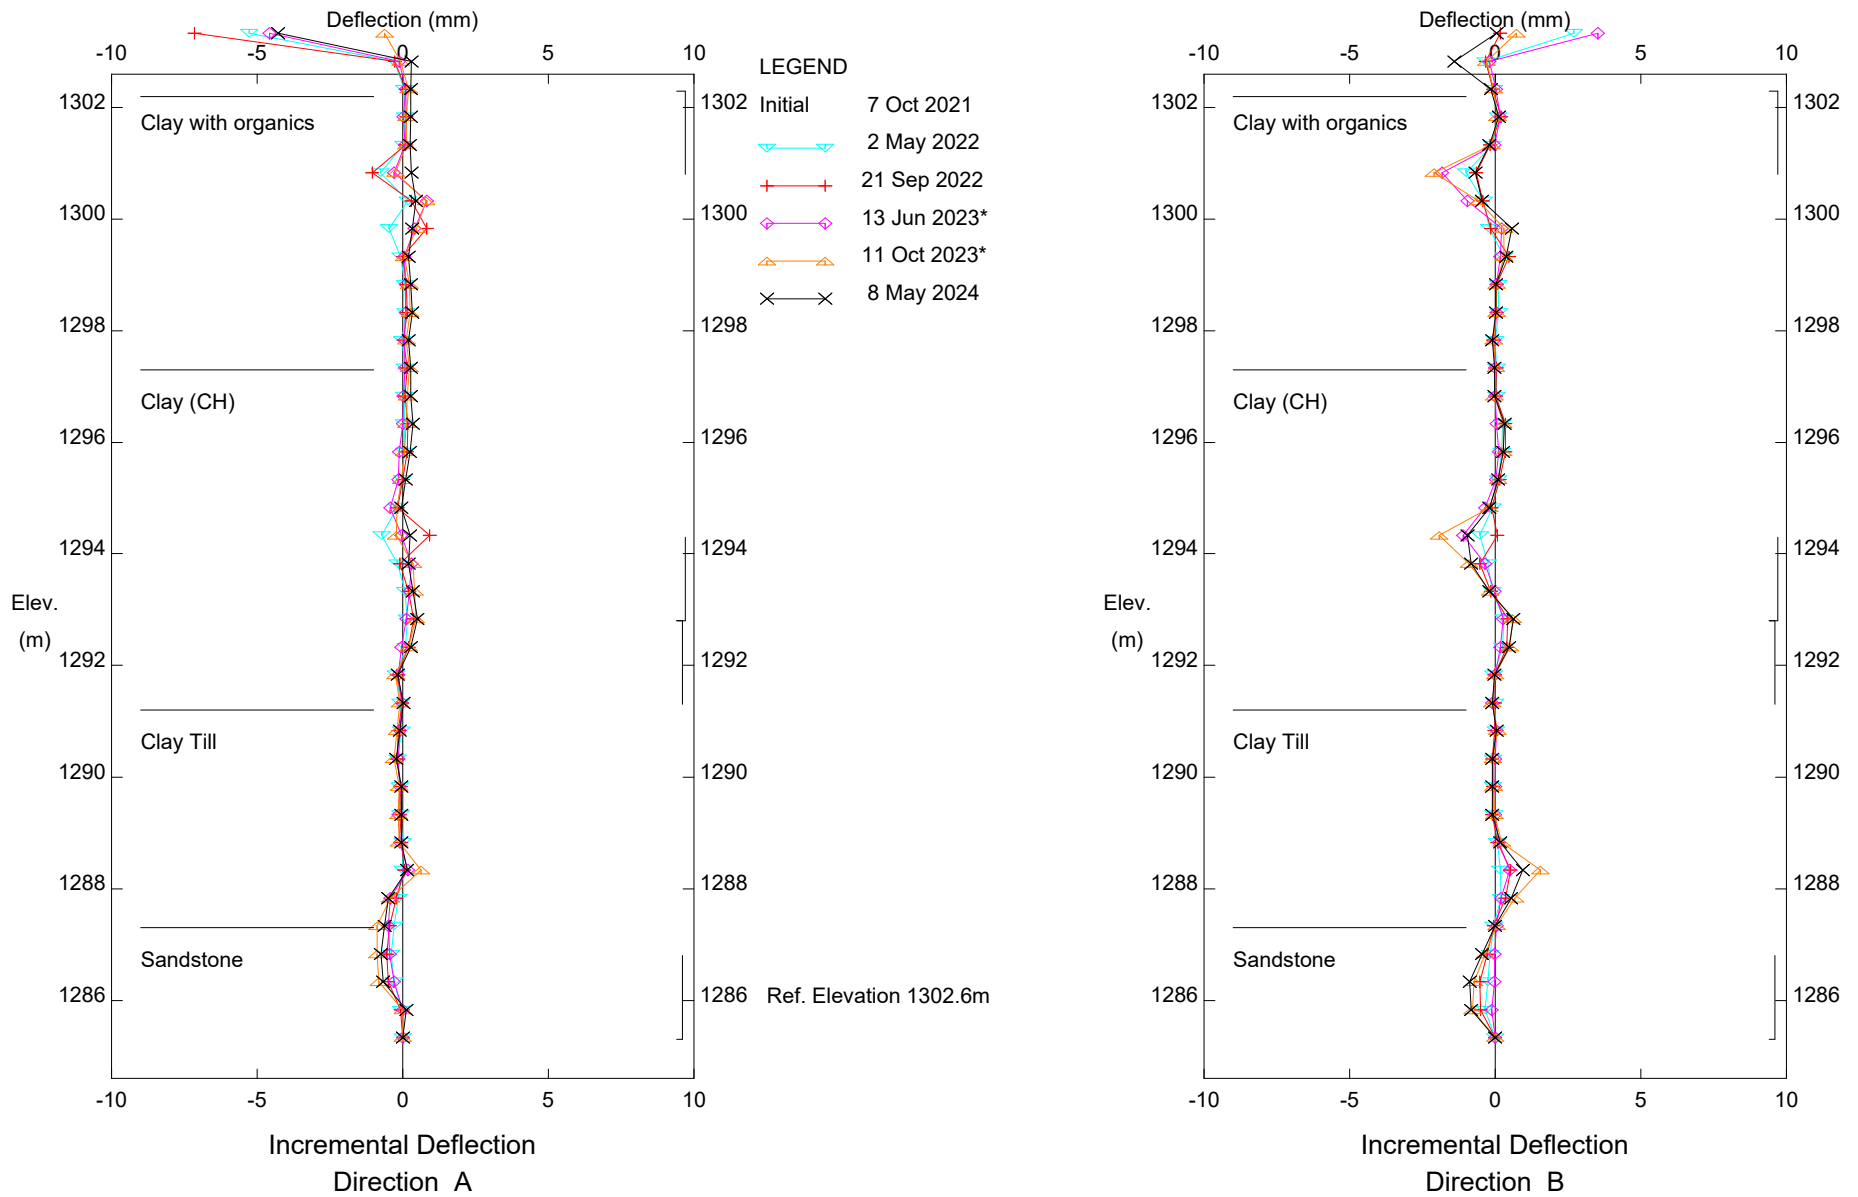
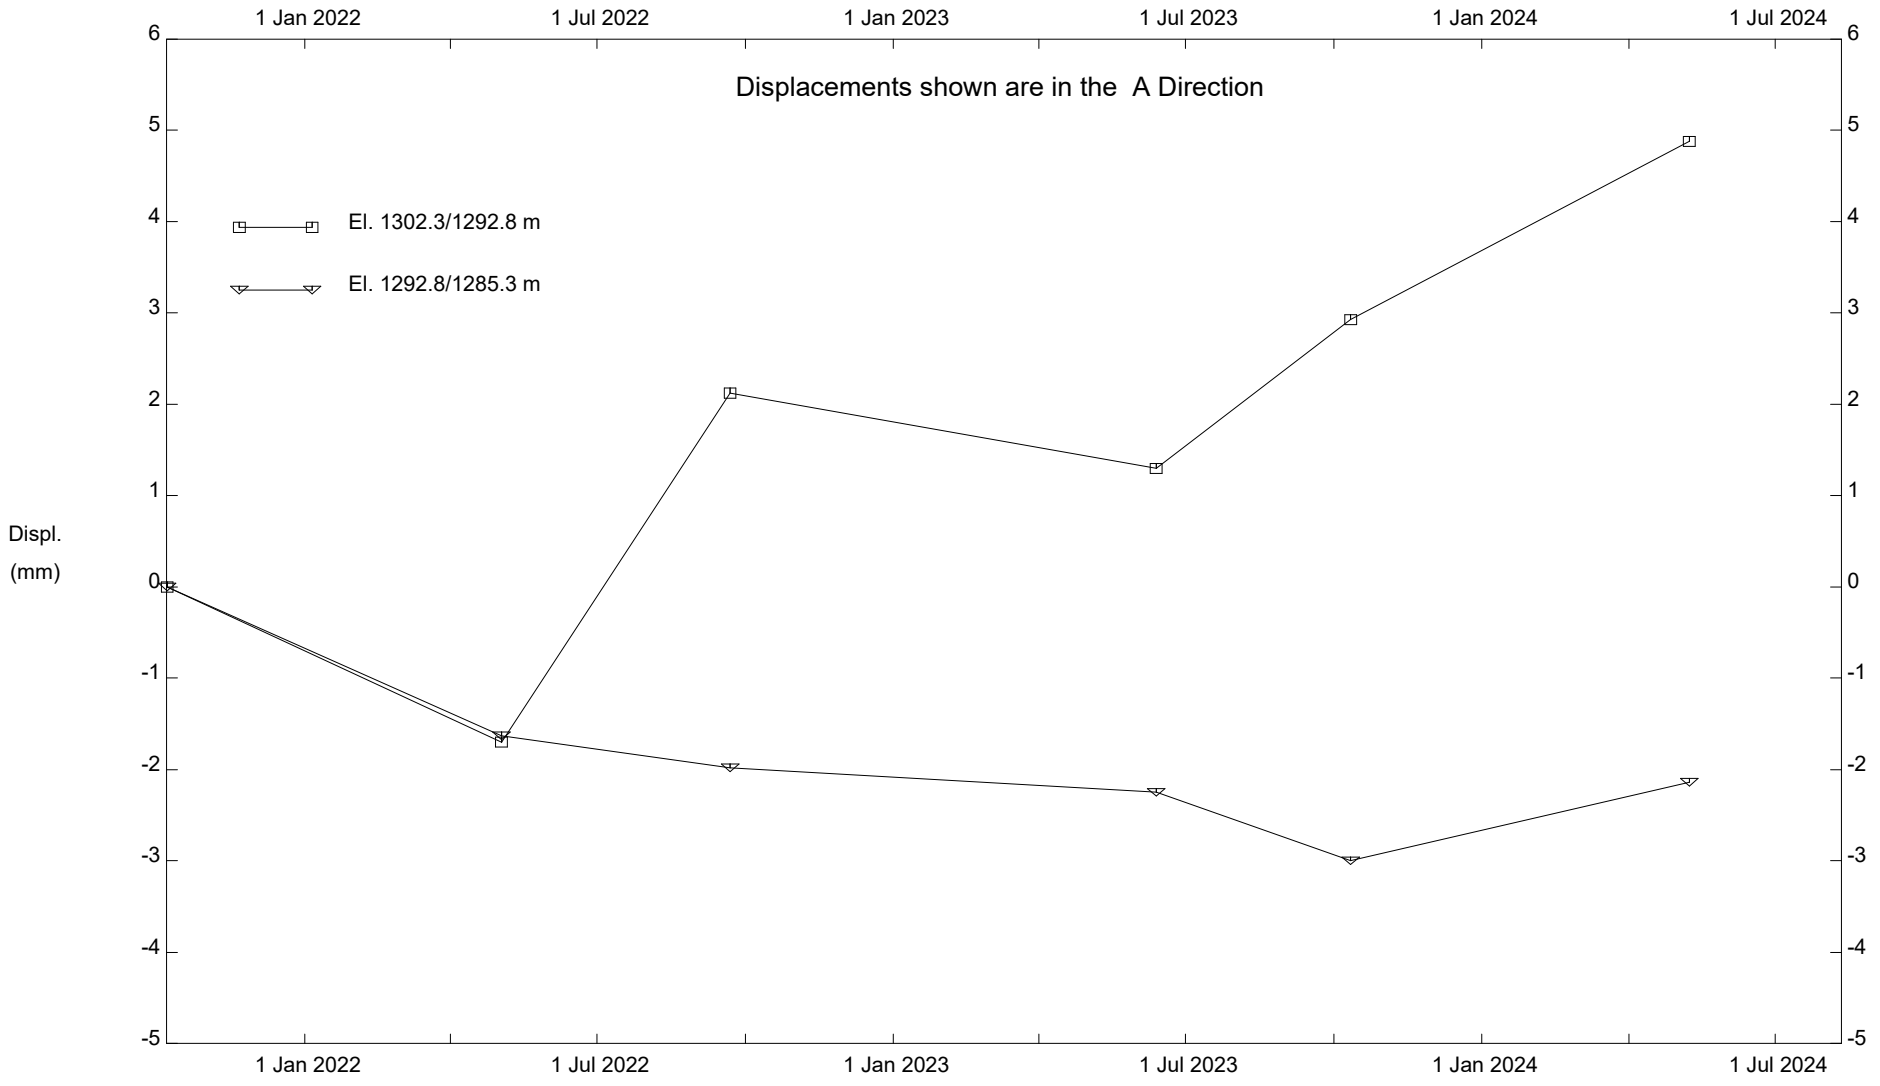
S008; H762:02, Fisher Creek, Inclinometer PILE15

Pile 15, located approximately 35 m from the south end of the pile wall is measuring movement in the B-direction at what appears to be SI casing joints, based on an approximate spacing of 3 m intervals between joints. More data is required to assess the cause of the B-direction movement.

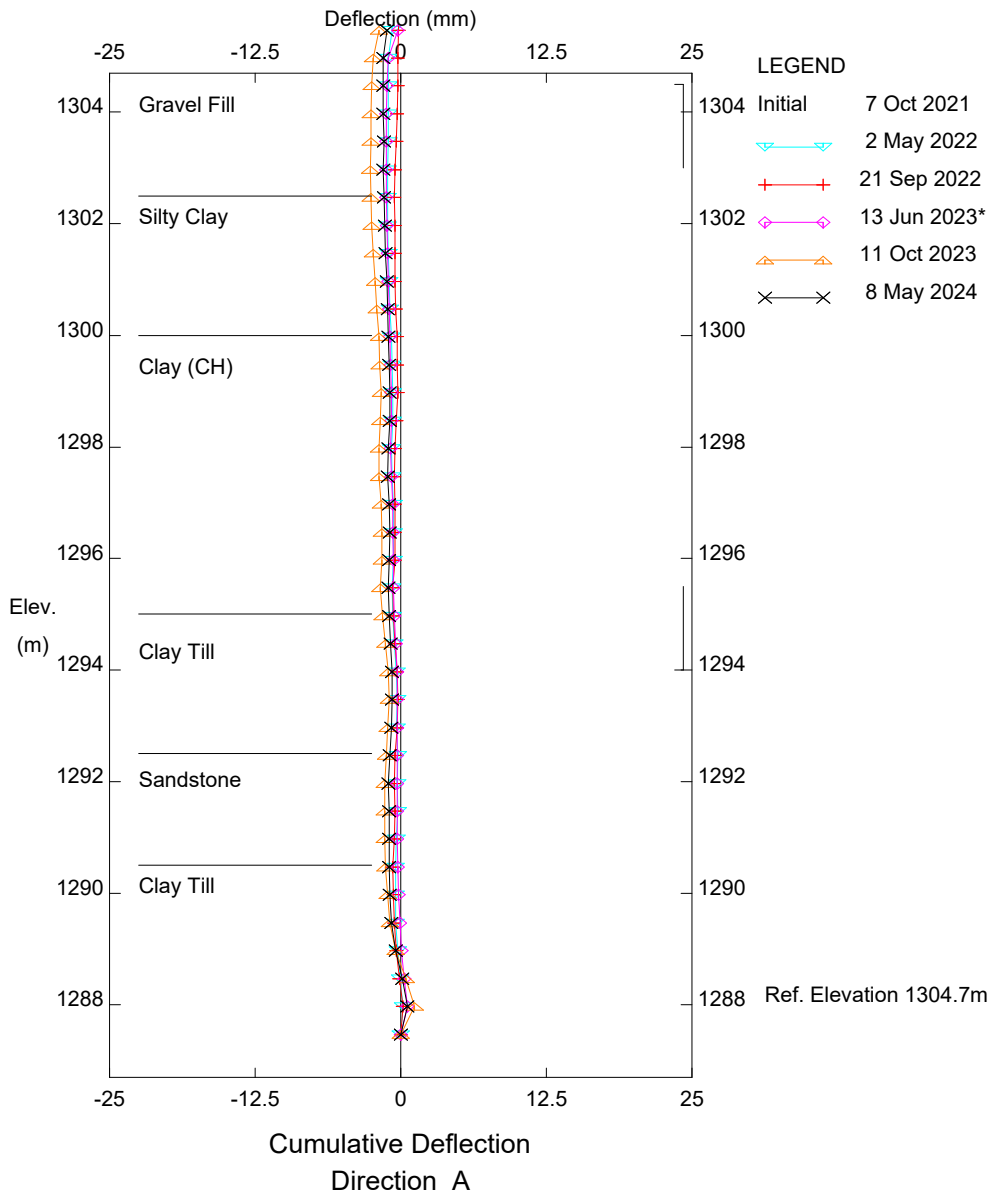
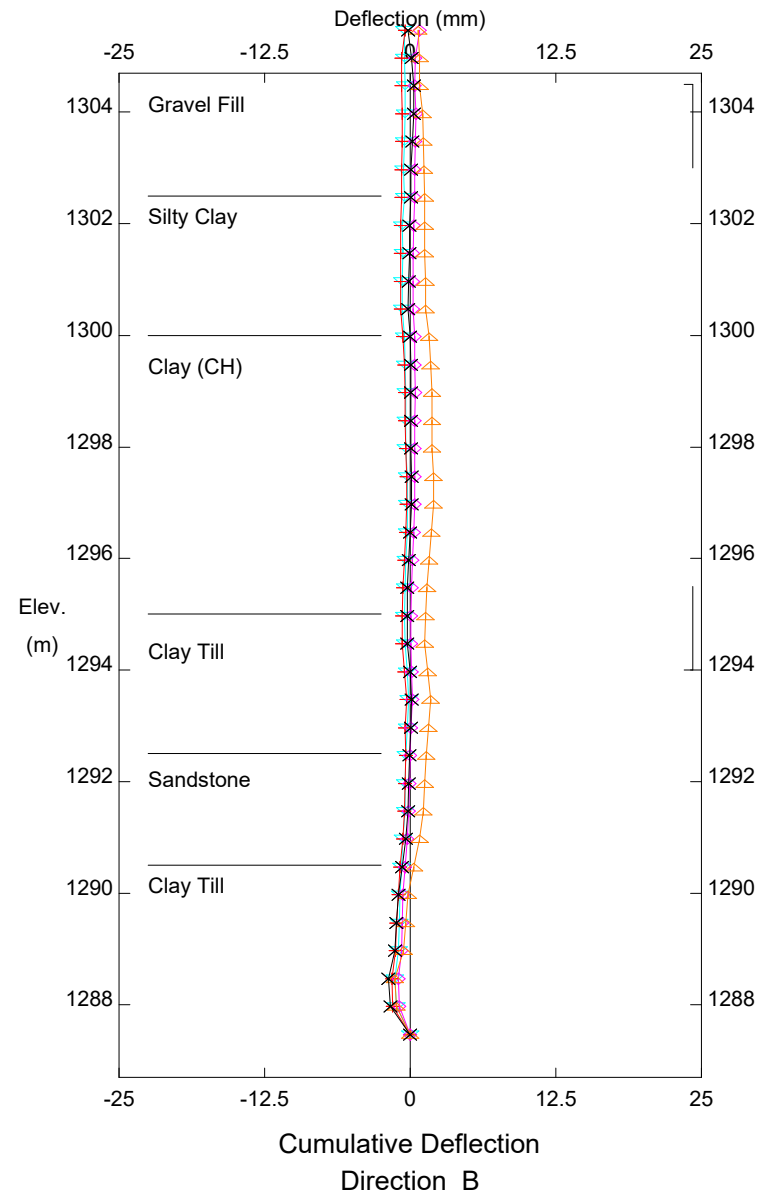
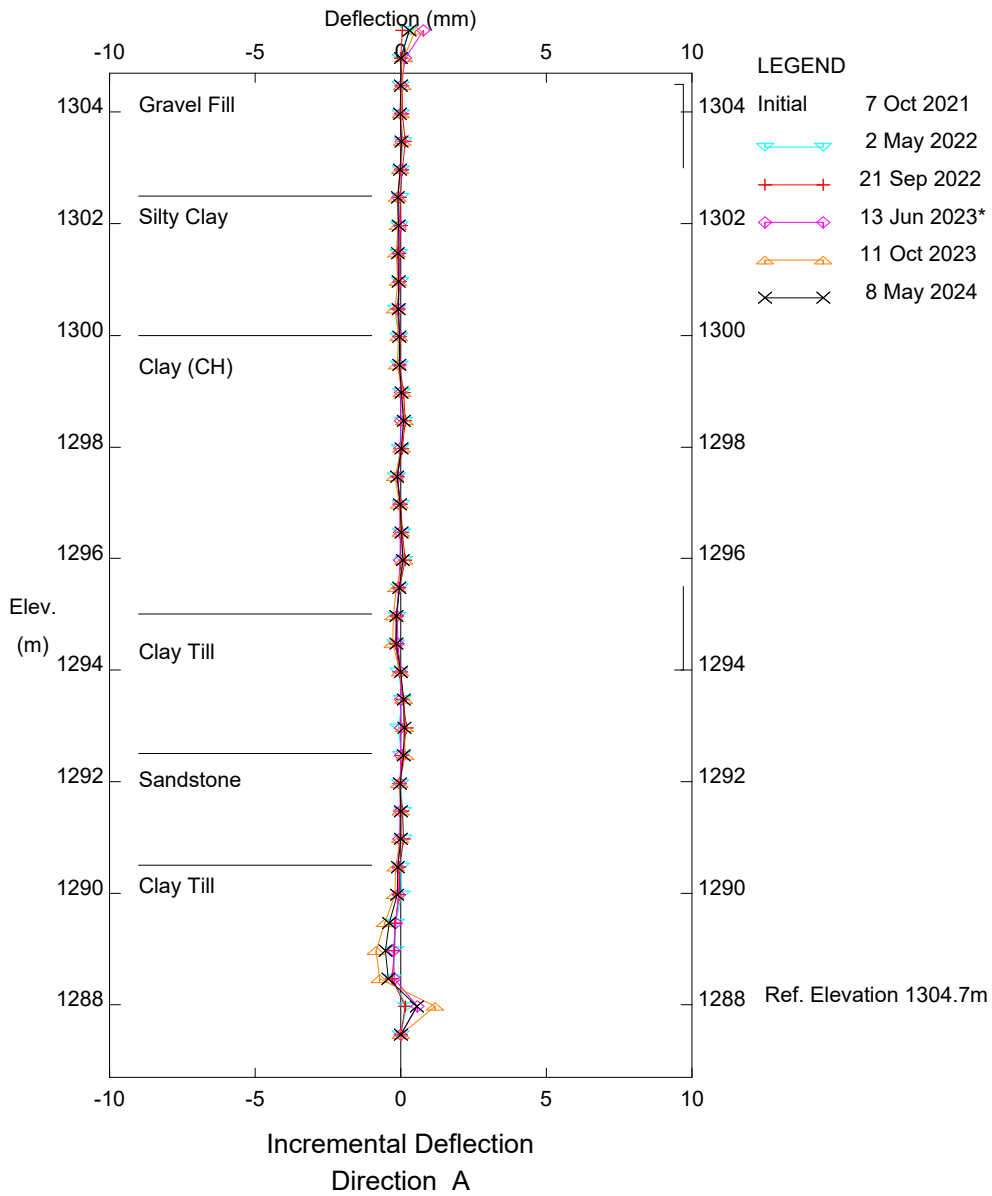
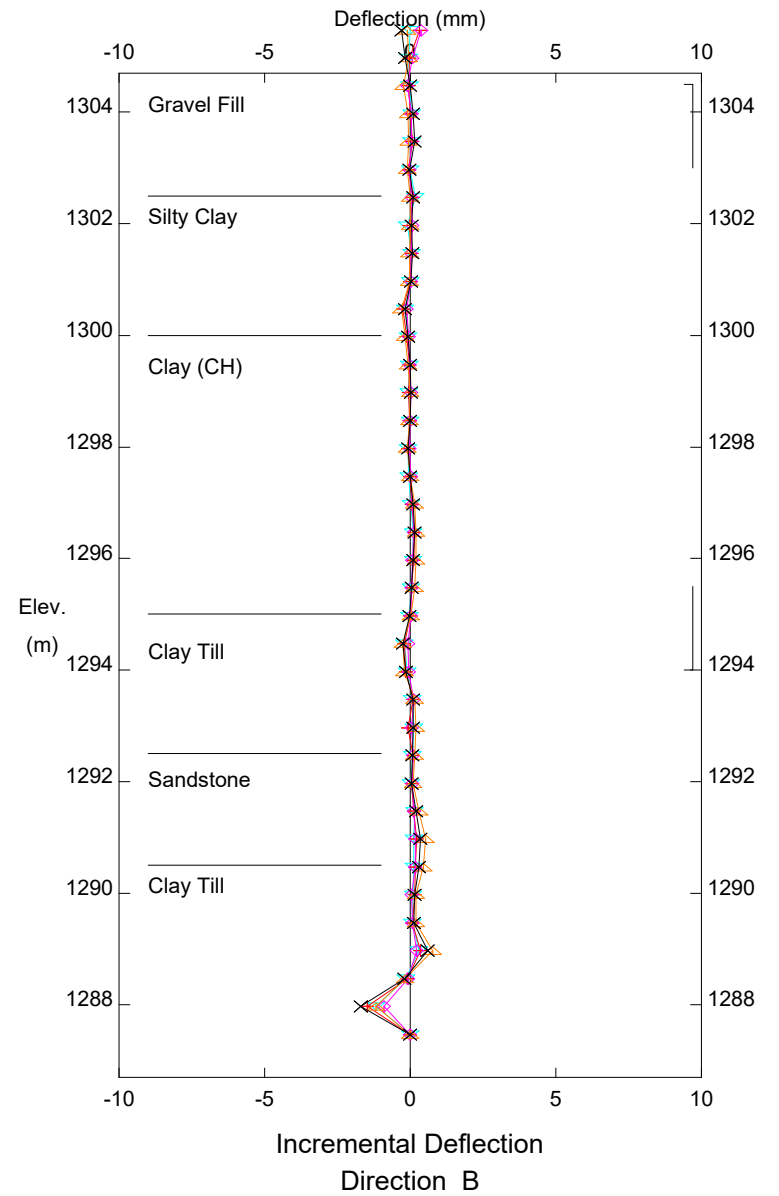
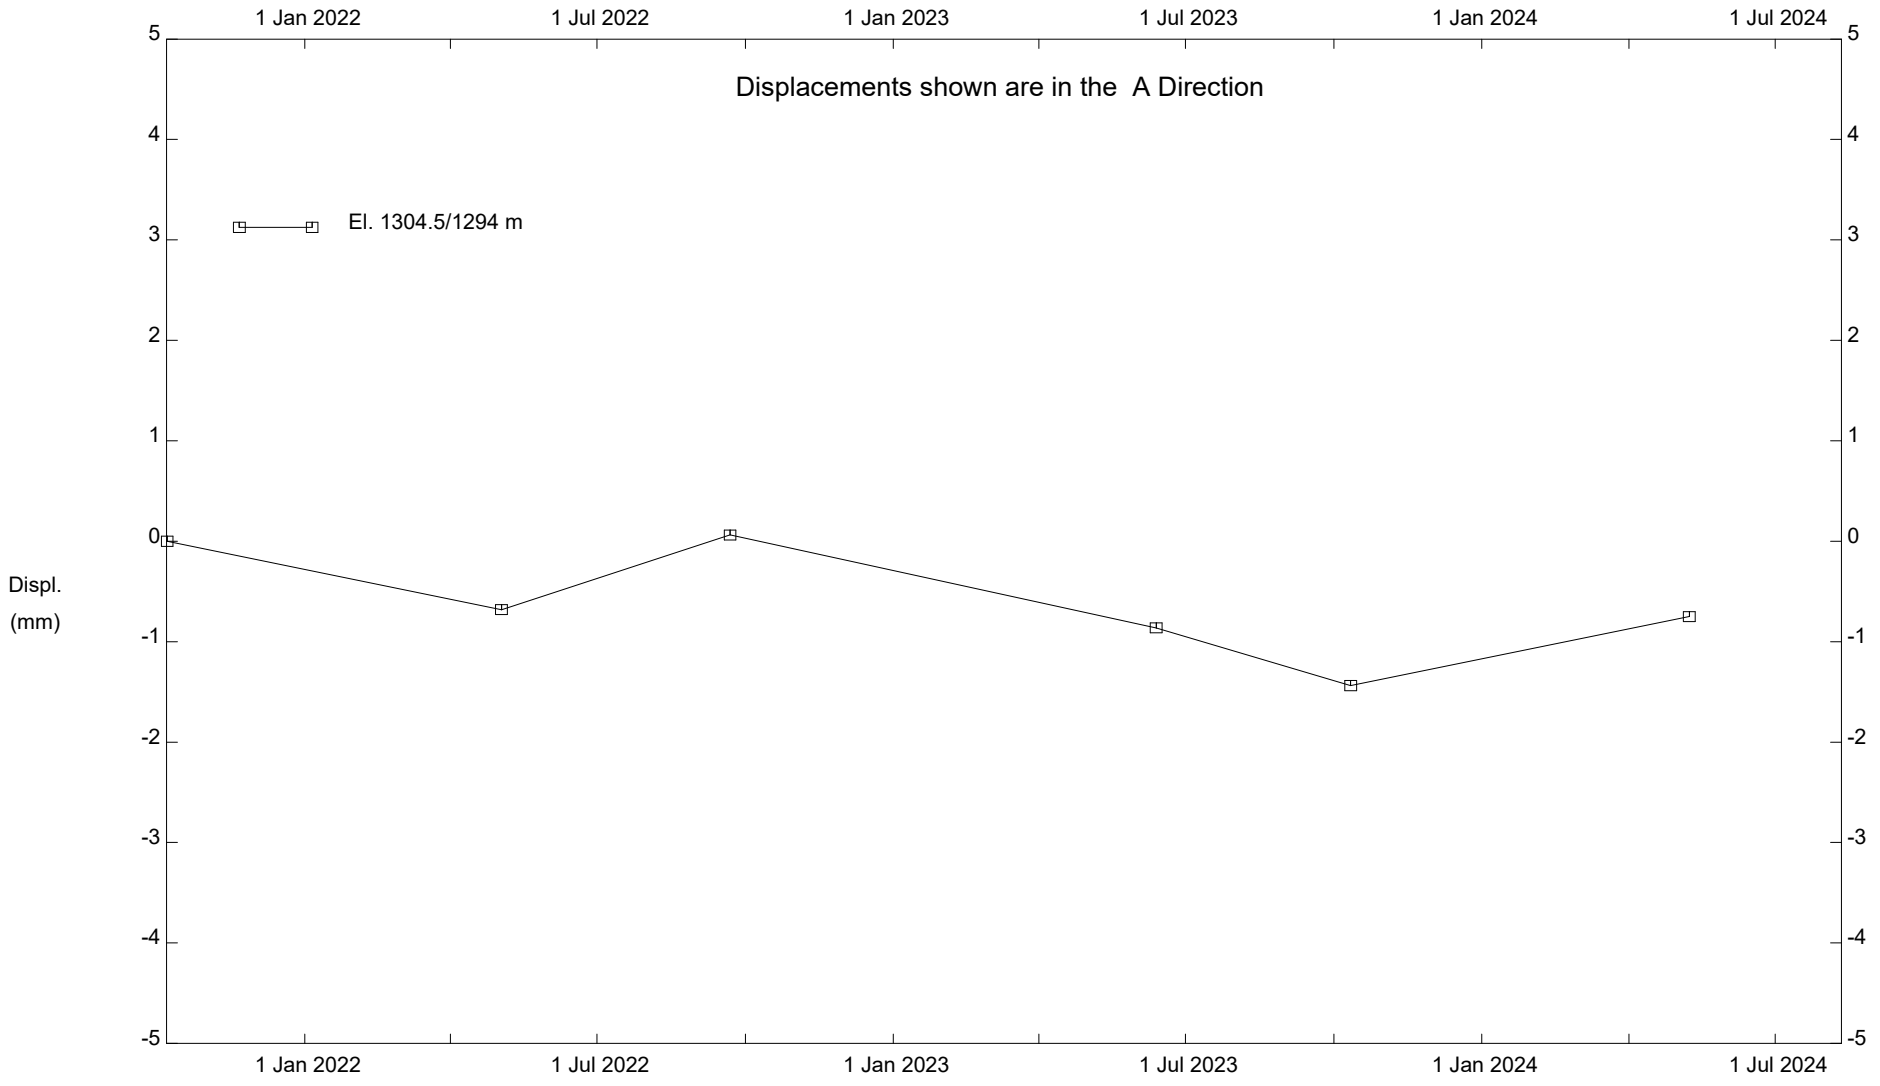
S008; H762:02, Fisher Creek, Inclinator PILE29

Since being re-initialized to the October 2021 reading, no discernible movement has been recorded in Pile 29, Pile 43, or Pile 49.
