July 10, 2024

**CON0022161 Southern Region GRMP Instrumentation Monitoring
Site S008; H762:02, km 2.125 Fisher Creek Pile Wall
Section C – 2024 Spring Readings**

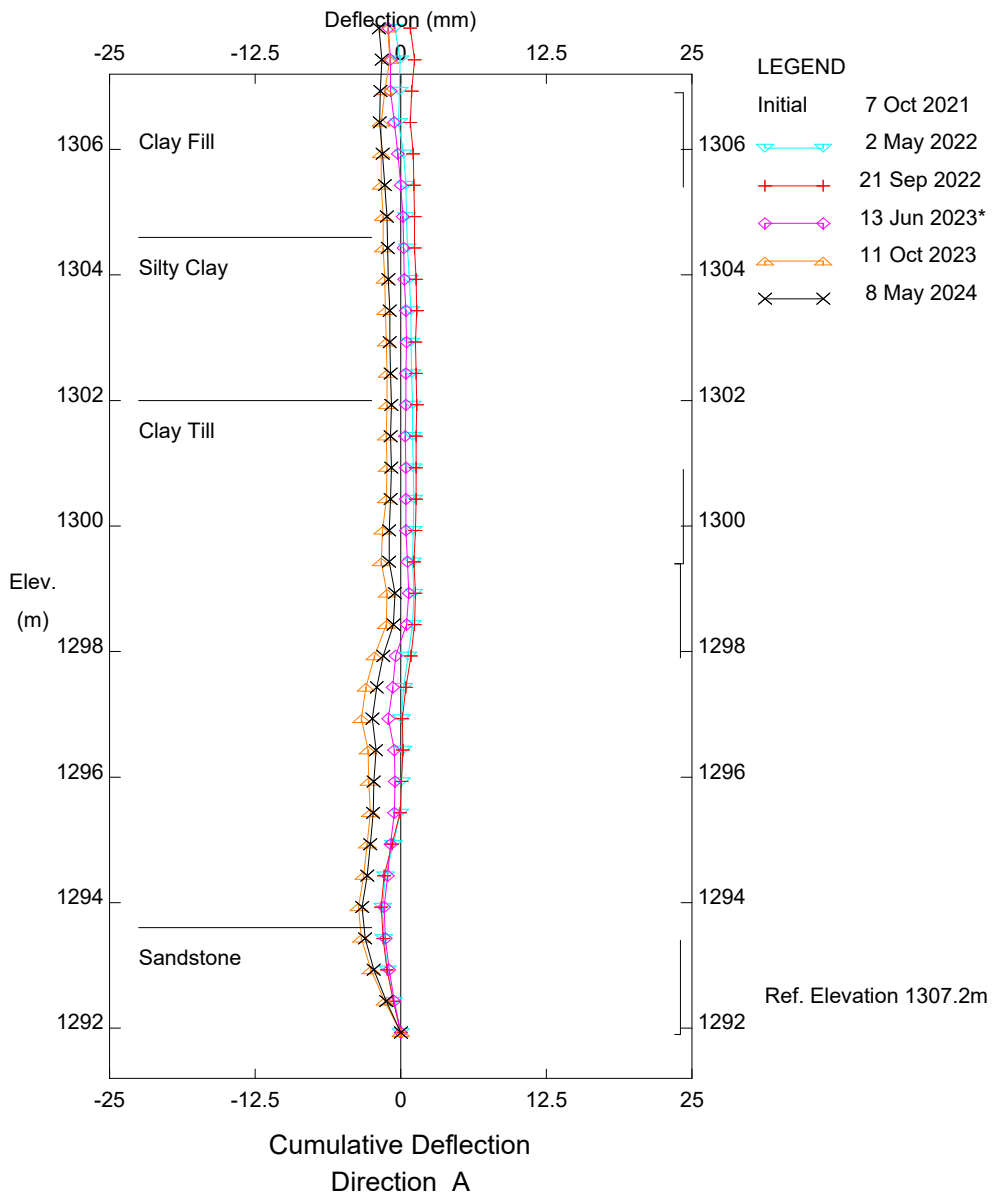
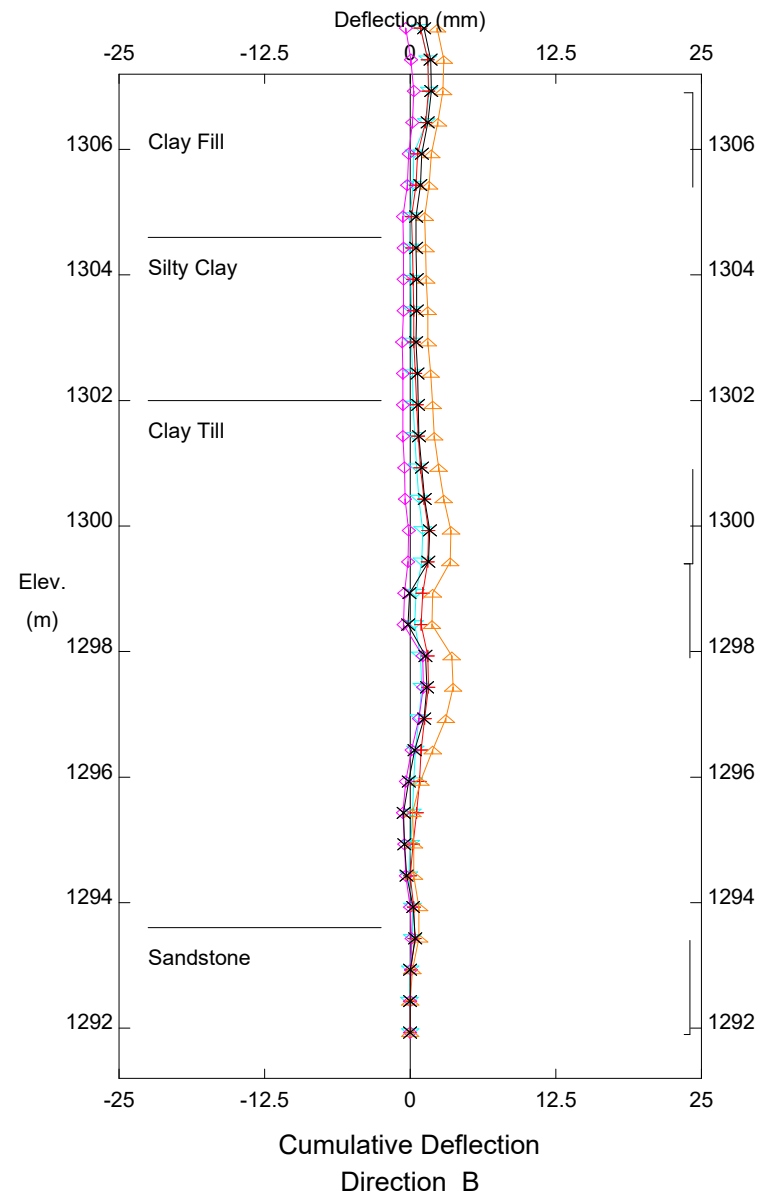
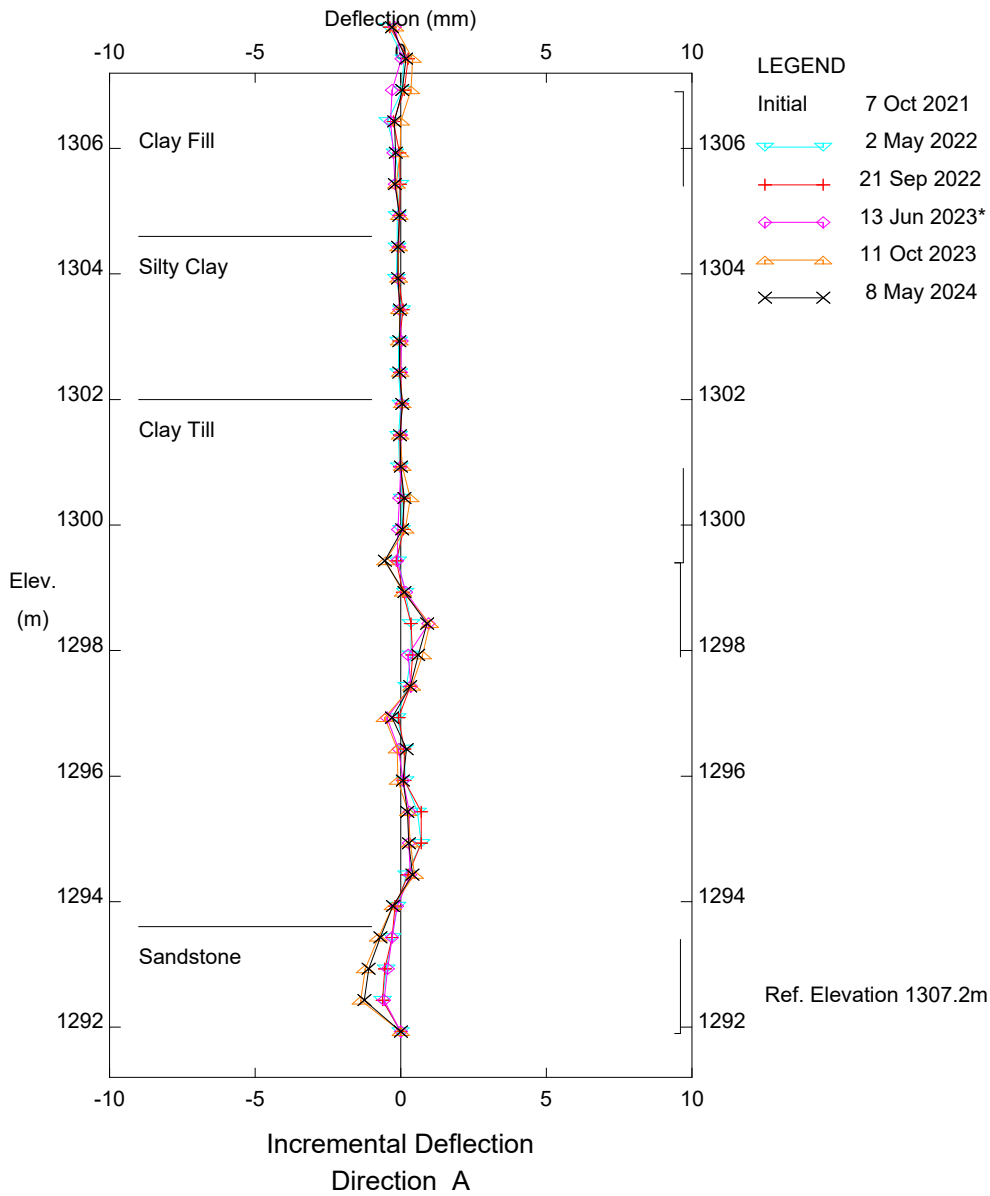
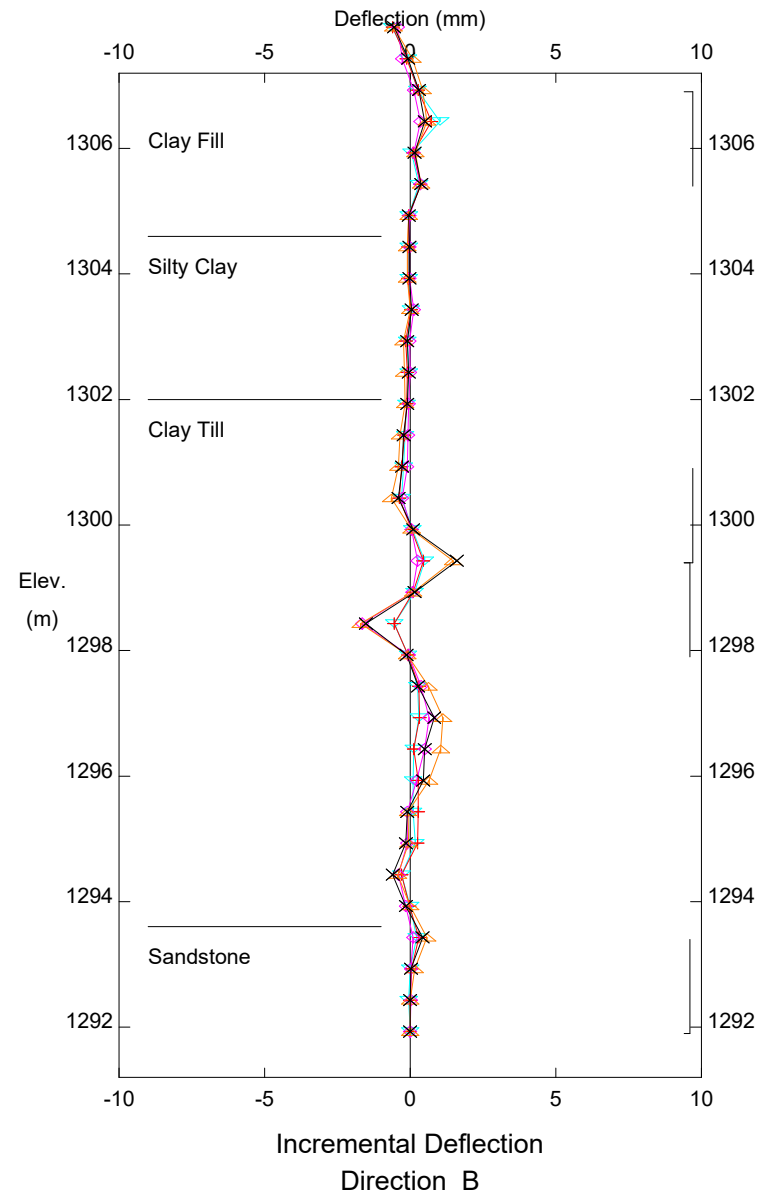
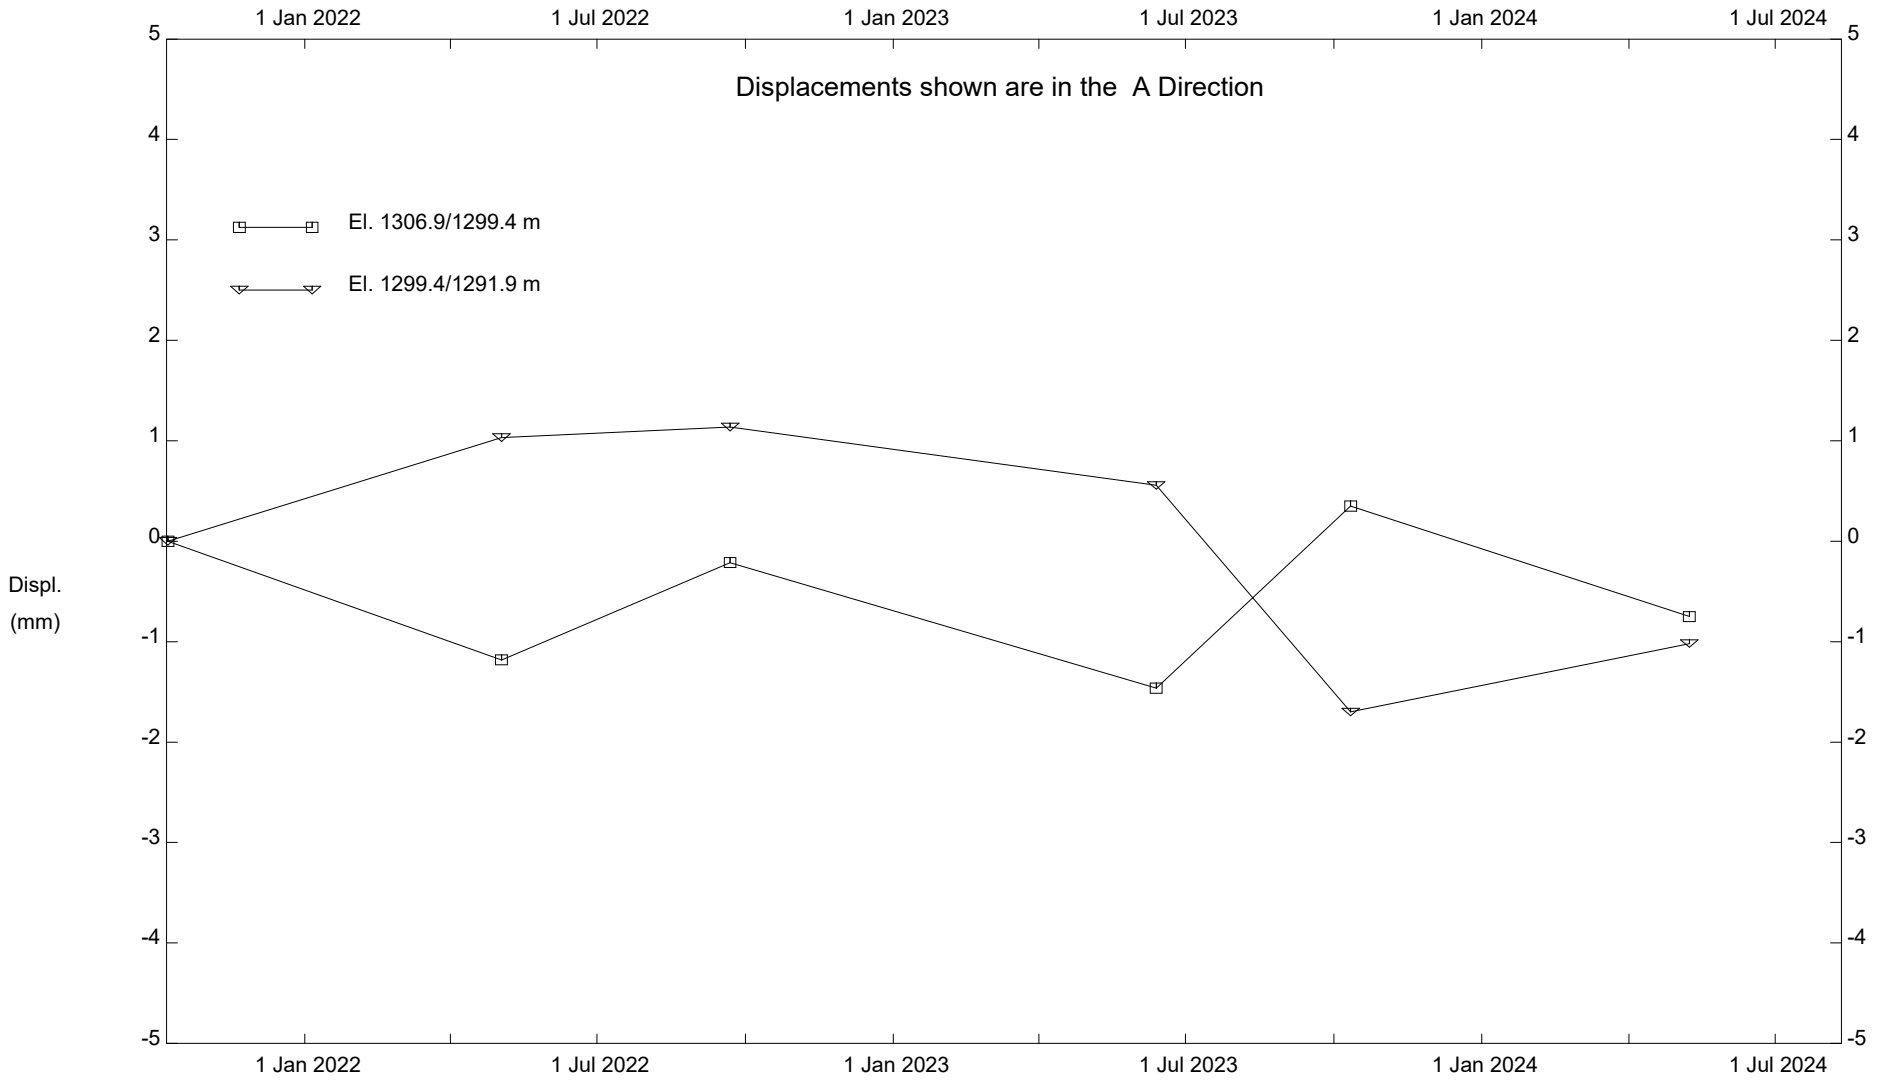
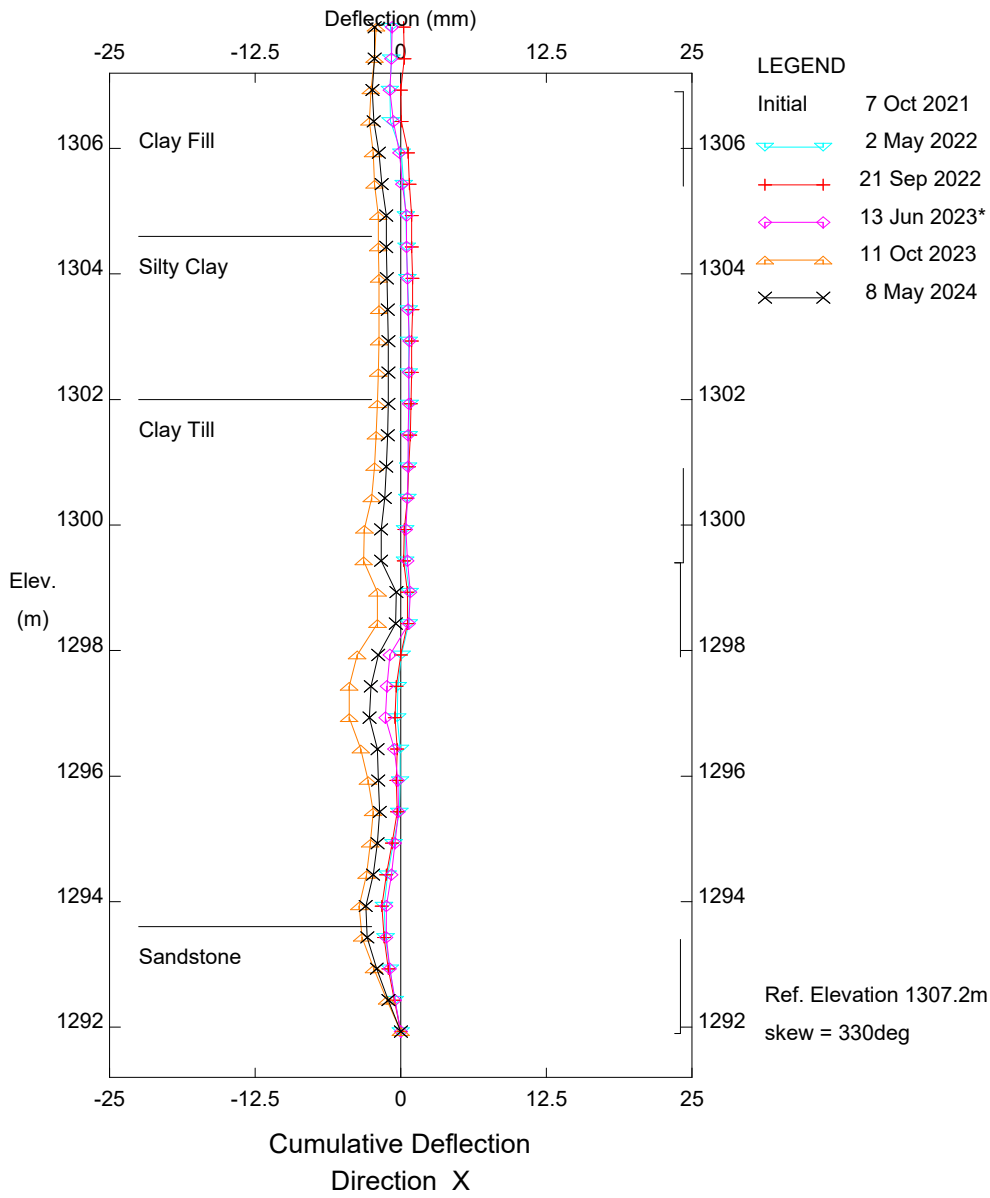
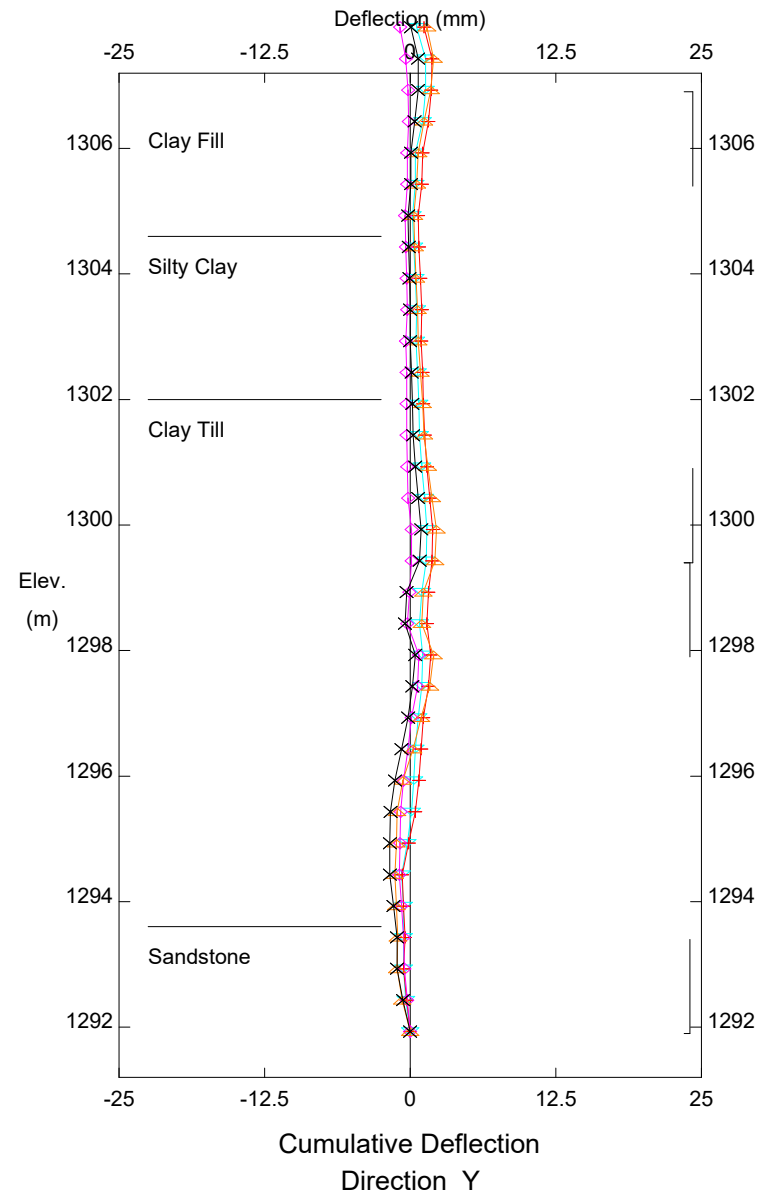
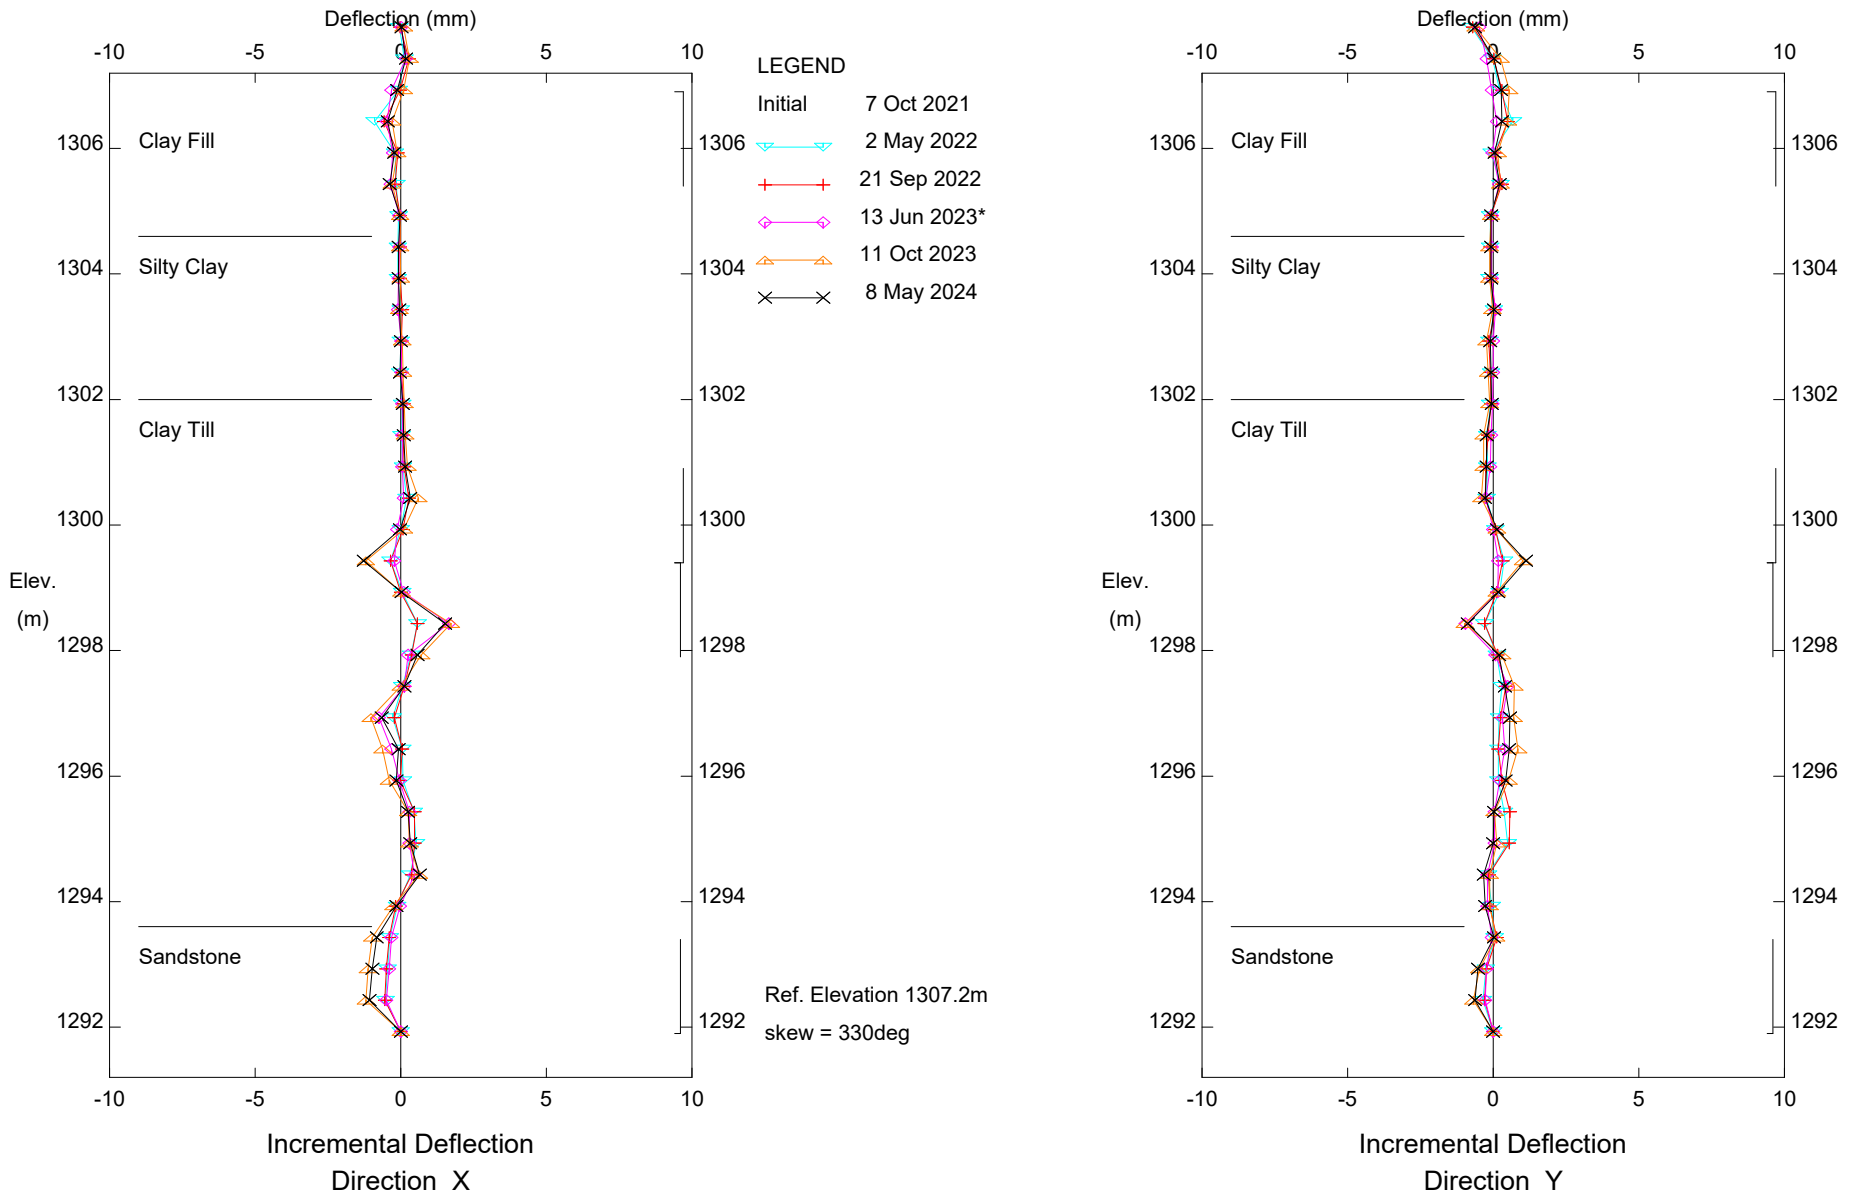
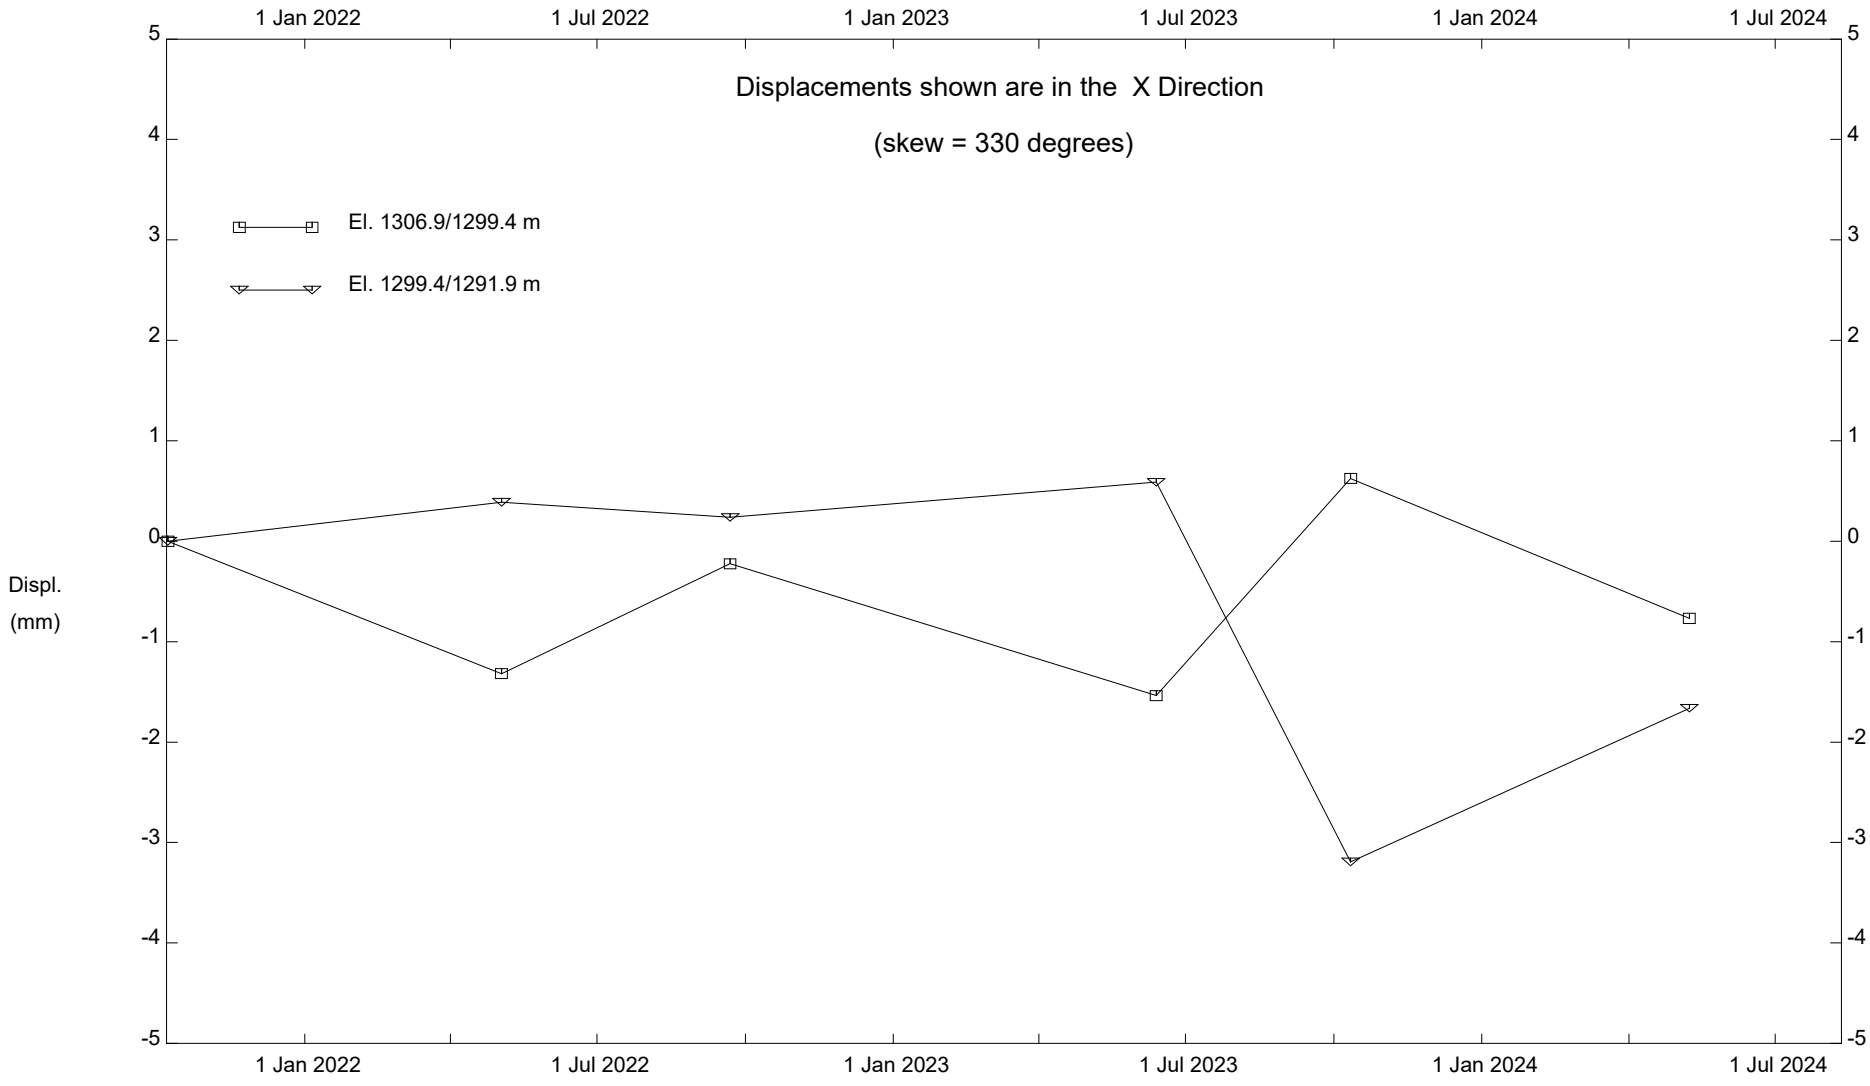
S008; H762:02, Fisher Creek, Inclinometer PILE49

Since being re-initialized to the October 2021 reading, no discernible movement has been recorded in Pile 29, Pile 43, or Pile 49.
