SITE NUMBER AND NAME: S036 Belly River		HIGHWAY & KM: 800:02, 9.050	PREVIOUS INSPECTION DATE: May 31, 2017	INSPECTION DATE: May 3, 2018
LEGAL DESCRIPTION: 12-18-003-27 W4M	NAD 83 COORDINATES: UTM Northing Easting 12 5454363 308507		RISK ASSESSMENT: PF: 3 CF: 1 TOTAL: 3	
AVERAGE ANNUAL DAILY TRAFFIC (AADT): 400 (north), 620 (south), (Ref No. 87010, 87030)			CONTRACTOR MAINTENANCE AREA (CMA): 25

SUMMARY OF SITE INSTRUMENTATION: 6 vibrating-wire piezometers and 2 slope inclinometers. LAST READING DATE: April 2018	INSPECTED BY: Chris Gräpel (KCB) Peter Roy (KCB) Alex Frotten (AT) Roger Skirrow (AT)
PRIMARY SITE ISSUE: Monitoring landslide repairs on outside of bend of Belly River.	
APPROXIMATE DIMENSIONS: Approximately 200 m at river bank, repaired slope is approximately 15 to 20 m high, and approximately 4H:1V from crest to toe.	
DATE OF ANY REMEDIAL ACTION: Slide repair in 2012 consisted of toe berm, subsurface drainage, regraded slopes with slope benches and improved surface drainage, rip rap longitudinal peaked stone toe protection (LPSTP) armouring with re-directive vanes and bio-engineering (including live staking).

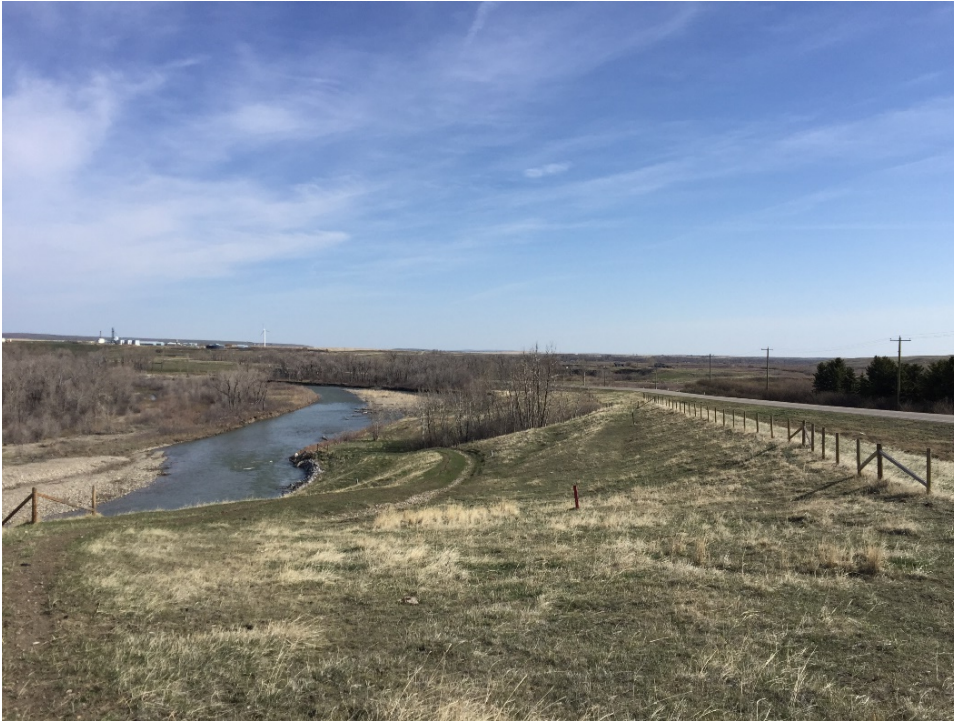
Photo 1 North half of repaired slide area. Photo was taken facing north on May 3, 2018.

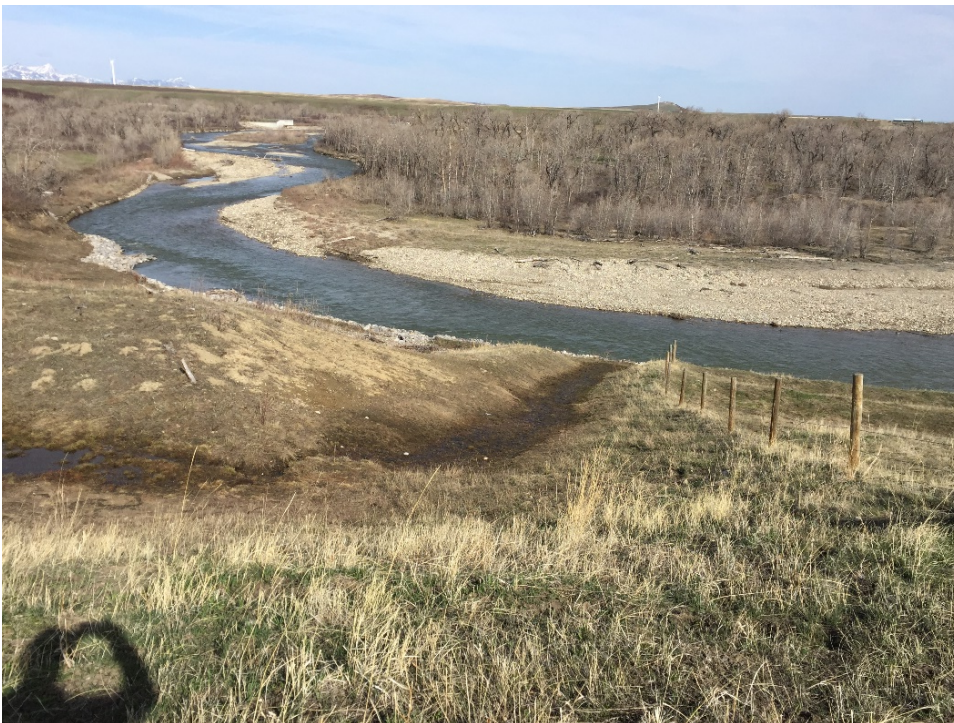
Photo 2 South portion of repaired slide area. Photo was taken facing west on May 3, 2018.

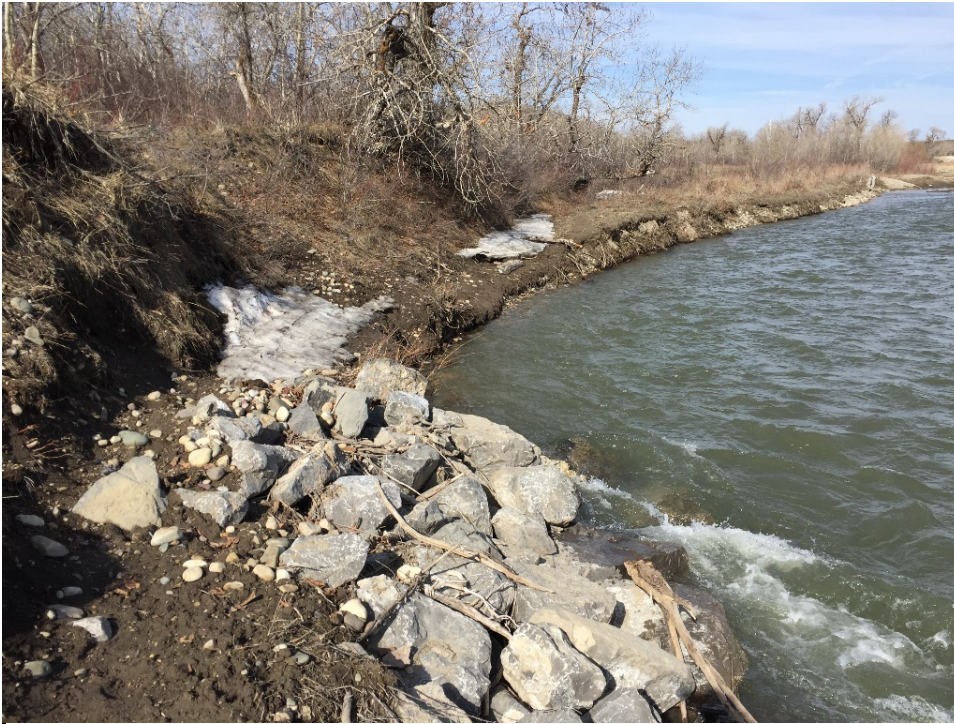
COMMENTS
Repaired slope in good condition with generally well-established vegetation.
Erosion noted on the bank upstream of riprap. The erosion feature has the potential to erode out behind the riprap. No change noted in since the 2017 inspection.
Lower bench wet where drain outlets are present. Logs and stumps/roots have been deposited on the lower bench by previous high-water events. High water event since the previous inspection in 2017 caused some erosion at the toe of the slope toward the south end of the site.
LPSTP riprap armouring in good condition, some minor displacement of particles at re-directive riprap vanes. Belly River was high at time of 2018 inspection, and most of the re-directive riprap vanes were underwater. Live staking near rip rap has not been very successful. Only a few live stake "branches" are alive.
Site will be visited every second year as part of the southern region GRMP tour.

Photo 3 Erosion at upstream limit of riprap. Minimal change noted from previous inspection. Photo was taken facing southwest on May 3, 2018.

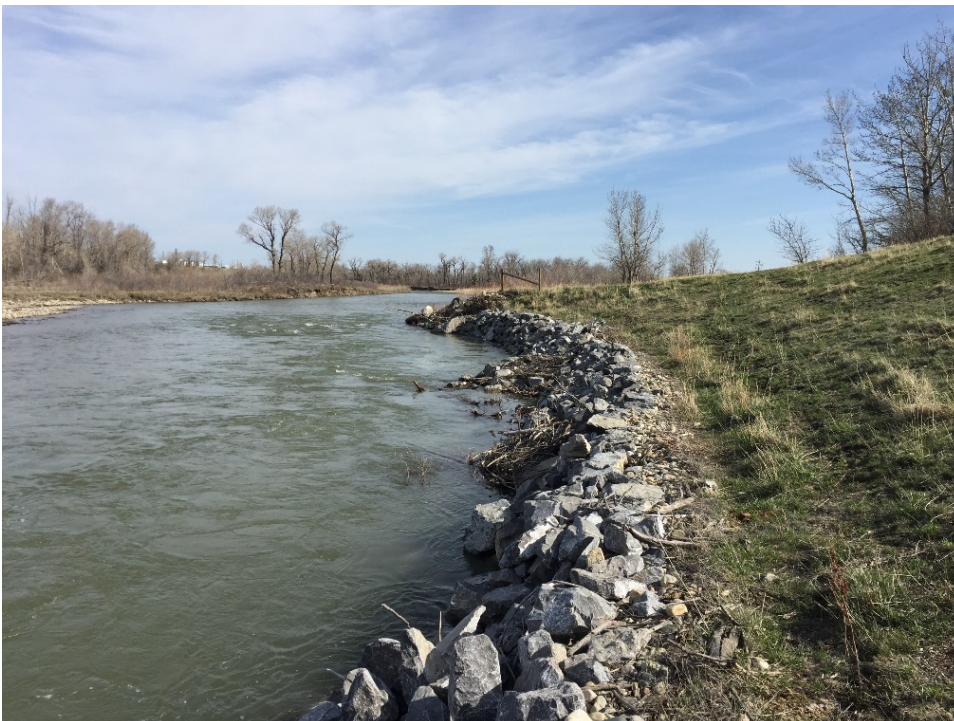
Photo 4 North toe area of repaired slide area. Some rip rap has been displaced from the re-directive vanes at river edge. Photo was taken facing north on May 3, 2018.

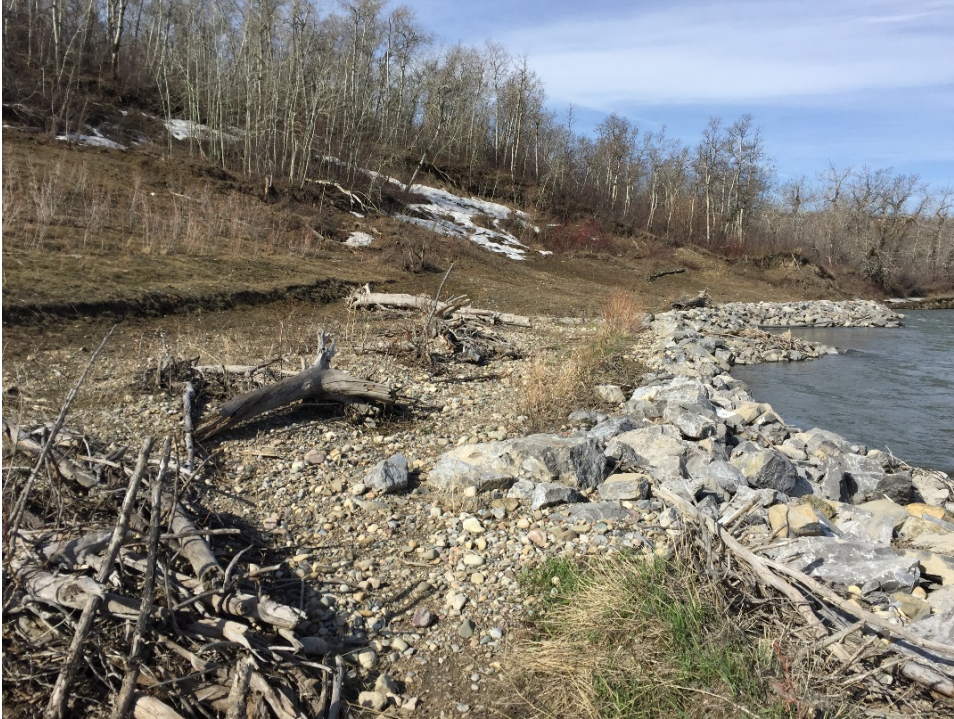
Photo 5 High water since the previous inspection in 2017 has deposited tree debris and caused some erosion at the toe of the slope. Photo was taken facing southwest on May 3, 2018.
