SITE NUMBER AND NAME: S036 Belly River		HIGHWAY & KM: 800:02, 9.050	PREVIOUS INSPECTION DATE: May 3, 2018	INSPECTION DATE: May 9, 2019
LEGAL DESCRIPTION: 12-18-003-27 W4M	NAD 83 COORDINATES: UTM Northing Easting 12 5454363 308507		RISK ASSESSMENT: PF: 3 CF: 1 TOTAL: 3	
AVERAGE ANNUAL DAILY TRAFFIC (AADT): 400 (north), 620 (south), (Ref No. 87010, 87030)			CONTRACTOR MAINTENANCE AREA (CMA): 25

NOTES: 1. HORIZONTAL DATUM: NAD83 2. GRID ZONE: UTM Zone 12N 3. IMAGE SOURCE: World Imagery, ESRI Arc GIS Online Southern Alberta 2015 Imagery 4. LPST = Longitudinal Peaked Stone Toe Protection	CLIENT 	PROJECT SOUTHERN REGION GEOHAZARD RISK MANAGEMENT PROGRAM
		TITLE Site Plan S036 - Belly River Hwy 800:02, km 9.050
	SCALE 1:1,250	PROJECT No. A05115A03
		FIG No. 1

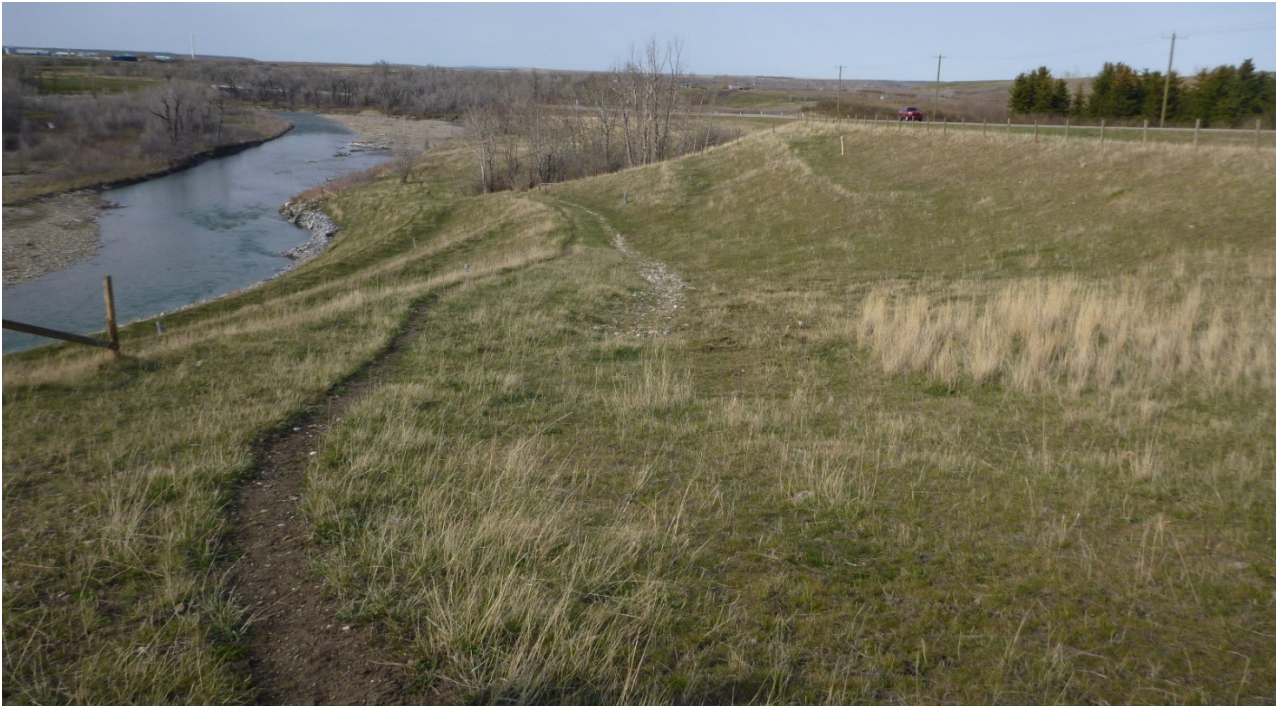
Photo 1 North section of repaired slide area. Photo was taken facing north on May 9, 2019.

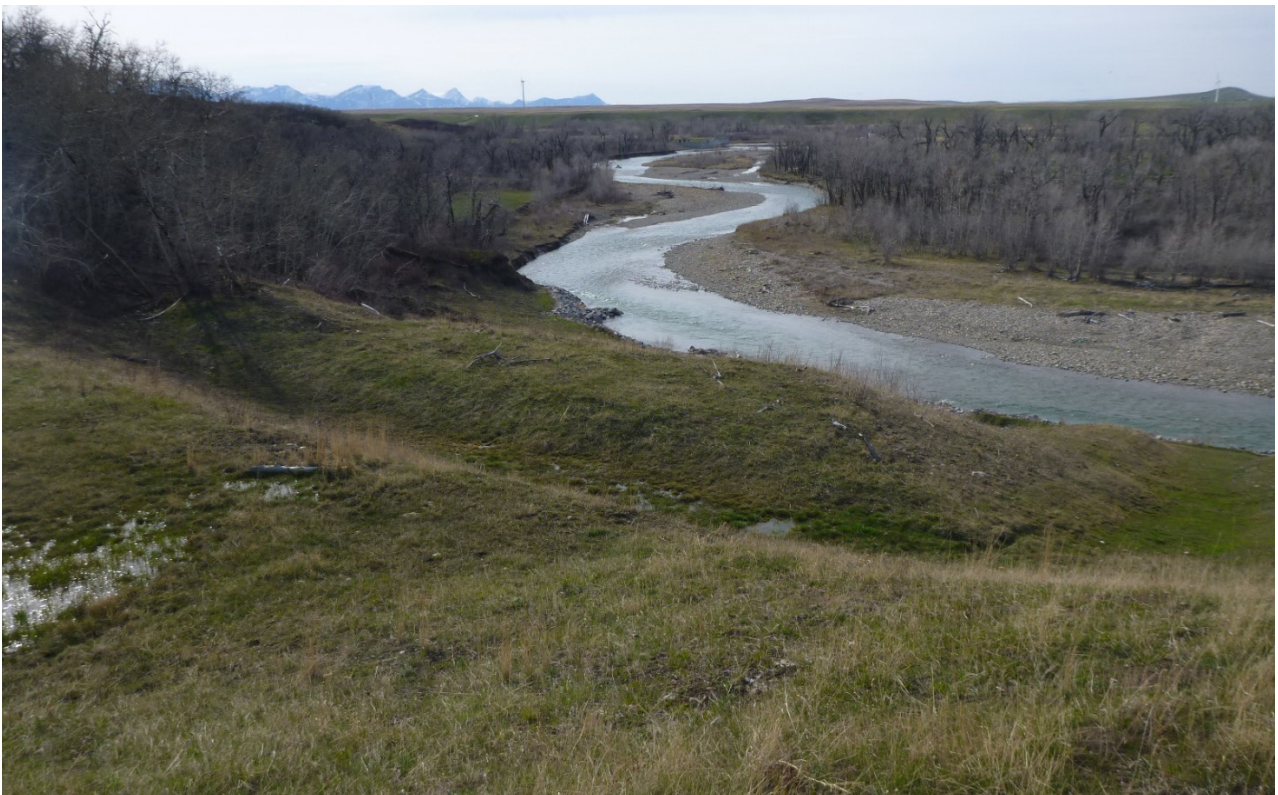
Photo 2 South section of repaired slide area. Photo was taken facing west on May 9, 2019.

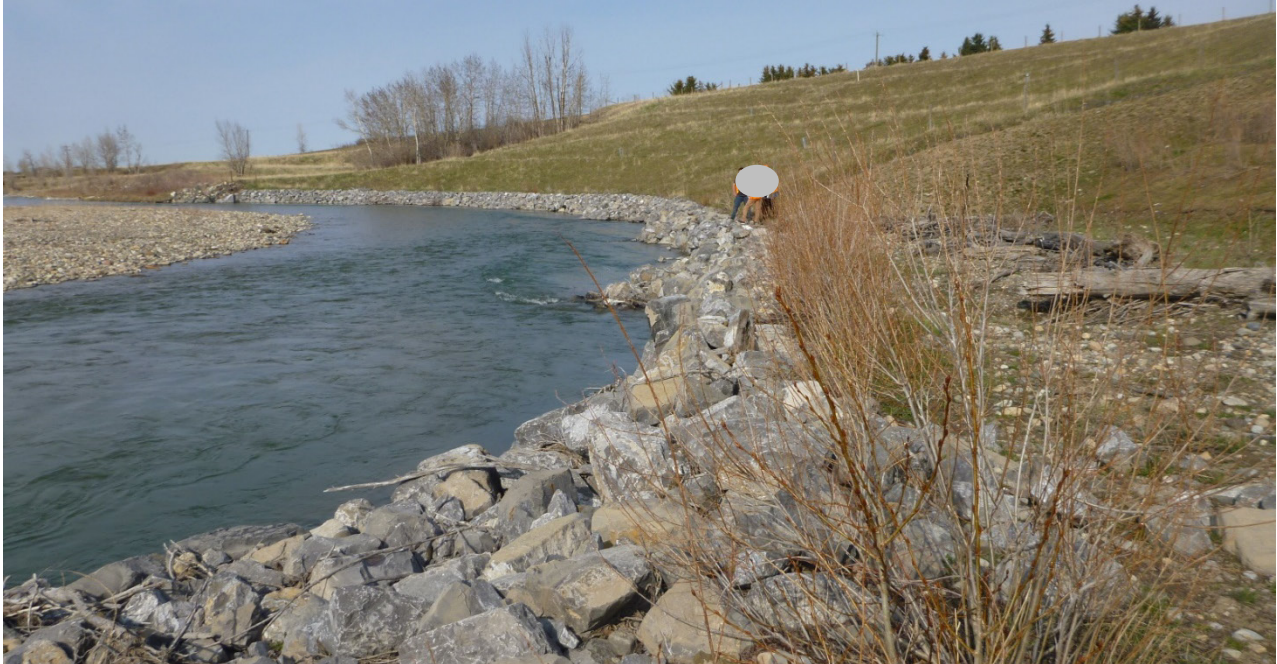
Lower bench is damp where drain outlets are present. Logs and stumps/roots were deposited on the lower bench by high-water event in 2017/2018. Some erosion at the toe of the slope near the south end of the site.

Photo 3 North toe area of repaired slide zone. Some riprap has been displaced from the redirective vanes at river edge. High water in 2017/2018 deposited woody debris at the toe of the slope. Photo taken facing northeast on May 9, 2019.

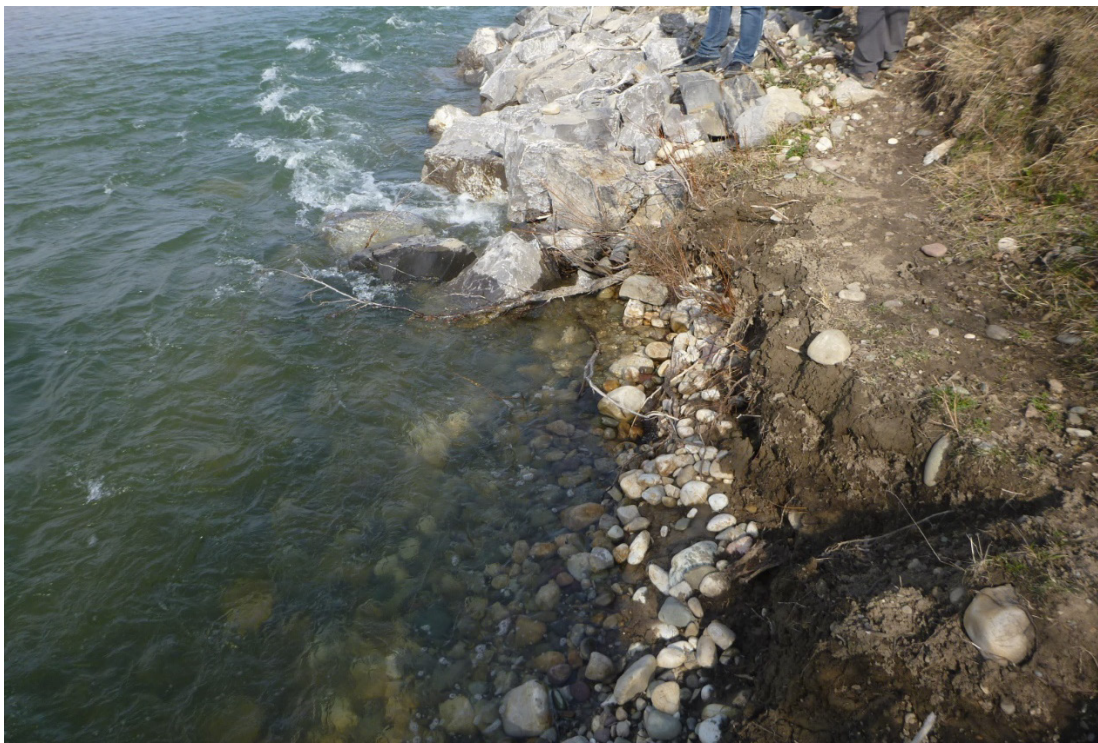
COMMENTS
Repaired slope in good condition with generally well-established vegetation. Visit site every 2 years on the GRMP tour moving forward. Keep reading the instruments twice a year.
Erosion noted on the bank upstream of northwestern end of riprap. The bank erosion has the potential to wash out behind the riprap. No change noted since the 2018 inspection.
LPSTP riprap armouring appears in good condition, although some minor displacement of riprap particles at the redirective vanes. No obvious changes since previous inspection. KCB took photos of the redirective vanes during low water flows in fall 2019.
There are mixed results with live staking of the slope toe. Willows on the left flank (down near the water) are doing well but the remainder of the planting is not very successful. It is possible that animals are eating the willows.

Photo 4 Erosion at upstream limit of riprap. Minimal change noted from previous inspection. Photo was taken facing east on May 9, 2019.
