September 21, 2022

**CON0022161 Southern Region GRMP Instrumentation Monitoring  
Site S036; H800:02, km 9.05 Belly River  
Section C – 2022 Spring Readings**

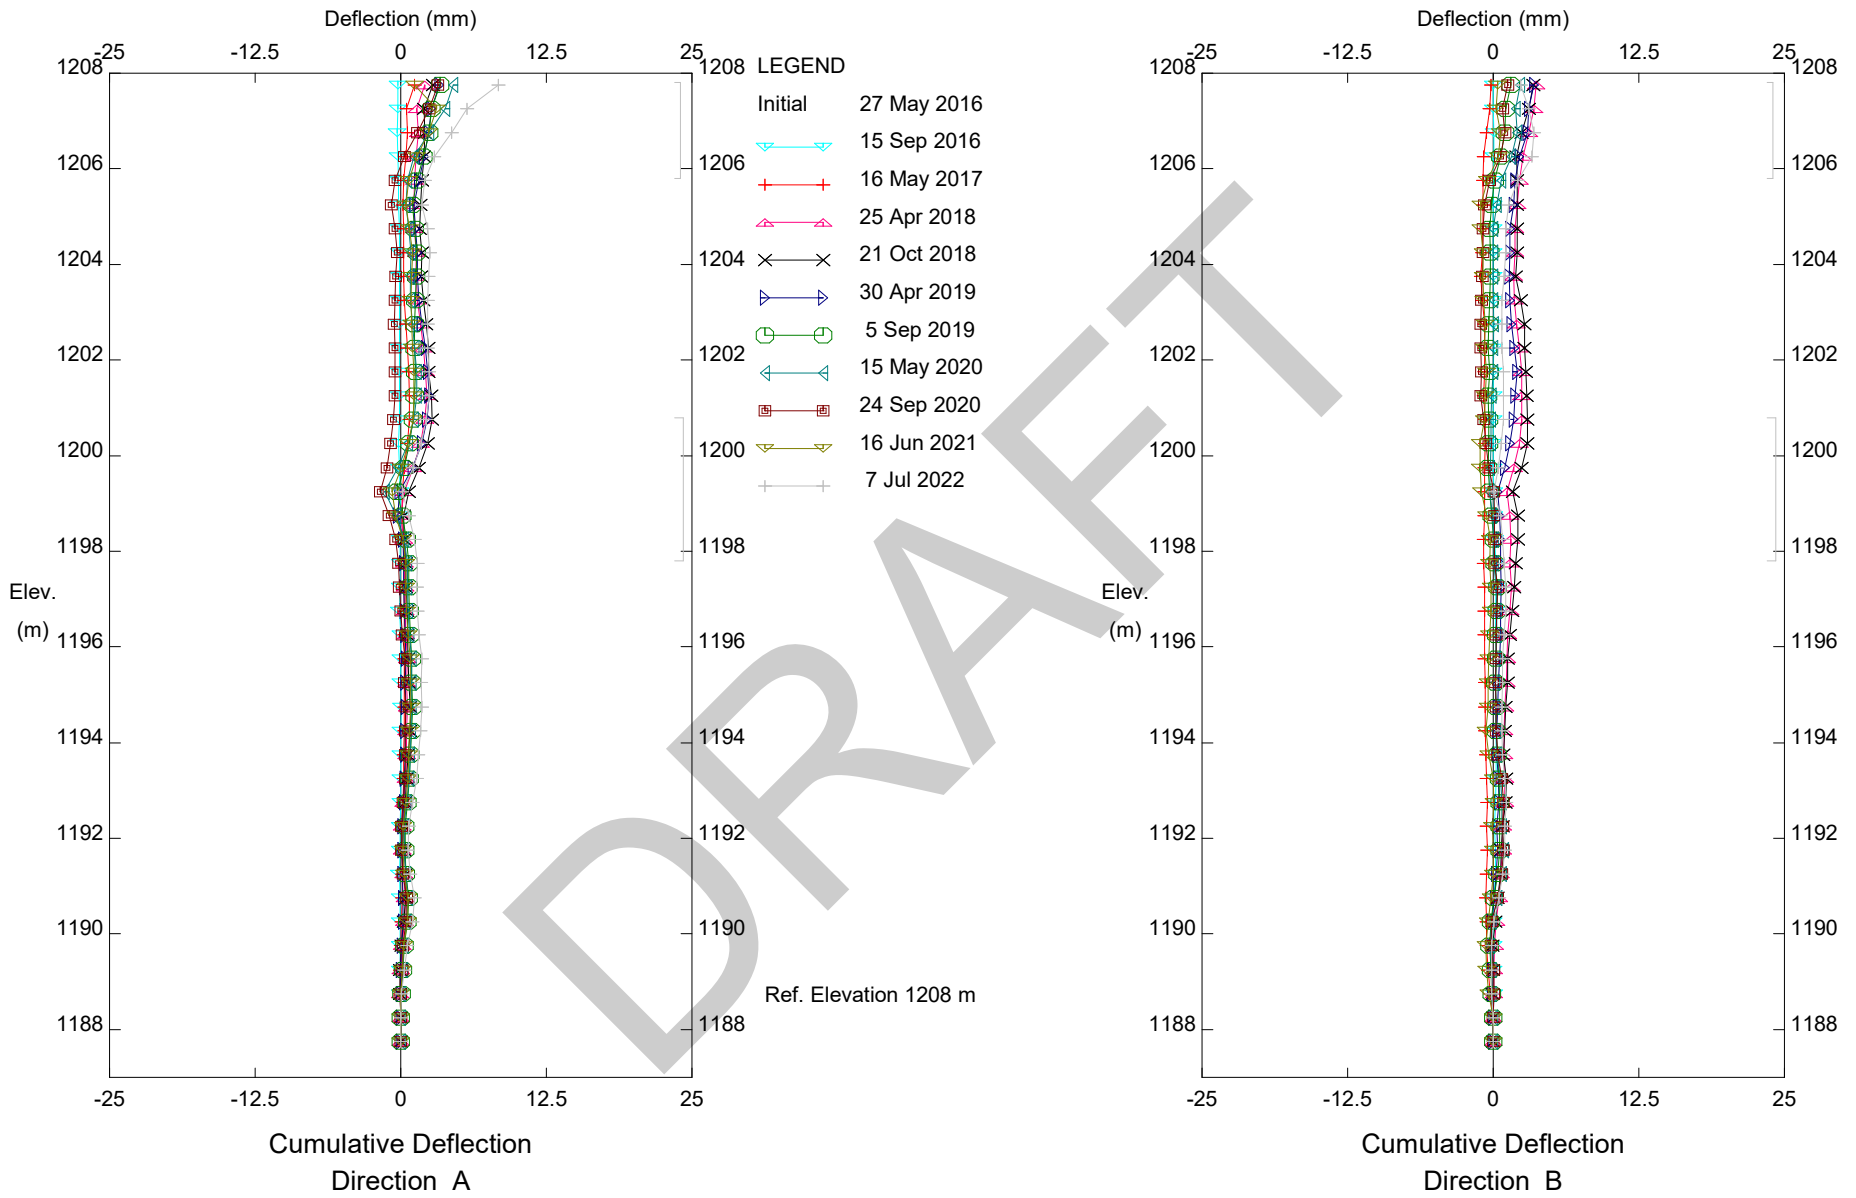
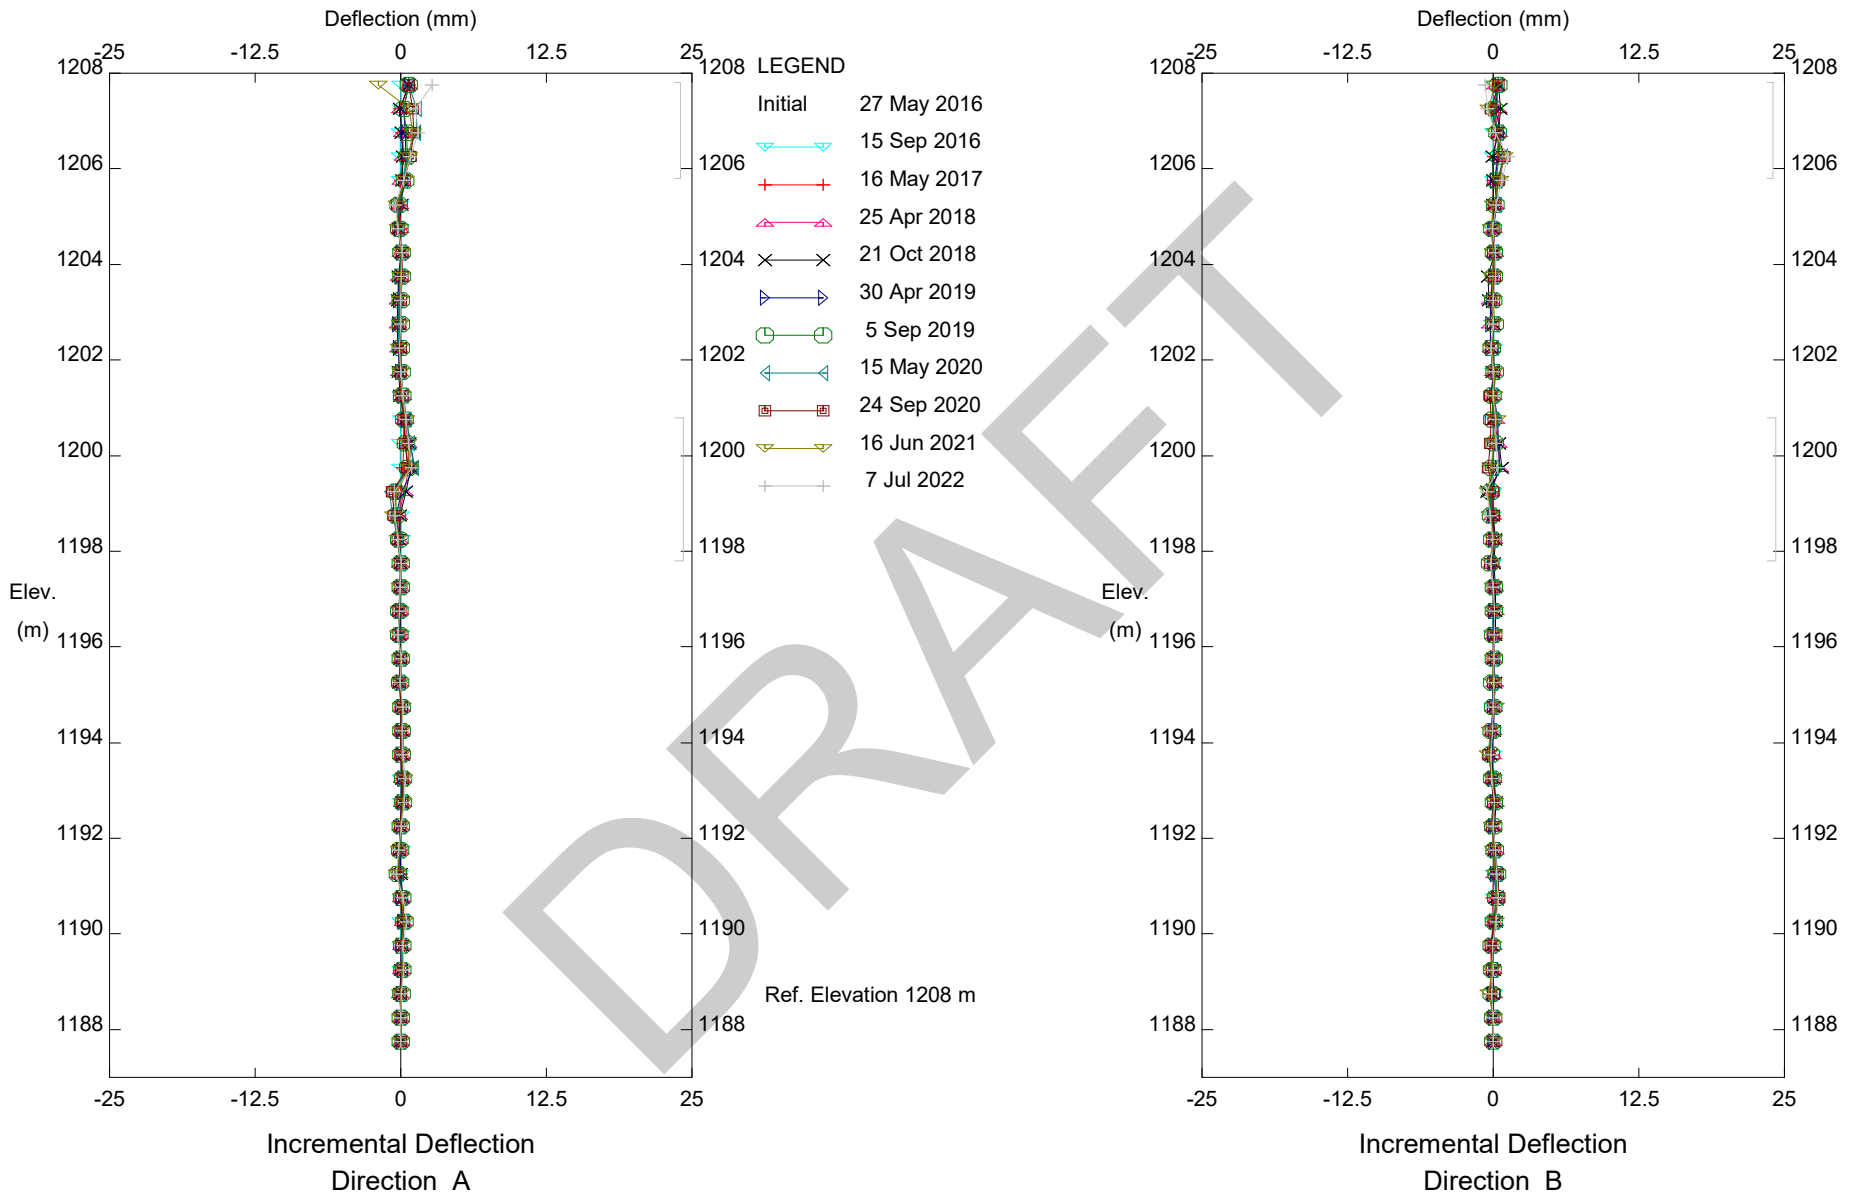
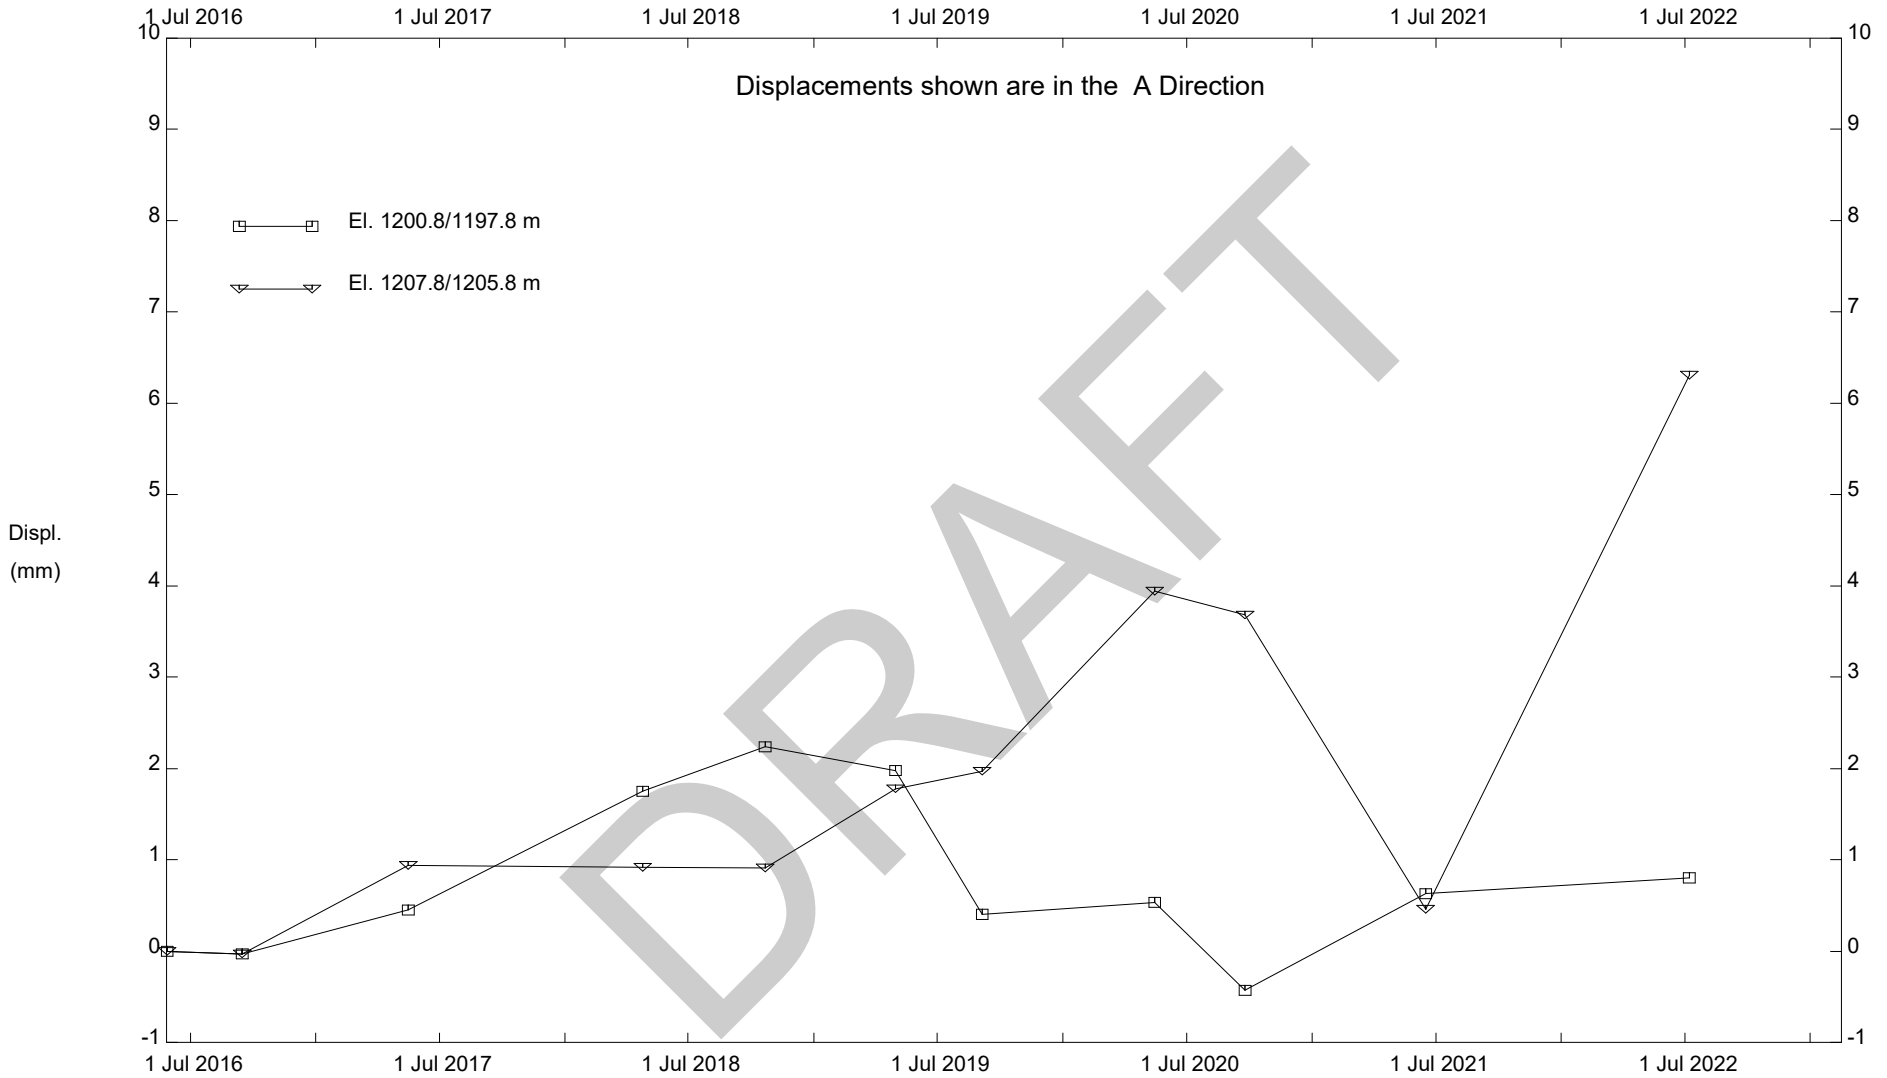
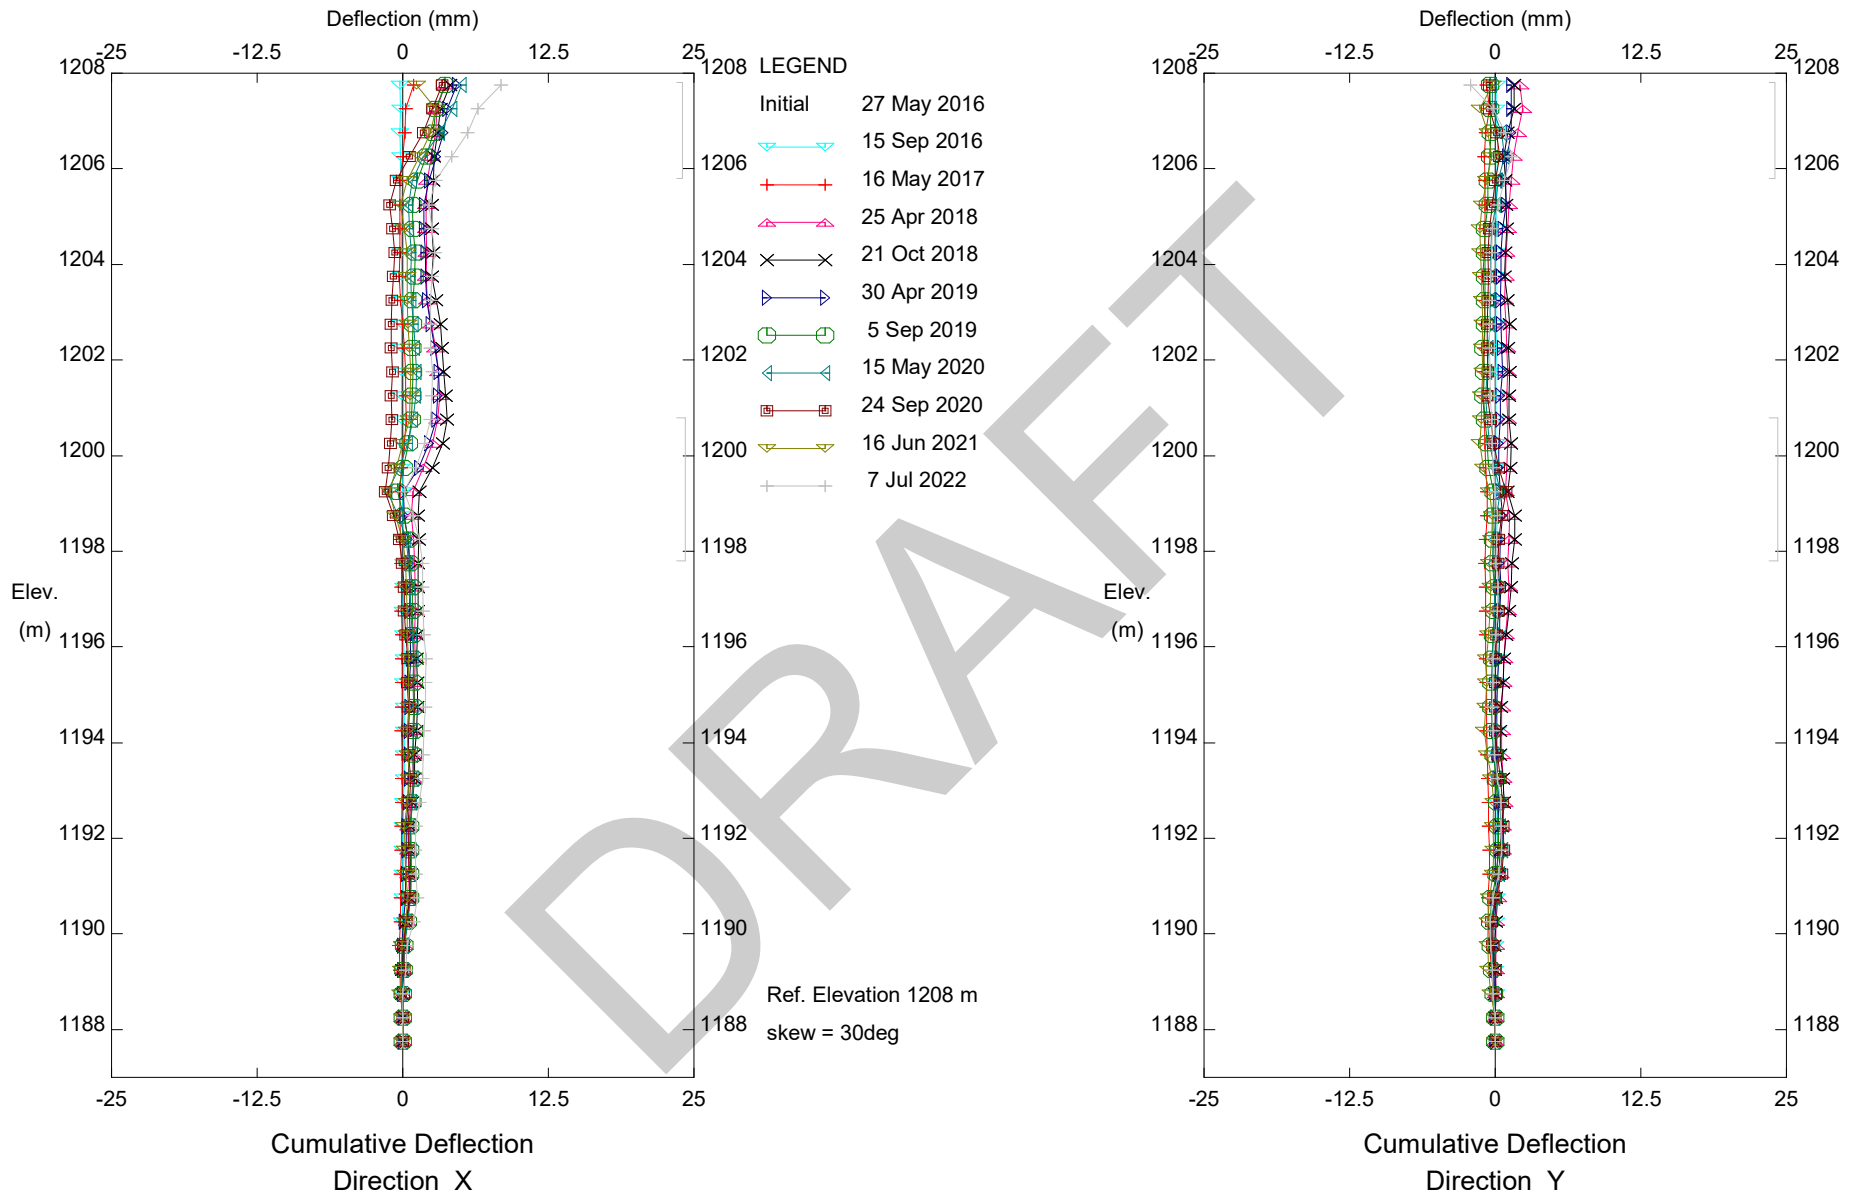
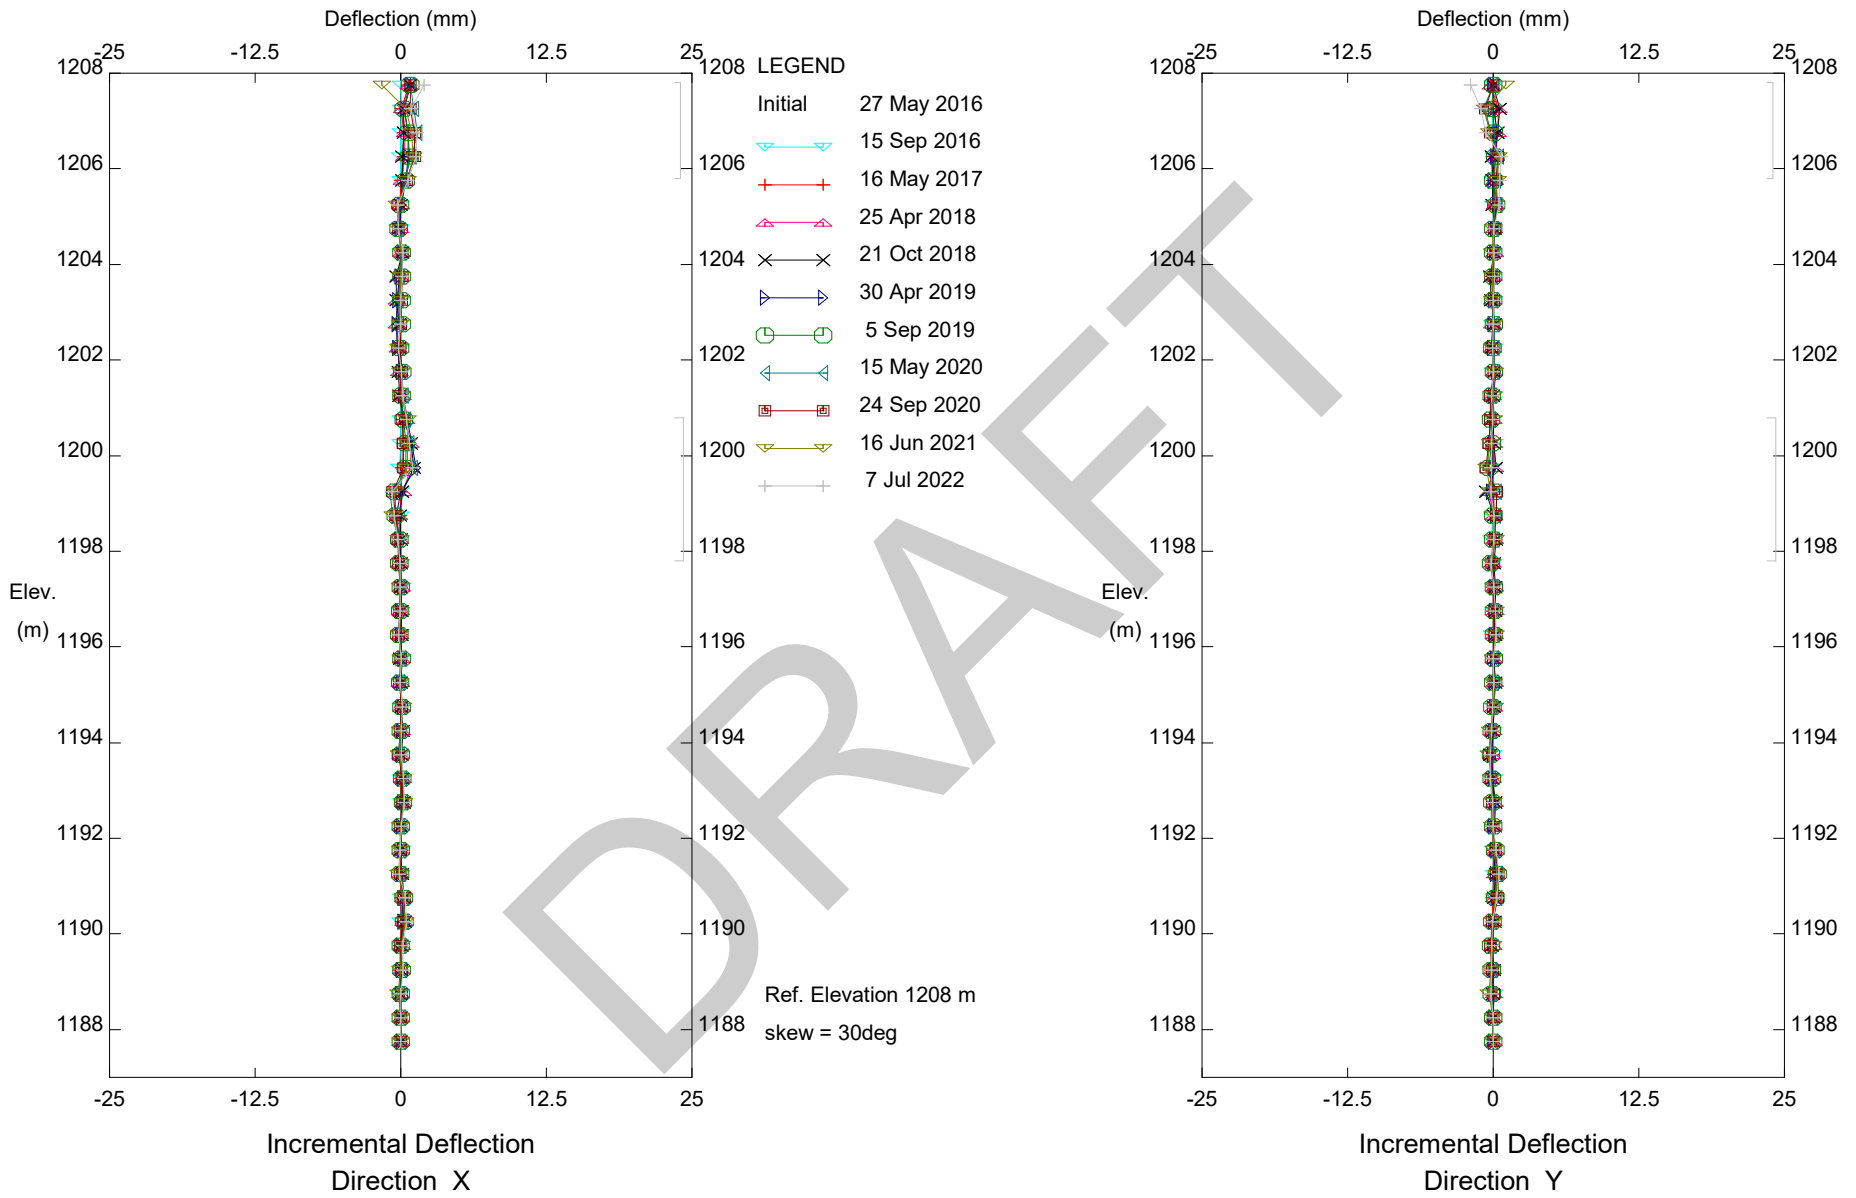
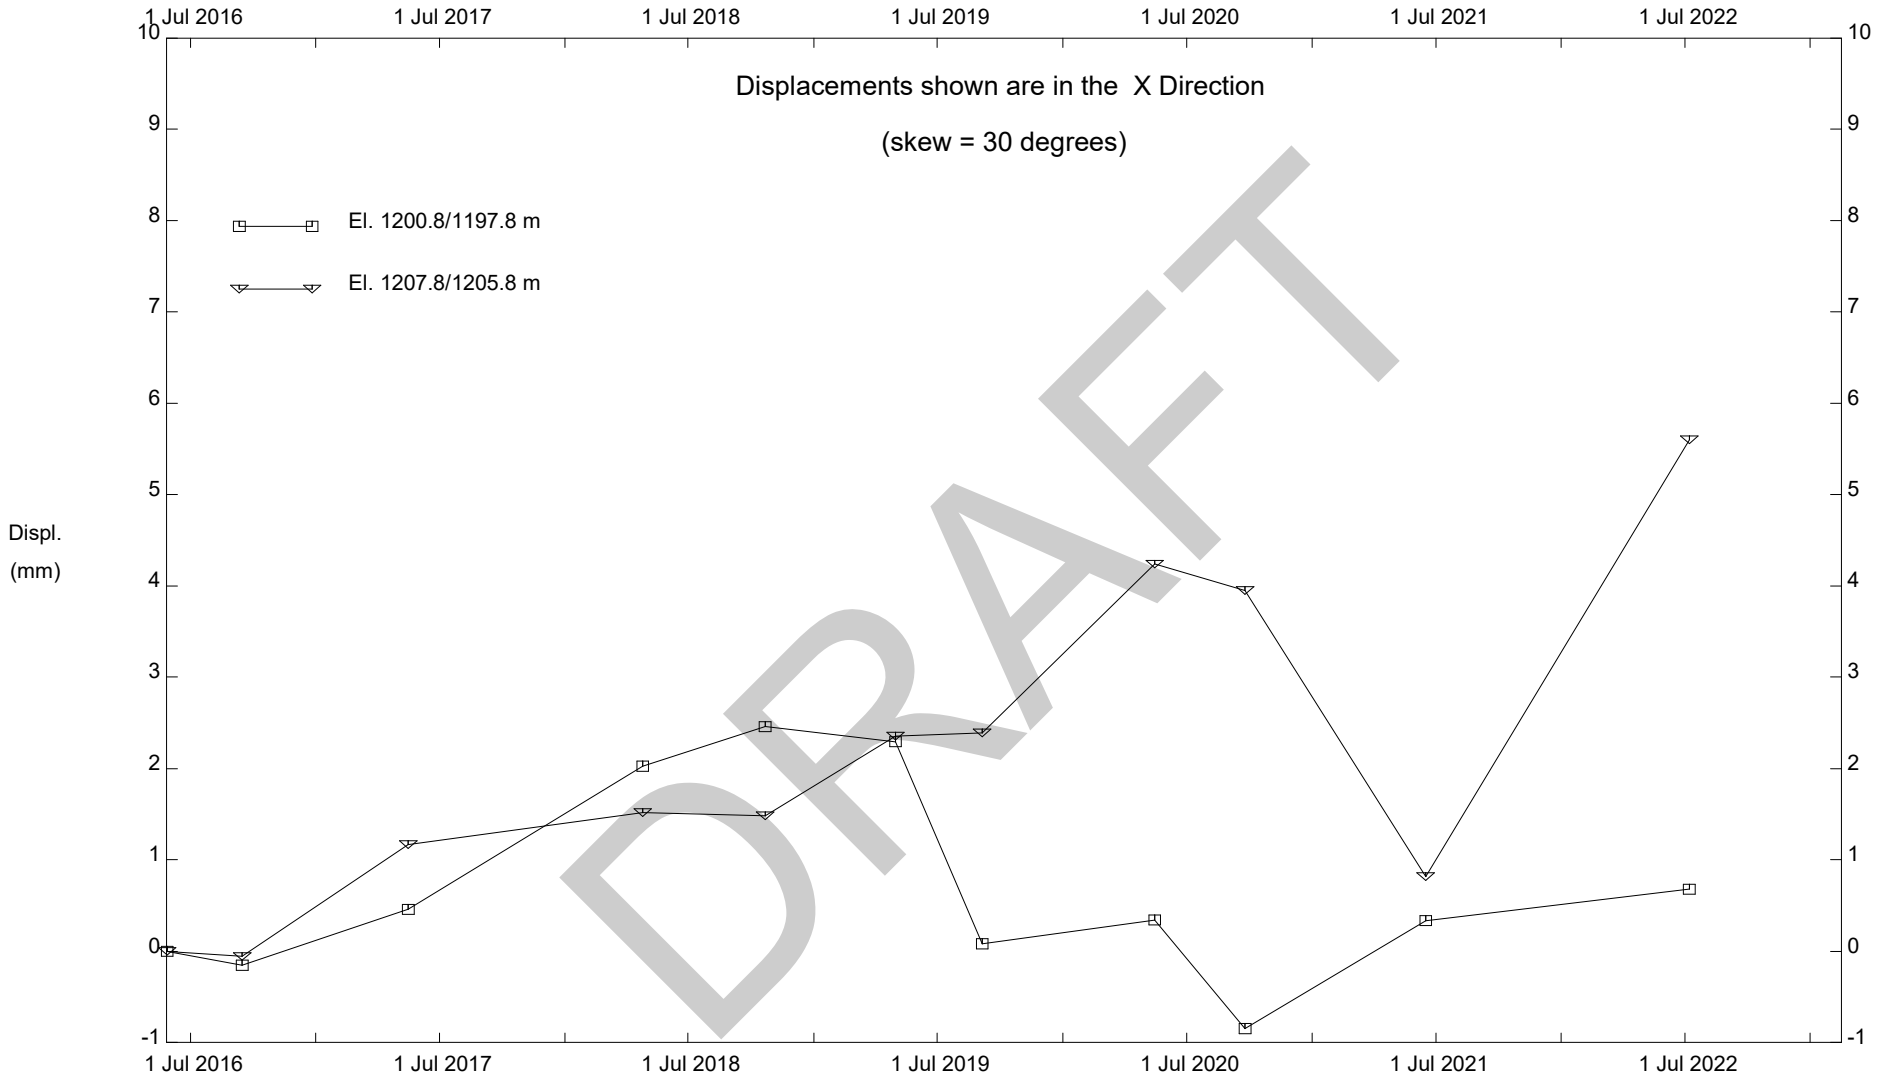
S036; H800:02, Belly River, Inclinator SI11-01

Movement has been recorded in SI11-01 from an approximate depth of 7 m to 10 m below ground surface (approximately El. 1198 m to El. 1201 m). Shallow movement from ground surface to approximately 2 m below ground surface (El. 1206 m) was also recorded between June 2021 and July 2022.

The July 2022 data indicates a small amount of movement (less than 6 mm) has occurred in the upper 2 m of SI11-01 since the fall 2021 reading. This movement could be due to instrument noise or reading error, or an indication that the slide is retrogressing towards the highway. More data is needed to assess.
