September 21, 2022

**CON0022161 Southern Region GRMP Instrumentation Monitoring  
Site S036; H800:02, km 9.05 Belly River  
Section C – 2022 Spring Readings**

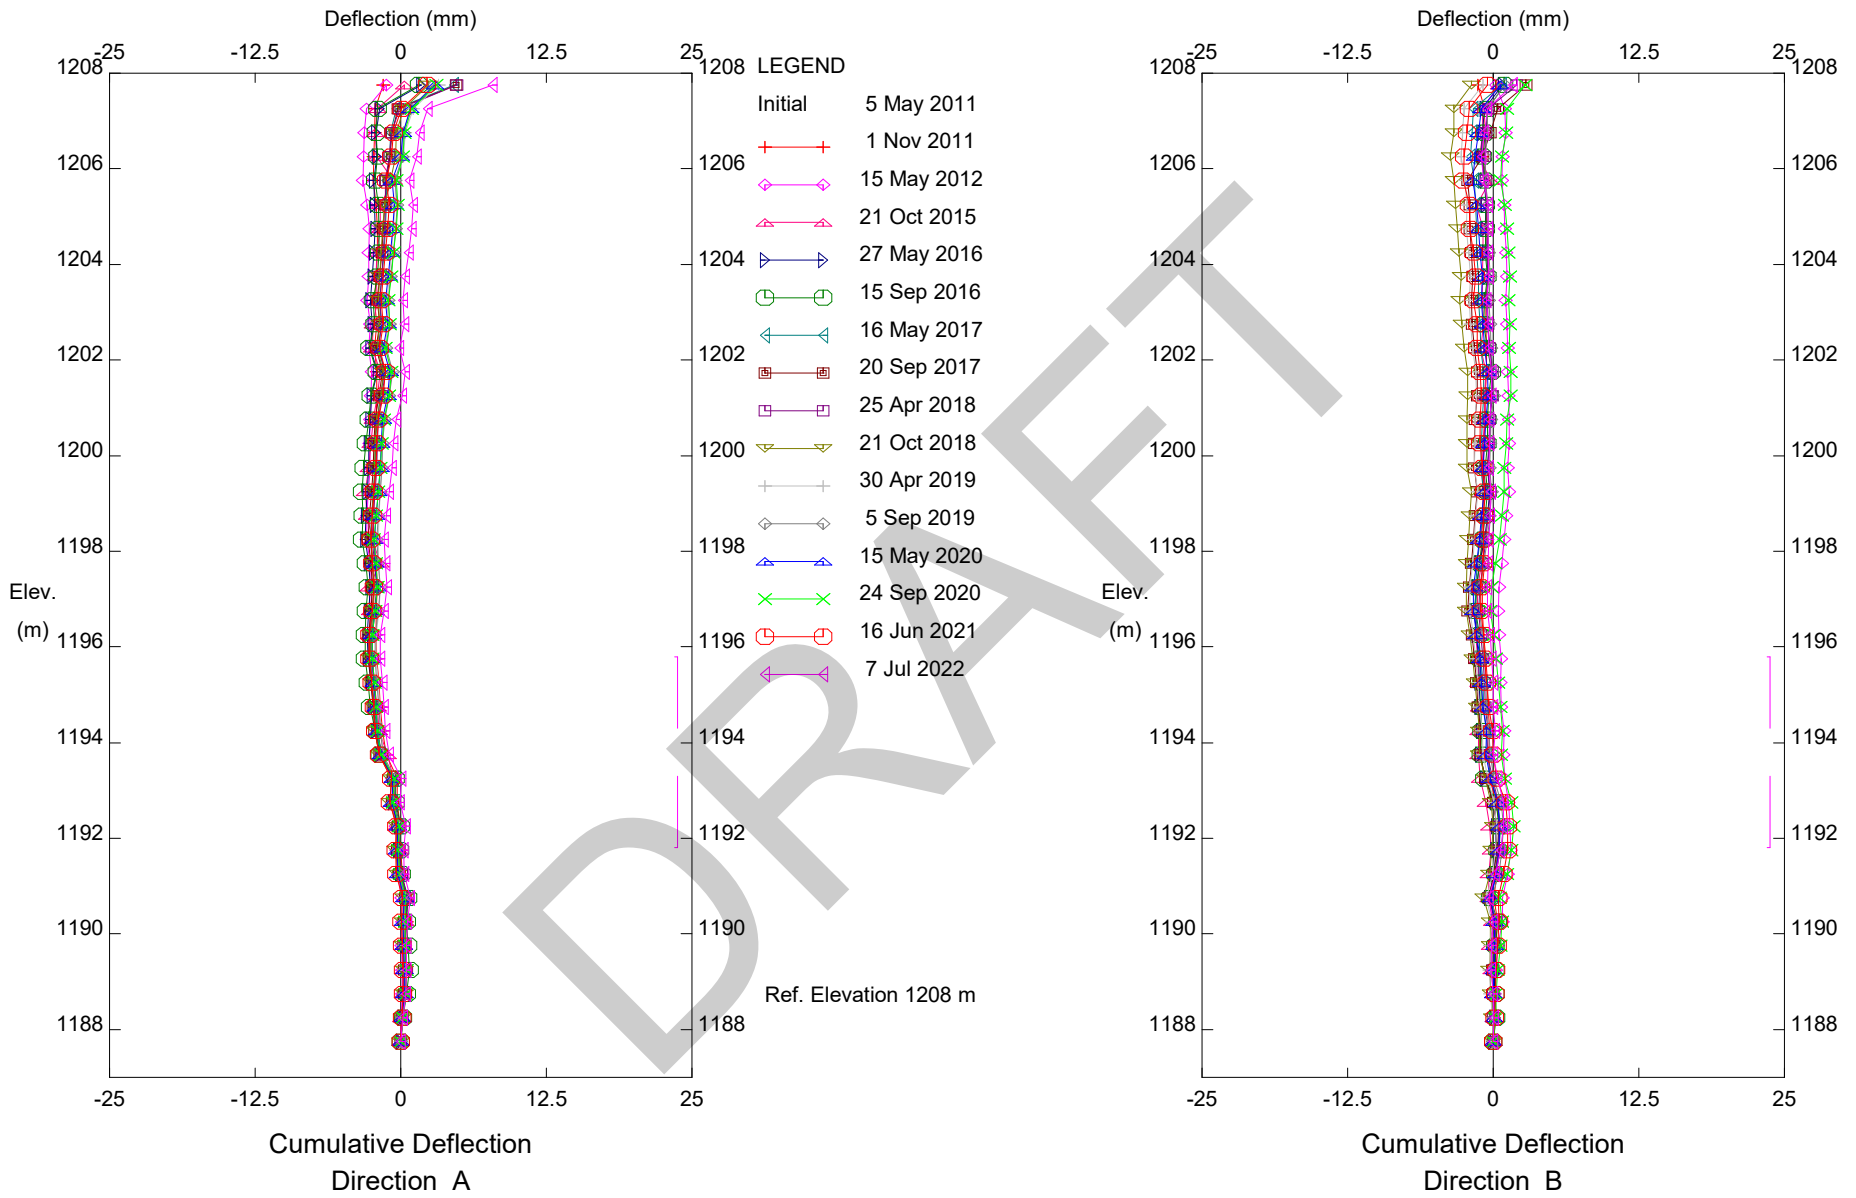
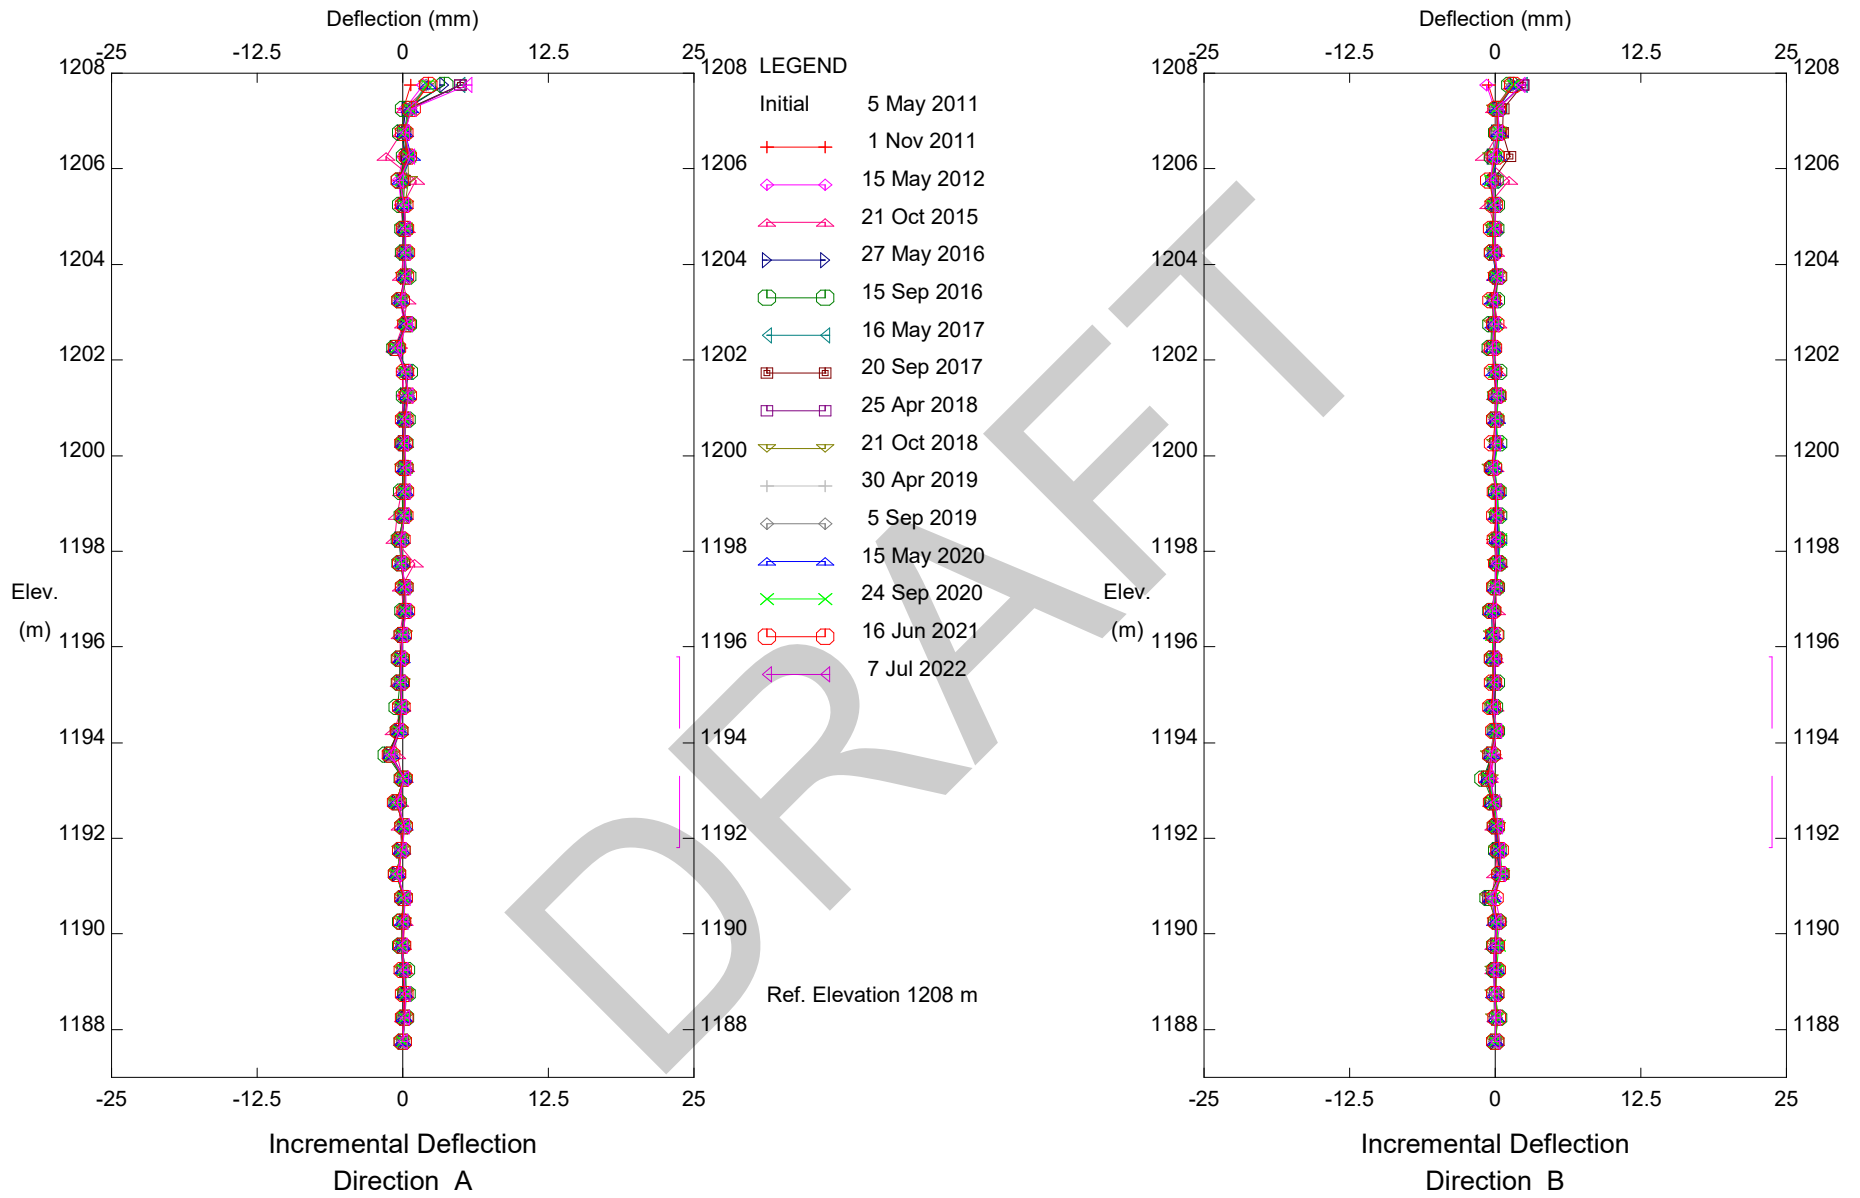
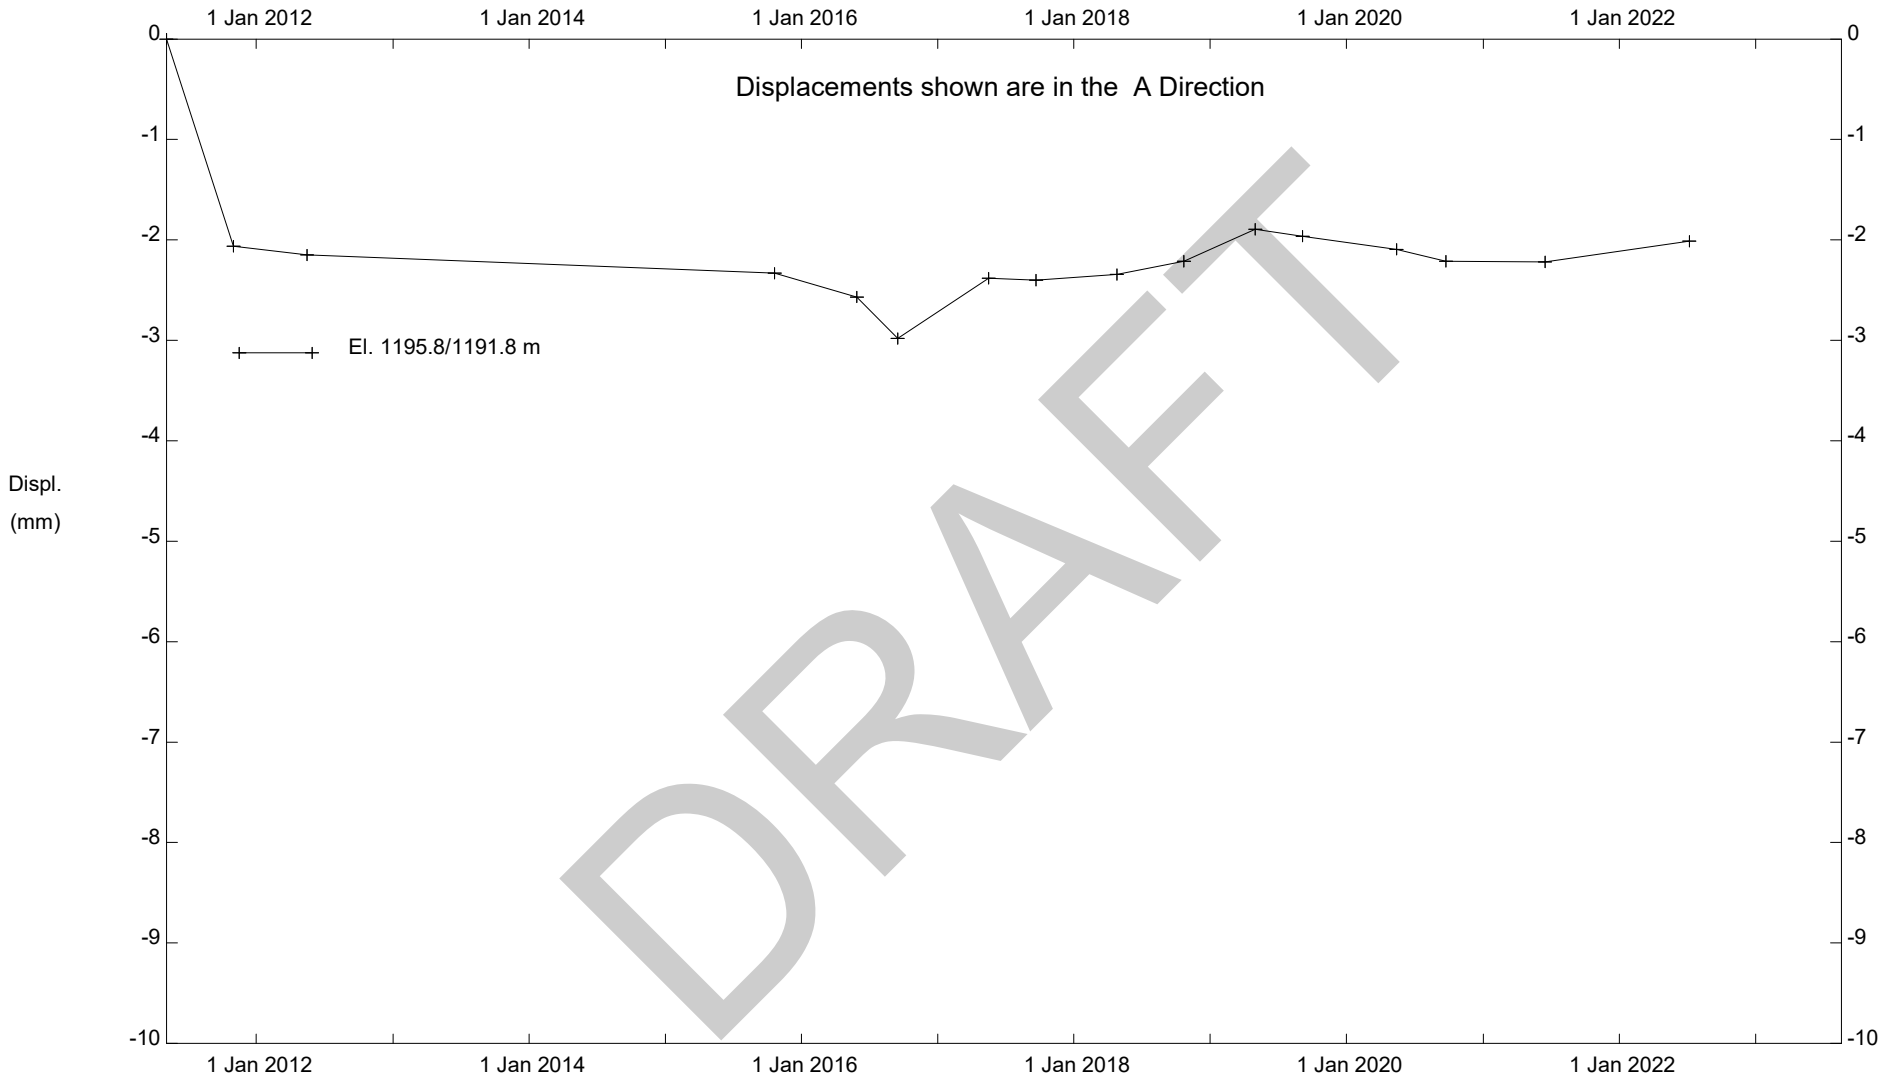
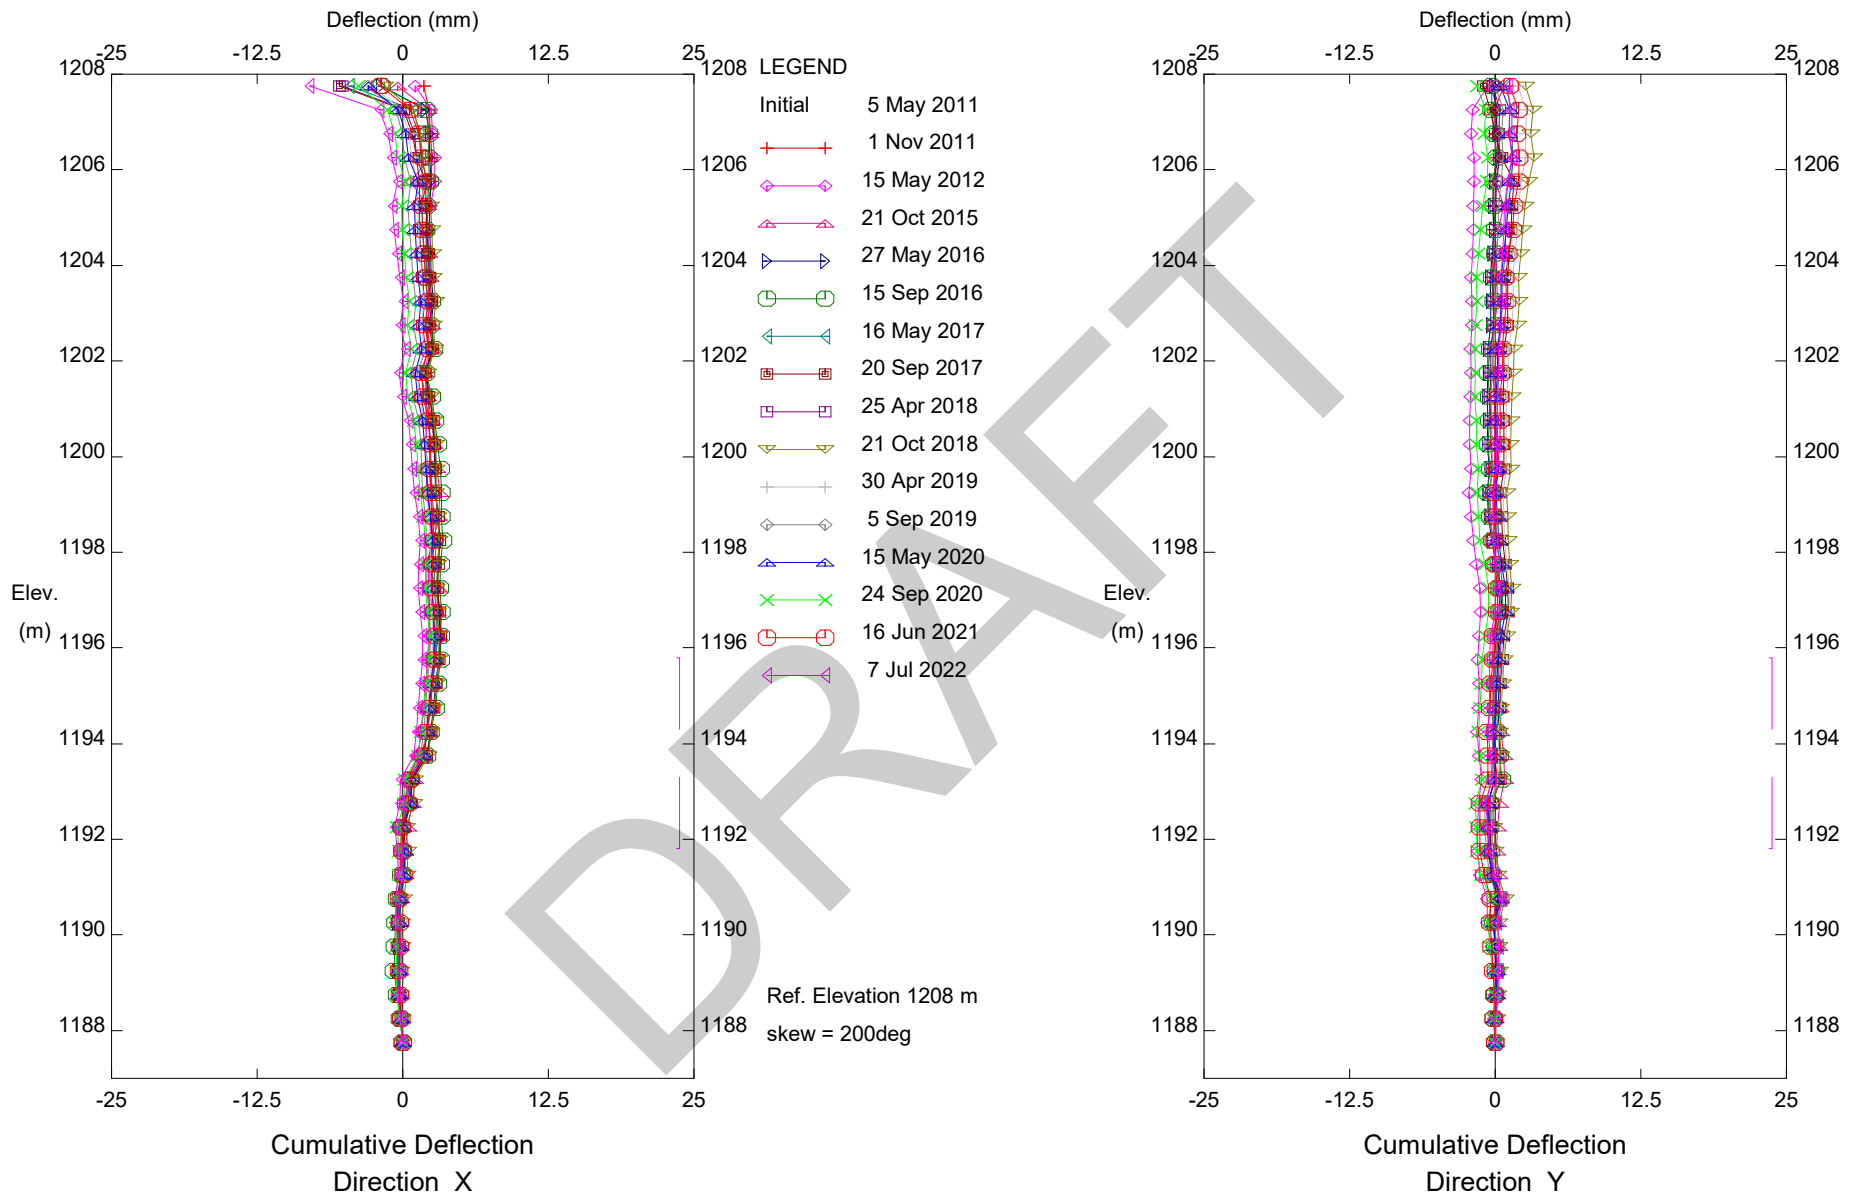
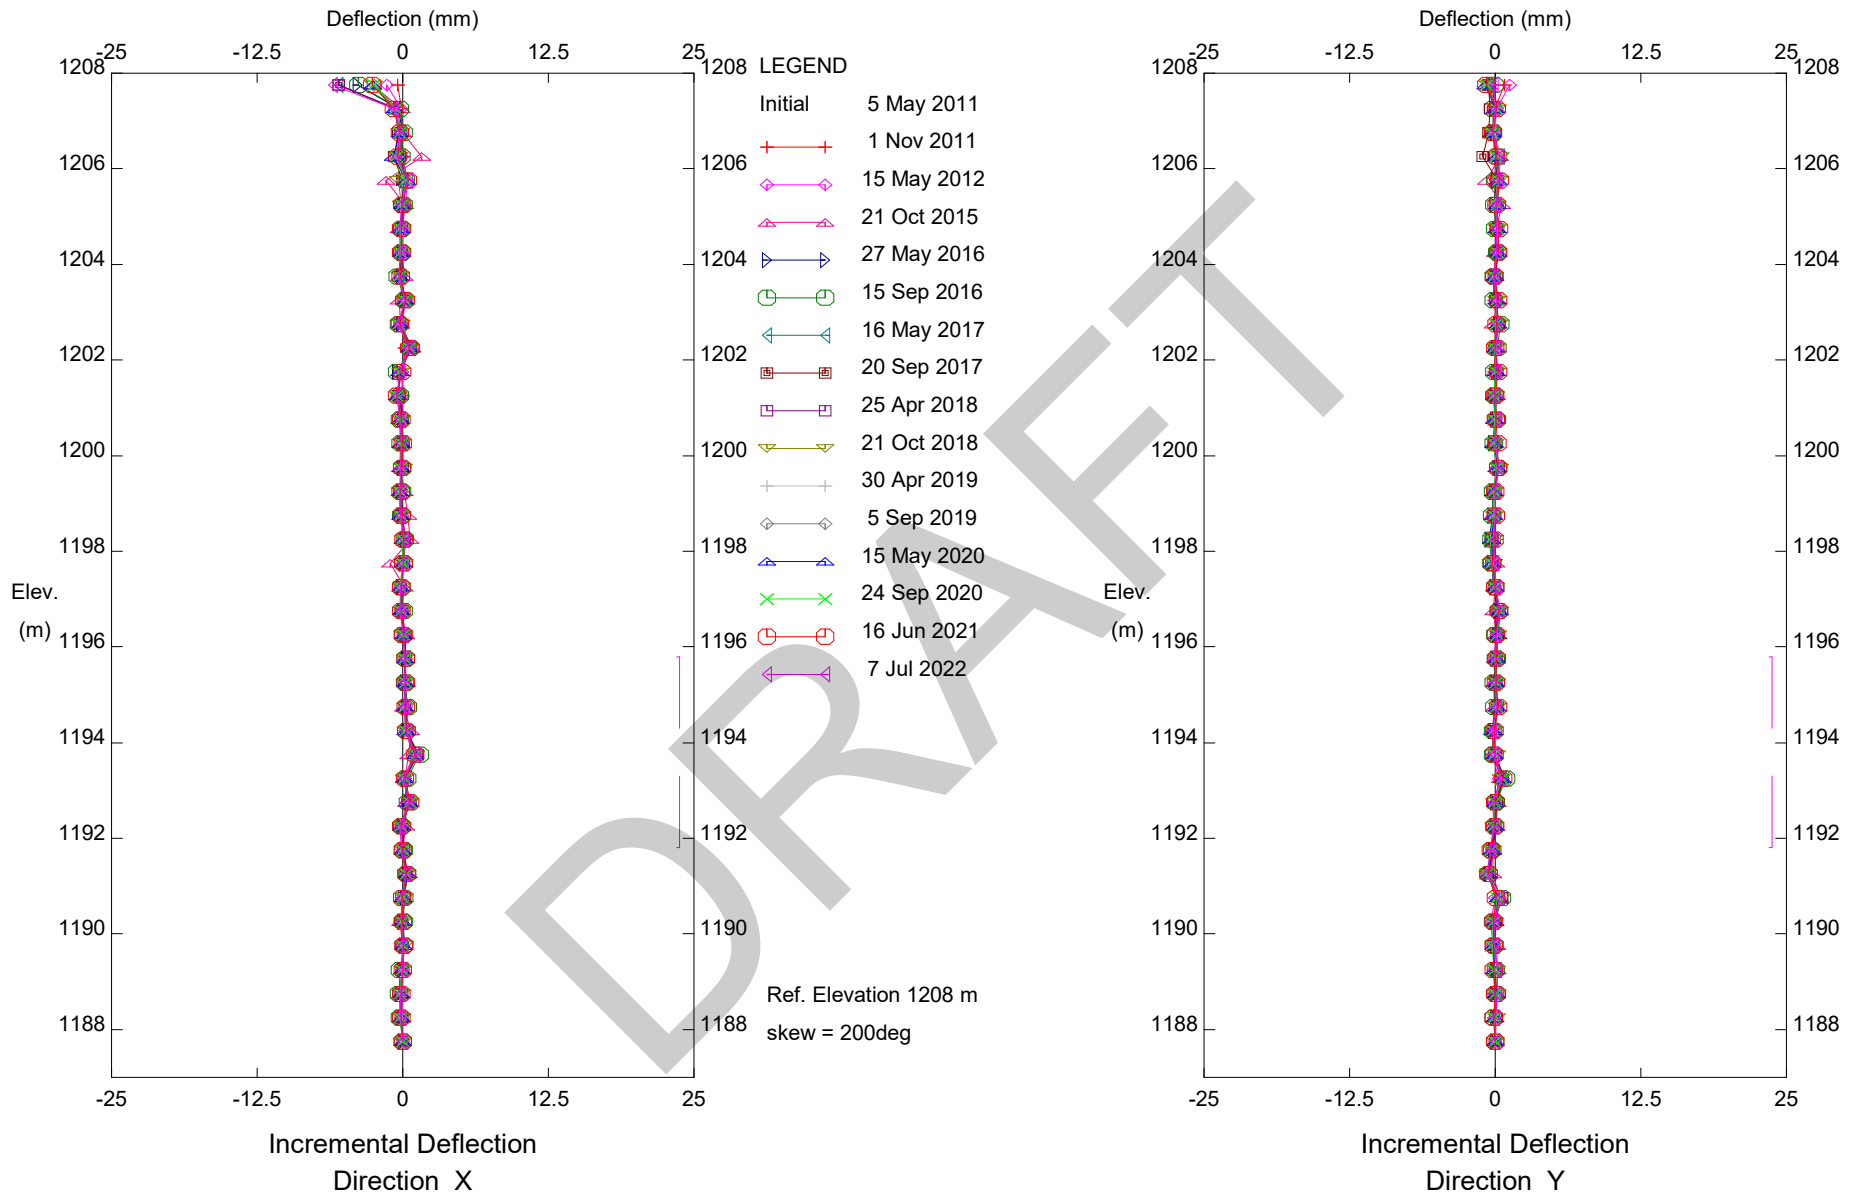
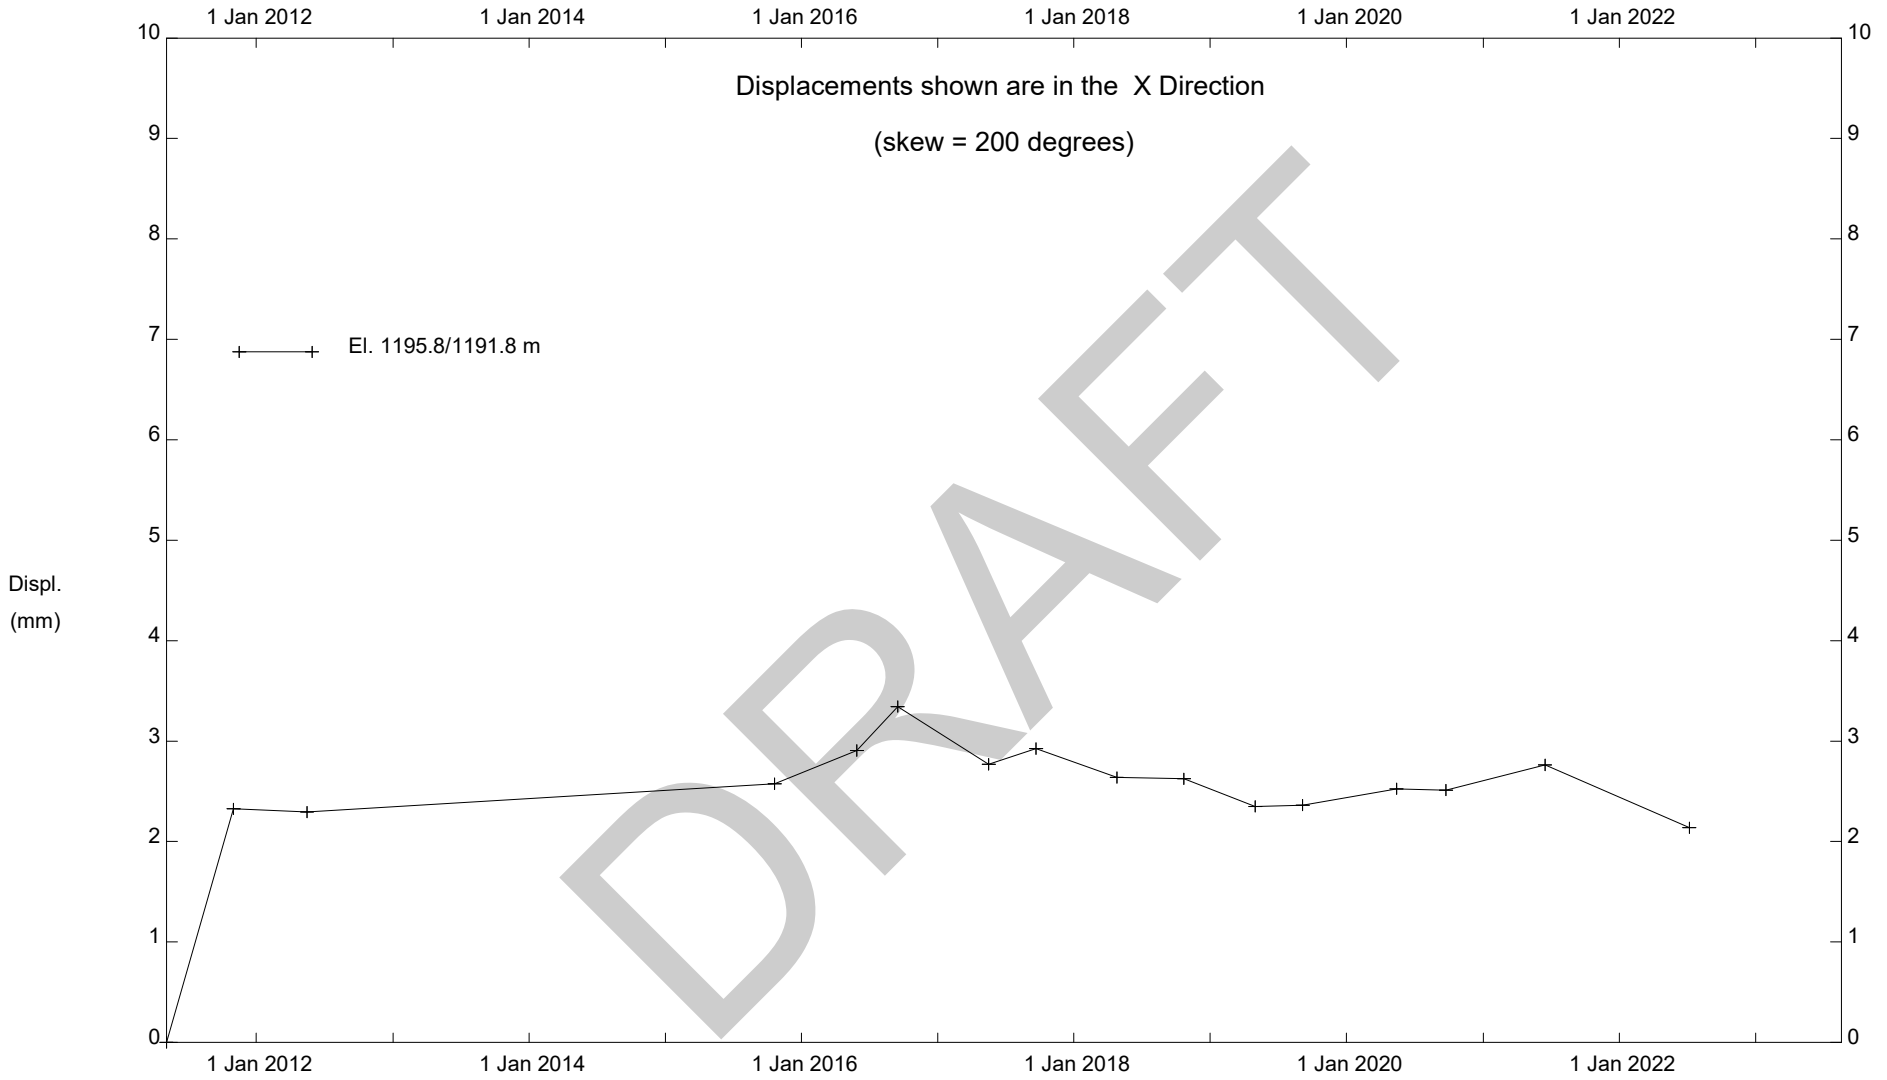
S036; H800:02, Belly River, Inclinator SI11-02  
 Alberta Transportation

Movement has been recorded in SI11-02 from an approximate depth of 16 m to 20 m below ground surface (approximately El. 1192 m to El. 1196 m).

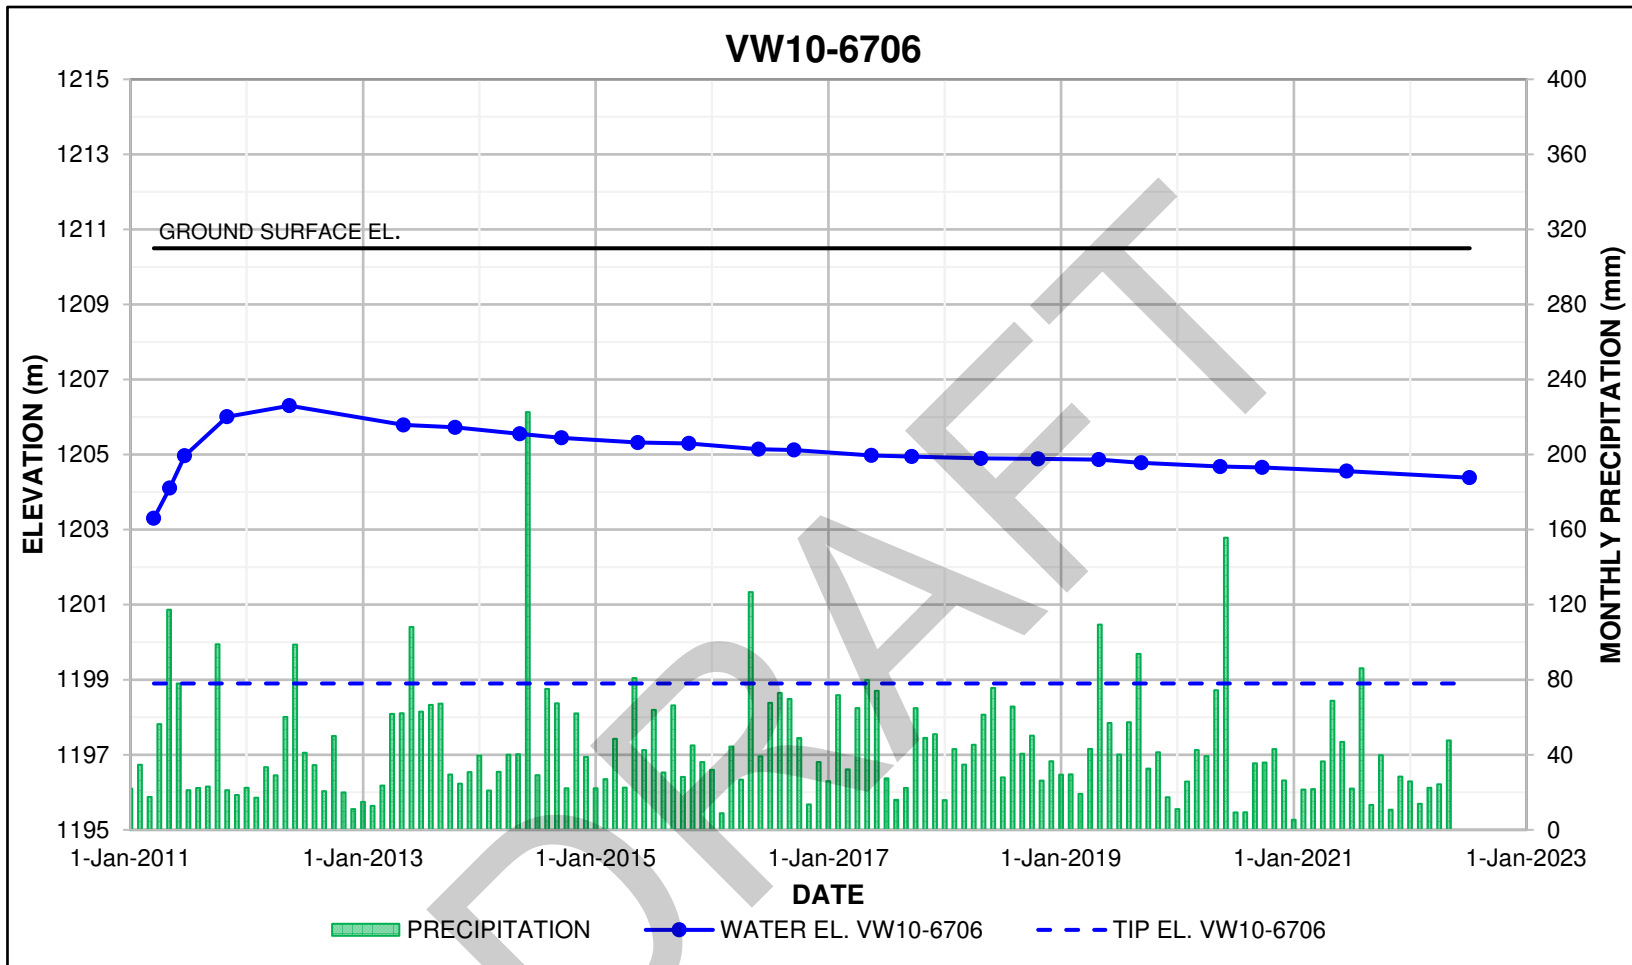
# VW10-6706

Since May 2012, water levels recorded in VW10-6706 have slowly decreased most likely due to excess porewater pressure dissipation following 2012 construction. In total, a 1.9 m and 0.2 m decrease has been recorded since May 2012 and the June 2021 reading, respectively.

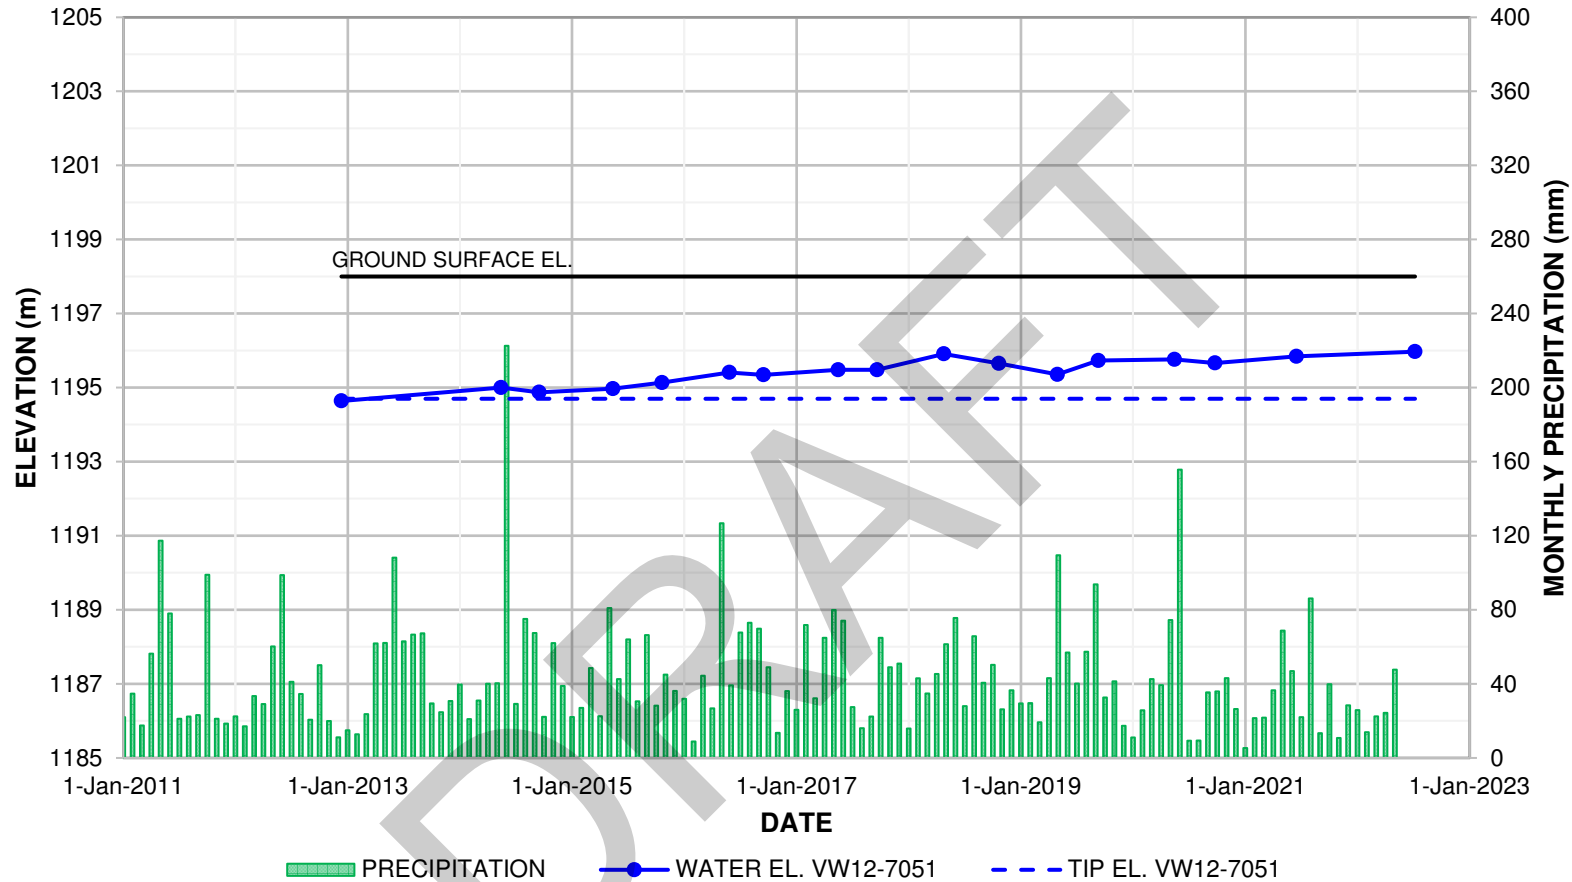
### VW12-7051

Water levels recorded in VW12-7888 and VW12-7899 have been relatively steady since installation between an approximate depth of 2.6 m to 3.1 m and 0.3 m to 1.1 m, respectively. Whereas water levels recorded in VW12-7051 and VW12-7982 have been steadily increasing (approximately 1.3 m and 1.1 m overall, respectively). The rate of increase recorded in VW12-7982 may be slowing or flattening but more data is needed to assess. Last year and the spring of 2022 were relatively dry.

Without reviewing stratigraphy or construction records for the site or installation details for the instruments, it is difficult to assess the cause of the increase recorded in VW12-7051 and VW12-7982.
