SITE NUMBER AND NAME: <b>S046 - I, II, and III Rosebud Slides</b>		HIGHWAY & KM: 840:02, 32.422 (I, III) 26.847 (II)	PREVIOUS INSPECTION DATE: June 13, 2017 (I & III))	INSPECTION DATE: <b>June 12, 2018</b>
LEGAL DESCRIPTION: 12-18-027-21 W4M	NAD 83 COORDINATES: UTM Northing Easting 12 5685886 363665		RISK ASSESSMENT: PF: 1 CF: 1 TOTAL: 1 PF: 9 CF: 2 TOTAL: 18	
AVERAGE ANNUAL DAILY TRAFFIC (AADT): 420 (south) 520 (north),(Reference No. 107240, 105210)			CONTRACT MAINTENANCE AREA (CMA): 29

<b>NOTES:</b> 1. HORIZONTAL DATUM: NAD83 2. GRID ZONE: UTM Zone 12N 3. IMAGE SOURCE: Abacus Datagraphics Ltd. Image dated July 5, 2011 to October 7, 2011	CLIENT 	PROJECT SOUTHERN REGION GEOHAZARD RISK MANAGEMENT PROGRAM
		TITLE Site Plan S046 Rosebud Slide Hwy 840:02, km 32.442
SCALE 1:750	PROJECT No. A05115A03	SKETCH No. 1

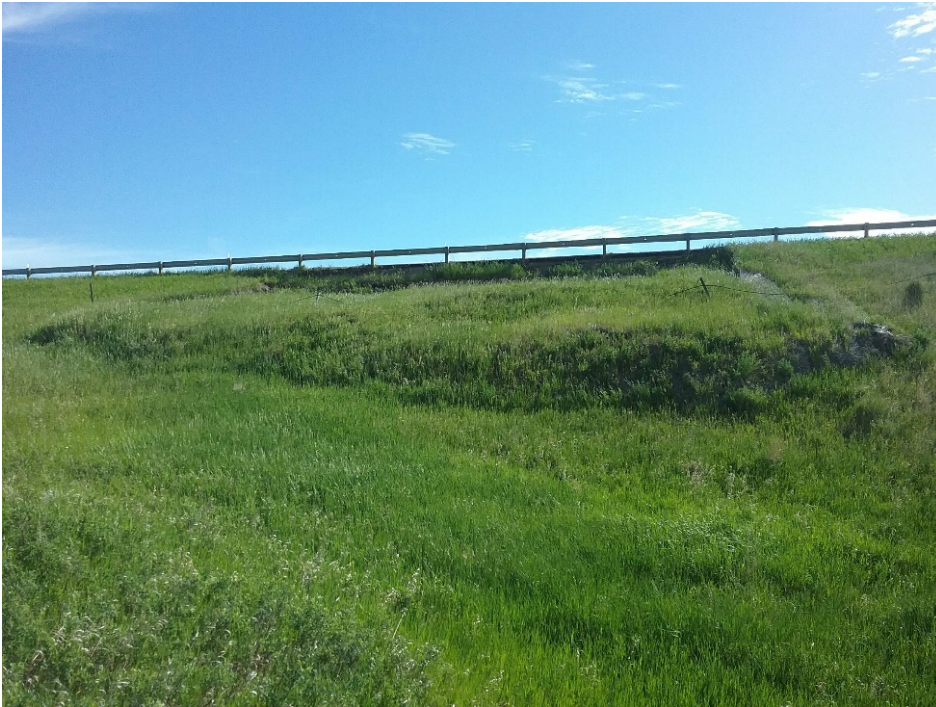
<b>COMMENTS</b>
At S046 – I, vegetation is establishing itself on the erosion control blanket (i.e., coconut matting).
At S046 – III:
<ul style="list-style-type: none"> <li>– The guardrail and southbound shoulder are being undermined by retrogression of the slope. Seven guardrail posts (an increase from five in 2017) are almost hanging.</li> <li>– Limits of the slide are beginning to extend towards the north.</li> <li>– Longitudinal cracking in the southbound lane could indicate potential retrogression of the backscarp into the highway.</li> <li>– Slope movements are likely exacerbated by surface water flow and infiltration during periods of heavy or prolonged rainfall, and seepage from the culvert.</li> </ul>
The S046 – II site was not inspected in 2017 or 2018.
Discussed remedial actions: S046 – III: excavate and reconstruct the slope with geosynthetic-reinforced fill, with a shear key and subsurface drainage as per KCB design. A remote-operated video camera survey of the culvert was completed in September 2017 by Maverick Inspection Ltd. Mavericks observations are summarized as follows: deformation of the culvert (described as “ovalling”) (up to 15% of the diameter) was observed from 21 to 40 m from the west end of the culvert; at 60 m, near the east end of the culvert, a large hole approximately 10 cm

**Photo 1**      **The slope failure continues to undermine the guardrail and shoulder of the southbound lane. Seven guardrail posts are exposed but not hanging. Photo taken June 12, 2018 looking east.**

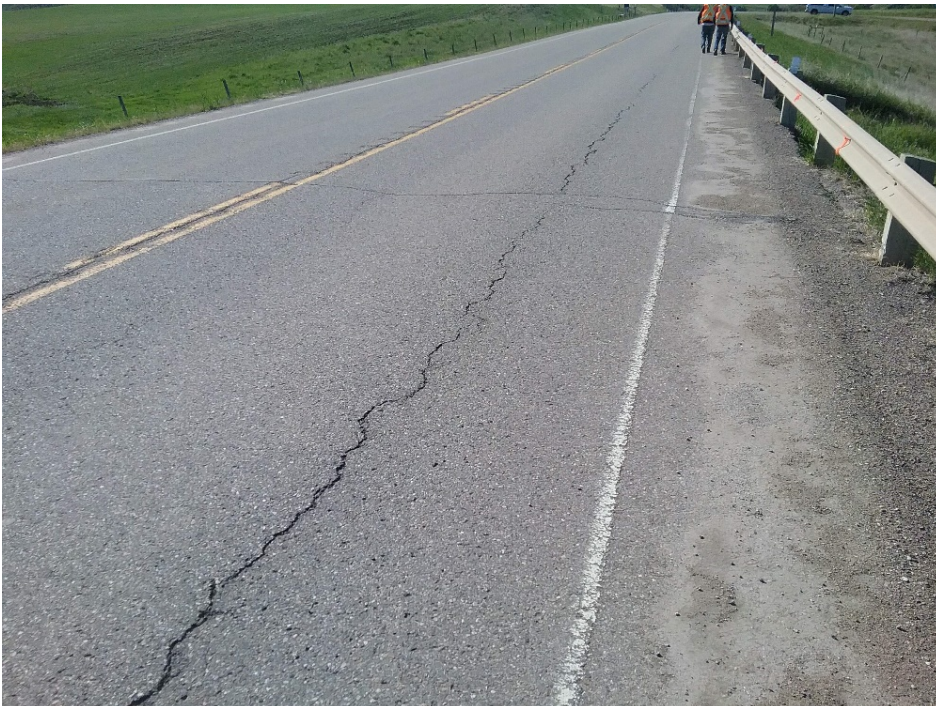
ITEM	CONDITION EXISTS		DESCRIPTION AND LOCATION	NOTICABLE CHANGE FROM LAST INSPECTION	
	YES	NO		YES	NO
Pavement Distress	X		S046 – III: pavement cracked in eastbound lane; eastbound shoulder undermined and collapsing		X
Slope Movement	X		S046 – III: fence damaged by toe roll; seven guardrail posts undermined and almost hanging	X	
Erosion		X	None observed		X
Seepage		X	None observed		X
Culvert Distress		X	S046 – I and III: 600 mm diameter CSP culvert flowing		X

**Photo 2**      **Condition of pavement at head of slide. Photo taken June 12, 2018 looking south.**
