SITE NUMBER AND NAME: S046 - I, II & III Rosebud Slides		HIGHWAY & KM: 840:02, 32.422 (I, III) 26.847 (II)	PREVIOUS INSPECTION DATE: June 12, 2018 (I & III))	INSPECTION DATE: July 10, 2019
LEGAL DESCRIPTION: 12-18-027-21 W4M	NAD 83 COORDINATES: UTM Northing Easting 12 5685886 363665		RISK ASSESSMENT: S046-I PF: 1 CF: 1 TOTAL: 1 S046-III PF: 1 CF: 1 TOTAL: 1	
AVERAGE ANNUAL DAILY TRAFFIC (AADT): 420 (south) 520 (north)(Reference No. 107240, 105210)			CONTRACT MAINTENANCE AREA (CMA): 29

SUMMARY OF SITE INSTRUMENTATION: None LAST READING DATE: n/a	INSPECTED BY: Chris Gräpel (KCB) Ryan Gazley (KCB) Rishi Adhikari (AT) Tony Penney (AT)
PRIMARY SITE ISSUE: S046 – I and III: adjacent shallow slope failures in the highway embankment fill where Hwy 840 crosses a creek valley. The slides are located on the west side (southbound lane) of Hwy 840. The slope failure at S046 – III occurred in June 2016 adjacent to the S046 – I site which was repaired in 2014.	
APPROXIMATE DIMENSIONS: S046 – I: the reconstructed slope is approximately 20 m wide. S046 – III: the reconstructed slope is approximately 25 m wide at the crest, and highway embankment is approximately 8 m high.	
DATE OF ANY REMEDIAL ACT

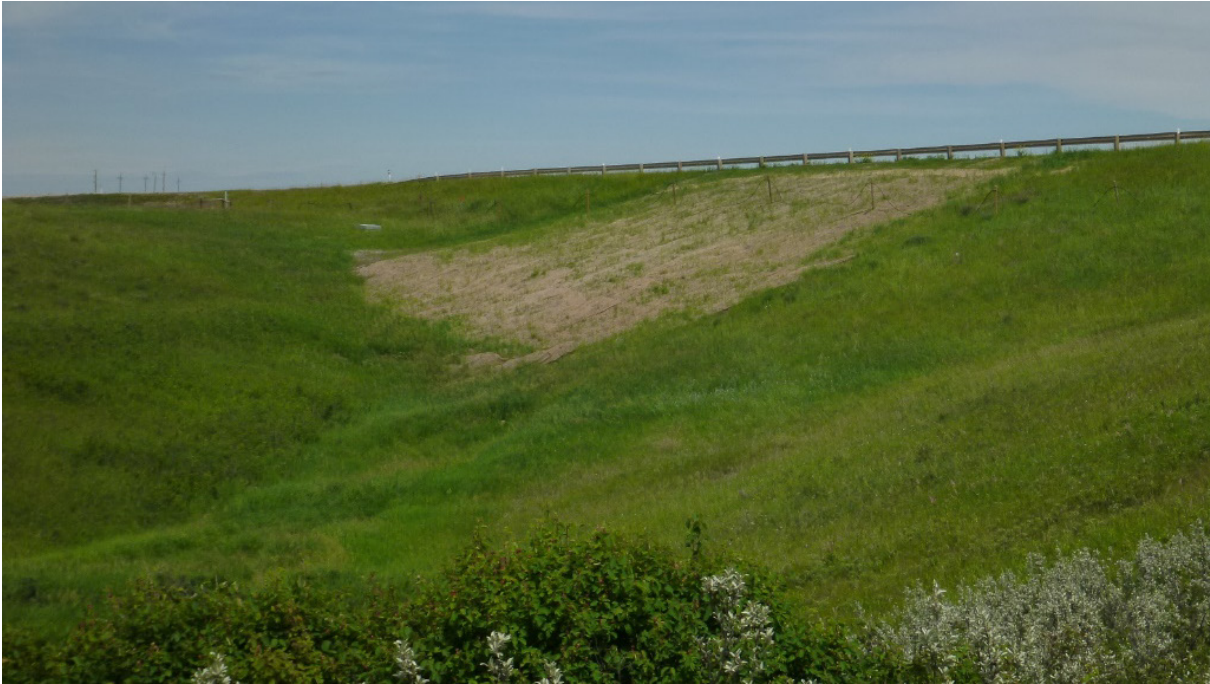
Photo 1 S046-III slide has been repaired since the 2018 inspection. Vegetation can be seen growing through the erosion control blanket. Photo taken July 10, 2019 looking north.

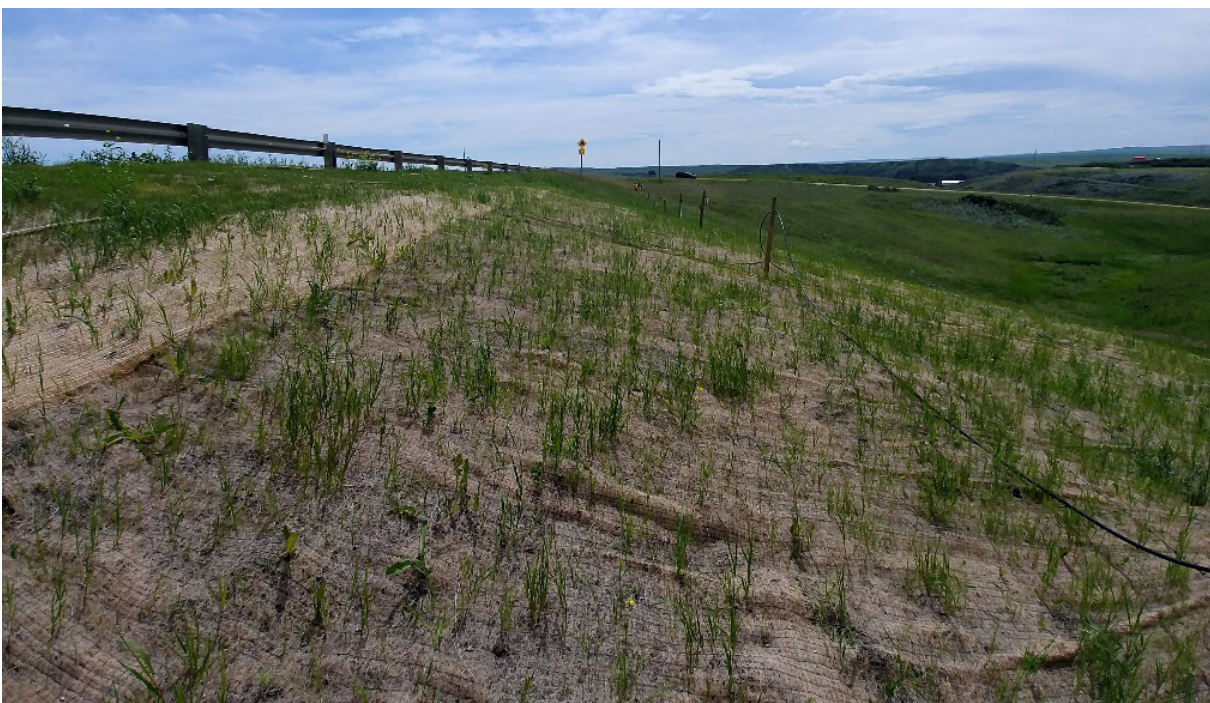
Photo 2 Close-up view of S046-III slide repair and erosion control blanket. Photo taken July 10, 2019 looking southeast.
