| SITE NUMBER AND NAME: S046-I and -III Rosebud Slides | HIGHWAY & KM: 840:02, 32.422 | PREVIOUS INSPECTION DATE: July 10, 2019 | INSPECTION DATE: June 26, 2023 |

PRIMARY SITE ISSUE: S046-I and -III: adjacent shallow slope failures in the highway embankment fill where Hwy 840 crosses a creek valley. The slides are located on the west (southbound) highway embankment slope. The slope failure at S046-III occurred in June 2016 (repaired in 2018/2019) just north of the S046-I site, which was repaired in 2014.

Inspection Photographs

TITLE
 Site Plan
 S046-I and -III - H840 Rosebud Slides
 Hwy 840:02, km 32.442

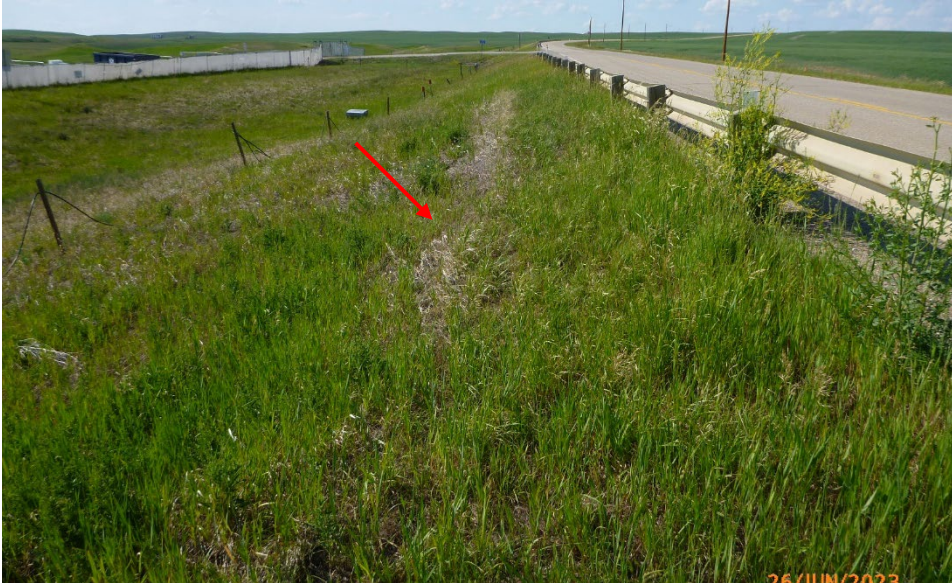
- The fence downslope of S046-I and -III is deflected towards the west (downslope direction). However, the deflection most likely occurred before the repairs were completed, or directly afterwards, as a minor dip/area of settlement was observed near the upper portion of the repaired embankment approximately 2.5 m west of the guardrail (Photo 1). This dip/area of settlement may be attributed to settlement of the fill material used to repair the slide.

Photo 1 Settlement parallel to the highway surface, approximately 2.5 m west from the guardrail (indicated by red arrow). The settlement is believed to be caused by settlement of the repair fill. Photo taken June 26, 2023, facing north.

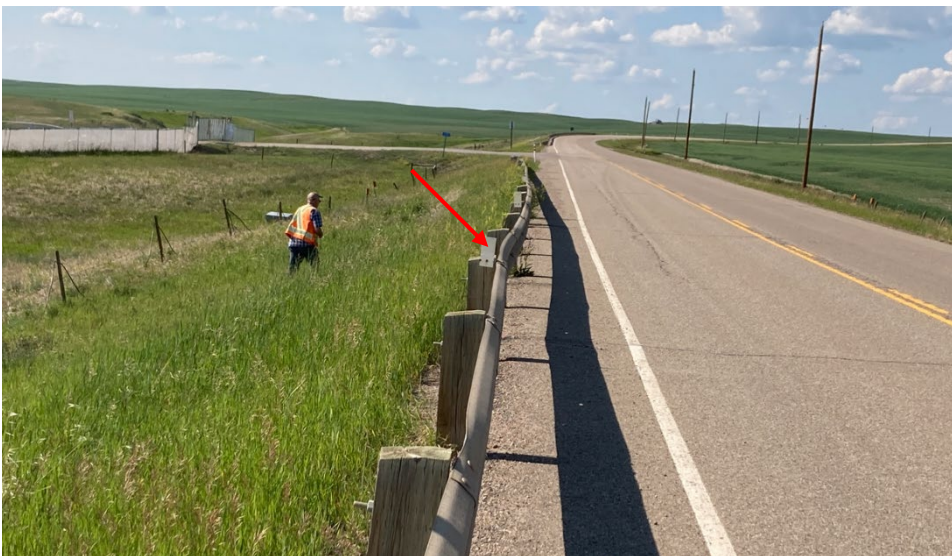
- The guardrail along the west (southbound) lane is deflected between the S046-I and -III slides and is believed to been caused by a vehicle accident or road maintenance activities (i.e., plowing) (Photo 2).

Photo 2 Minor guardrail deflection (indicated by red arrow) upslope of S046-I, most likely attributed to a vehicle accident or road maintenance activities since the 2019 inspection. Photo taken June 26, 2023, facing north.

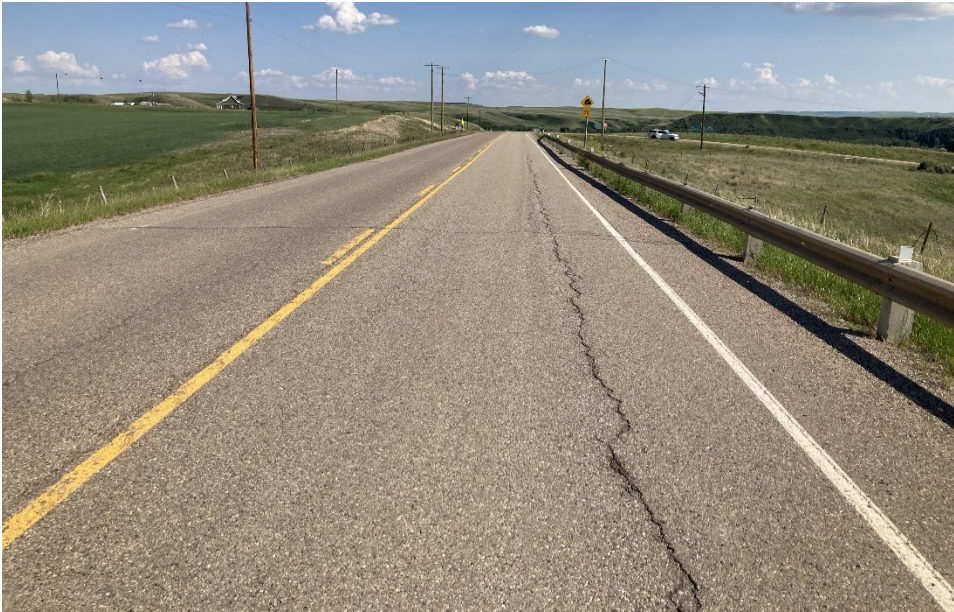
| ITEM | CONDITION EXISTS | | DESCRIPTION AND LOCATION | NOTICABLE CHANGE FROM LAST INSPECTION | |
|---|---|---|--|---|---|
| Pavement Distress | X | | Longitudinal pavement cracking in west (southbound) lane upslope of the S046-I and -III repairs. | | X |

- There is a longitudinal pavement crack in the west (southbound) lane, upslope of S046-I and -III slides. The pavement crack does not appear to have changed since the 2019 inspection (Photo 3).

Photo 3 Longitudinal pavement crack in the west (southbound) lane upslope of S046-I and -III. Photo taken June 26, 2023, facing south.

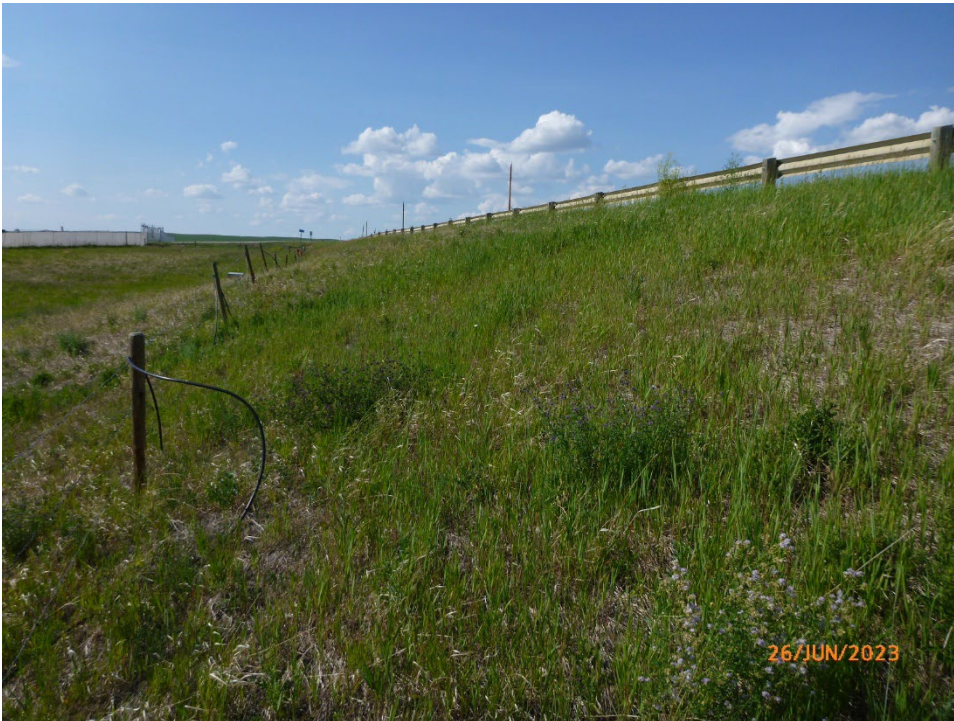
- The S046-III site was repaired in 2018 or 2019 and the repair appears to be performing well.
- The repaired slope is well vegetated, and the coconut matting is intact (Photo 4).

Photo 4 The west highway embankment slope and S046-I and -III repairs are well vegetated and appear to be performing well. The fence near the embankment toe is deflected towards the west, and may be attributed to slope movement before construction, or settlement of the repair fill. Photo taken June 26, 2023, facing north.

- The site should continue to be inspected by TEC's Highway Maintenance Contractor (HMC).
- KCB recommends the S046 site be removed the active list of sites and no longer be inspected as part of the Southern Region GRMP Section B Inspections.
