12 April 2012
CG25352.400

**Re: S40 – HIGHWAY 848:02 - DOROTHY SINKHOLES SITE
REPORT ON NOVEMBER 21, 2011 SITE INSPECTION**

Client	Alberta Transportation		Figure 1		
Project	S40 - Hwy 848 - Dorothy Sinkholes Site		Date:	Revision	
	Site Sketch		Apr-12		
			Job No.	CG25352.400	
			File No.:	hwy848_figures.xlsx

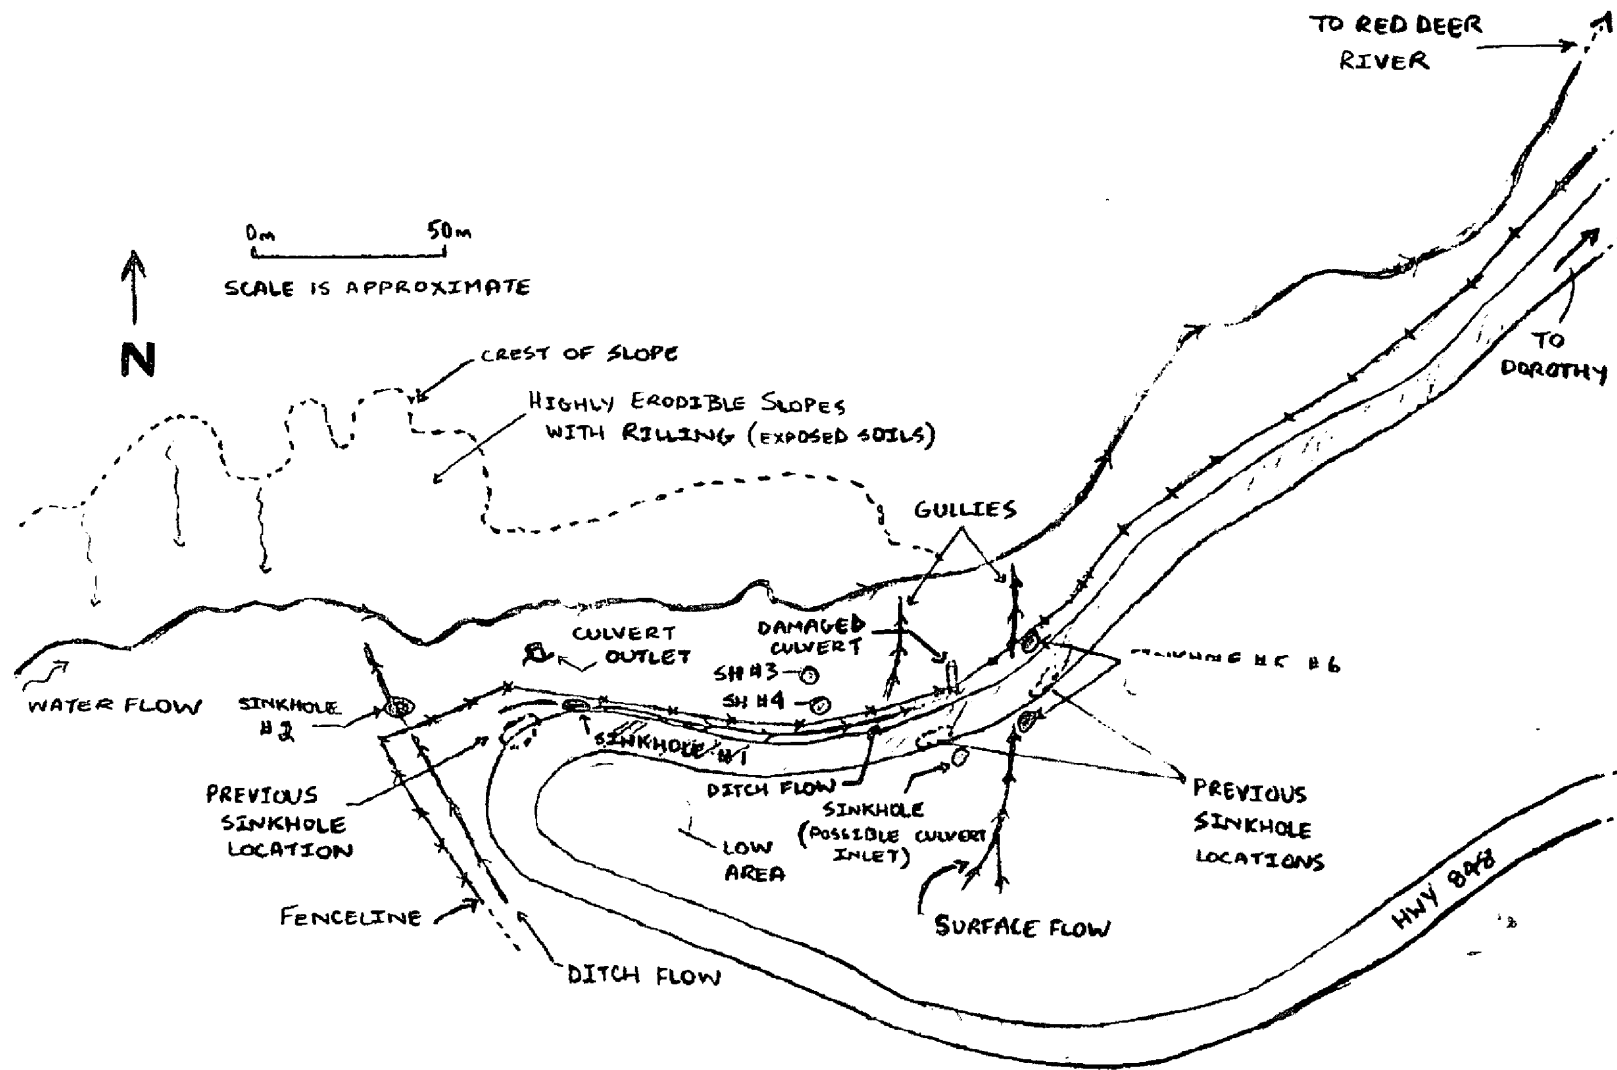
1. AMEC was shown three areas along a 150 to 200 m long section of the road by the MCI during the November 2011 inspection that were indicated to have had sinkholes develop within the last year (shown on Figure 1). The MCI indicated the sinkhole formed without warning and did not seem to be preceded by significant rainfall events. At the time of the inspection, the previously damaged areas had been repaired by backfilling with gravel and there was no evidence within the road surface of cracking or settlement.

2. AMEC inspected the area surrounding the affected highway section and found numerous sinkholes in the ditches and gullies at the site. Approximately 6 separate sinkholes were identified (shown on Figure 1), the largest were greater than 2 m wide and deep and some appeared to connect to subsurface drainage “tunnels” (see Photos 1 and 2). The majority of these sinkholes were within 25 m distance from the road surface.

4. Two culvert outlets were observed along the slope towards the ravine north of the road. There was significant erosion of the soils around culvert outlets and one of the culverts was broken near the outlet. The culvert inlet locations were not confirmed during the inspection, but one possible culvert inlet is shown on Figure 1.

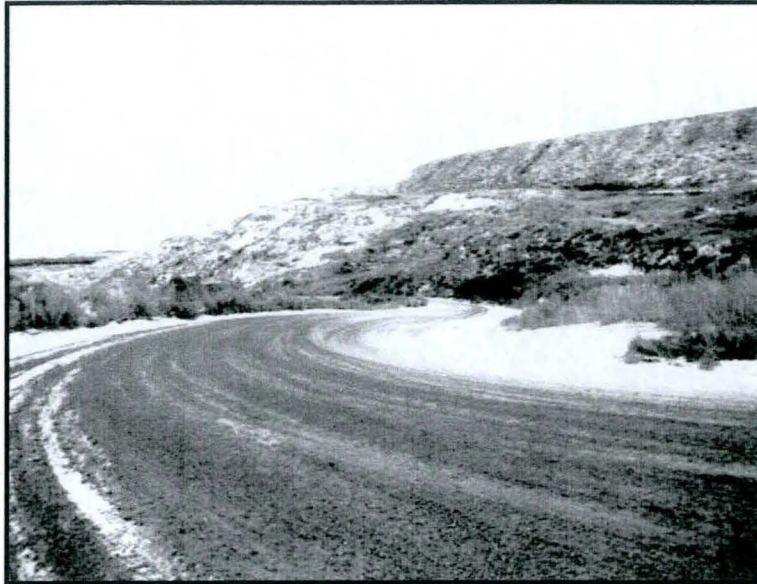
Photo 1 (left)
Standing at the hairpin turn where previous sinkhole damage was reported by the MCI. Facing towards the east.
(Photo Date: November 21, 2011)

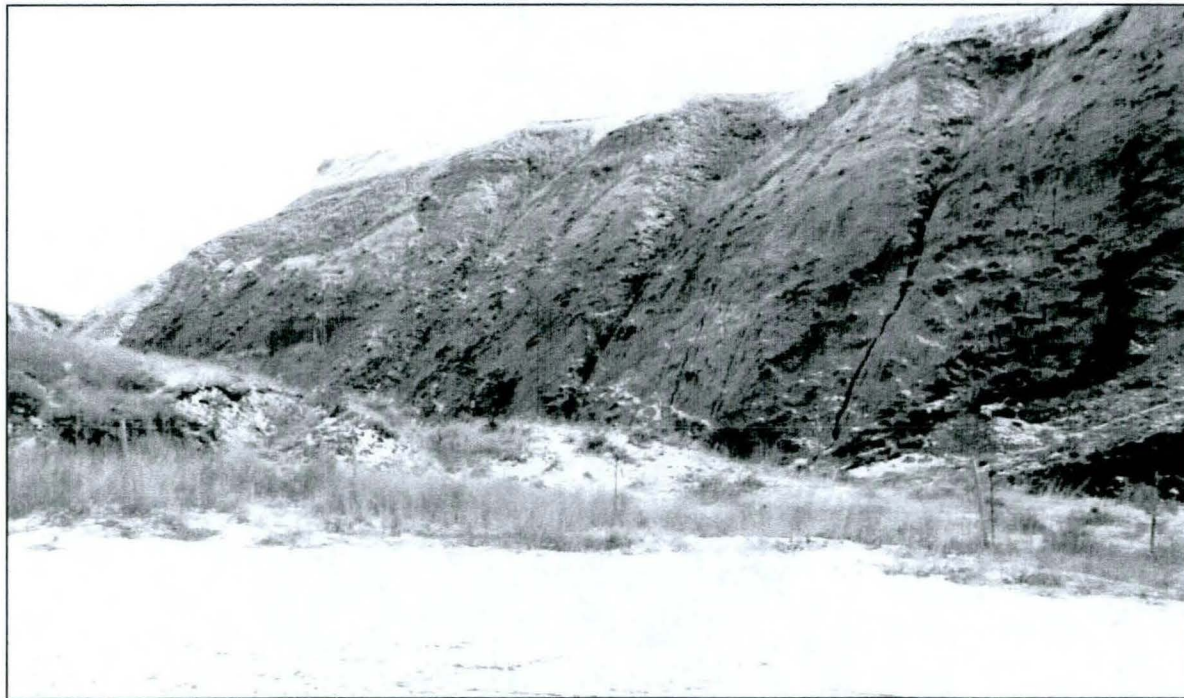
Photo 2 (above)
Standing at the same location as Photo 1, facing the opposite direction towards the northwest. The highly erodible slopes with rilling can be seen. A deep ravine has formed at the bottom of these slopes.
(Photo Date: November 21, 2011)

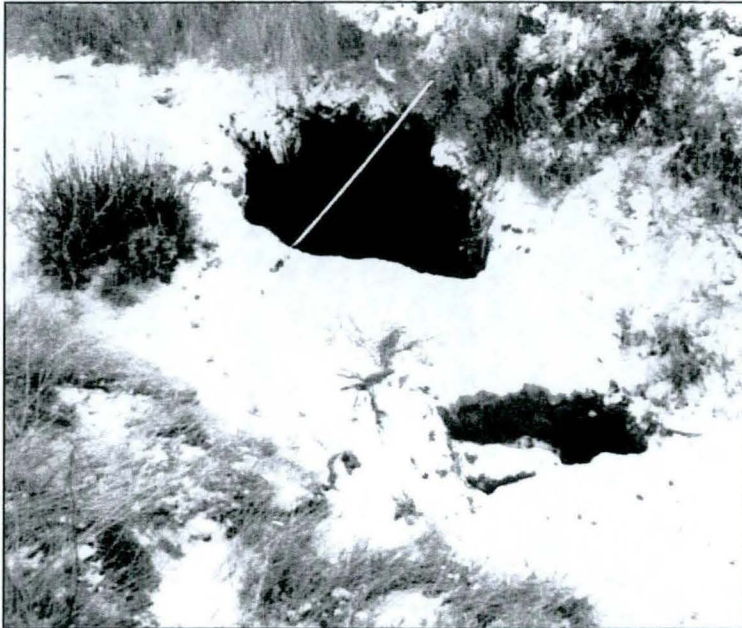
Photo 3 (top)

These sinkholes were found in a ditch channel that drained towards the north into the deep ravine north of the road. The main hole measured 2 m long, 1.3 m wide and 1.6 m deep. The locations of the sinkholes are marked on the site sketch as sinkhole #2.

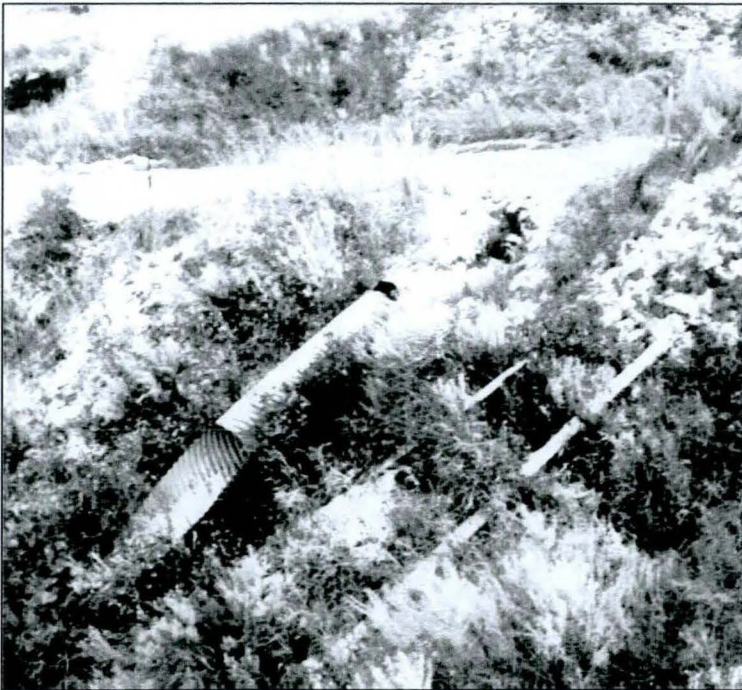
Photo 4 (bottom)

The damaged culvert on the north side of the highway (noted on site sketch). Appears to have been undermined from erosion and collapsed under its own unsupported weight.

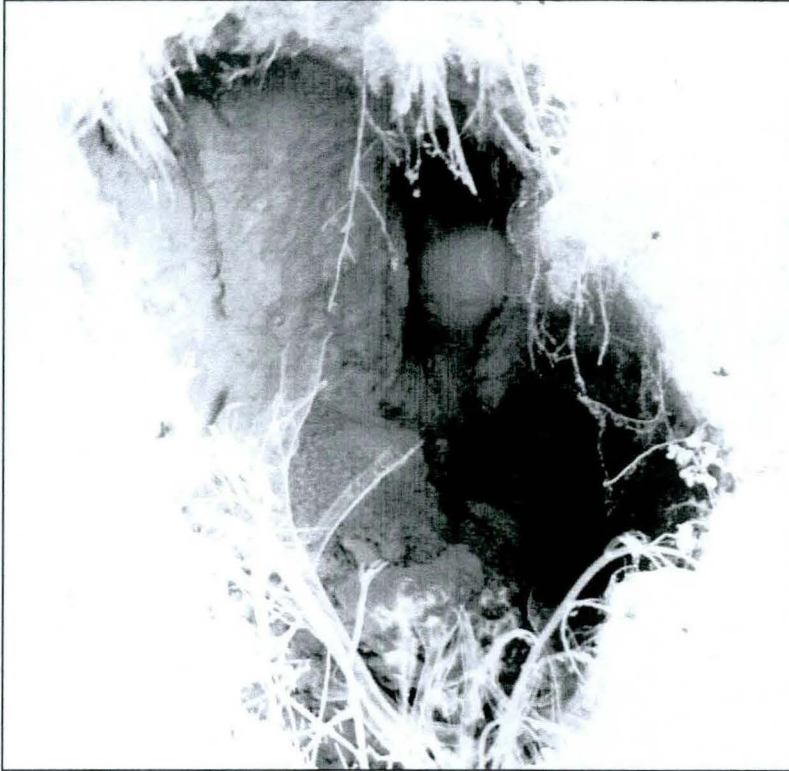
Photo 5 (above)

This sinkhole was found on the north side of the road and appeared to have an underground channel connected to it. This sinkhole was located at sinkhole #4 on the site sketch.

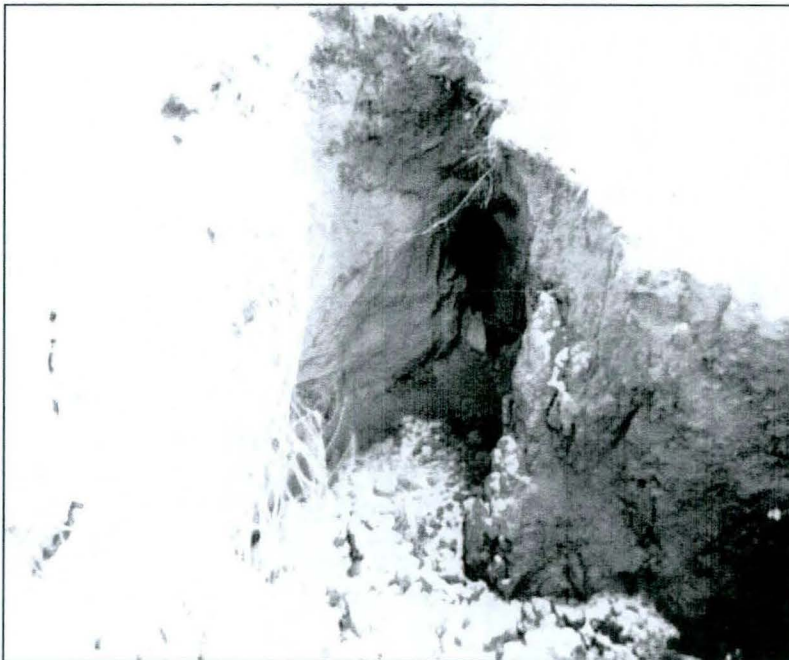
Photo 6 (bottom)

This sinkhole was found on the north side of the road and also appeared to have an underground channel connected to it. This sinkhole was located at sinkhole #5 on the site sketch.
