SITE NUMBER AND NAME: S040 Dorothy Sinkholes		HIGHWAY & KM: 848:02, 11.507	PREVIOUS INSPECTION DATE: June 12, 2018	INSPECTION DATE: July 10, 2019
LEGAL DESCRIPTION: 06-04-027-17 W4M	NAD 83 COORDINATES: UTM Northing Easting 12 5681315 406434		RISK ASSESSMENT: PF: 8 CF: 4 TOTAL: 32	
AVERAGE ANNUAL DAILY TRAFFIC (AADT): 60 (north), 120 (south), (Reference No. 116220, 114210)			CONTRACT MAINTENANCE AREA (CMA): 21

PROJECT SOUTHERN REGION GEOHAZARD RISK MANAGEMENT PROGRAM		
TITLE Site Plan S040 - Dorothy Sinkholes Hwy 848:02, km 11.507		
SCALE 1:1,250	PROJECT No. A05115A03	FIG No. 1

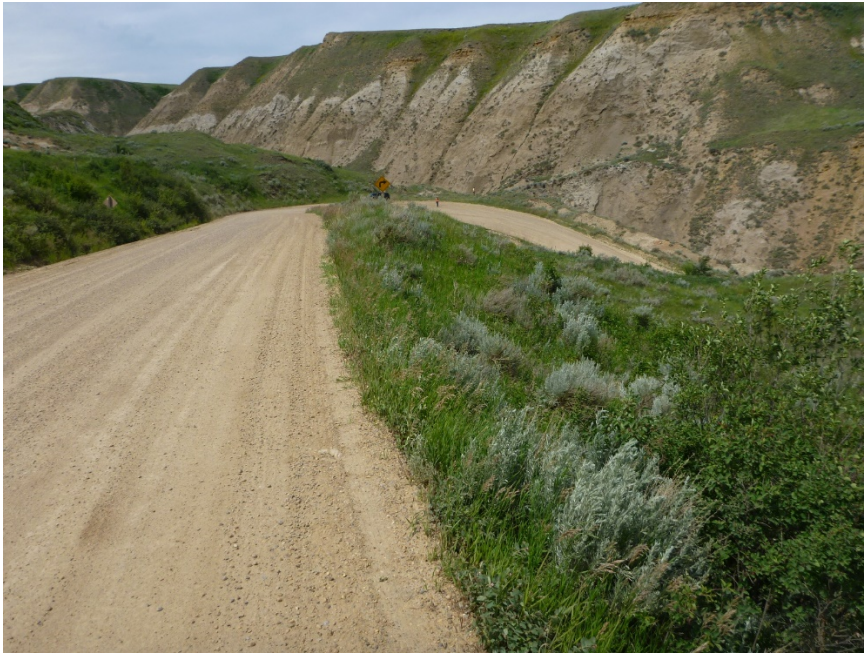
Photo 1 No new sinkholes observed on or near road surface during 2019 inspection. Photo taken July 10, 2019 looking northwest.

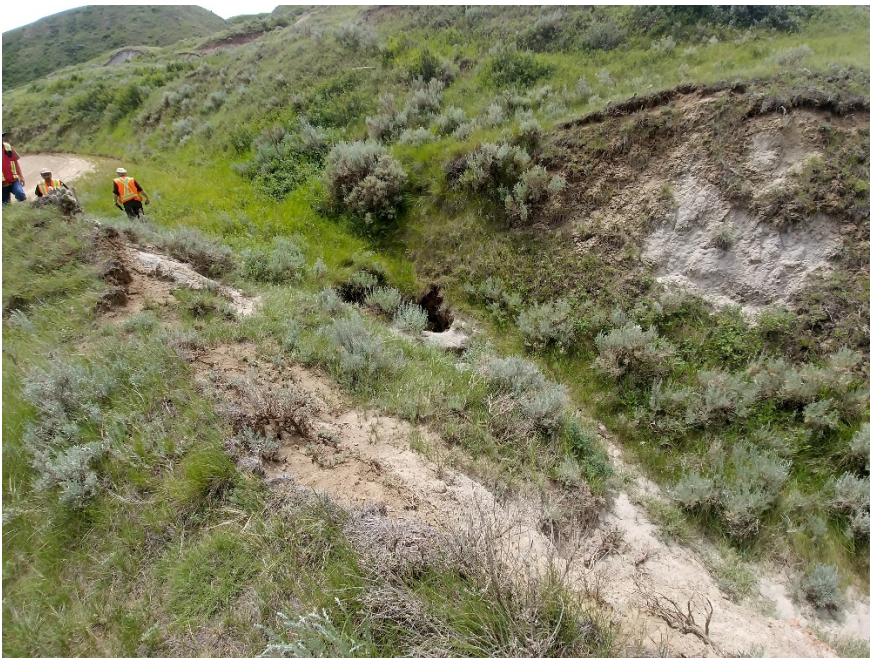
Photo 2 Existing erosion gully and void directly west of hairpin curve. Photo taken July 10, 2019 looking south.
