SITE NUMBER AND NAME: S040 Dorothy Sinkholes		HIGHWAY & KM: 848:02, 11.507	PREVIOUS INSPECTION DATE: July 10, 2019	INSPECTION DATE: May 31, 2022
LEGAL DESCRIPTION: 06-04-27-17 W4M	NAD 83 COORDINATES: UTM Northing Easting 12 5681315 406434		RISK ASSESSMENT: PF: 8 CF: 4 TOTAL: 32	
AVERAGE ANNUAL DAILY TRAFFIC (AADT): 60 (north) & 180 (south) (Reference No. 116220 & 114210)			CONTRACT MAINTENANCE AREA (CMA): 21

PROJECT SOUTHERN REGION GEOHAZARD RISK MANAGEMENT PROGRAM		
TITLE Site Plan S040 - Dorothy Sinkholes Hwy 848:02, km 11.507		
SCALE 1:1,250	PROJECT No. A05116A03	FIG No. 1

Inspection Photographs

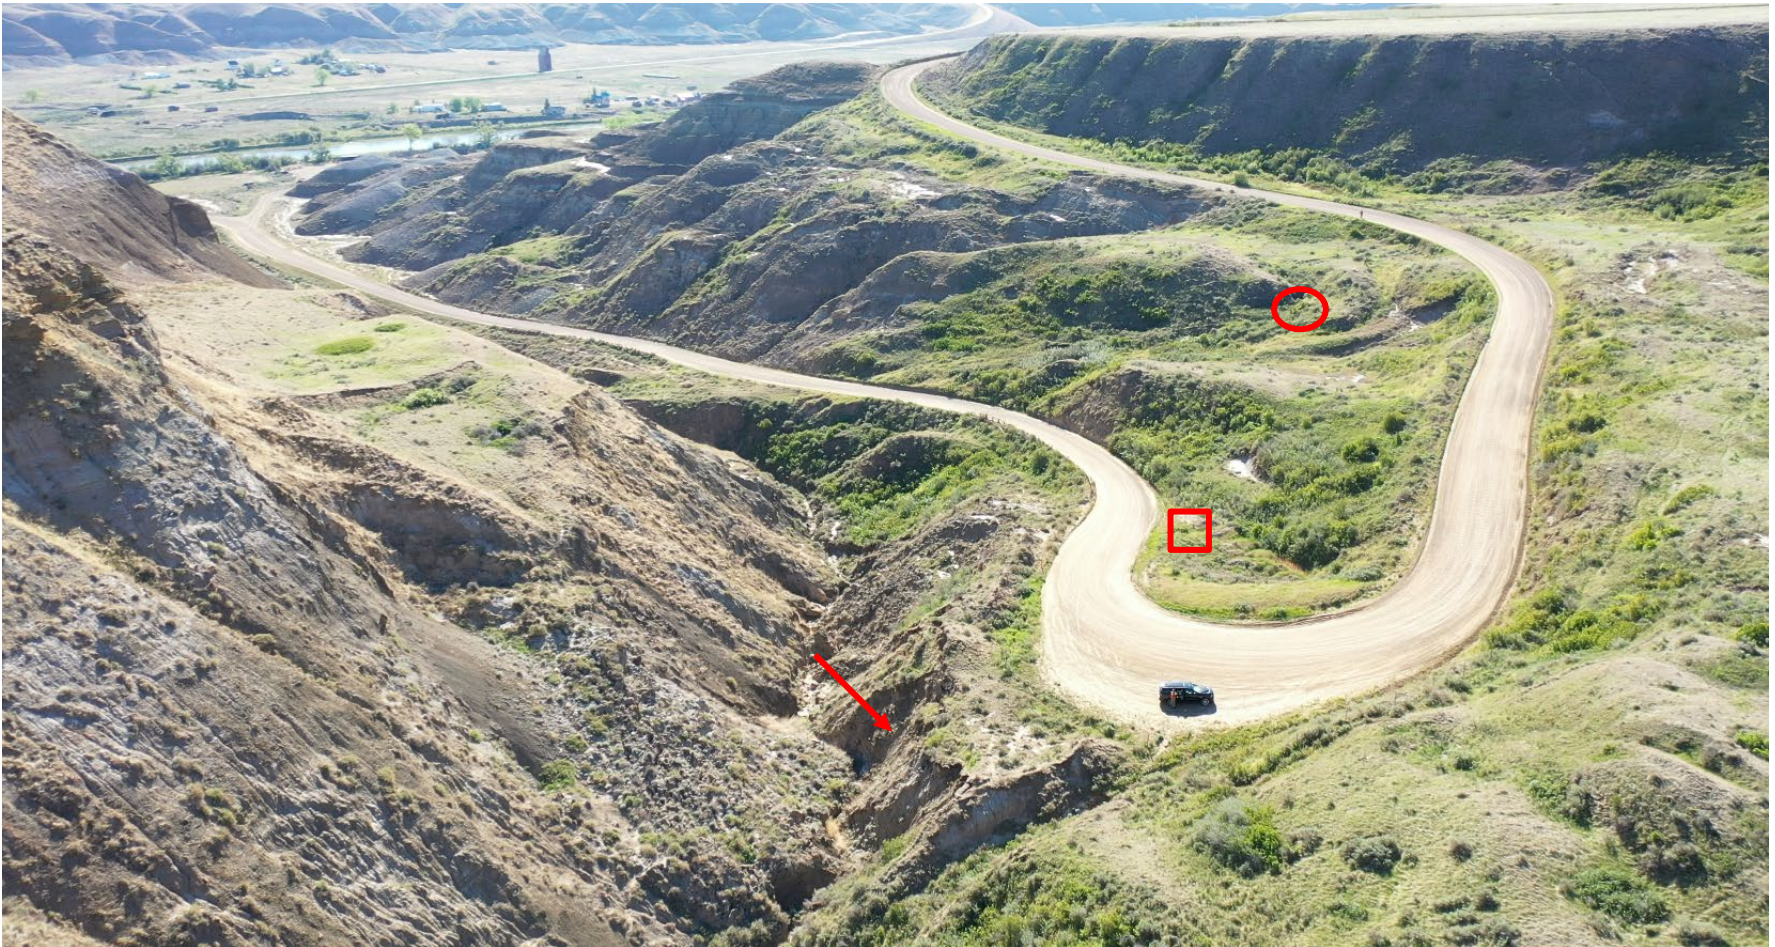
During the 2018 inspection, a 0.15 m diameter 0.10 m deep sinkhole was observed near the north shoulder of the highway (WP 693). AT marked the location with a survey stake and flagging to warn motorists. A long, shallow sinkhole was discovered along the south shoulder (WP 694) approximately 100 m east of WP 693.
An Unmanned Aerial Vehicle (UAV) flight of the site was completed during the 2022 inspection to take aerial videos/photos (Photo 1 and 2).

Photo 1 An aerial photo of the S040 Dorothy Sinkholes site. The erosion on the ditch slope, approximate location of the culvert inlet, and a large new sinkhole (WP 164) are indicated by a red arrow, square, and circle, respectively. The highway was graded shortly before the 2022 inspection. Photo taken May 31, 2022, facing east.

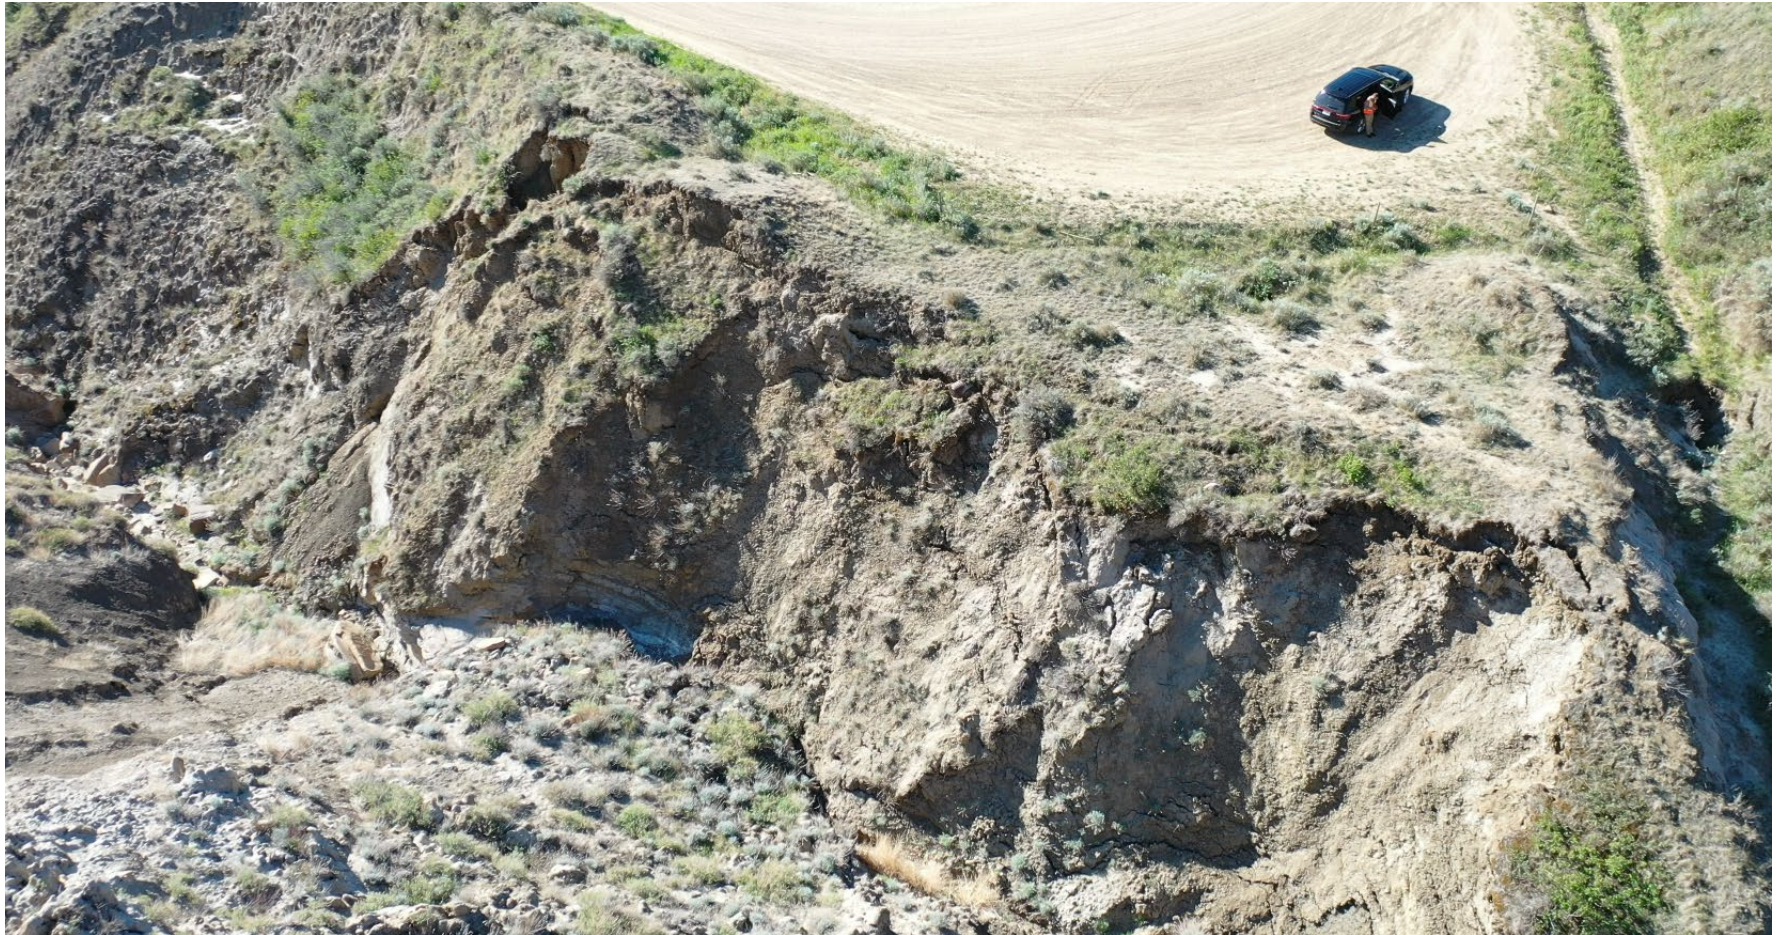
Photo 2 Aerial photo of the north side of the highway at the S040 Dorothy Sinkholes site. There is ongoing erosion of the north slope and the erosion has exposed bedrock at the toe of the slope/ditch bottom. Photo taken May 31, 2022, facing southeast.

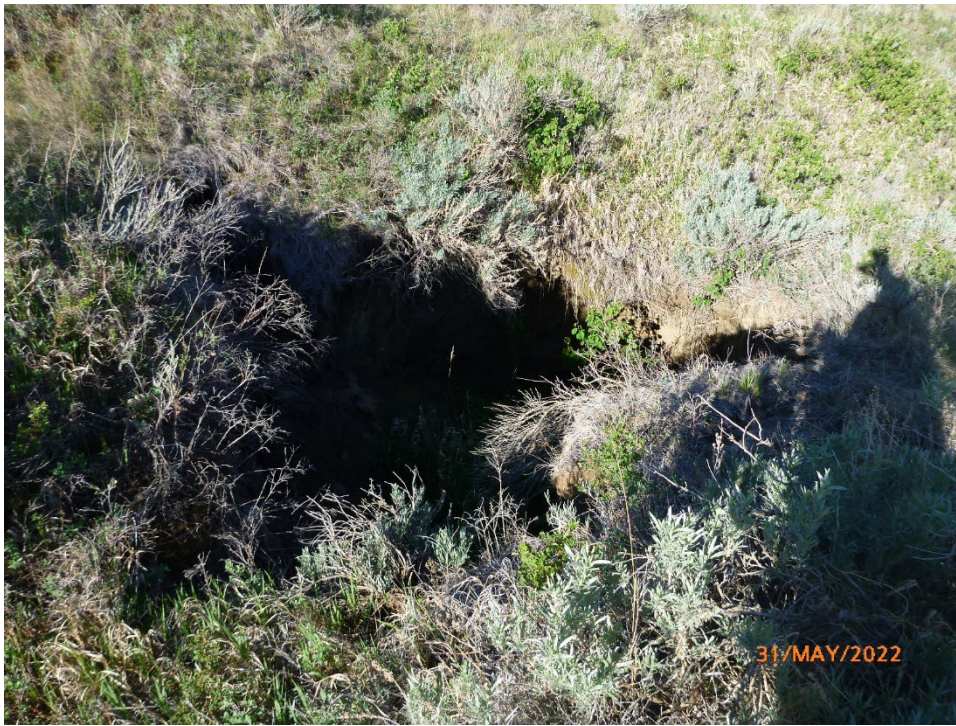
During the 2022 inspection the back slope was inspected but no sinkholes were observed. No sinkholes were observed along or near the highway surface. However, a large new sinkhole was observed approximately 30 m from the north edge of the highway on the inside of the hairpin curve (Photo 3) (WP 164).

Photo 3 Sinkhole observed on the inside of the hairpin curve (location shown in Photo 1) north of the highway (WP 164). Photo taken May 31, 2022, facing north.

- Install signage (e.g., speed reduction and hazard markers) to warn motorists of hazard (e.g., potential washouts and collapse features); improve drainage (e.g., increase ditch drainage capacity) to reduce infiltration into underlying dispersive soils and erosion of steep natural slopes; backfill sinkholes and voids as needed; conduct a geotechnical site investigation that includes:
 - conducting a detailed topographic survey of the area (e.g., a LiDAR survey or an unmanned aerial vehicle [UAV] photogrammetry survey), so previous, current and future locations of sinkholes and voids can be plotted relative to the survey data to assess if they correspond to areas with concentrated drainage.
- A risk assessment guideline for dispersive soil sites should be developed.
- The site should be inspected every two-years as part of the Southern Region GRMP Section B inspections.

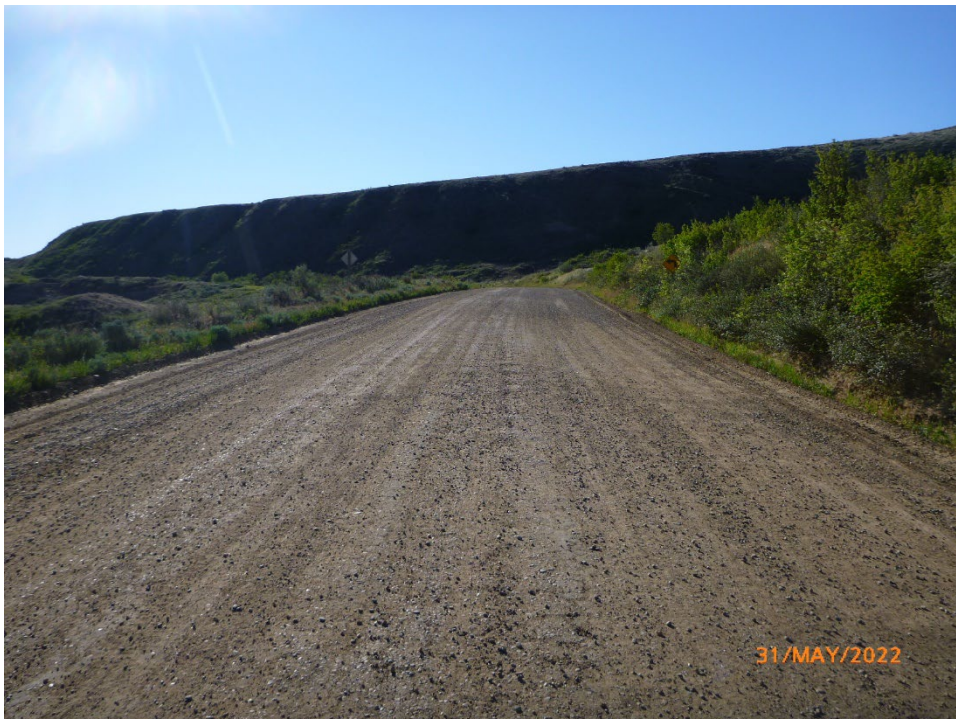
The highway surface was recently graded before the 2022 inspection (Photo 4).

Photo 4 The highway was graded shortly before the 2022 site inspection. Photo taken May 31, 2022, facing east.
