**SOUTHERN REGION GRMP  
SITE INSPECTION FORM**

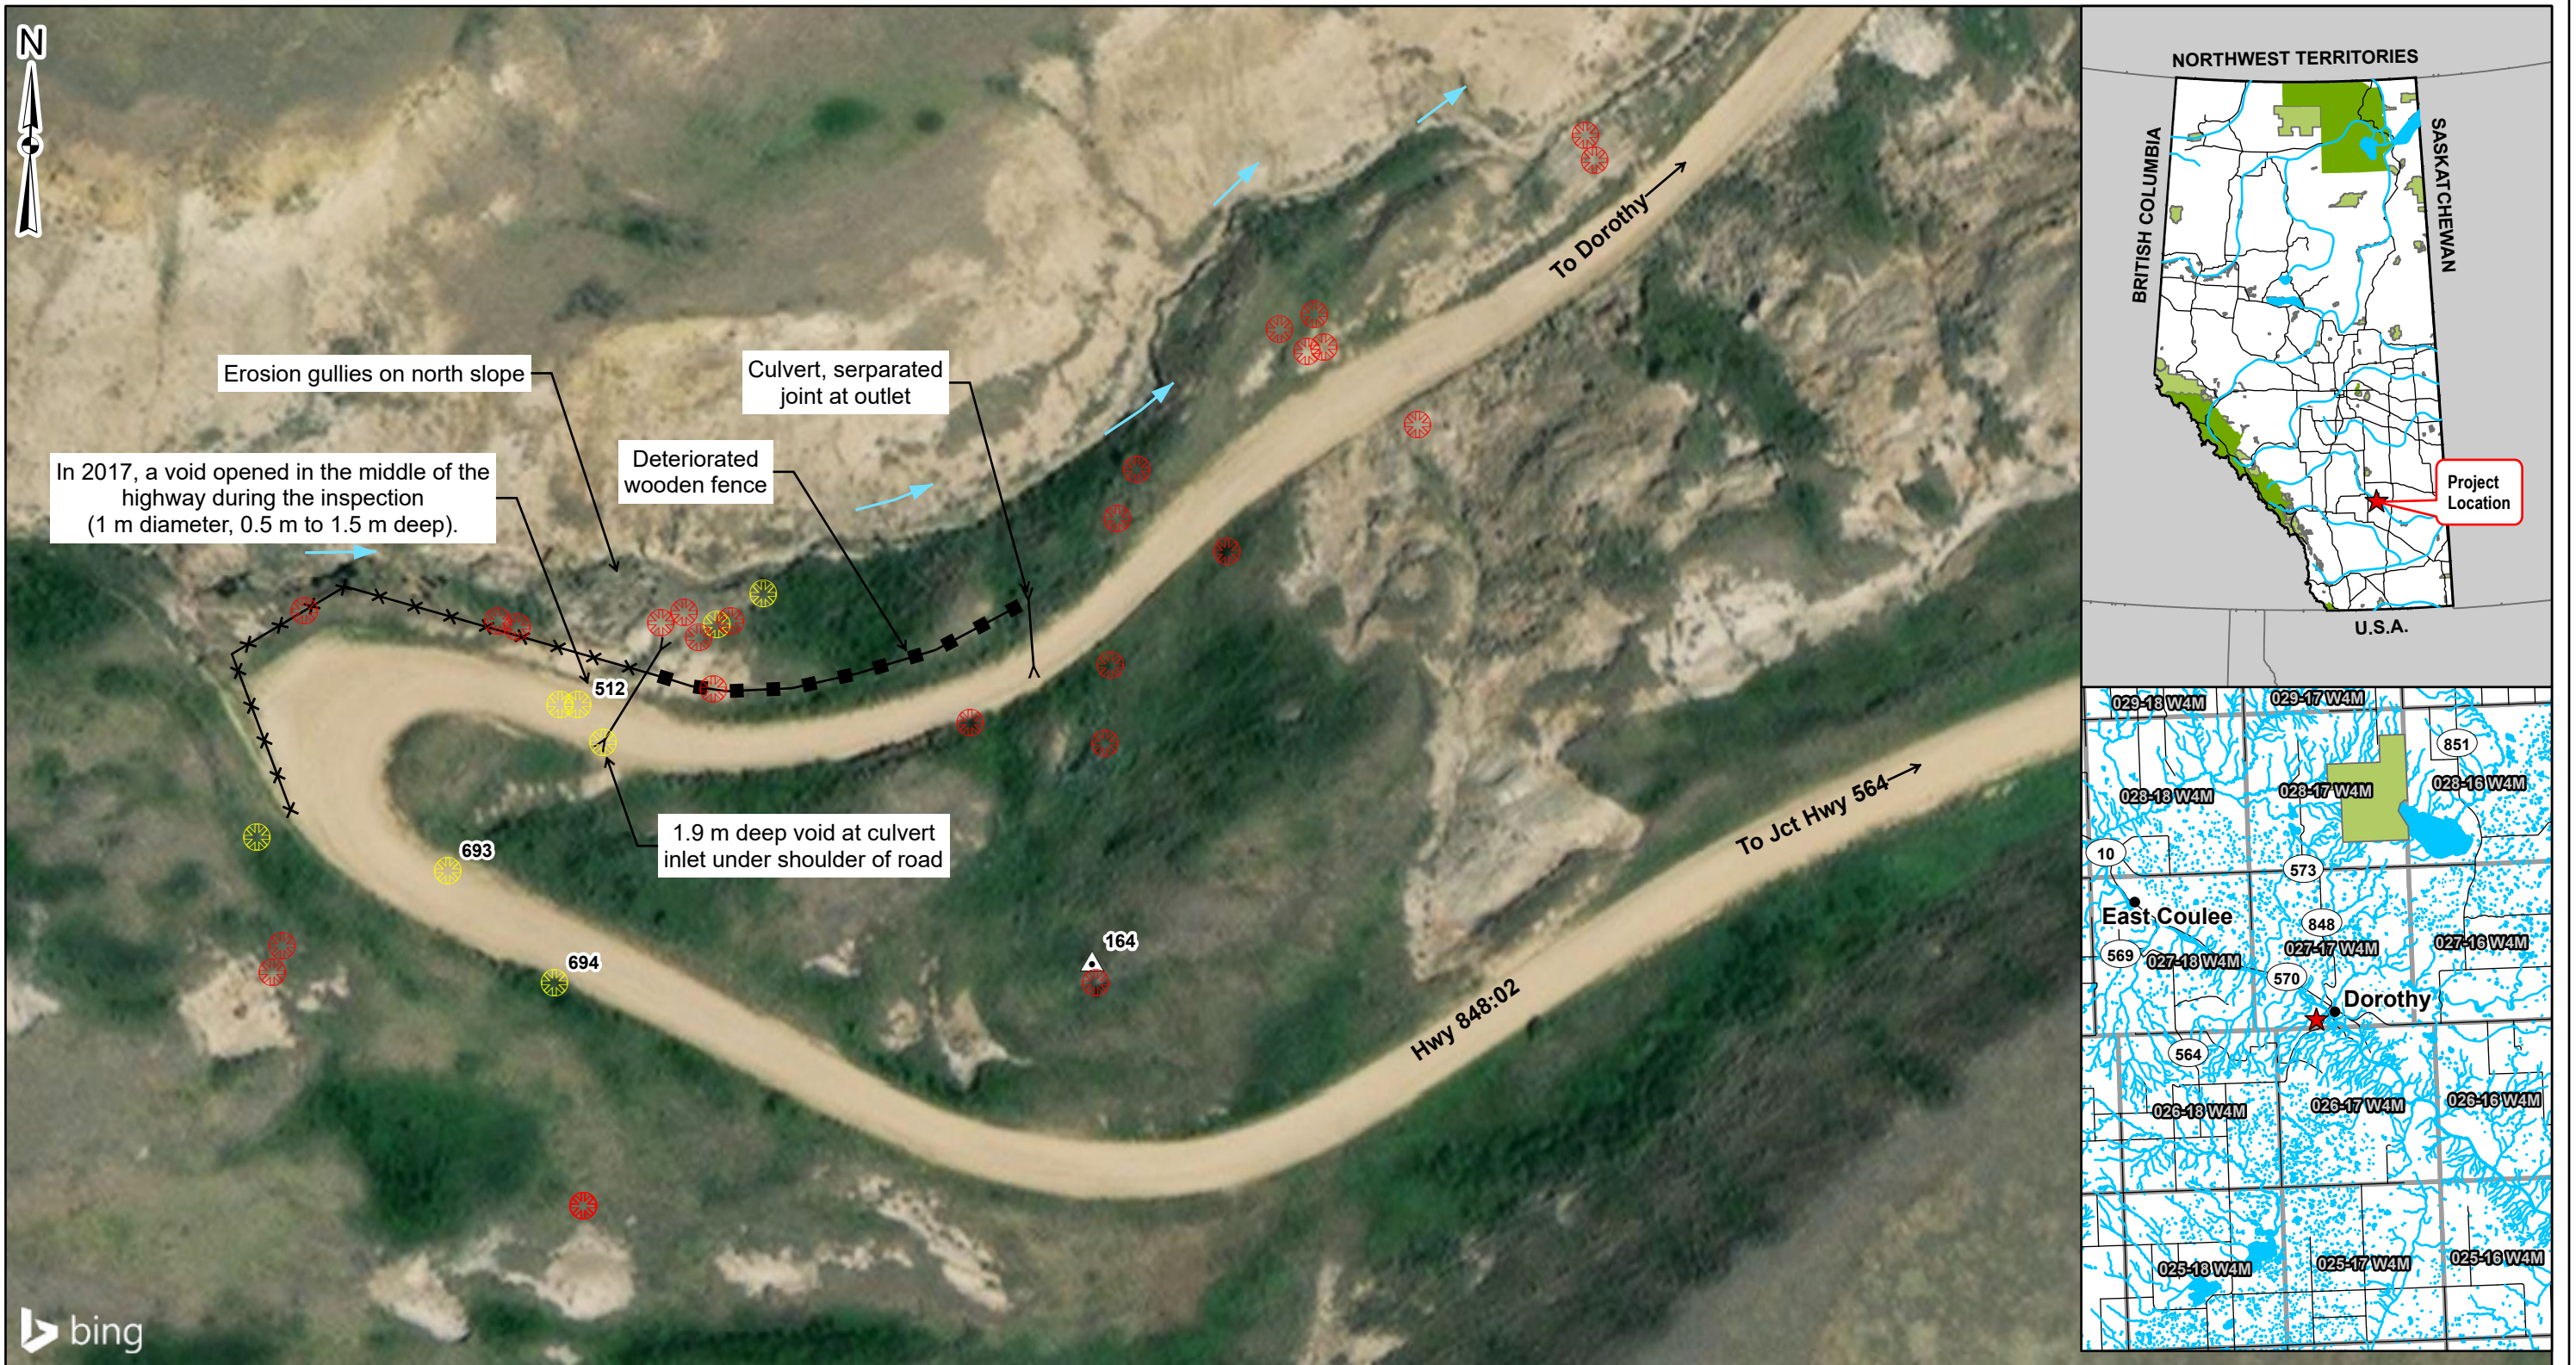
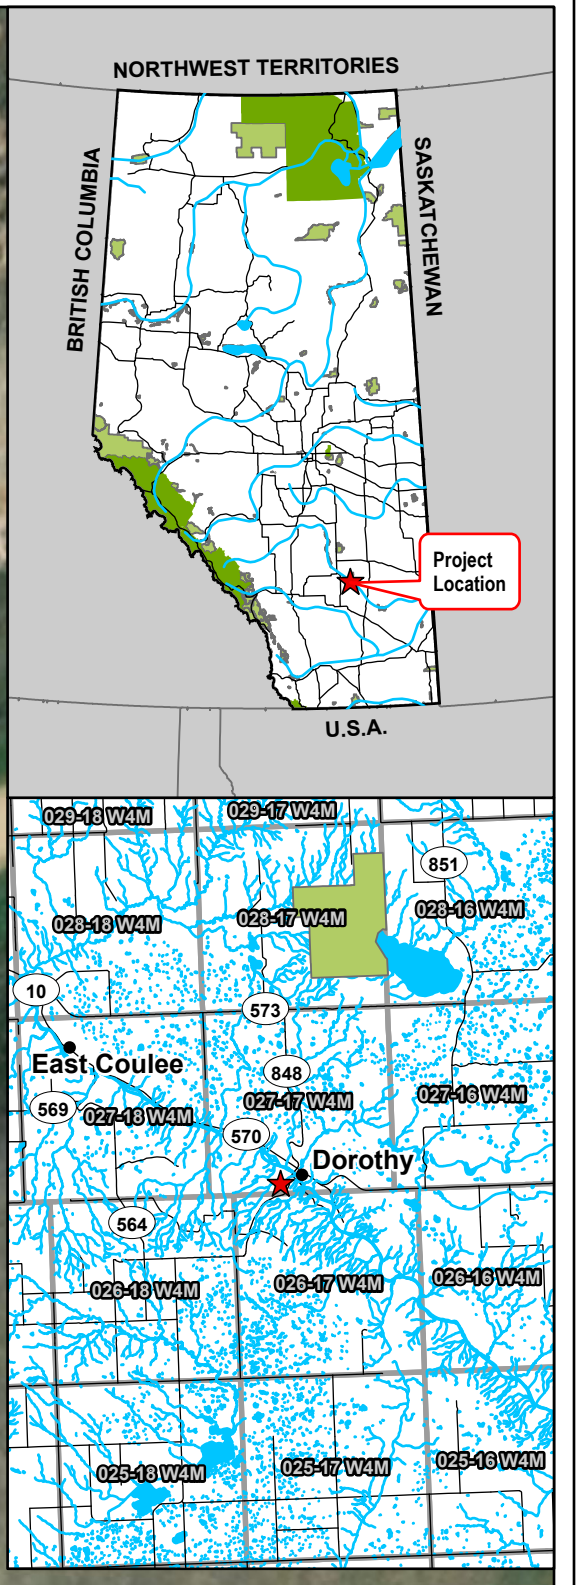
James Lyons, P.Eng.  
Civil Engineer

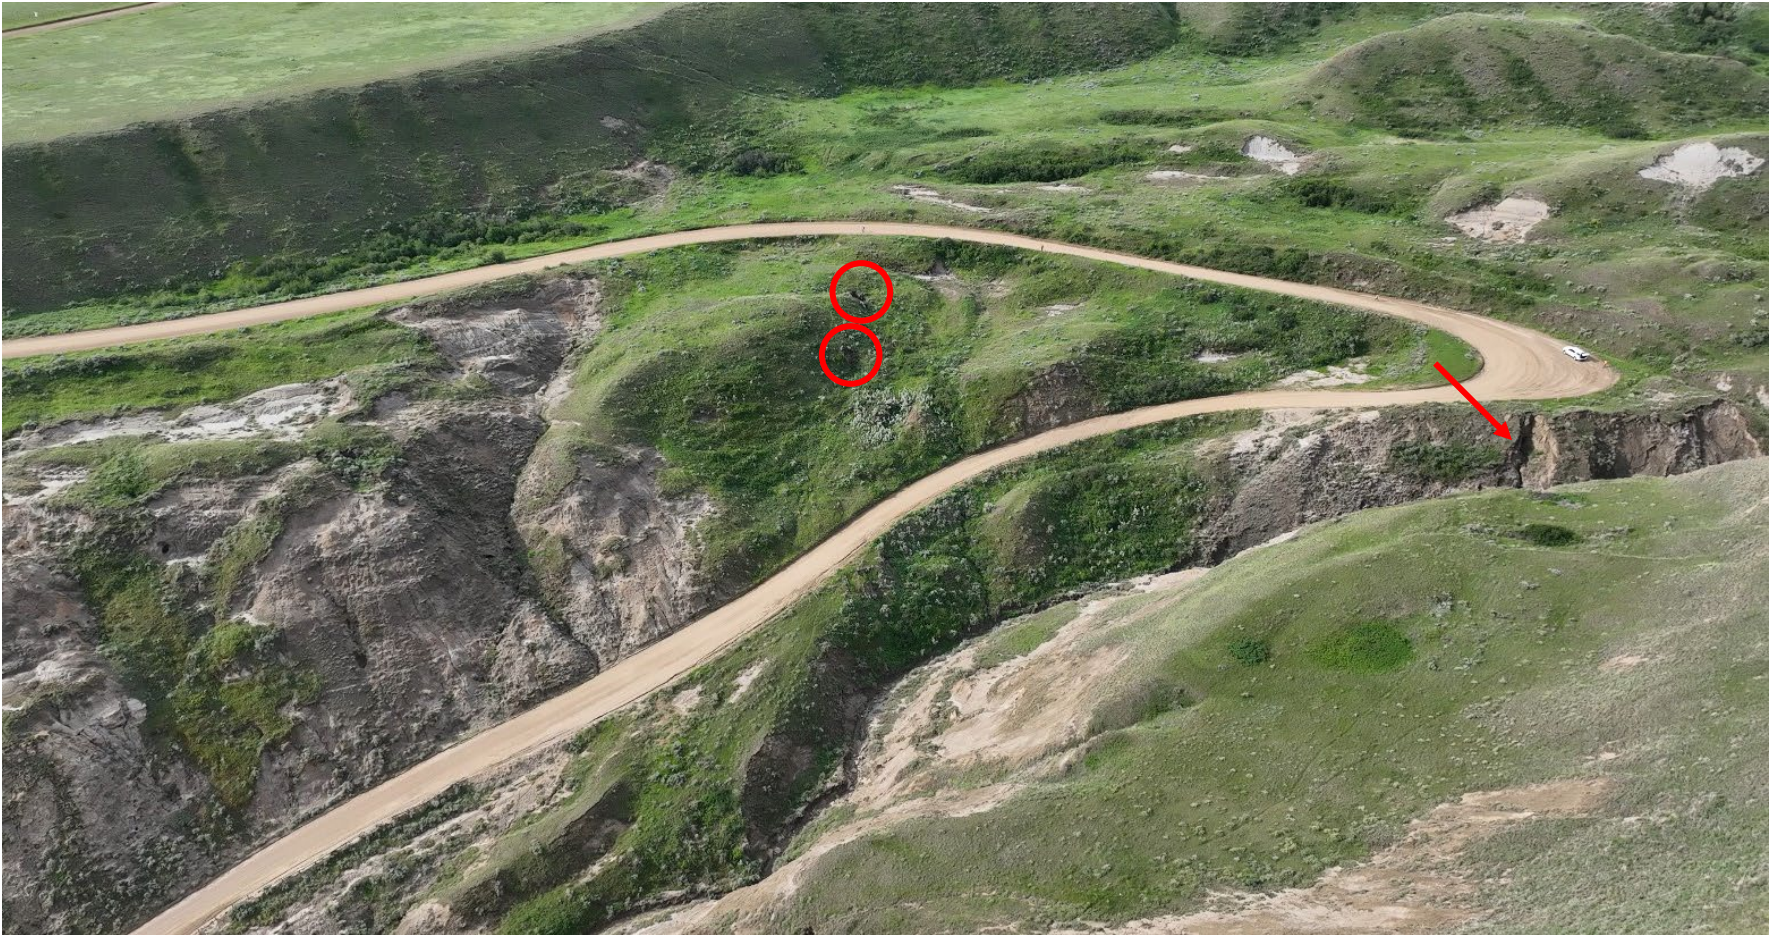
**Photo 3** Sinkhole observed on the north side of the highway near the corrugated-steel-pipe (CSP) culvert (outlet shown in Photo 5). Photo taken June 18, 2024.

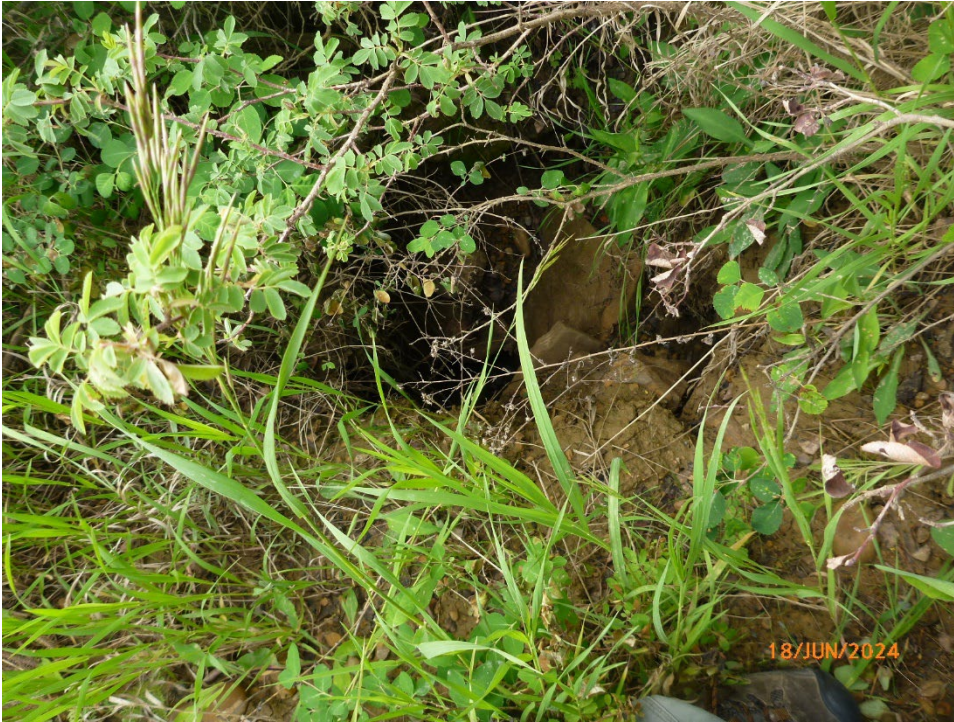
**Photo 4** Location of sinkhole (shown in Photo 3) obscured by vegetation. The sinkhole could be above the inlet of an old collapse CSP culvert. Photo taken June 18, 2024, facing south.

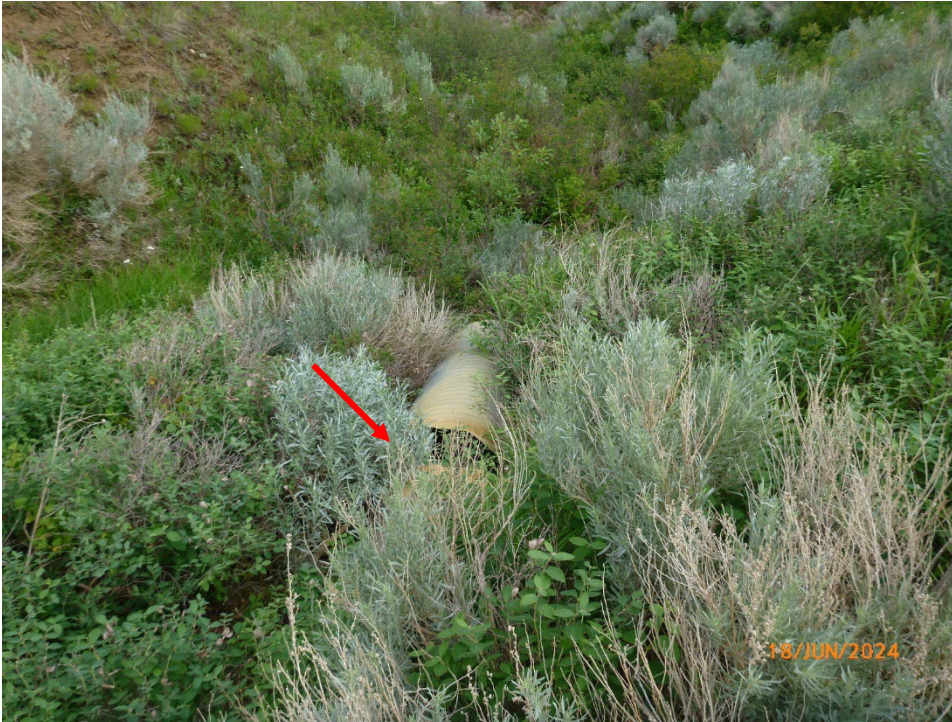
**Photo 6** The highway surface was in good condition during the inspection. Photo taken June 18, 2024, facing east.
