SOUTHERN REGION GRMP SITE INSPECTION FORM

SITE NUMBER AND NAME:	HIGHWAY & KM:	PREVIOUS	INSPECTION DATE:	
S053 Rattlesnake Dip	879:04, 1.00	INSPECTION DATE:	May 31, 2017	
		June 16, 2016	,	
LEGAL DESCRIPTION:	NAD 83 COORDINATES:	RISK ASSESMENT:		
09-20-006-11 W4M	UTM Northing Easting	PF: 9 CF: 2 TO	OTAL: 18	
	12 5481930 467953			
AVERAGE ANNUAL DAILY TF		CONTRACTOR MAINTENANCE AREA (CMA):		
510 (north), (Ref. No. 125050)		24

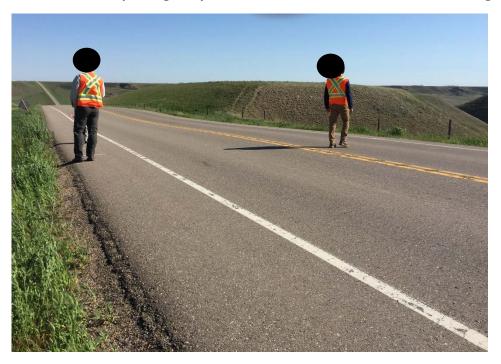
Highway appears to be constructed on an in-filled coulee which is settling. There is evidence of numerous pavement lifts.

Photo 1 Dip in highway, over entire width. Photo was taken facing north on May 31, 2017.

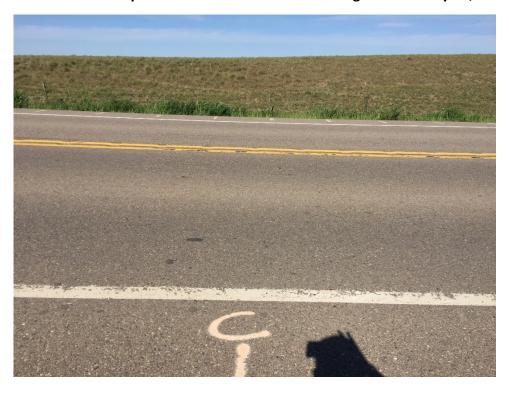
Photo 2 Survey pins installed in the highway in a grid pattern. Centerline of dip area marked on pavement. Photo was taken facing west on May 31, 2017.

Survey monitoring points in a grid on the pavement surface are being monitored by a surveyor retained by the MCI. The survey data should be provided to AT GRMP staff and KCB for review.

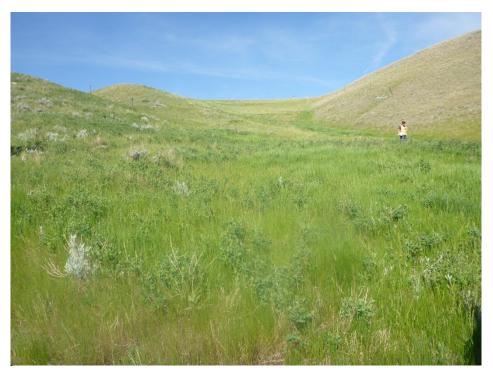
Site reconnaissance along the upland and embankment slope indicated no sign of embankment sliding, seepage, piping, void formation or other settlement. A zone of denser and more lush vegetation was noted at waypoint 326, but no other sign of seepage or eroded materials was noted.

Photo 3 Embankment slope on east side of the highway. Photo taking looking west, from the base of the slope, on May 31, 2017.

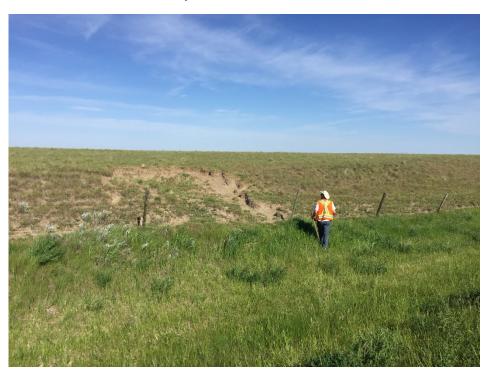
Photo 4 Depression/erosion feature on the west side of the highway. Photo was taken facing west on May 31, 2017.
