SITE NUMBER AND NAME: S053 Foremost Slide		HIGHWAY & KM: 879:04 km 1.125	PREVIOUS INSPECTION DATE: May 31, 2017	INSPECTION DATE: July 8, 2021
LEGAL DESCRIPTION: 9-20-6-11 W4M	NAD 83 COORDINATES: UTM: Northing: Easting: 12 5481930 467953		RISK ASSESMENT: PF: 10 CF: 3 TOTAL: 30	
AVERAGE ANNUAL DAILY TRAFFIC: 800 (north) & 370 (south) (Ref. No. 125050 & 125060)			CONTRACTOR MAINTENANCE AREA (CMA): 18

NOTES: 1. HORIZONTAL DATUM: NAD83 2. GRID ZONE: UTM Zone 12N 3. IMAGE SOURCE: World Imagery from ESRI ArcGIS Online. Source date January 2015	CLIENT 	PROJECT SOUTHERN REGION GEOHAZARD RISK MANAGEMENT PROGRAM
		TITLE Site Plan S053 - Foremost Slide Hwy 879:04
SCALE 1:1,000	PROJECT No. A05116A03	FIG No. 1

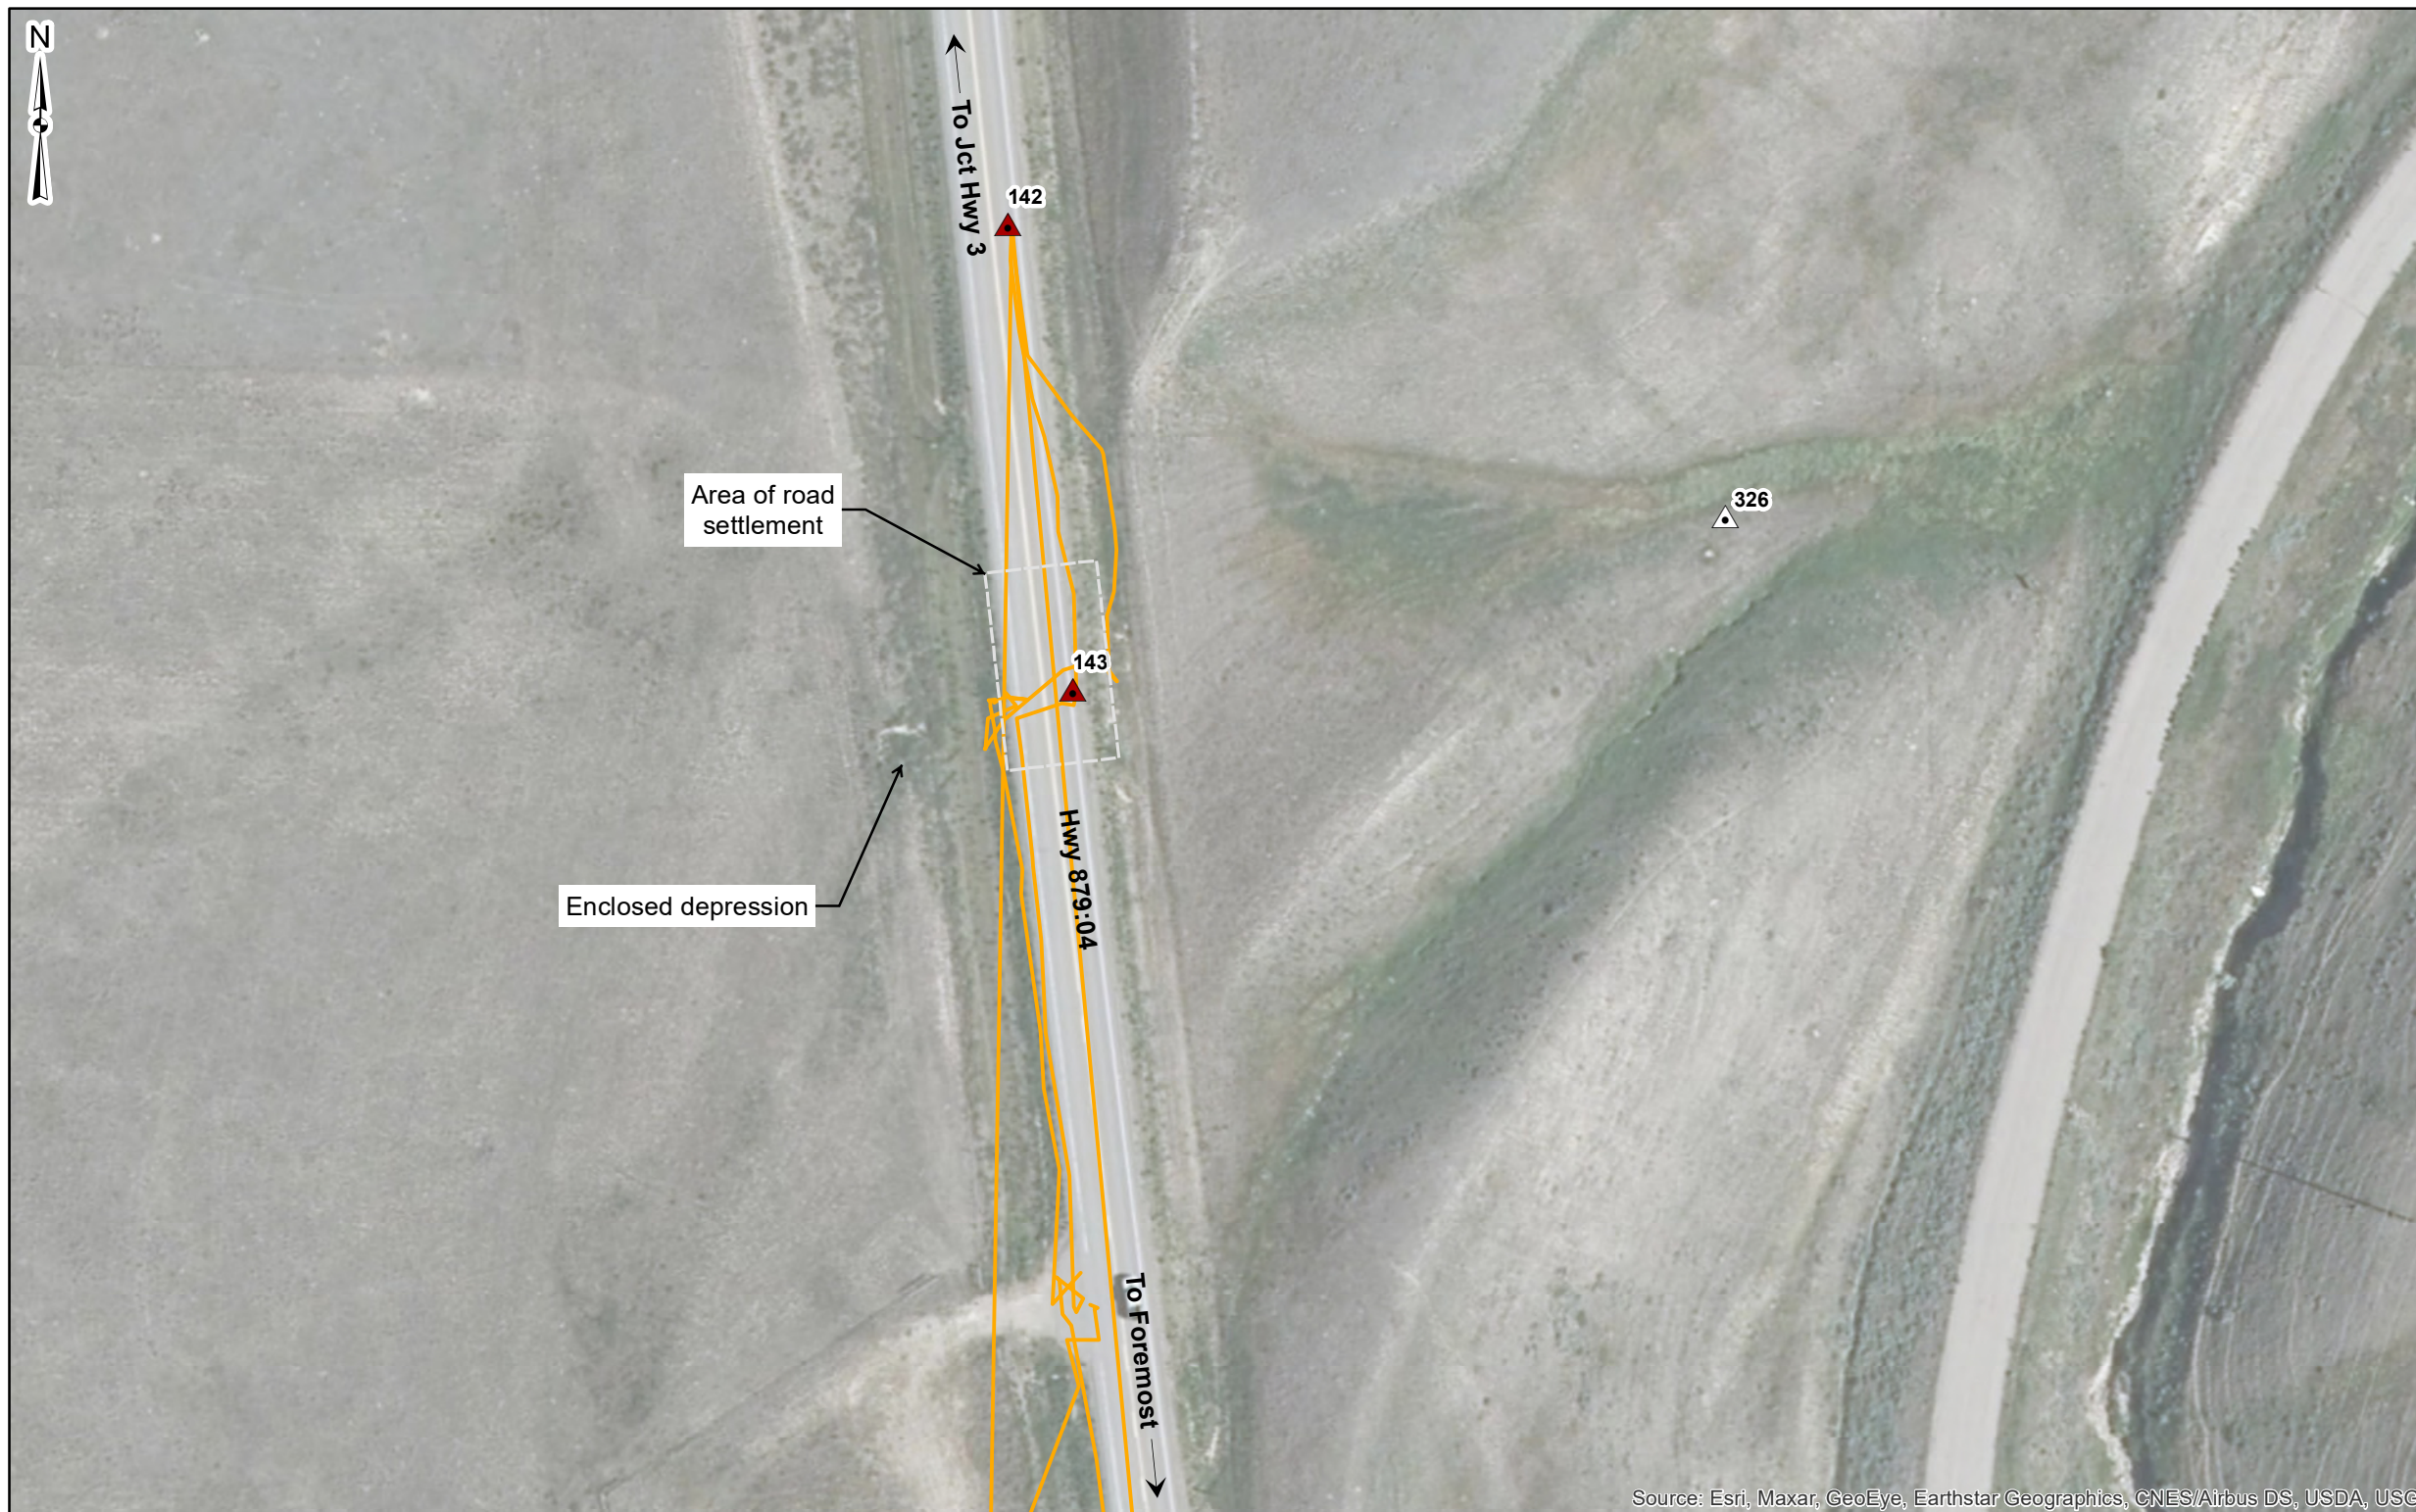
ITEM	CONDITION EXISTS		DESCRIPTION AND LOCATION	NOTICABLE CHANGE FROM LAST INSPECTION	
	YES	NO		YES	NO
Pavement Distress	X		Transverse pavement crack across entire width of highway, approximately 30 cm north of fourth row of monitoring points on highway	X	
Slope Movement		X			
Erosion	X		An erosion feature is located west of the highway, in upland area		X
Seepage		X			
Culvert Distress		X

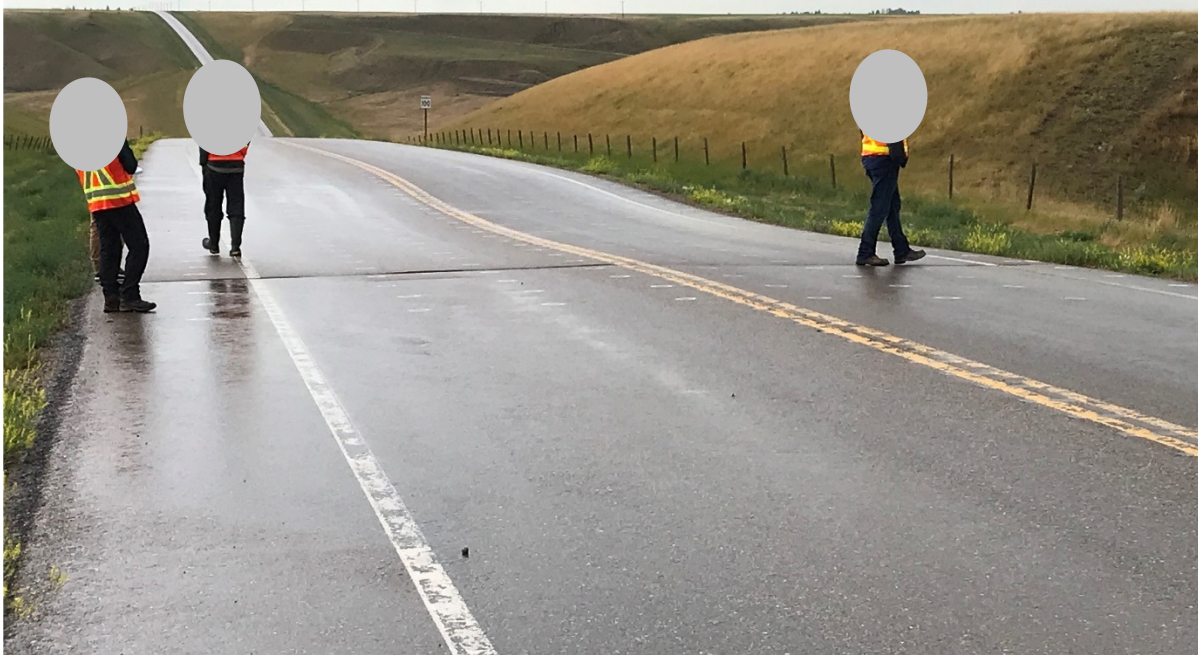
Photo 1 Transverse pavement crack which has formed north of the dip in the highway. Photo was taken facing north on July 8, 2021.

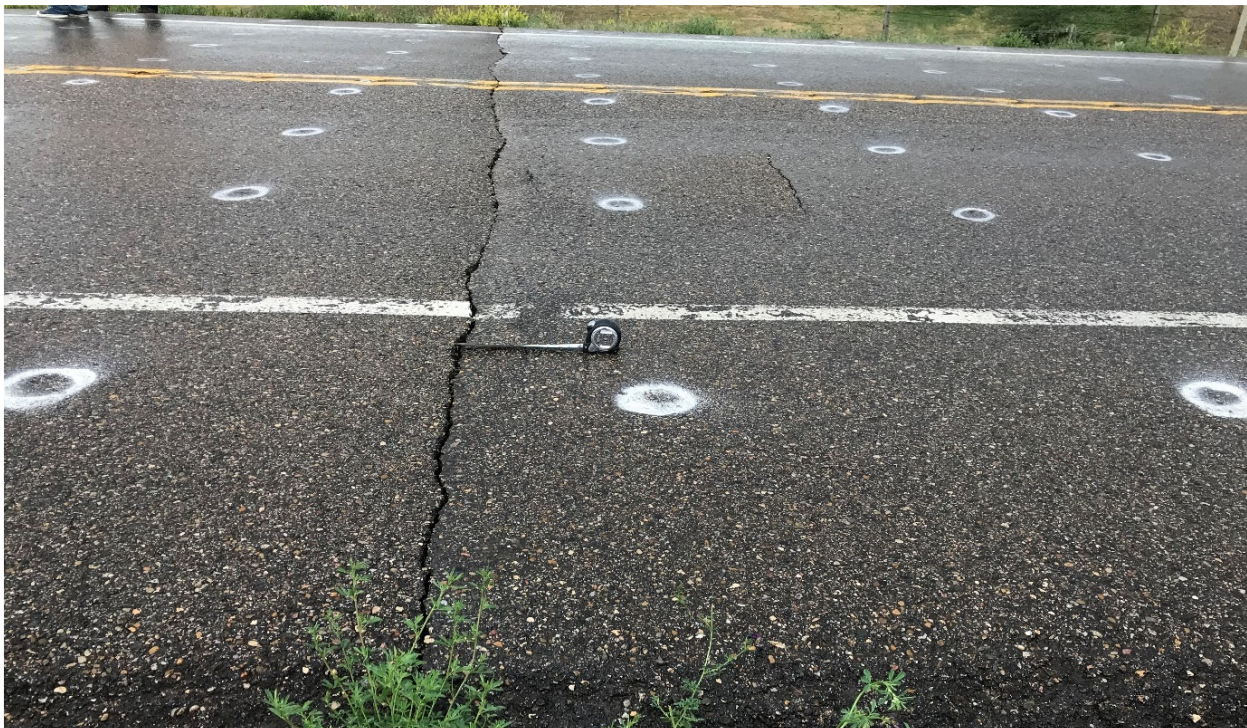
COMMENTS
Highway appears to be constructed on an infilled coulee which is settling. There is evidence of numerous pavement lifts. The site was previously referred to as Rattlesnake Dip.
A transverse pavement crack across the entire highway, up to 20 mm wide and for the full depth of the pavement (waypoint 143). A second crack is forming approximately 1.1 m to the south of waypoint 143.
A transverse pavement crack was observed at waypoint 142, north of the dip.
Downslope of the dip, the highway ditch on the east side appears to have settled. The fence line on the east side of the highway appears straight with no evidence of dislocation.
Survey monitoring points were installed in grid pattern on the pavement surface in 2016-2017 and are being monitored annually by a surveyor retained by the MCI. Recent survey data has been provided to KCB for review.

Photo 2 Full pavement depth transverse crack at the dip. Crack is up to 2 cm wide. White circles denote survey pins installed in a grid pattern. Photo was taken facing north on July 8, 2021.

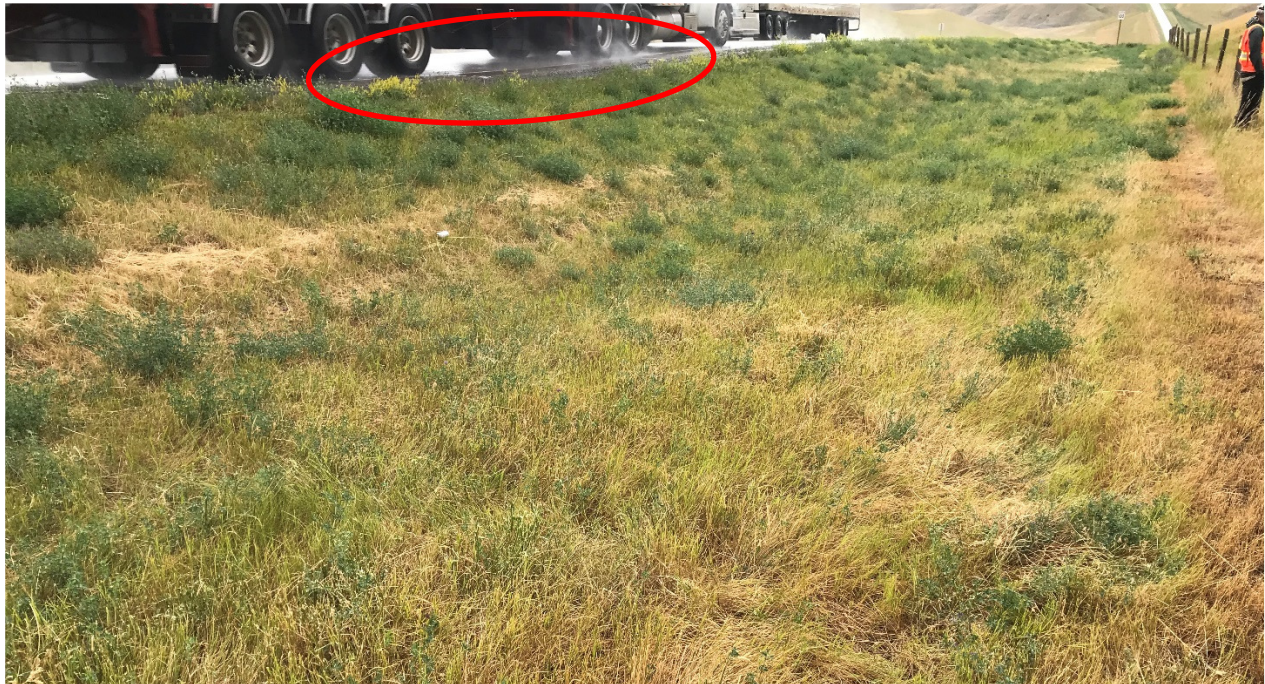
Photo 3 View north along east side of the highway, red circle shows the dip location. Photo taking facing north on July 8, 2021.

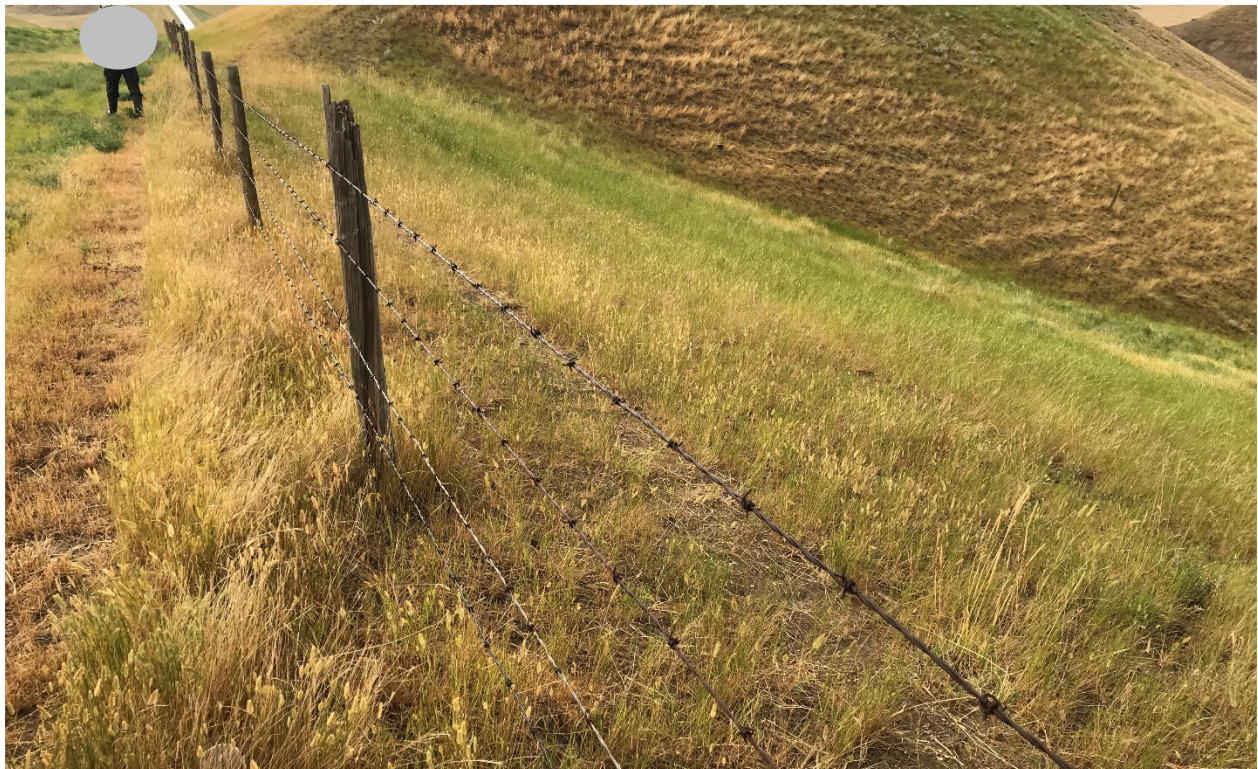
A site reconnaissance in 2017 walked the upland and to the toe of the embankment slope. No evidence of embankment sliding, seepage, piping, void formation or other settlement was observed. A zone of denser and more lush vegetation was noted at waypoint 326 but no other sign of seepage or eroded materials was noted.

Photo 4 Fence line and embankment slope on east side of highway. Photo was taken facing north on July 8, 2021.
