March 25, 2022

Alberta Transportation
2nd Floor, Willowglen Business Park
803 Manning Road NW
Calgary, Alberta
T2E 7MB

CON0022161 Southern Region GRMP
Call-Out Report – S053 Foremost Settlement

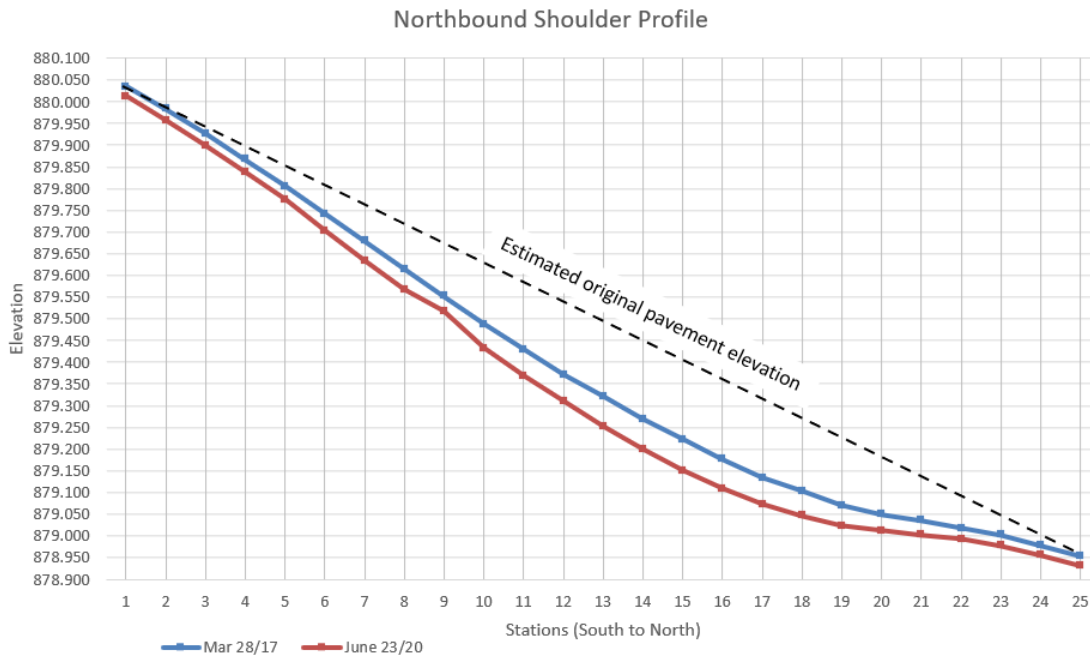
Figure 5.1 Topographic survey data for the northbound shoulder profile

- Pavement settlement had taken place prior to the baseline survey from March 2017.
- Settlement of the pavement continued between March 2017 and June 2020, as illustrated in Table 5.1. Shading has been included for illustration purposes.
- For the survey pin data, KCB have estimated the original pavement elevation and compared it against topographic information. Based on the survey pin data, KCB have estimated that the road surface may have settled by up to 0.25 m (250 mm). An illustration is included in Figure 5.1.

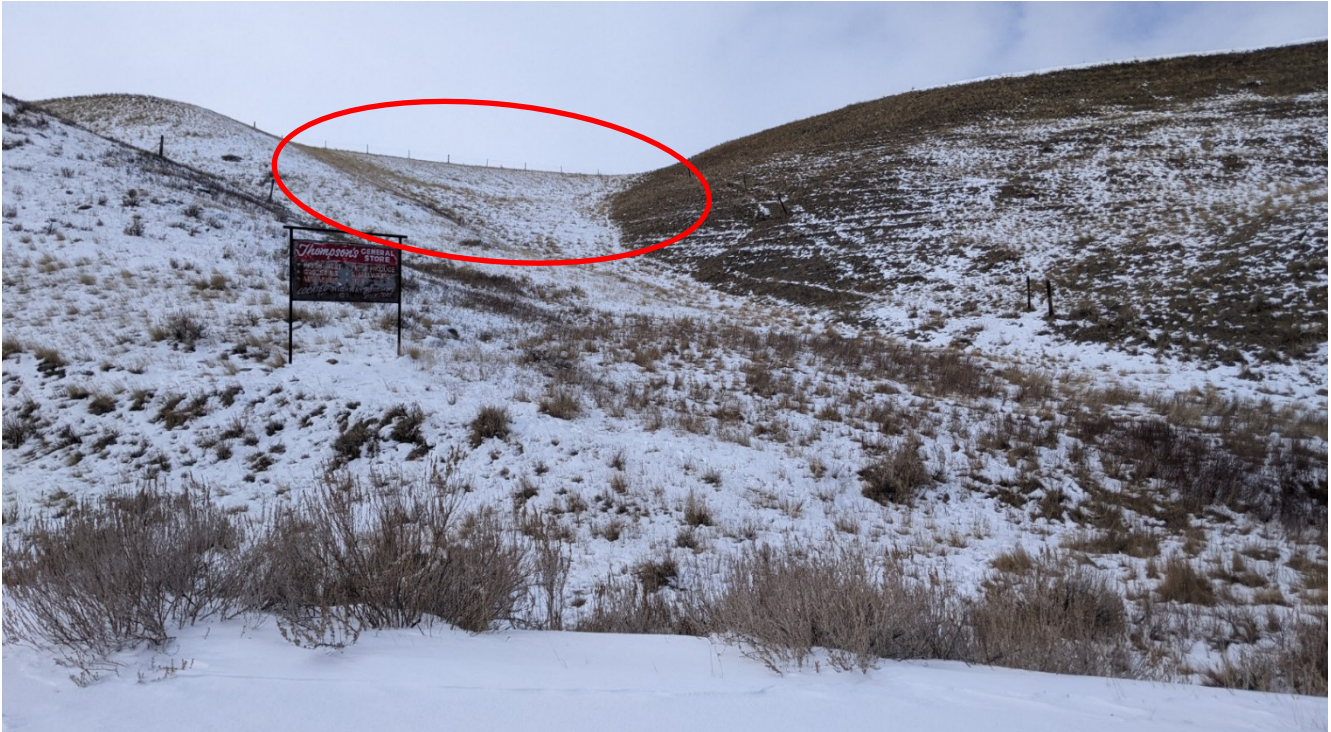
Photo 1 View west from Becker Coulee (old highway alignment) towards the ravine that was infilled during construction of Highway 879 (red circle). Photo taken facing west on March 10, 2022.

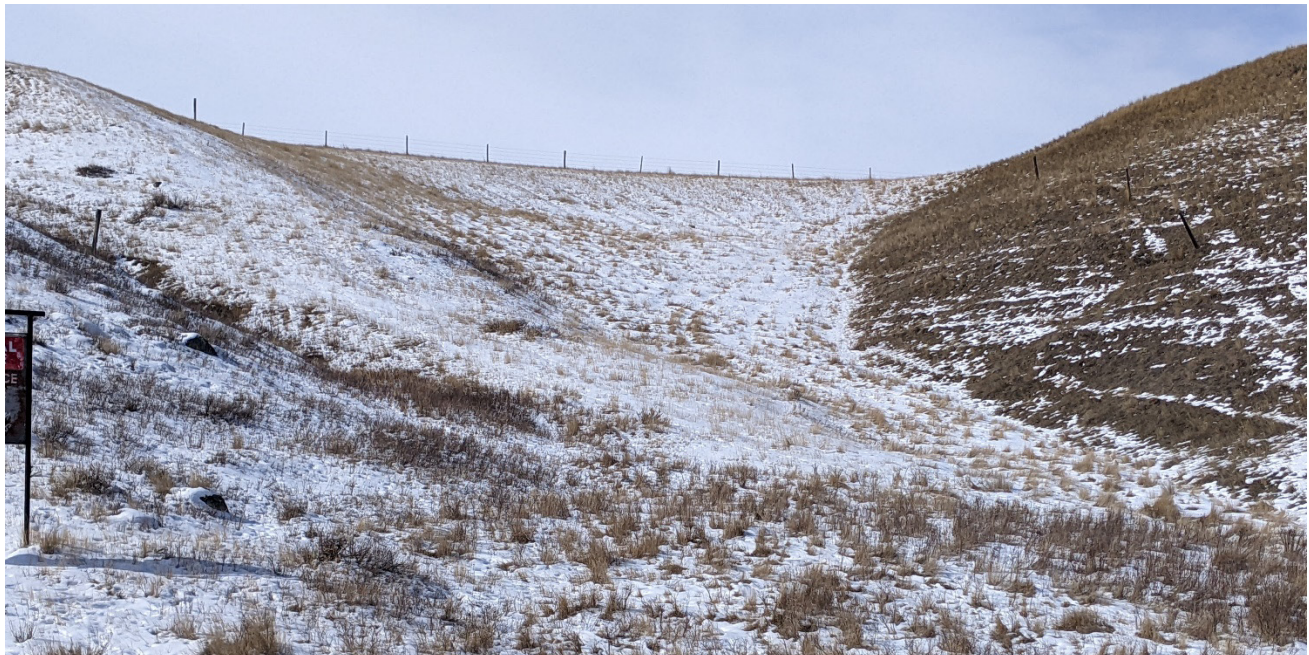
Photo 2 View west towards ravine infilled during construction of Highway 879. Photo taken on March 10, 2022.

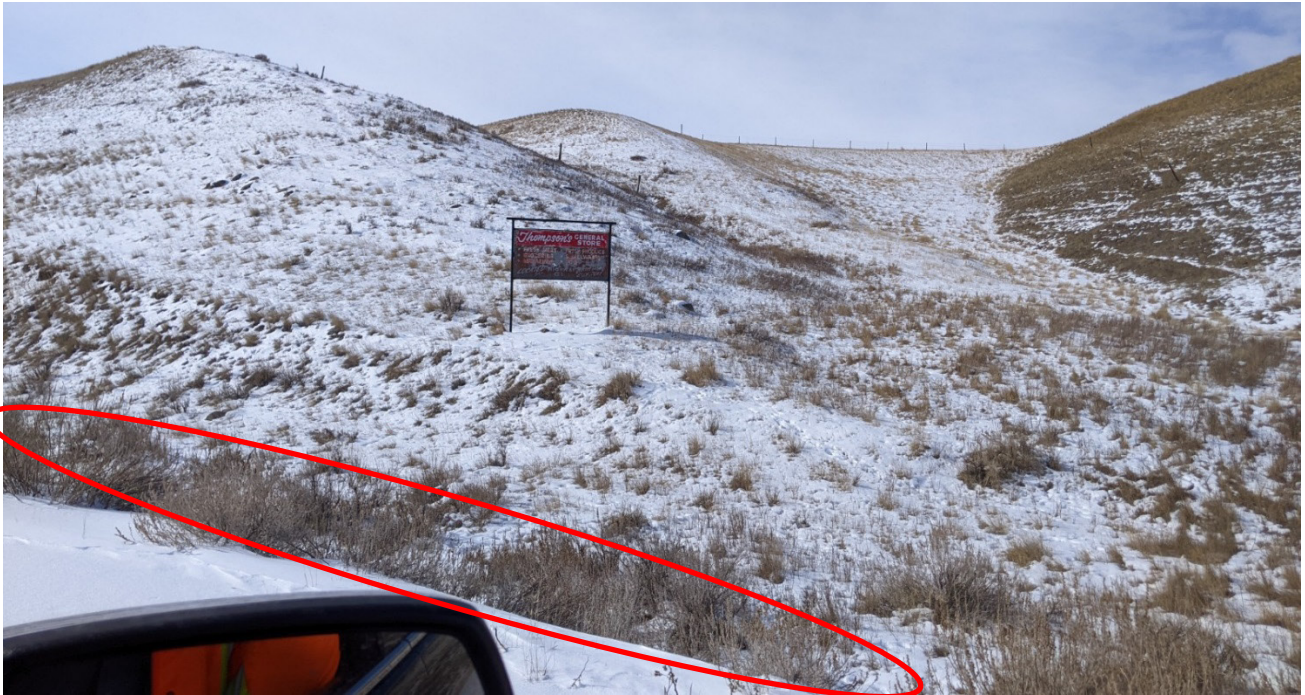
Photo 3 Drainage ditch (red circle) west of old highway at the base of Becker Coulee. Photo taken facing southwest on March 10, 2022.

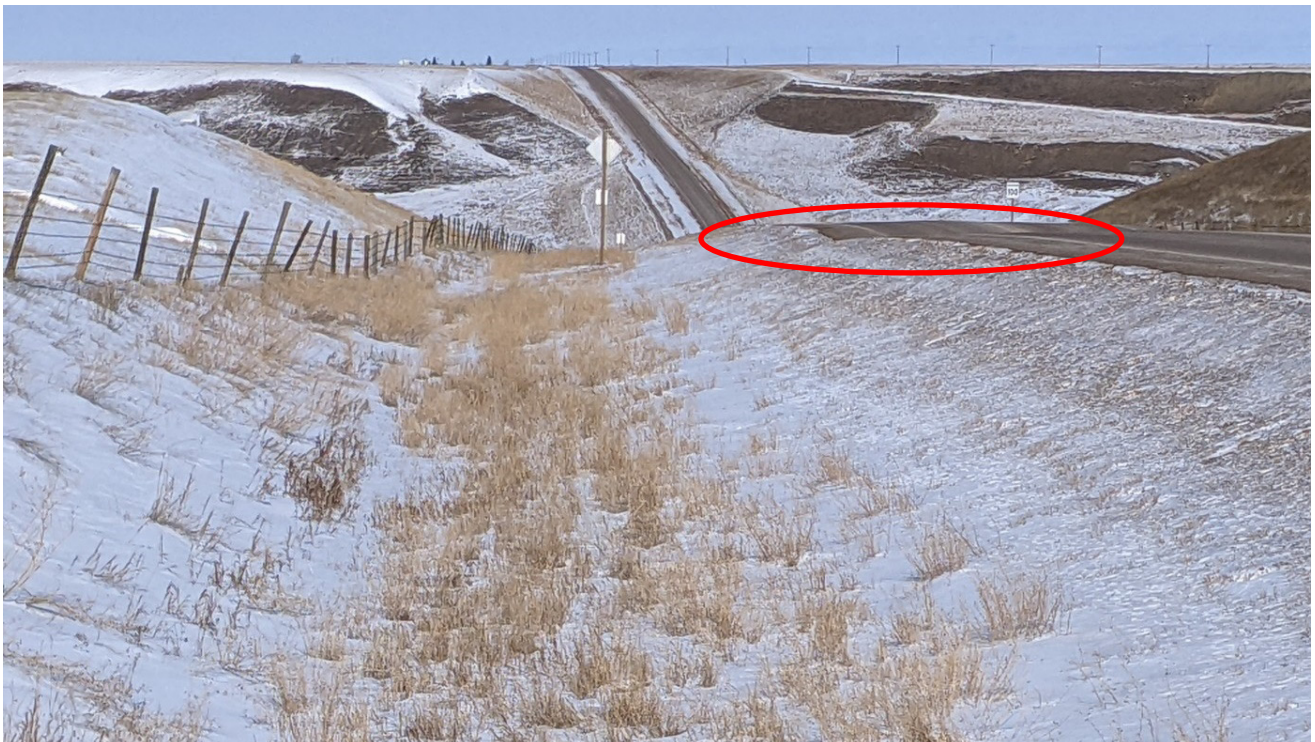
Photo 4 View north along ditch on west side of the highway (red circle shows the dip location). Photo taken facing north on March 10, 2022.

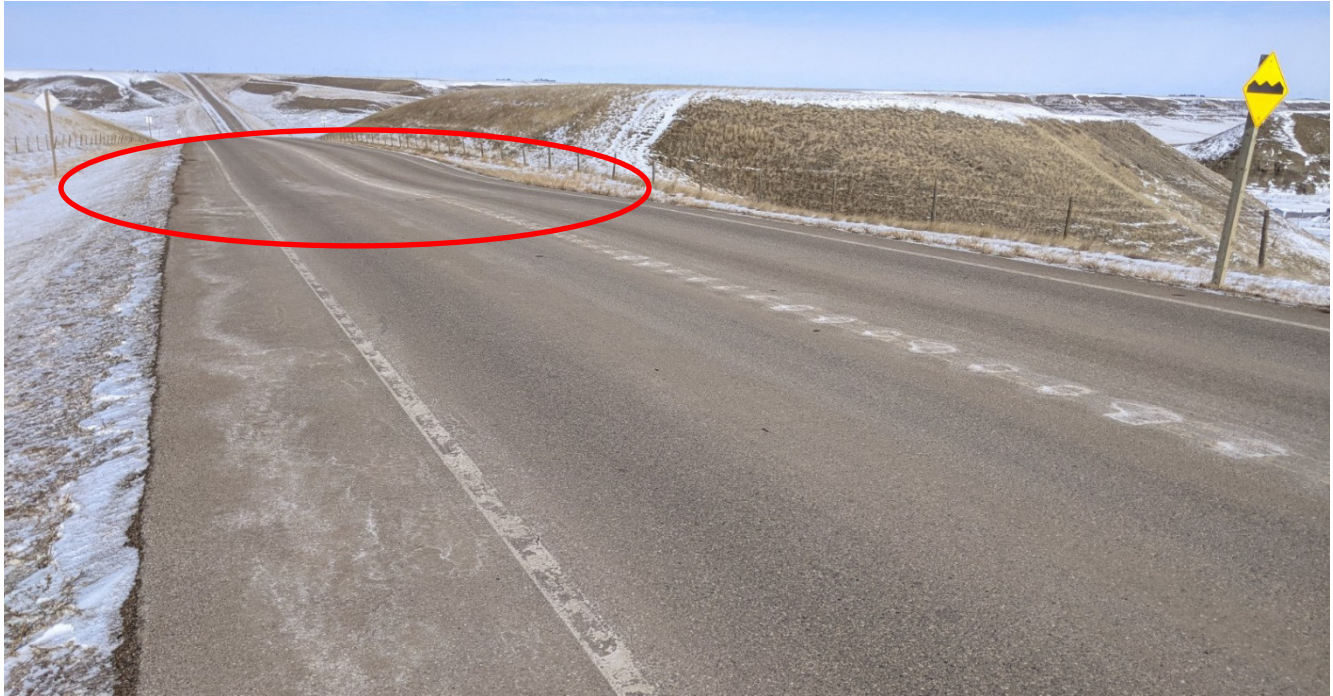
Photo 5 View north from south of the dip (red circle shows the dip location). Photo taken facing north on March 10, 2022.

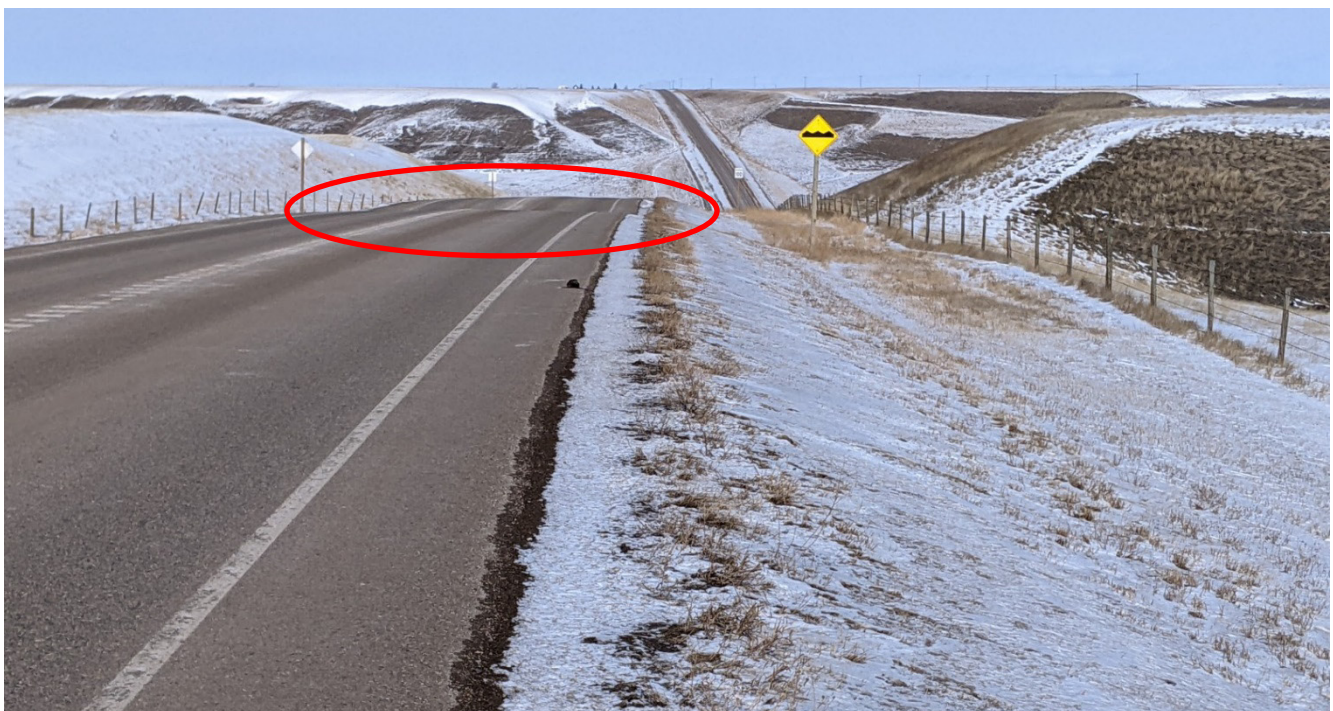
Photo 6 View north along east ditch from south of the dip (red circle shows the dip location). Photo taken facing north on March 10, 2022.

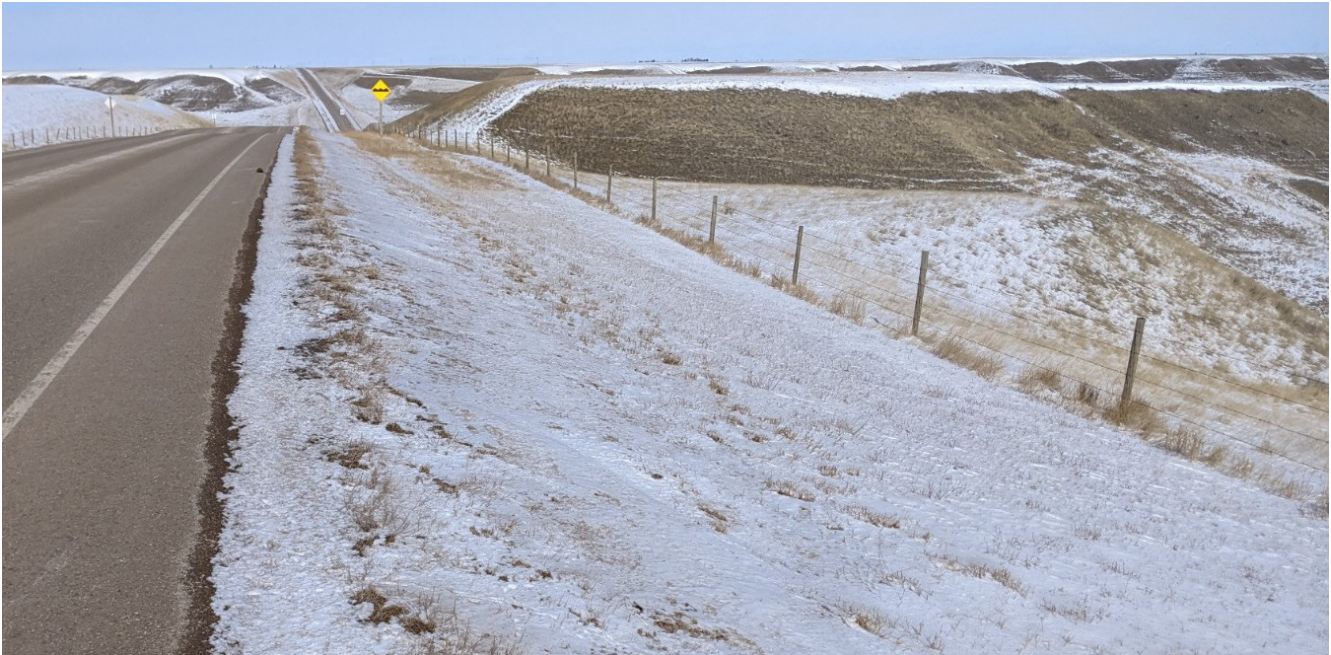
Photo 7 East ditch and infilled ravine viewed from south of the dip (bump in road sign is located near the dip). Photo taken facing north on March 10, 2022.

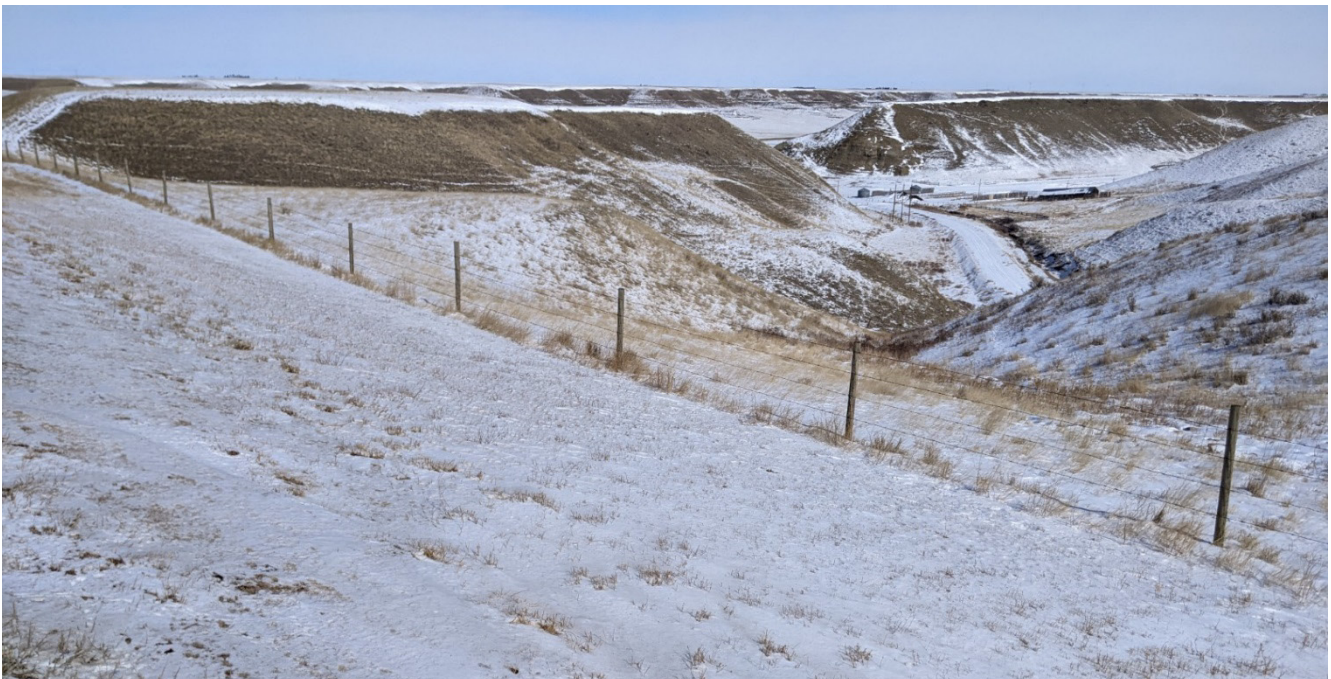
Photo 8 View from Highway 879 northeast down the infilled ravine towards the old highway in Becker Coulee. Photo taken facing northeast on March 10, 2022.

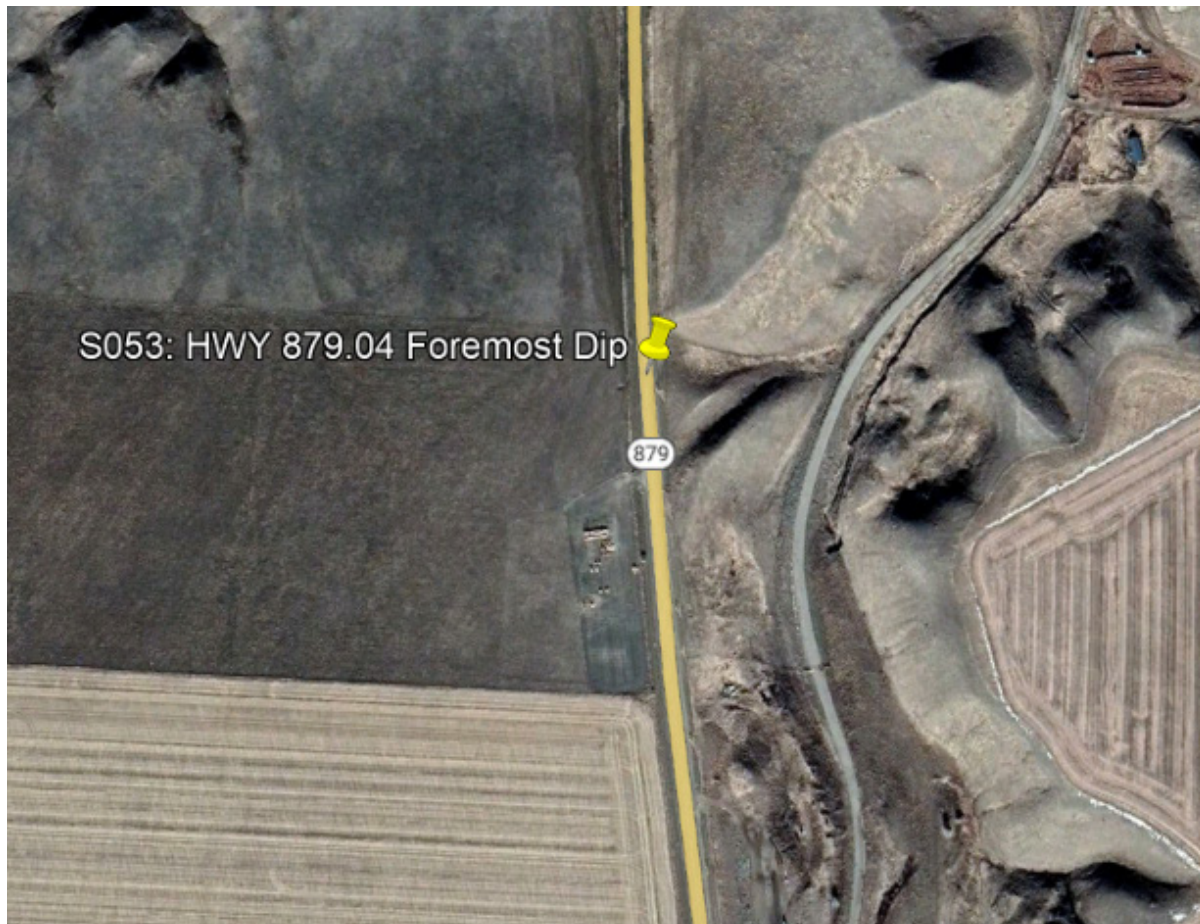
Google Earth (October 2020)

| Date of Photo | Comment |
|---|--|
| October 2020 | Highway 879 is located on the present alignment. No visible evidence of slope instability. |

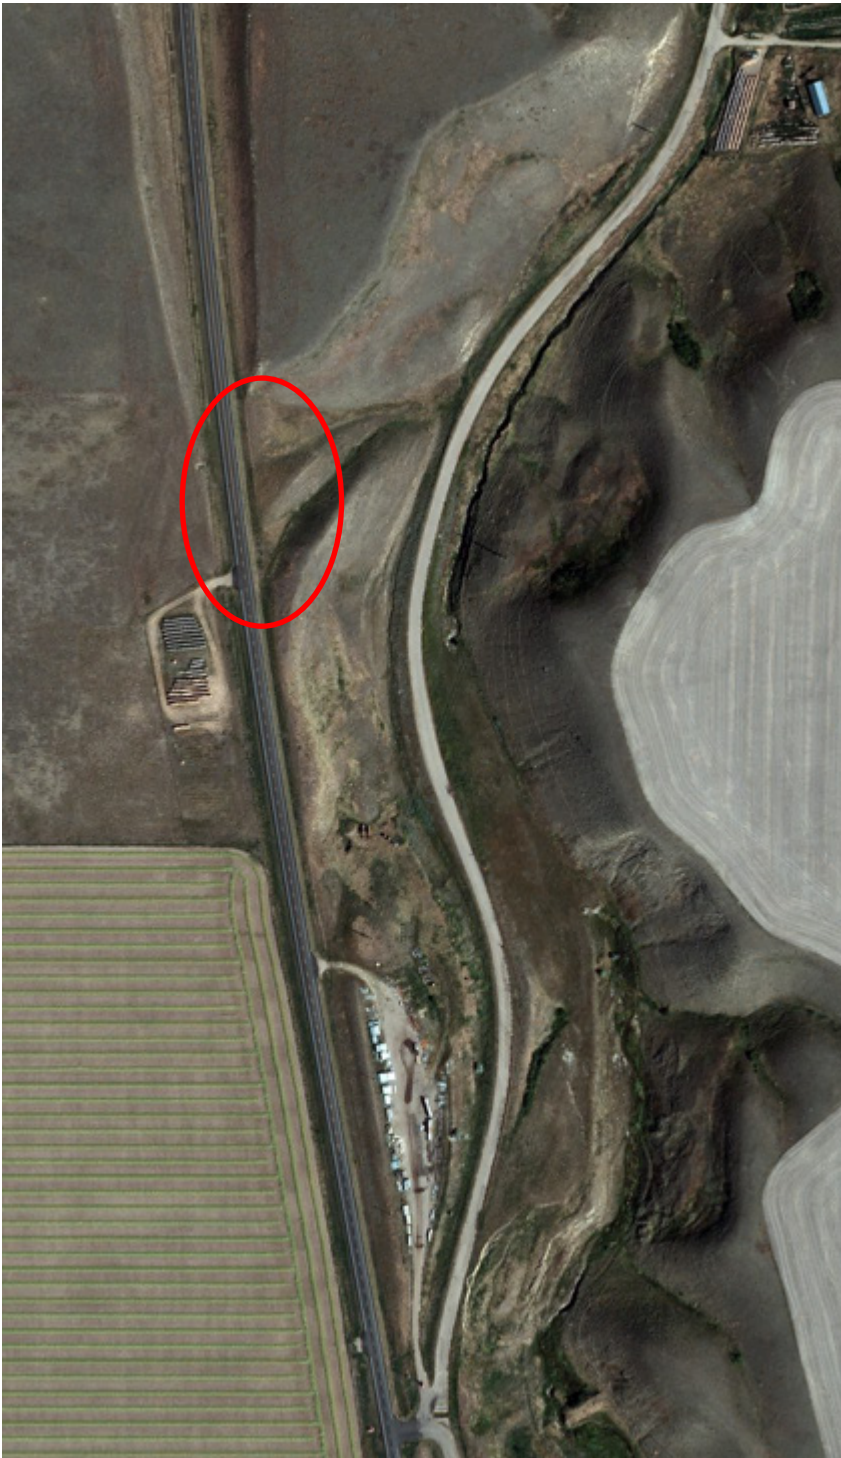
Air Photo (August 2012)

| Date of Photo | Comment |
|---|--|
| August 2012 | Highway 879 is located on the present alignment. No visible evidence of slope instability. |

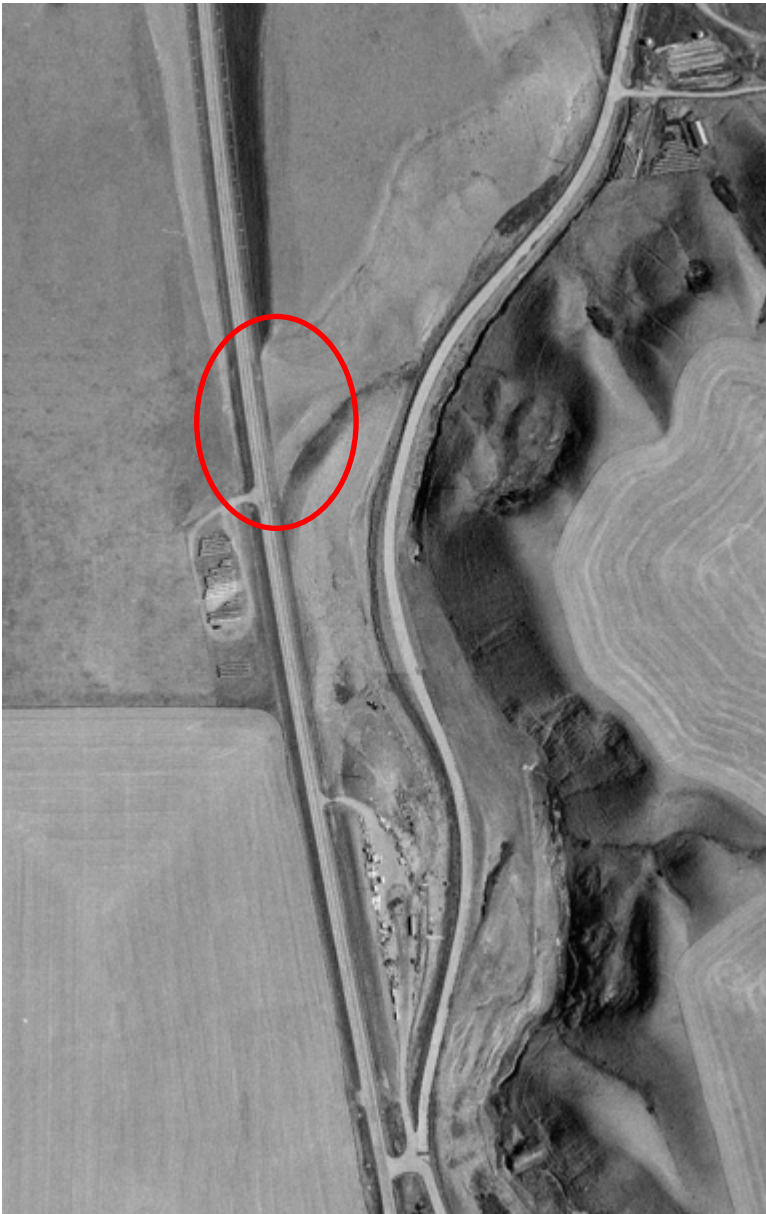
Air Photo (July 2004)

| Date of Photo | Comment |
|---|--|
| July 2004 | Highway 879 is located on the present alignment. No visible evidence of slope instability. |

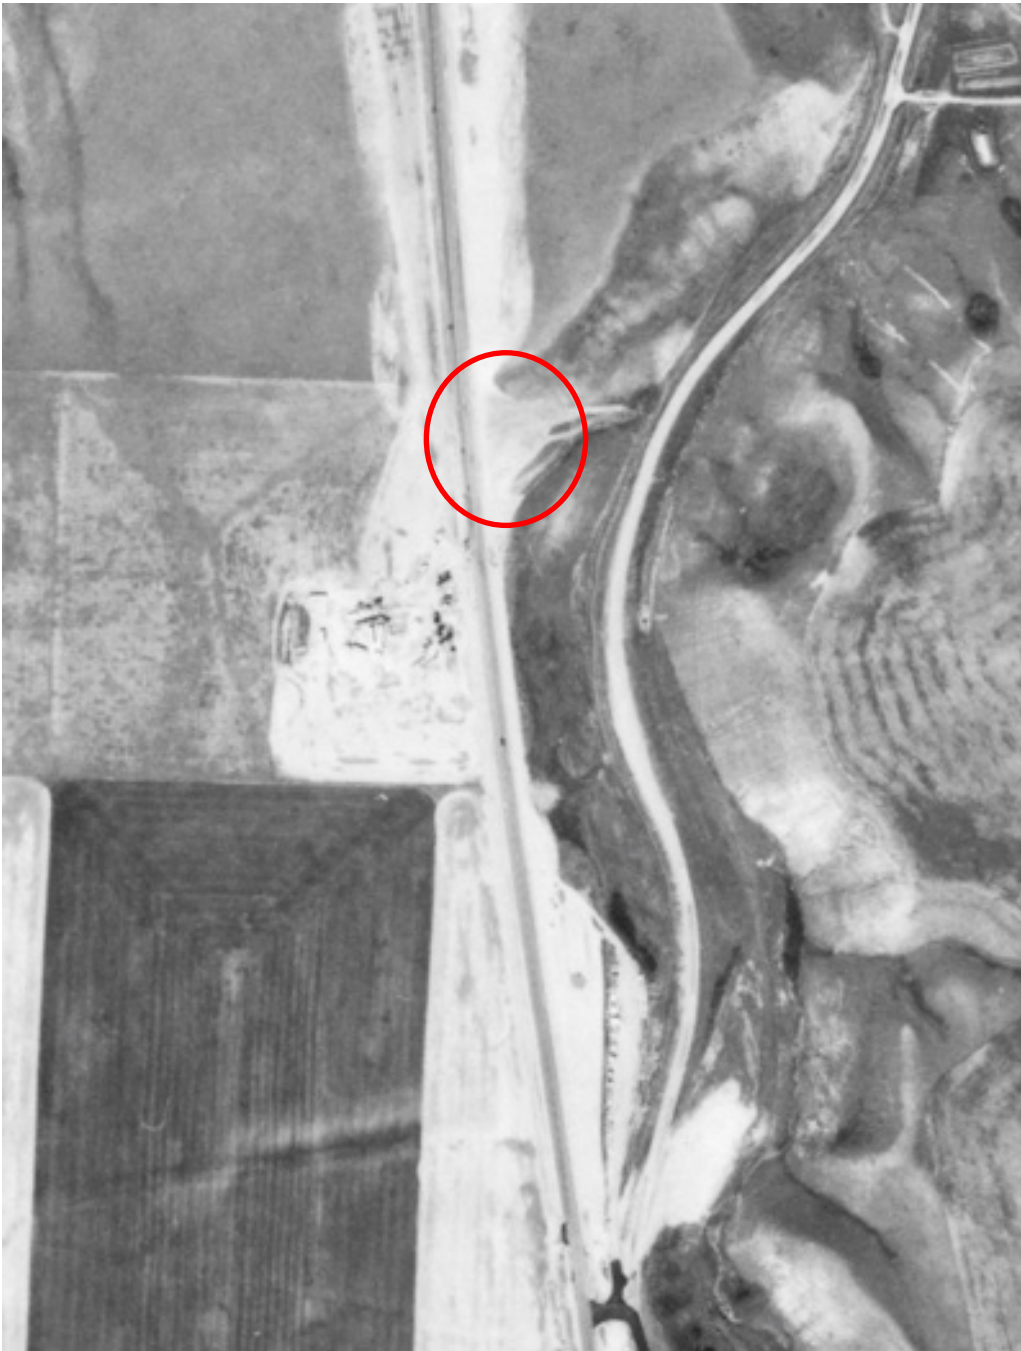
Air Photo (July 1992)

Review of the available air photos indicates that construction of Highway 879 included infilling a steeply sloped V-shaped ravine at the approximate location of the depression. No details are available of the construction; however, site observations suggest that the depression in the pavement is due to settlement of fill materials over the partially filled ravine.

| Date of Photo | Comment |
|---|--|
| July 1992 | Highway 879 is under construction on the present alignment, located at the crest of the slope and oriented approximately north to south. Construction of the new road alignment included infilling a ravine at the location of the observed dip. |

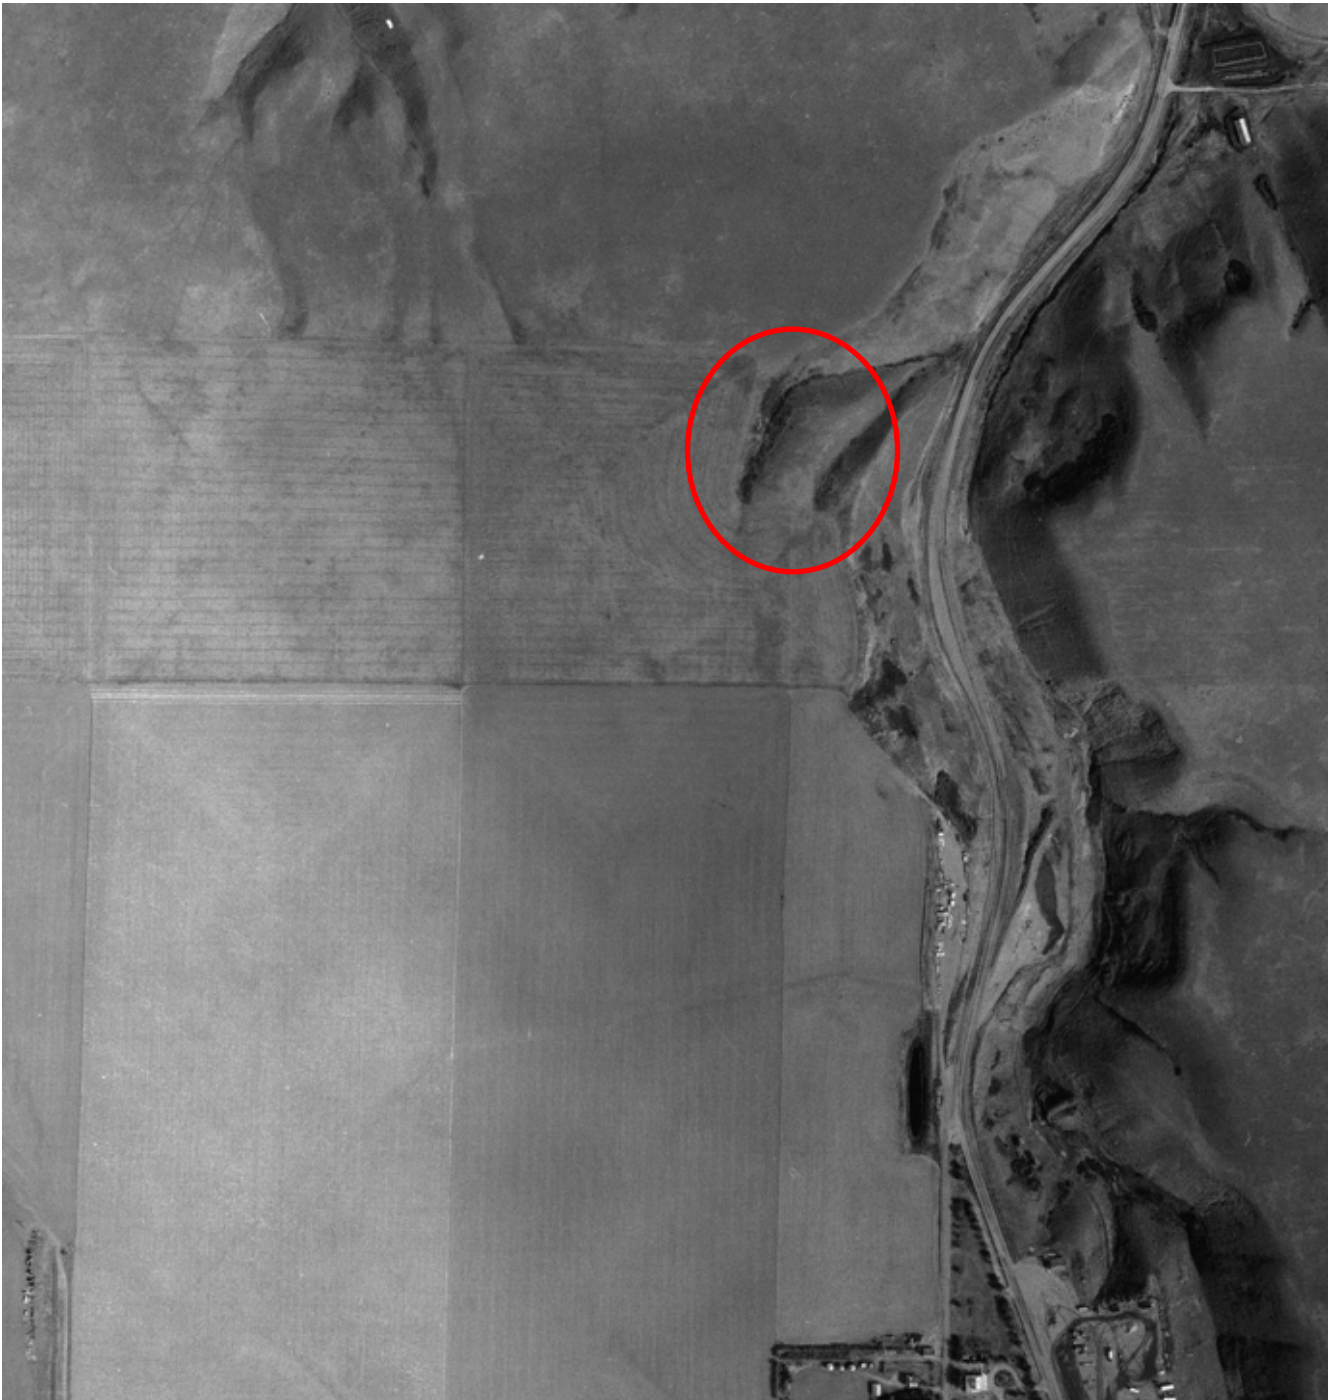
Air Photo (August 1981)

| Date of Photo | Comment |
|---|--|
| August 1981 | No significant changes to the site since 1951. |

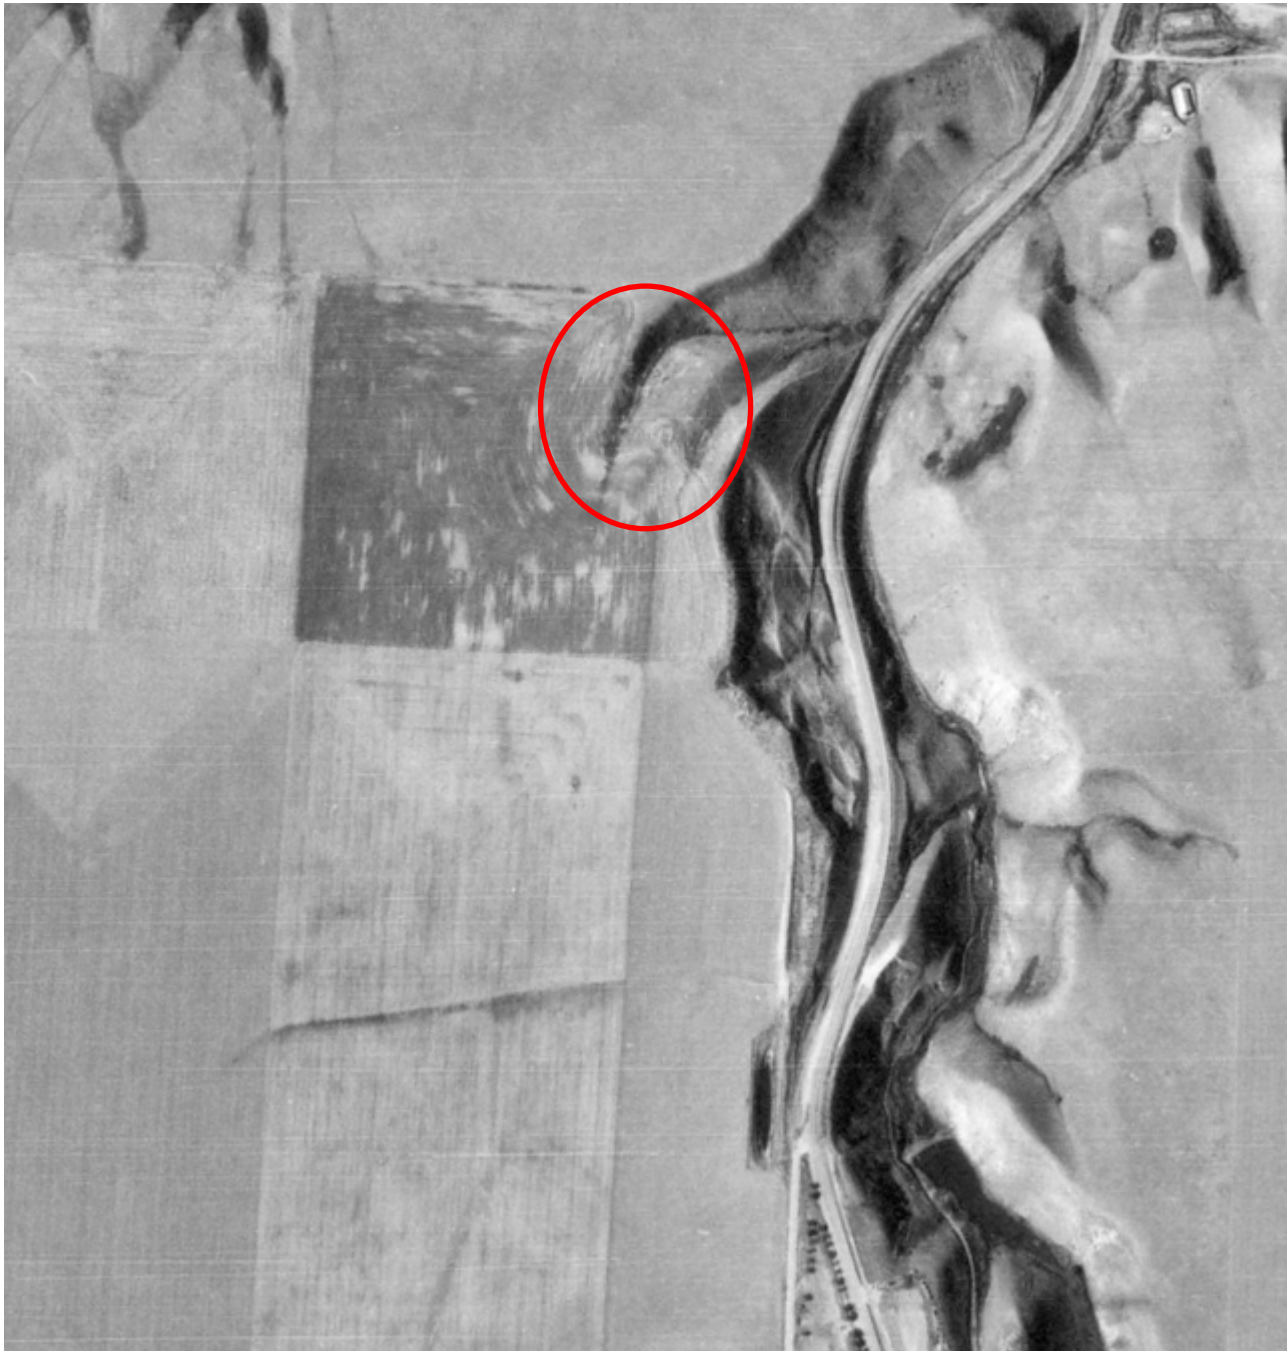
Air Photo (July 1974)

| Date of Photo | Comment |
|---|--|
| July 1974 | No significant changes to the site since 1951. |

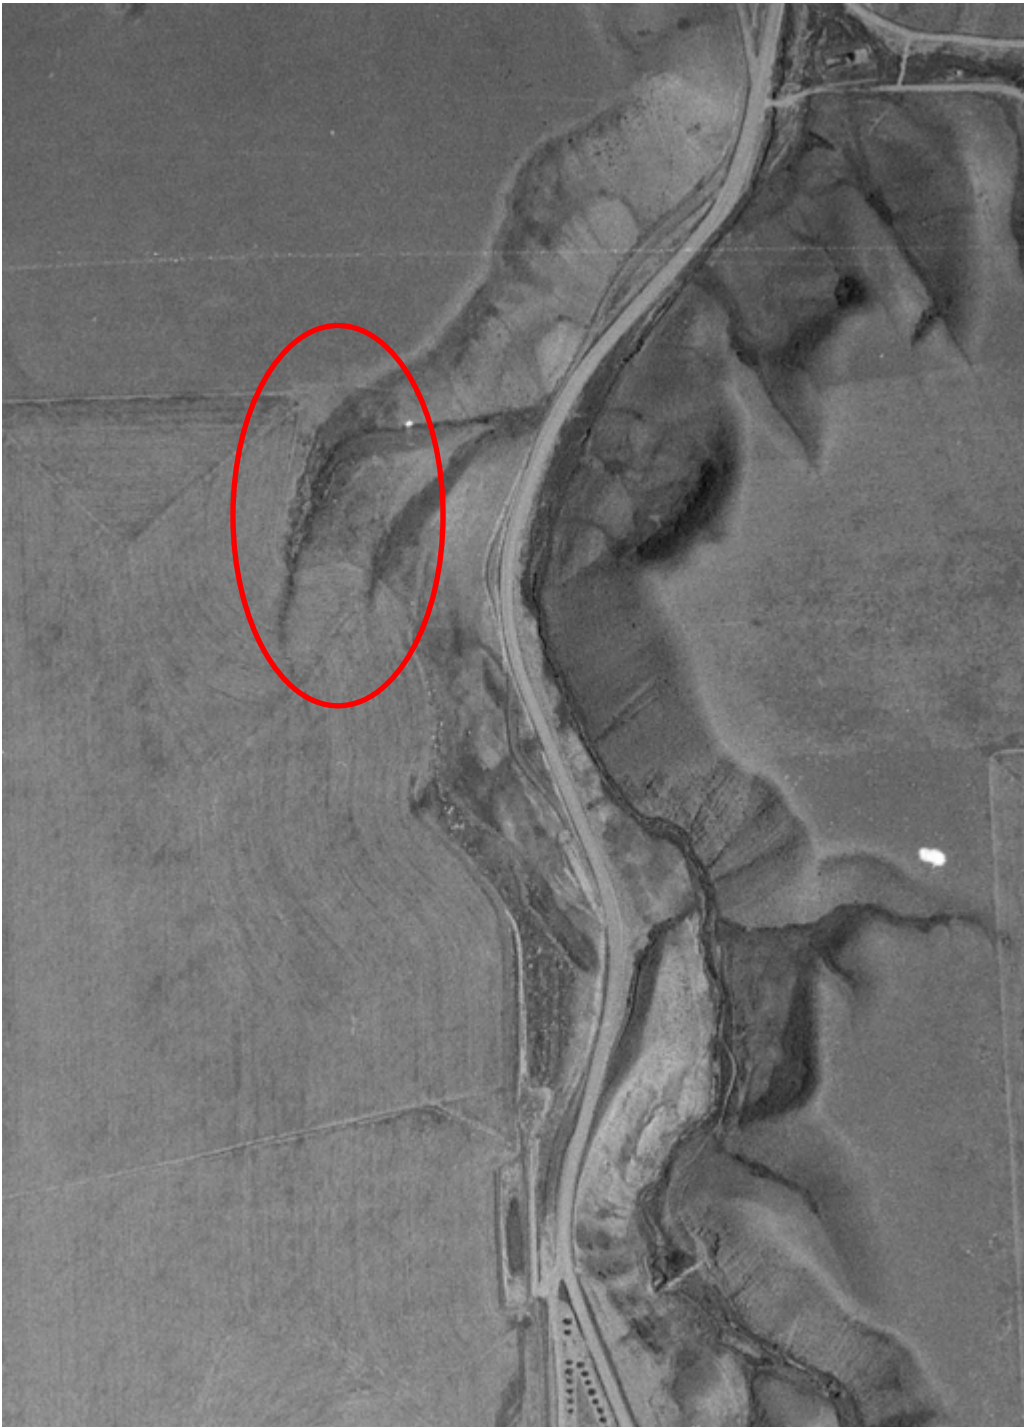
Air Photo (June 1962)

| Date of Photo | Comment |
|---|--|
| June 1962 | No significant changes to the site since 1951. |

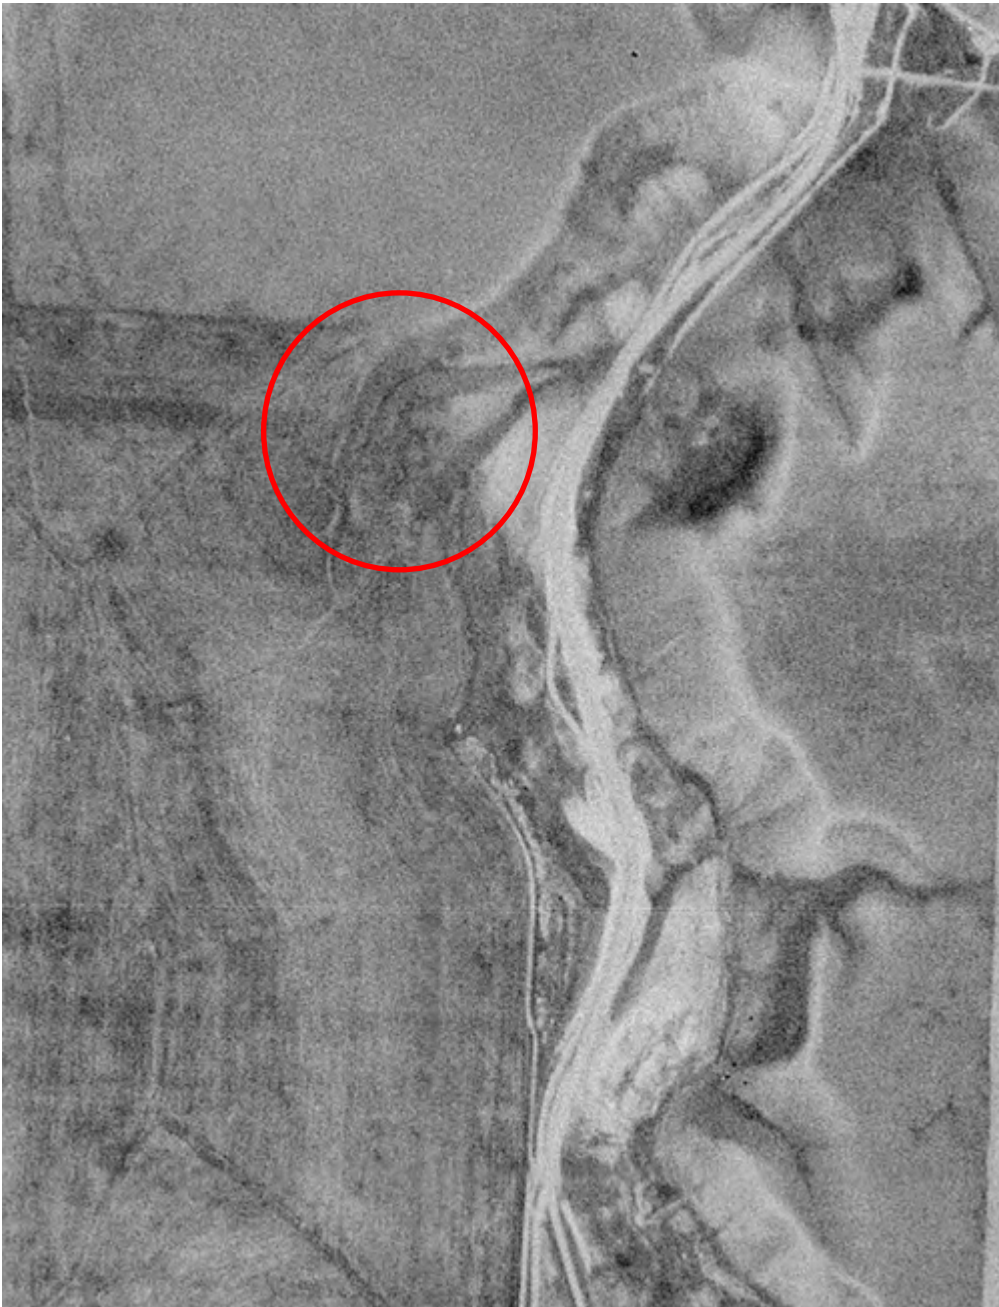
Air Photo (July 1951)

| Date of Photo | Comment |
|---|--|
| July 1951 | Highway located on old alignment. Highway is situated east of the existing alignment, following the curvilinear Becker Coulee at is descends into Chin Coulee. |
