SITE NUMBER AND NAME: S055 East of Gleichen		HIGHWAY & KM: 901X, 9.2 km east of 547	PREVIOUS INSPECTION DATE: May 8, 2019	INSPECTION DATE: July 8, 2020
LEGAL DESCRIPTION: 02-12-022-22 W4M	NAD 83 COORDINATES: UTM Northing Easting 12 5634864 364825		RISK ASSESMENT Slide: PF: 11 CF: 4 TOTAL: 44 Erosion: PF: 6 CF: 2 TOTAL: 12	
AVERAGE ANNUAL DAILY TRAFFIC (AADT): 360 (west), (Ref. No. 109170)			CONTRACTOR MAINTENANCE AREA (CMA): 30

PRIMARY SITE ISSUE: A runoff erosion gully on the north side of the highway and slope instability on the south side. Repair activities were completed in 2018, however the slope drain became blocked in spring 2019 due to grass buildup on the fine mesh screen (aperture size of 15 mm) fitted to the pipe inlet, leading to overtopping of the ditch block and erosion of the repaired surfaces. The erosion gully and slope drain on the north side were repaired in late 2019, including replacement of the inlet trash rack.

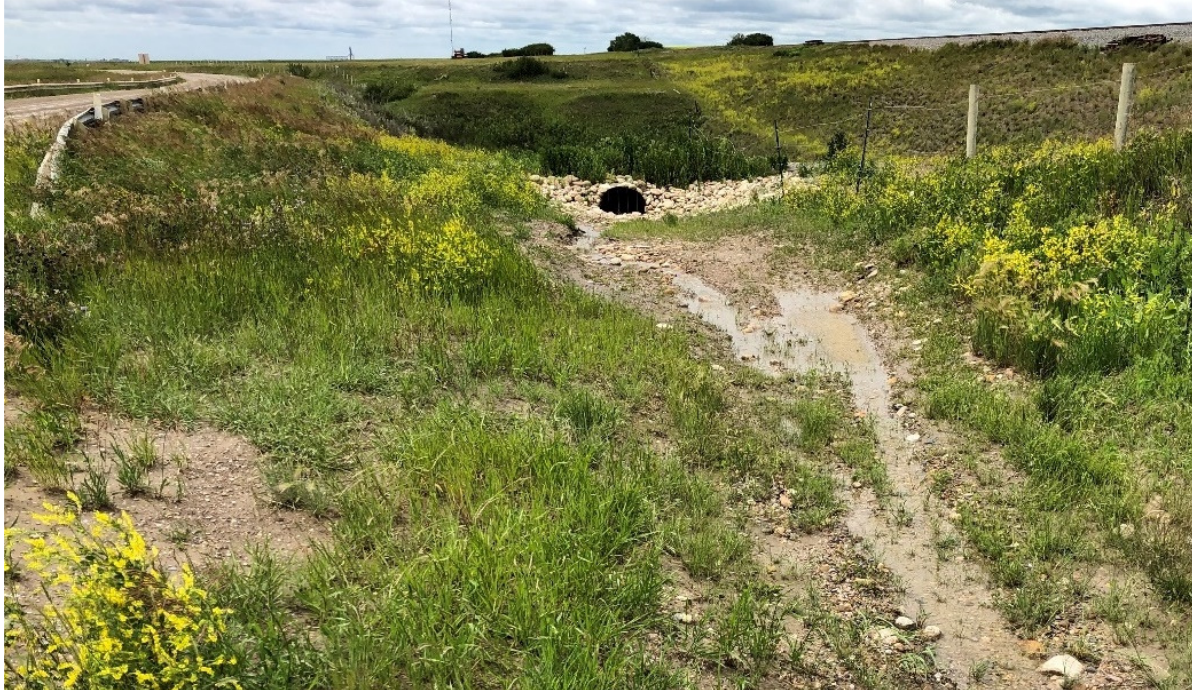
Photo 1 North side of highway – Reinstated ditch block at slope drain inlet. Small amount of standing water in the highway ditch. Photo taken facing west on July 8, 2020.

- Improve highway drainage on the south side, construct a berm, or regrade the highway surface to avoid runoff concentrating at the granular repair location (which represents a low point on the south side of the highway).
- Install HDPE geofabric at the inlet to the slope drain to direct all ditch flow into the HDPE pipe. A custom "boot" is recommended around the HDPE pipe to provide a full seal around the pipe.

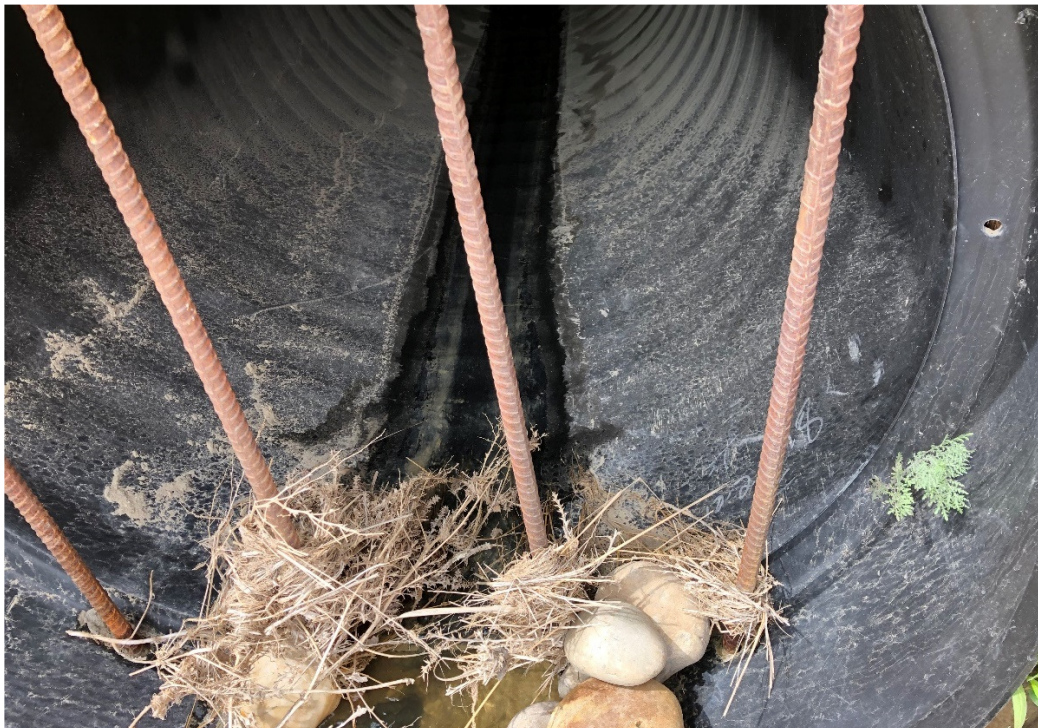
During the 2020 site visit, the flow in the HDPE pipe on the north side was estimated as less than flow in the ditch, possibly due to runoff bypassing under the slope drain.

Photo 2 Flow in the HDPE pipe. The volume of flow in the slope drain appeared to be lower than the volume of flow in the ditch. Photo taken on July 8, 2020.

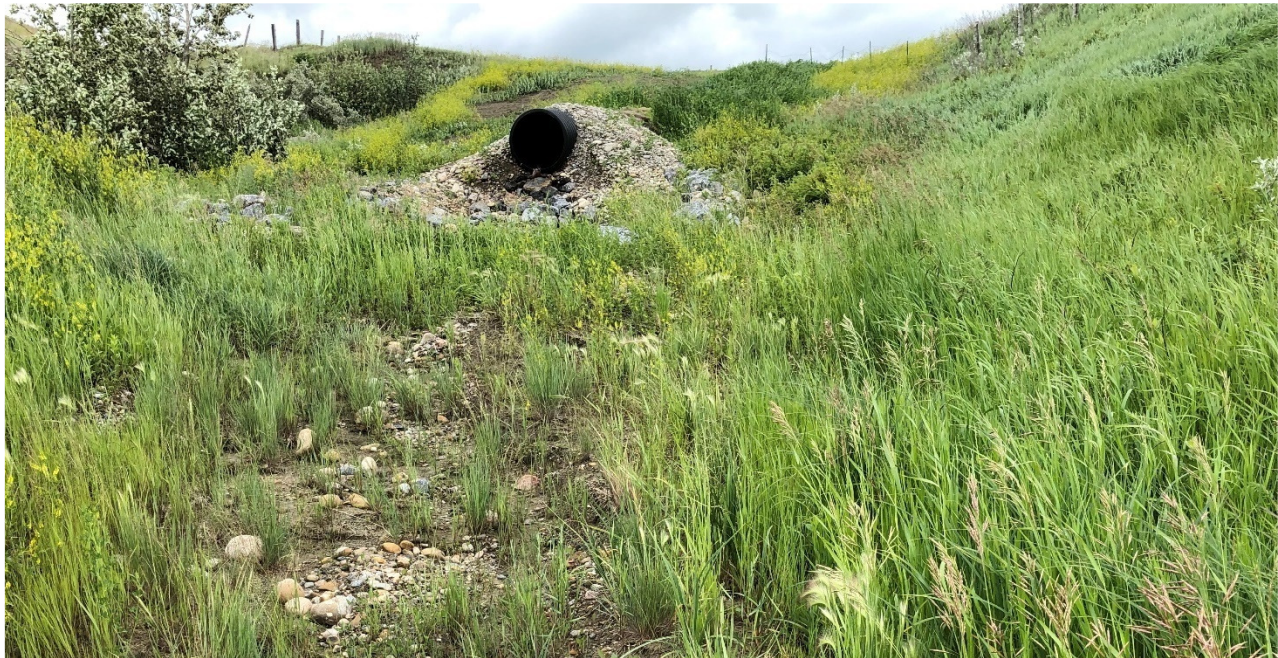
The v-ditch from the slope drain outlet has been partially eroded but is still functional. A steel culvert beneath the highway at the toe of the embankment remains infilled with sediment as a result of the spring 2019 ditch block overtopping. The sediment plug restricts flows to the south, which also impedes flow from the CSP culvert under the CP Rail line.

When compared to 2019, vegetation was well established across large portions of the repair. The lower portion of the slope drain is covered with straw matting to promote vegetation growth, and the outlet is covered with riprap (150 mm minus) to minimize deflection during outflows. Erosion rills 5 to 50 mm deep were noted where vegetation coverage is poor.

Photo 3 North side of highway – View looking upslope from slope drain outlet. Photo taken facing east on July 8, 2020.

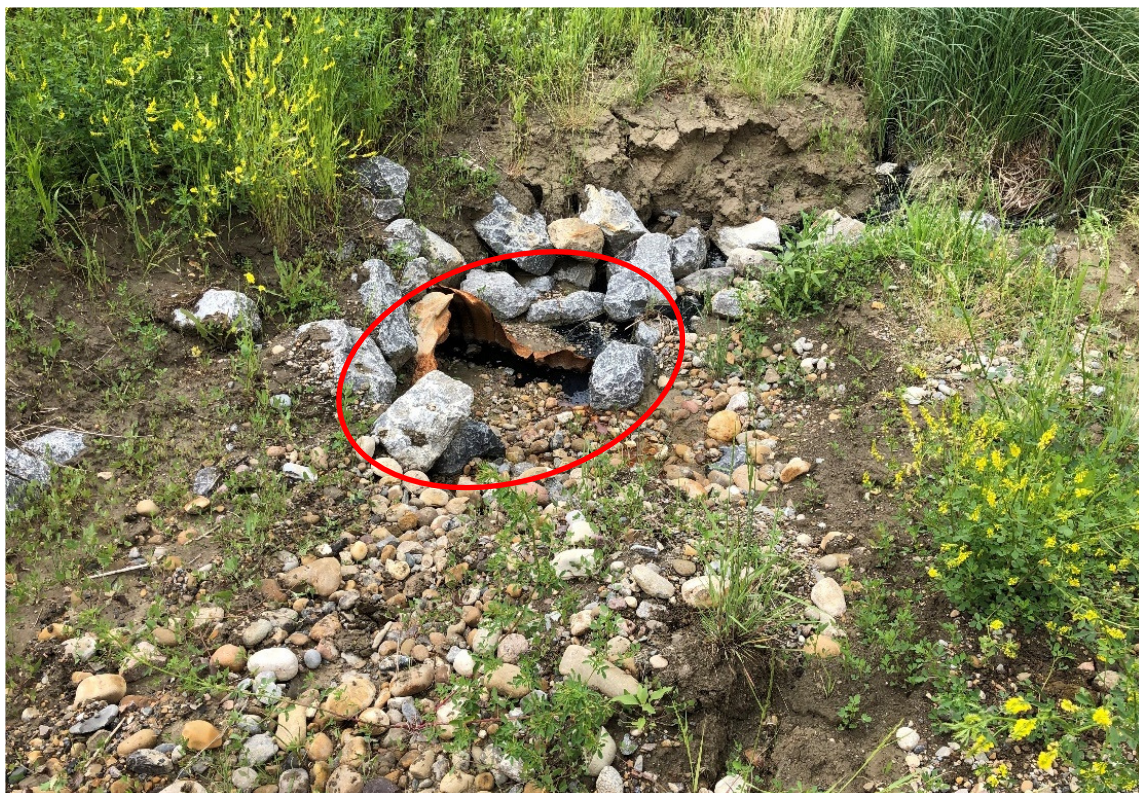
Photo 4 North side of highway – Culvert under highway remains blocked with sediment due to 2019 ditch block overtopping. Photo taken facing south on July 8, 2020.

The two CSP culverts at the toe of the north slope should be cleaned out and restored to full functionality to provide highway drainage, and to permit drainage from agricultural land north of the CP Rail line.

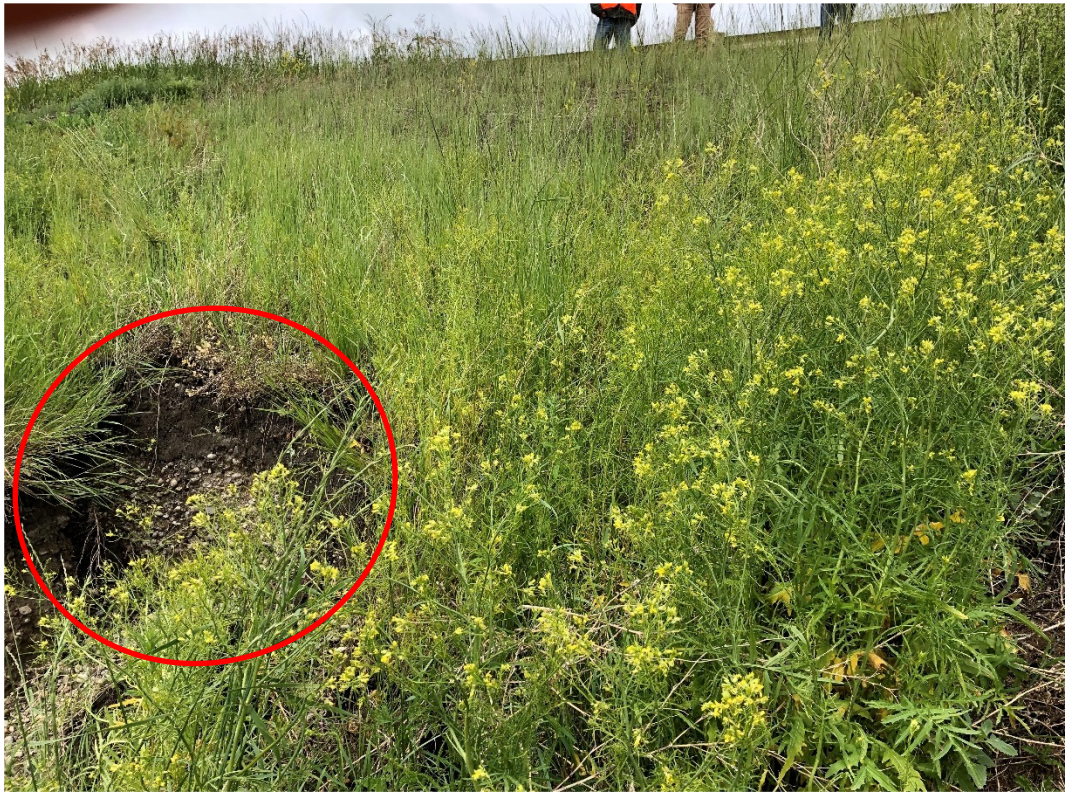
On the south side of the highway, the 2018 granular repair is starting to slough. It appears that surface runoff is contributing to ground saturation, and that the granular fill is acting as a preferential flow pathway. Granular backfill has failed at the toe of the repaired zone, near to the fence line. The head scarp of the sloughing is located 2.8 m upslope from the fence line and is approximately 2 m wide by 1 m high.

Tension cracking was noted midslope on the east and west sides of the repaired area, and ongoing retrogression of the failure is likely over time. The recently failed material is displacing the fence downslope. Vegetation growth on the slide repair has improved when compared to 2019 observations.

Photo 5 South side of highway – Recent failure at the toe of the repaired section (previously repaired in 2018). Photo taken facing north on July 8, 2020.

It is anticipated that the sloughing on the south side of the highway will retrogress over time, however due to the steepness of the embankment side slope and the height, non-anchored solutions are unlikely to be effective in the long-term.

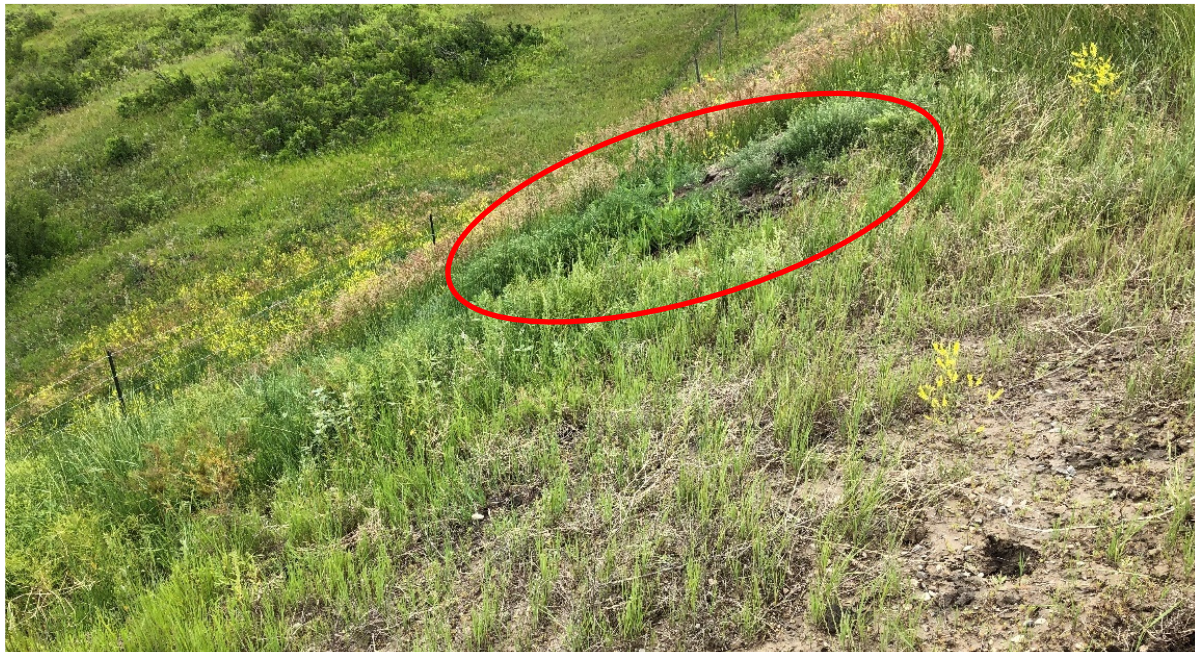
Photo 6 South side of highway – Recent failure at the toe of the repaired section (previously repaired in 2018). Photo taken facing south on July 8, 2020.

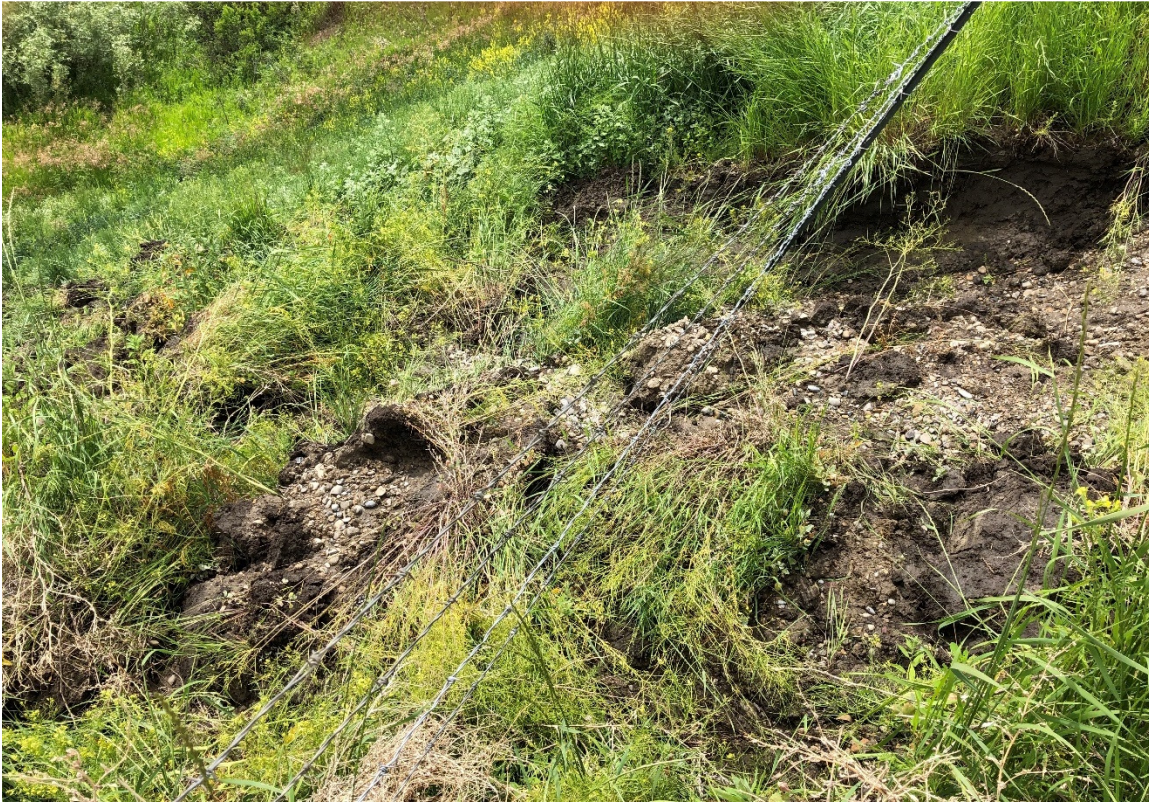
Photo 7 South side of highway – Failure of 2018 granular embankment repair adjacent to the fence line. Photo was taken facing west on July 8, 2020.
