SITE NUMBER AND NAME: S055 East of Gleichen		HIGHWAY & KM: 901X, 9.2 km east of 547	PREVIOUS INSPECTION DATE: July 8, 2020	INSPECTION DATE: July 7, 2021
LEGAL DESCRIPTION: 02-12-022-22 W4M	NAD 83 COORDINATES: UTM Northing Easting 12 5634864 364825		RISK ASSESSMENT Slide: PF: 9 CF: 2 TOTAL: 18 Erosion: PF: 5 CF: 2 TOTAL: 10	
AVERAGE ANNUAL DAILY TRAFFIC (AADT): 320 (west), (Ref. No. 109170)			CONTRACTOR MAINTENANCE AREA (CMA): 30

PRIMARY SITE ISSUE: A runoff erosion gully on the north side of the highway and slope instability on the south side. Repair activities were completed in 2018, however the slope drain became blocked in spring 2019 due to grass buildup on the fine mesh screen (aperture size of 15 mm) fitted to the pipe inlet, leading to overtopping of the ditch block and erosion of the repaired surfaces. The erosion gully and slope drain on the north side were repaired in late 2019, including replacement of the inlet trash rack.

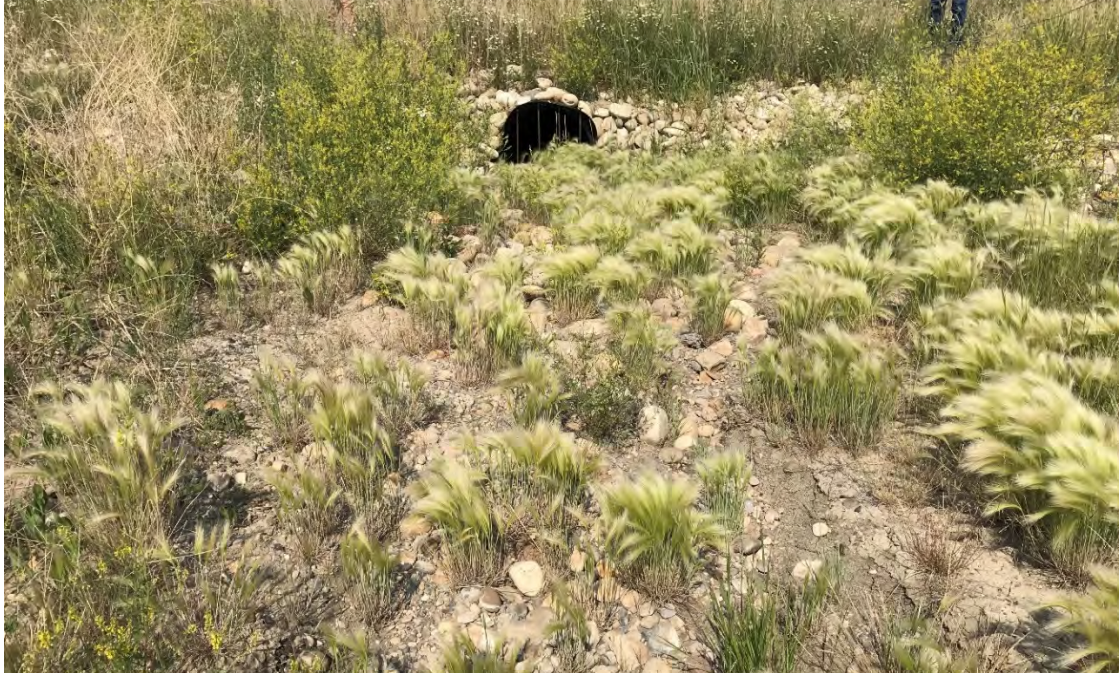
Photo 1 North side of highway – Reinstated ditch block at slope drain inlet. Photo taken facing west on July 7, 2021.

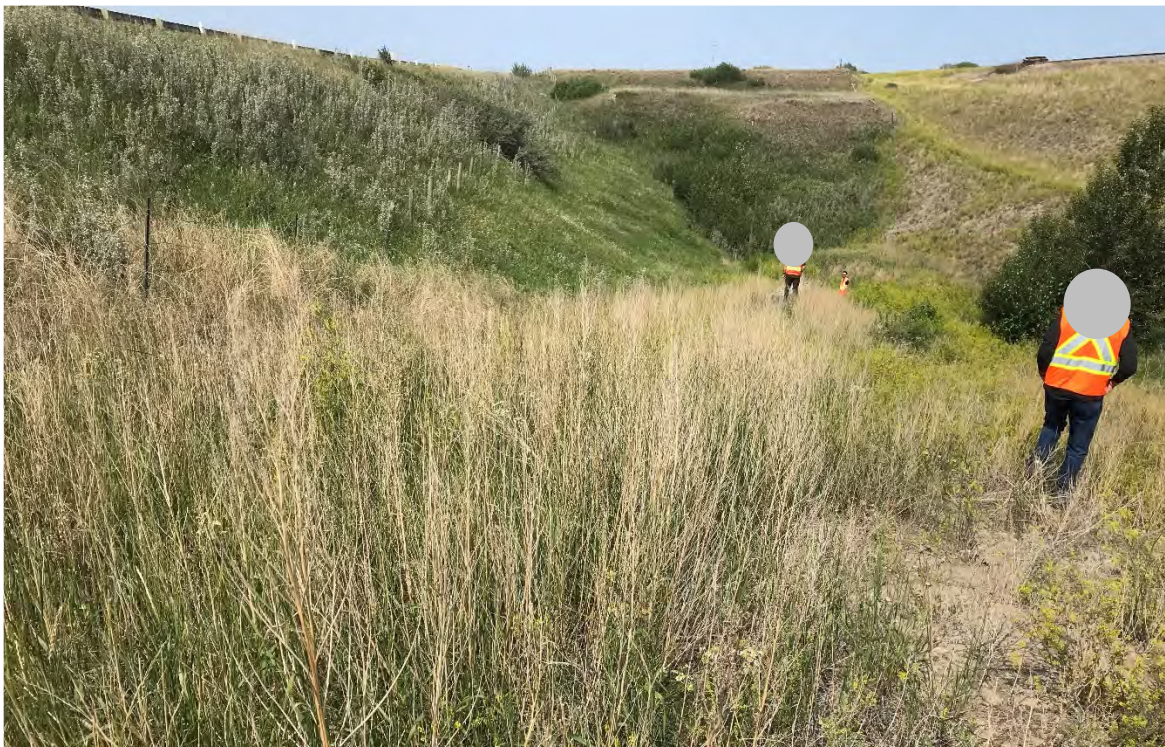
Photo 2 North side of highway – View west from upper part of slope drain towards outlet. Photo taken facing west on July 7, 2021.

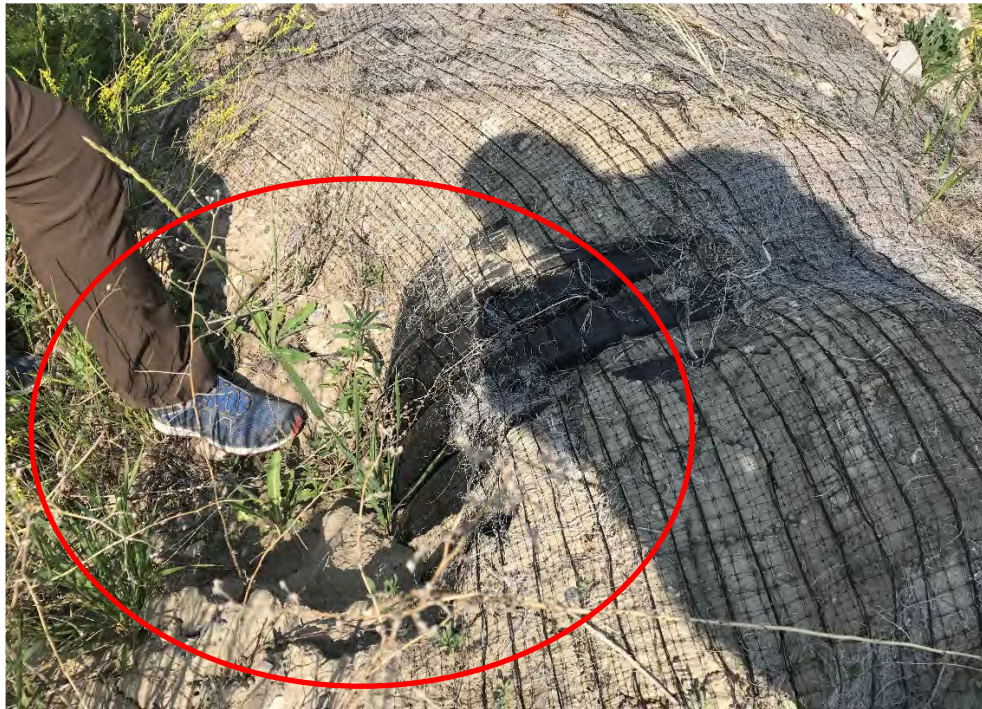
COMMENTS
<p>Construction was carried out in winter 2018 to repair an erosion gully and slope instability. The slope drain installed north of the highway became obstructed in spring 2019 leading to erosion and undermining of the HDPE pipe. The MC completed slope drain repairs in late 2019.</p>
<p><u>North Side of Highway</u></p> <p>Vegetation is well established across large portions of the repair. Erosion rills 5 to 50 mm deep were noted where vegetation coverage is poor. The lower portion of the slope drain is covered with straw matting to promote vegetation growth, and the outlet is covered with riprap (150 mm minus) to minimize deflection during outflows.</p> <p>During the 2021 site visit the ditch was dry. Localized ditch erosion upstream of the slope drain inlet was visible. Erosion rills were up to 100 mm deep and 0.5 m wide.</p> <p>In 2020 it was estimated that outflows from the HDPE slope drain were less than flow in the ditch, possibly due to leakage. Site observations in 2021 noted that the final joint at the downstream end of the HDPE pipe had separated, leading to leakage at the joint, minor erosion of riprap, and settlement of the geotextile on the south side of the pipe.</p> <p>The v-ditch from the slope drain outlet has been partially eroded but is still functional. A steel culvert beneath the highway at the toe of the embankment remains infilled with sediment as a result of the spring 2019 ditch block overtopping. The sediment plug restricts flows to the south, which also impedes flow from the CSP culvert under the CP Rail line.</p>

Photo 3 North side of highway – Localized erosion due to separation of HDPE pipe joint in lower portion of slope drain. Photo taken July 7, 2021.

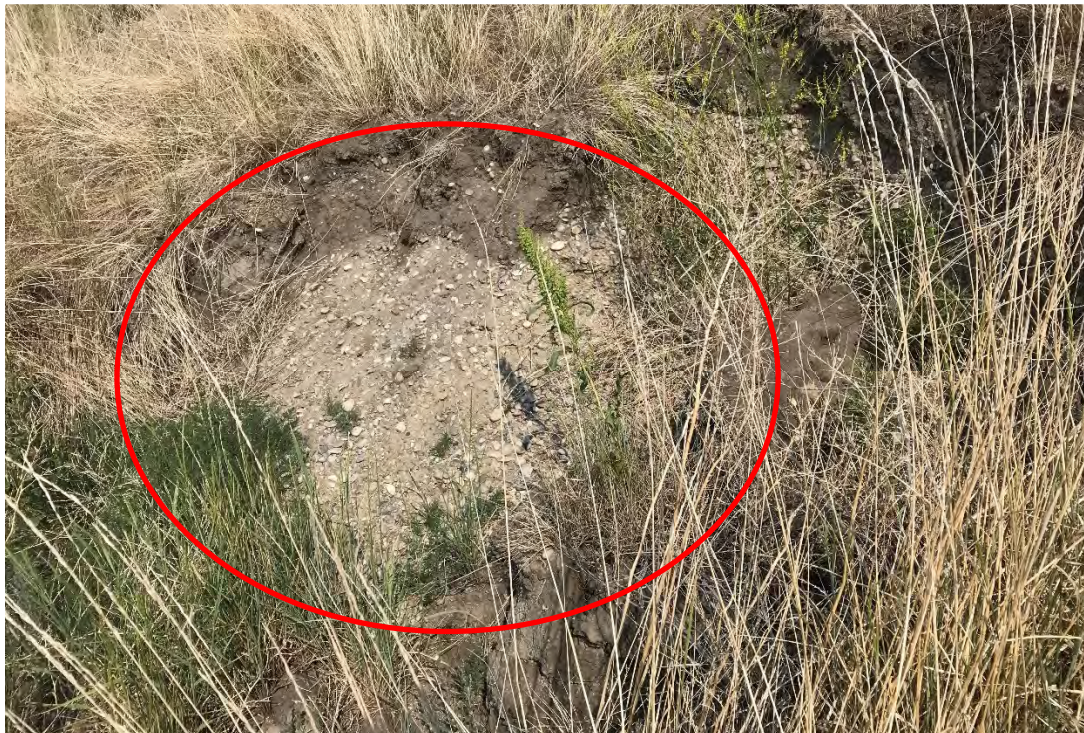
<p><u>South Side of Highway</u></p> <p>On the south side of the highway, sloughing of the 2018 granular repair continues. It appears that surface runoff or seepage is contributing to ground saturation, and that the granular fill is acting as a preferential flow pathway. Granular backfill has failed at the toe of the repaired zone, near to the fence line. The head scarp of the sloughing is located 2.8 m upslope from the fence line and is approximately 2.3 m wide by 1 m high.</p> <p>Tension cracking was noted midslope on the east and west flanks of the repaired area during the 2020 inspection, and ongoing retrogression of the failure is likely over time. The failed material is displacing the fence downslope. Vegetation coverage has not changed significantly when compared to 2020 observations.</p>
<p>Recommendations:</p> <ul style="list-style-type: none"> • North side: Clean out the two CSP culverts at the toe of the slope and restore full functionality to provide highway drainage, and to permit drainage from agricultural land north of the CP Rail line. • North side: Monitor leakage due to separated slope drain joint. • North side: Install geofabric at the inlet to the slope drain to direct all ditch flow into the HDPE pipe. A custom “boot” is recommended around the HDPE pipe to provide a full seal around the pipe. • South side: Improve highway drainage, construct a berm or regrade the highway surface to avoid runoff concentrating at the 2018 repair location (which represents a low point on the south side of the highway). • South side: Monitor sloughing at the location of the 2018 repair, and adjacent areas of sloughing which are visible but were not a part of the 2018 repair. The embankment on the south side of the highway is steep and future slope stabilization may be required. Due to the steepness, active ground anchoring solutions should be considered.

Photo 4 South side of highway – Visible granular fill and displaced vegetation near fence line due to washout of a portion of the repaired section. Photo taken on July 7, 2021.

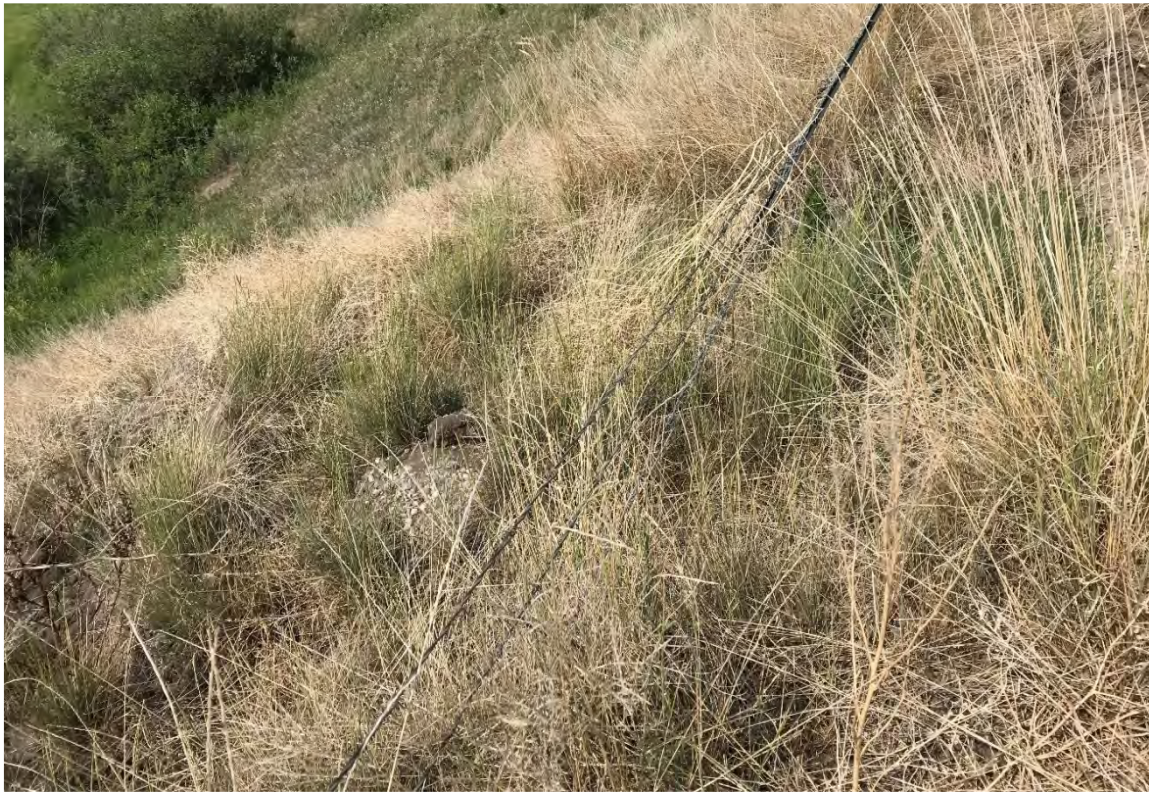
Photo 5 South side of highway – Displaced mid slope fence line due to failure of 2018 granular embankment repair. Photo was taken facing west on July 7, 2021.
