SITE NUMBER AND NAME: <b>S055 East of Gleichen</b>		HIGHWAY & KM: 901X, 9.2 km east of 547	PREVIOUS INSPECTION DATE: July 7, 2021	INSPECTION DATE: <b>May 12, 2023</b>
LEGAL DESCRIPTION: 02-12-022-22 W4M	NAD 83 COORDINATES: UTM Northing Easting 12 5634864 364825		RISK ASSESSMENT Slide: PF: 9 CF: 2 TOTAL: 18 Erosion: PF: 5 CF: 2 TOTAL: 10	
AVERAGE ANNUAL DAILY TRAFFIC (AADT): 300 (west), (Ref. No. 109170)			CONTRACTOR MAINTENANCE AREA (CMA): 30

**PRIMARY SITE ISSUE:** A runoff erosion gully on the north side of the highway and slope instability on the south side. Repair activities were completed in 2018, however the slope drain became blocked in spring 2019 due to grass buildup on the fine mesh screen (aperture size of 15 mm) fitted to the pipe inlet, leading to overtopping of the ditch block and erosion of the repaired surfaces. The erosion gully and slope drain on the north side were repaired in late 2019, including replacement of the inlet trash rack.

PROJECT  
SOUTHERN REGION GEOHAZARD RISK MANAGEMENT PROGRAM

TITLE  
Site Plan  
S055 - East of Gleichen Slide  
Hwy 1:14, km 40.353

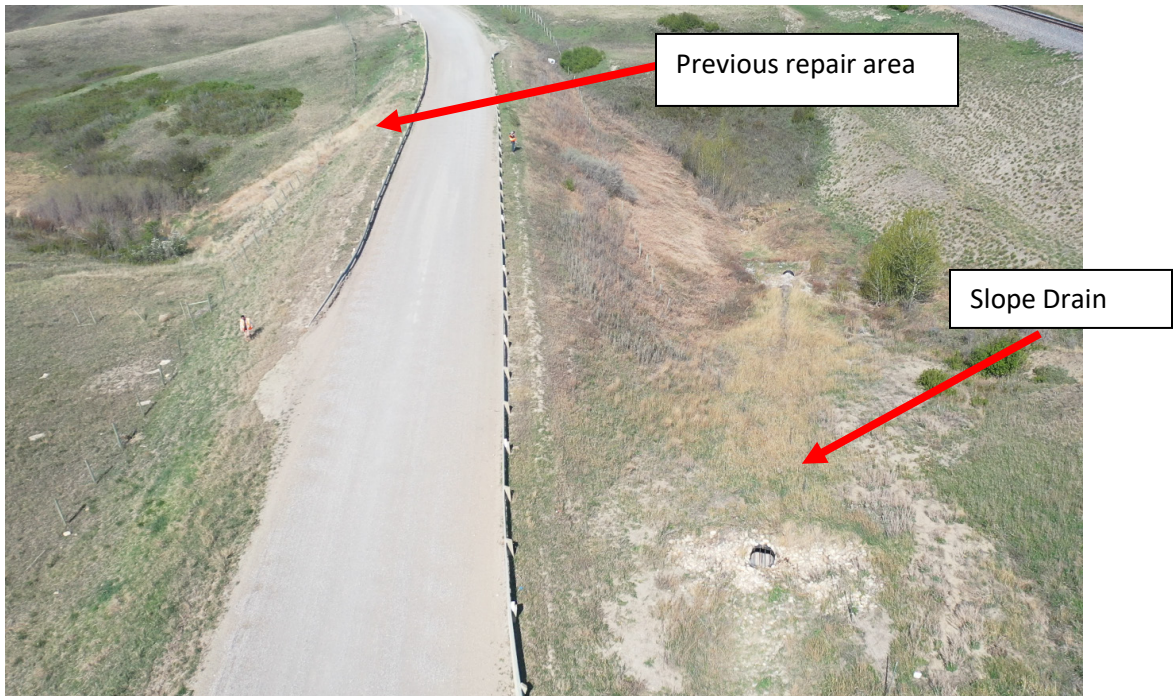
**Photo 1** Overview of the site. Photo taken facing west on May 12, 2023.

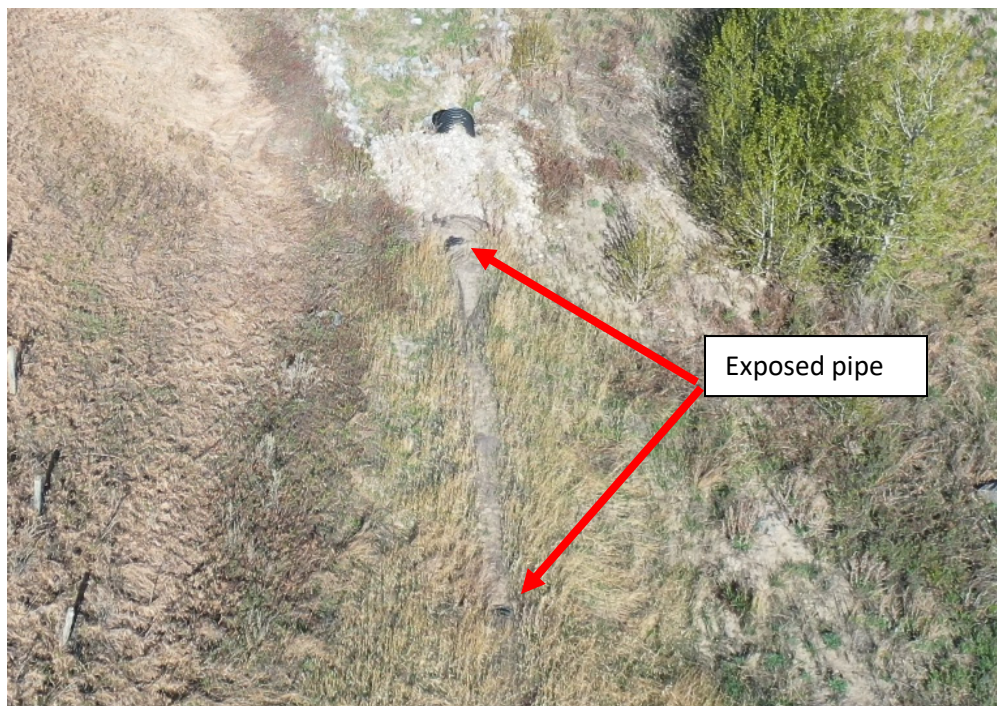
In 2020 it was estimated that outflows from the HDPE slope drain were less than flow in the ditch, possibly due to leakage. Site observations in 2021 noted that the final joint at the downstream end of the HDPE pipe had separated, leading to leakage at the joint, minor erosion of riprap, and settlement of the geotextile on the south side of the pipe. There was no change observed in the 2023 inspection based on the drone video.

**Photo 2** North side of highway – slope drain. Note exposed pipe at two locations. Photo taken facing west on May 12, 2023.

- North side: Monitor leakage due to separated slope drain joint.
- North side: Install geofabric at the inlet to the slope drain to direct all ditch flow into the HDPE pipe. A custom “boot” is recommended around the HDPE pipe to provide a full seal around the pipe.

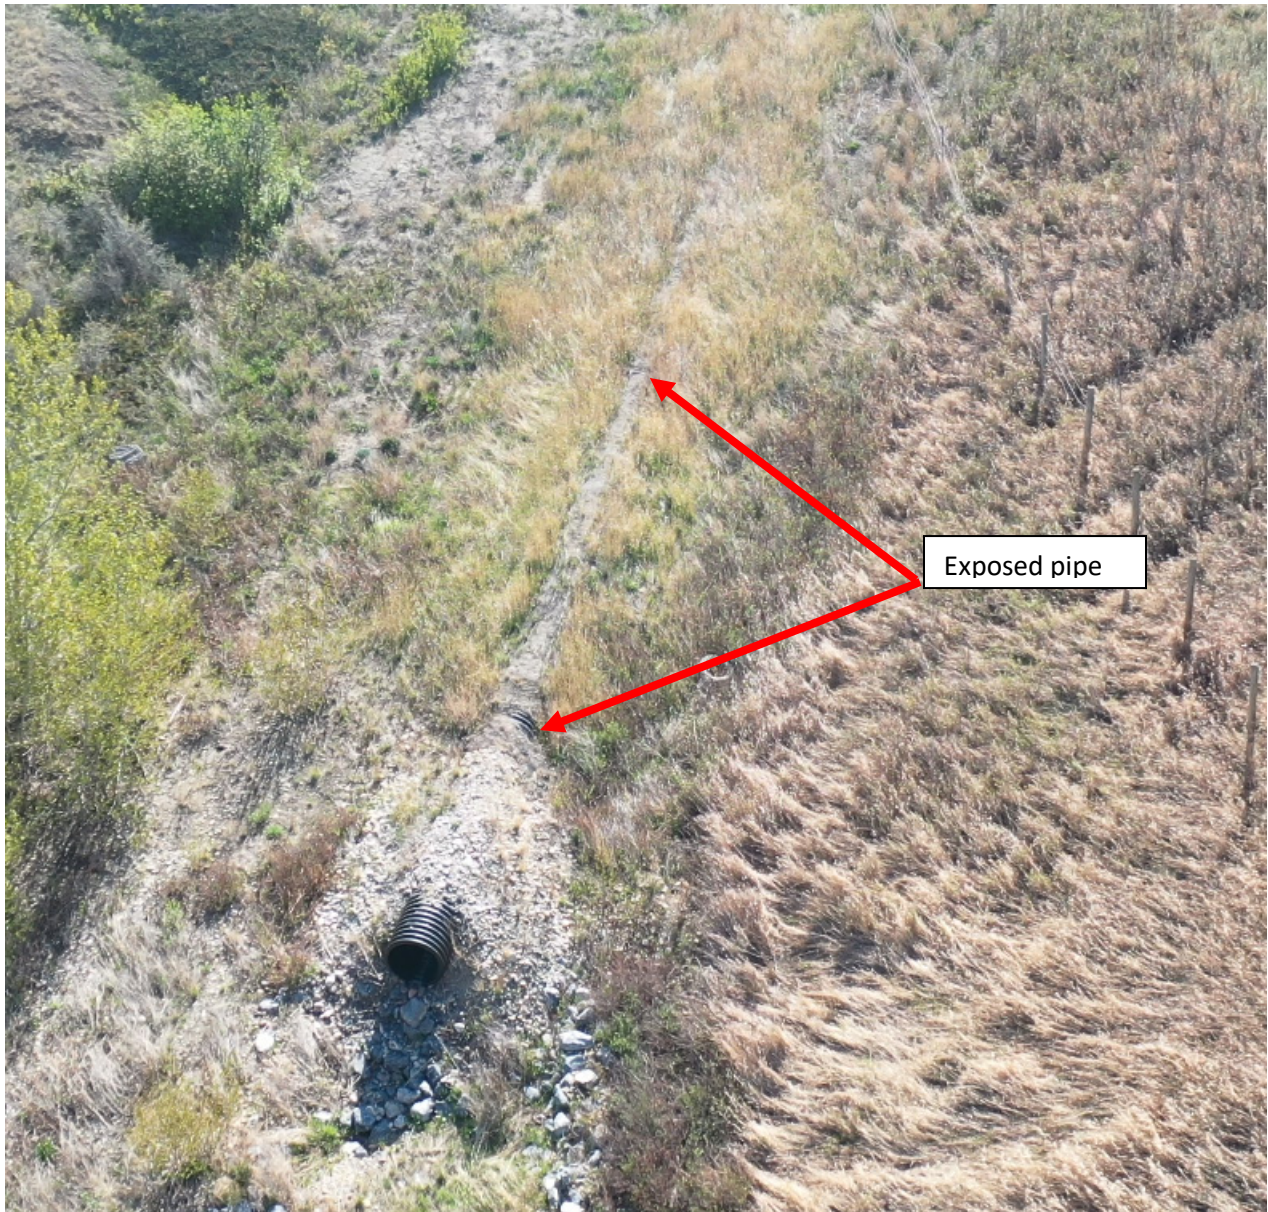
**Photo 3** North side of highway – slope drain. Note exposed pipe at two locations. Photo taken facing east on May 12, 2023.

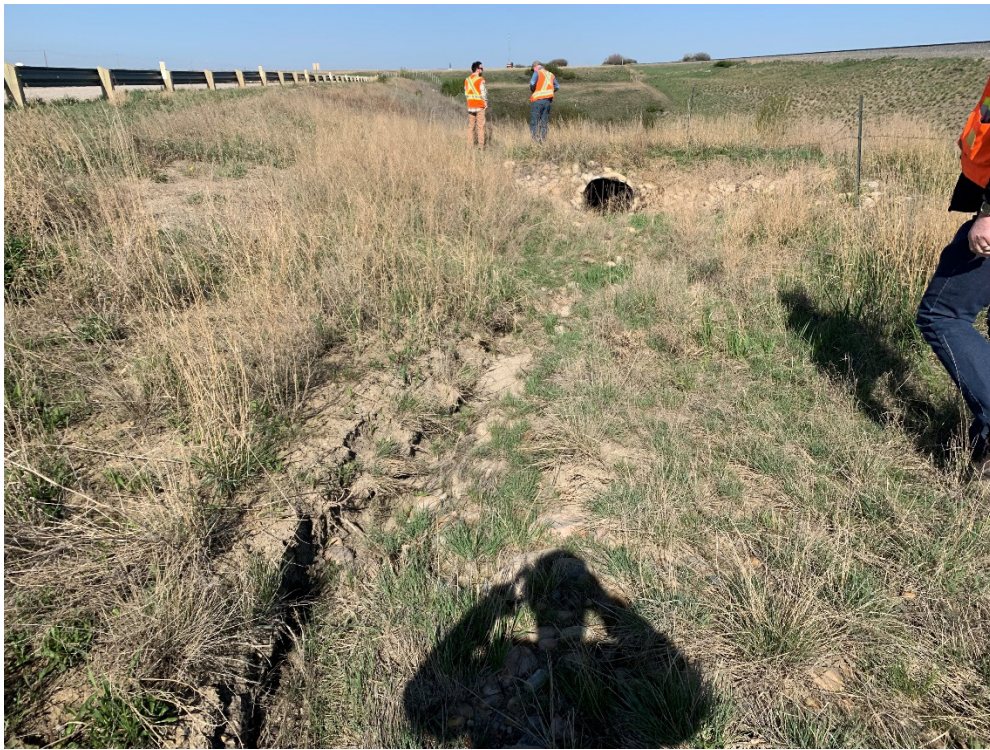
During the 2023 site visit the ditch was dry. Localized ditch erosion upstream of the slope drain inlet was visible. Erosion rills were up to 150 mm deep and 0.5 m wide.

**Photo 4** North side of highway – Ditch erosion and slope drain inlet. Photo taken facing west on May 12, 2023.

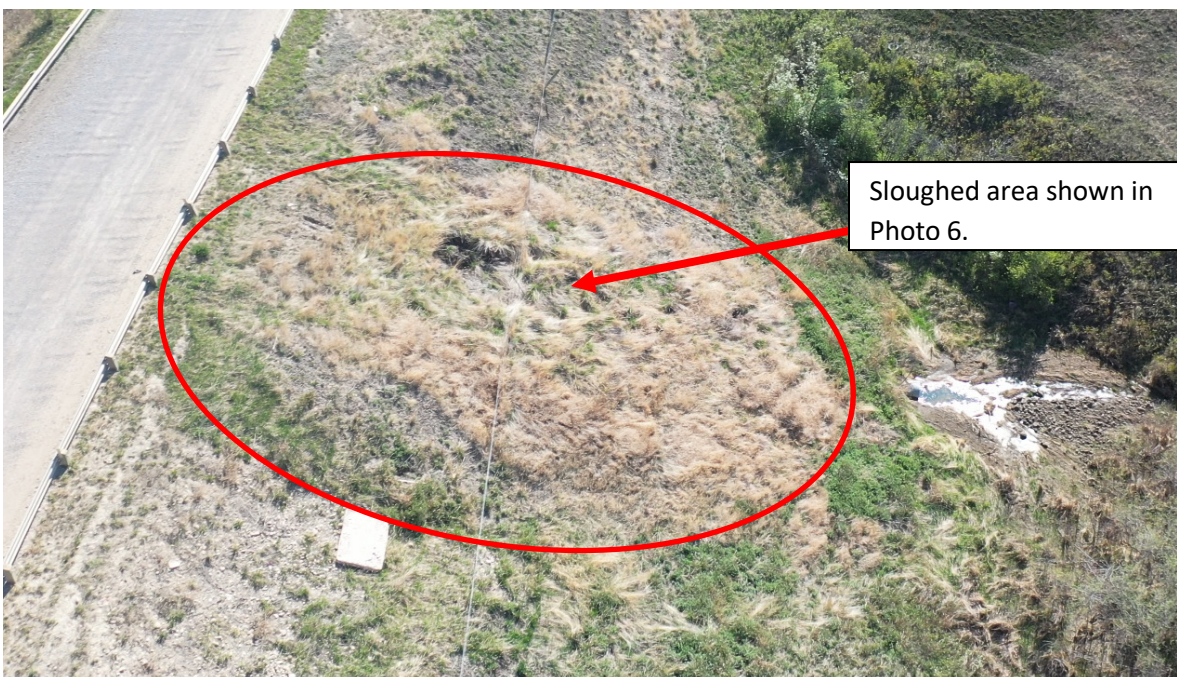
On the south side of the highway, sloughing of the 2018 granular repair continues. It appears that surface runoff is contributing to ground saturation, and that the granular fill is acting as a preferential flow pathway. Granular backfill has failed at the toe of the repaired zone, near to the fence line. The head scarp of the sloughing is located 2.8 m upslope from the fence line and is approximately 2.5 m wide by 1 m high.

Tension cracking was noted midslope on the east and west flanks of the repaired area during the 2020 inspection, minimal change was noted during the 2023 inspection. The failed material is displacing the fence downslope. Vegetation coverage has not changed significantly when compared to 2021 observations.

**Photo 5** South side of highway – Slope failure at repair area. Red circle notes previous repair area. Photo taken facing east on May 12, 2023.

- South side: Improve highway drainage, construct a berm or regrade the highway surface to avoid runoff concentrating at the 2018 repair location (which represents a low point on the south side of the highway).

- South side: Monitor sloughing at the location of the 2018 repair, and adjacent areas of sloughing which are visible but were not a part of the 2018 repair. The embankment on the south side of the highway is steep and future slope stabilization may be required. Due to the steepness, active ground anchoring solutions should be considered.

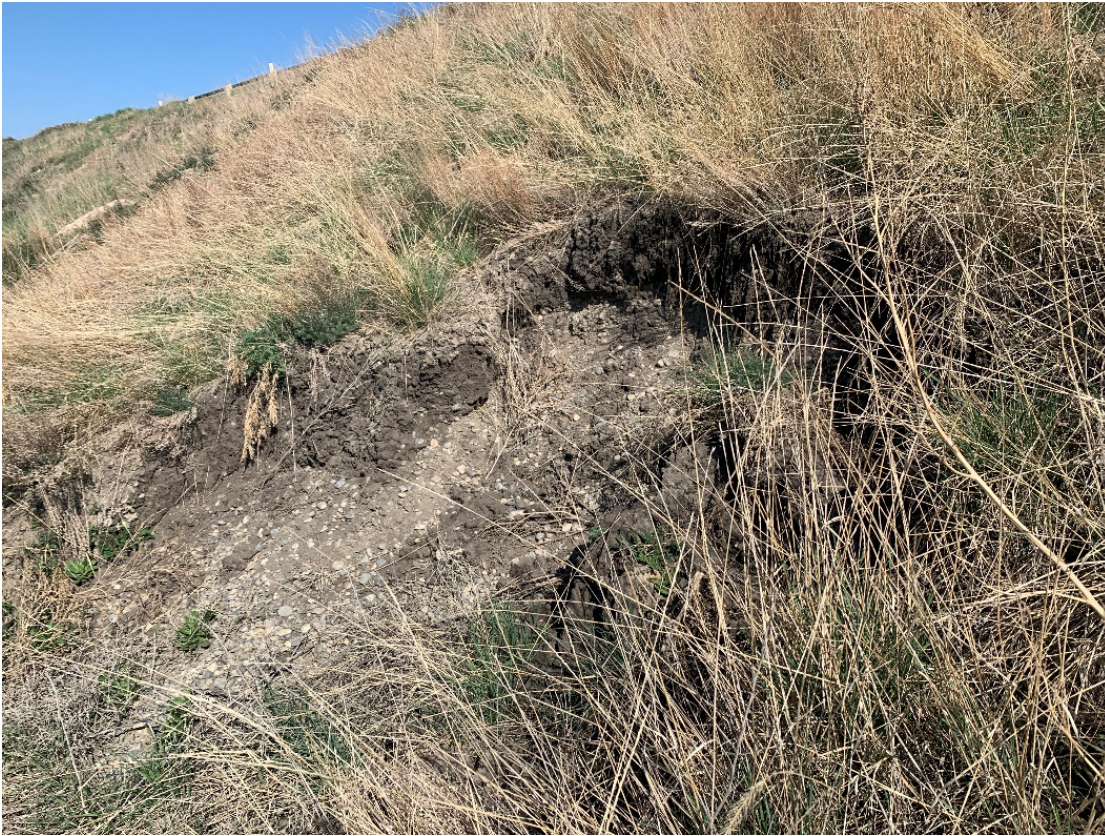
**Photo 6** South side of highway – Visible granular fill and displaced vegetation near fence line of the repaired section. Photo taken facing west on May 12, 2023.
