SITE NUMBER AND NAME: <b>S032 Crowfoot Ferry</b>		HIGHWAY & KM: <b>H56</b>	PREVIOUS INSPECTION DATE: May 8, 2019	INSPECTION DATE: <b>July 15, 2020</b>
LEGAL DESCRIPTION: 10/14/15-24-021-20 W4M	NAD 83 COORDINATES: UTM Northing Easting 12 5629086 383958		RISK ASSESMENT: PF: 13 CF: 4 TOTAL: 52	
AVERAGE ANNUAL DAILY TRAFFIC (AADT): 60 (south) (Ref. No. 110170)			CONTRACTOR MAINTENANCE AREA (CMA): 30

SUMMARY OF SITE INSTRUMENTATION:  None  LAST READING DATE: N/A	INSPECTED BY: Justin Corbiell (AT)
PRIMARY SITE ISSUE: River erosion and slope instability along east bank of the Bow River retrogressing towards north access road to Crowfoot Ferry (BF 13129).	
APPROXIMATE DIMENSIONS: Landslide estimated as approximately 350 m long. Slope is approximately 15 m high and slope of failure surface is approximately 5H to 6H:1V. The backscarp is 3.6 m from the edge of highway.	
DATE OF ANY REMEDIAL ACTION: Ferry infrastructure was replaced to make the ferry operational, but no repairs to the river bank slide were carried out.

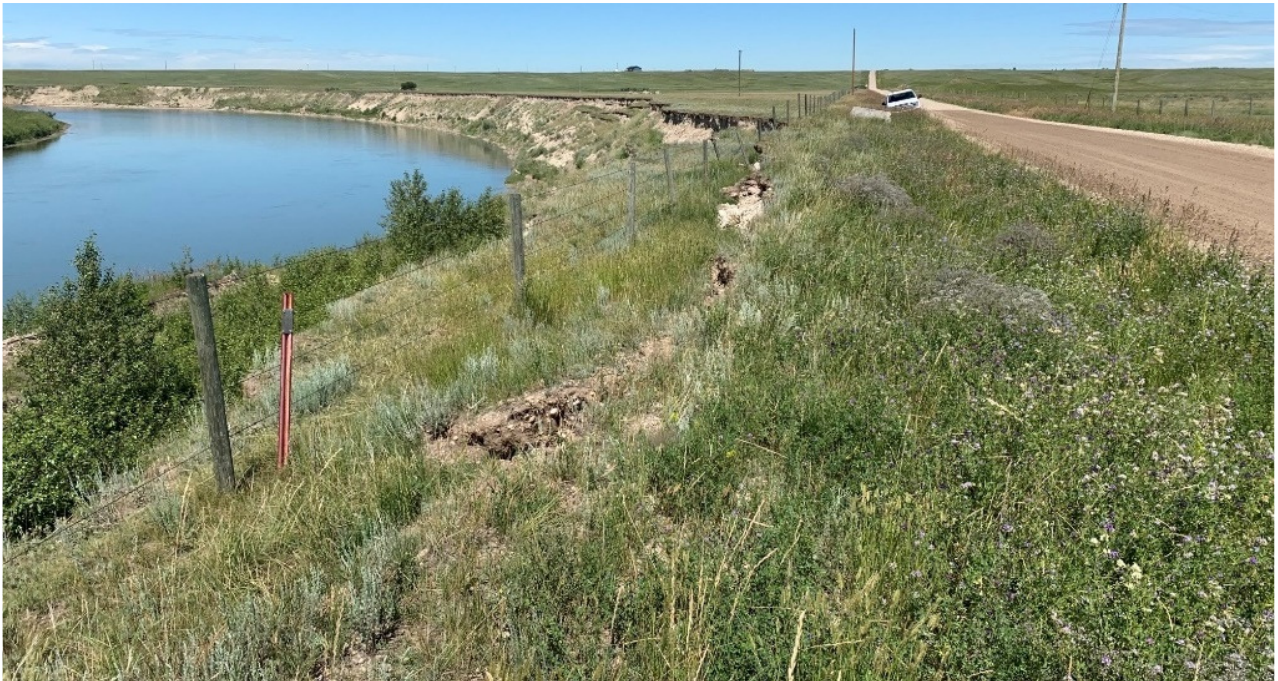
**Photo 1** Retrogressing river bank slide north of the Crowfoot Ferry. Photo was taken facing north from south end of slide on July 15, 2020.

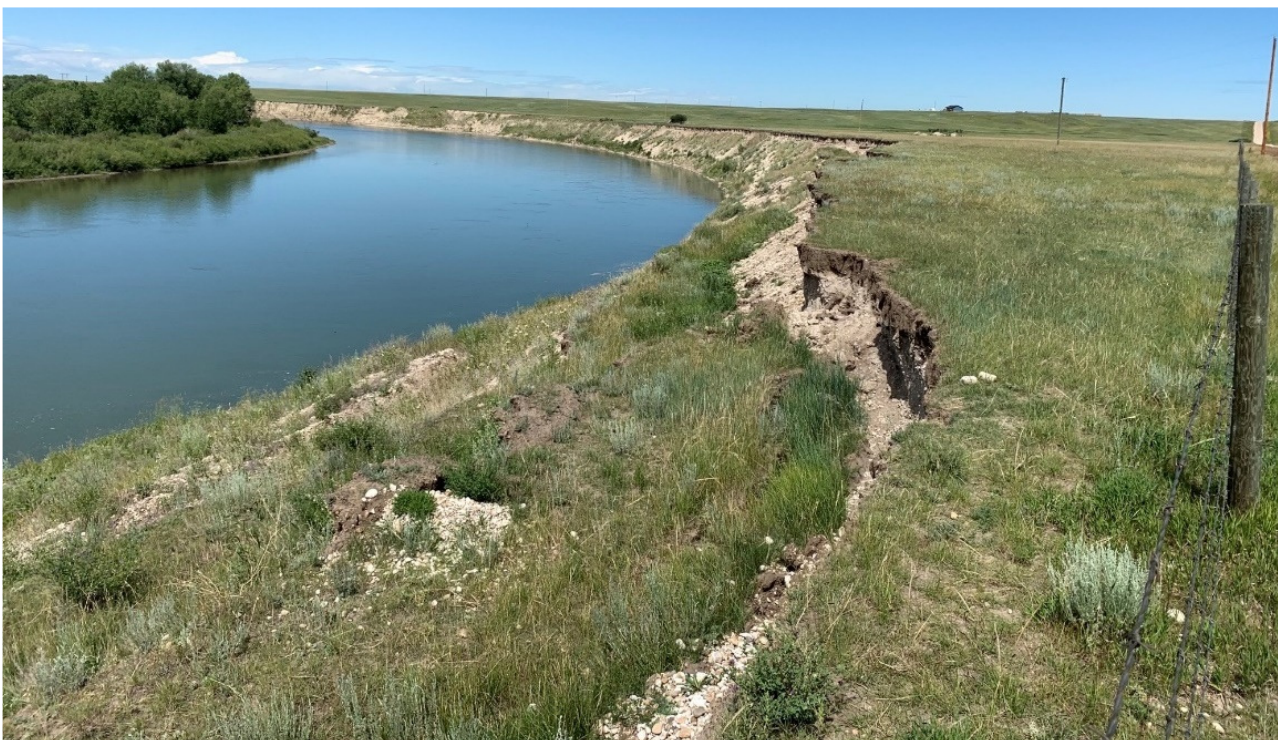
**Photo 2** Tension cracking at the north end of the slide. Photo taken facing north on July 15, 2020.

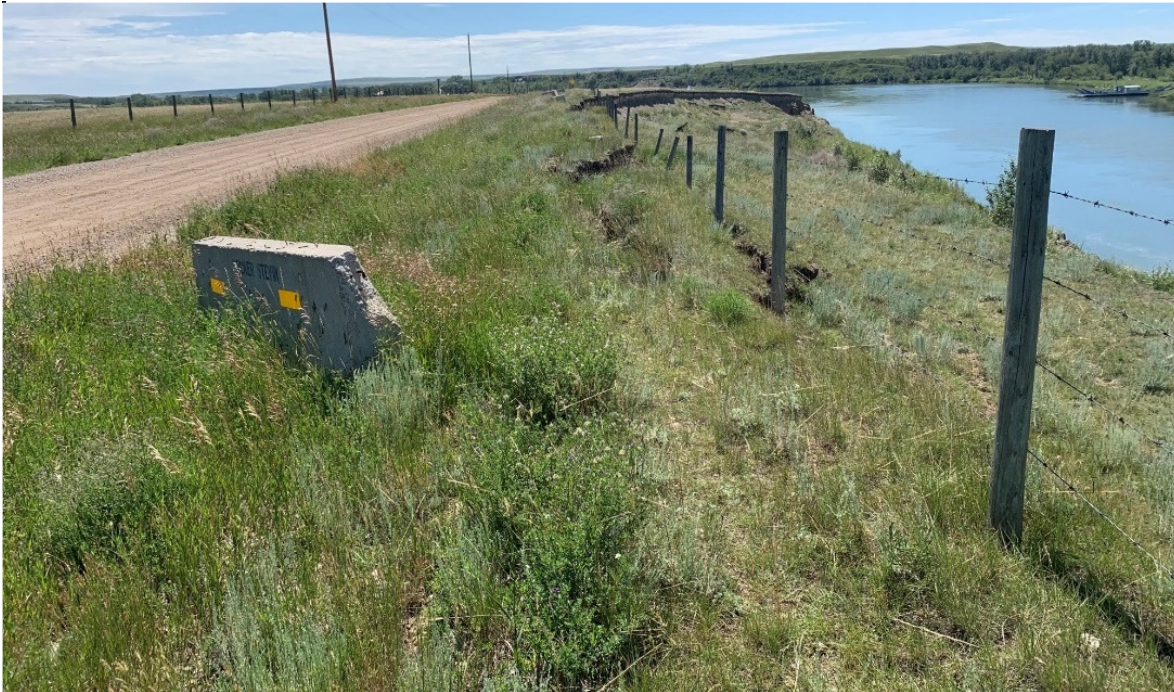
**Photo 3** Tension cracking and fence undermining adjacent to the highway. Photo was taken midway along the slide facing south on July 15, 2020.

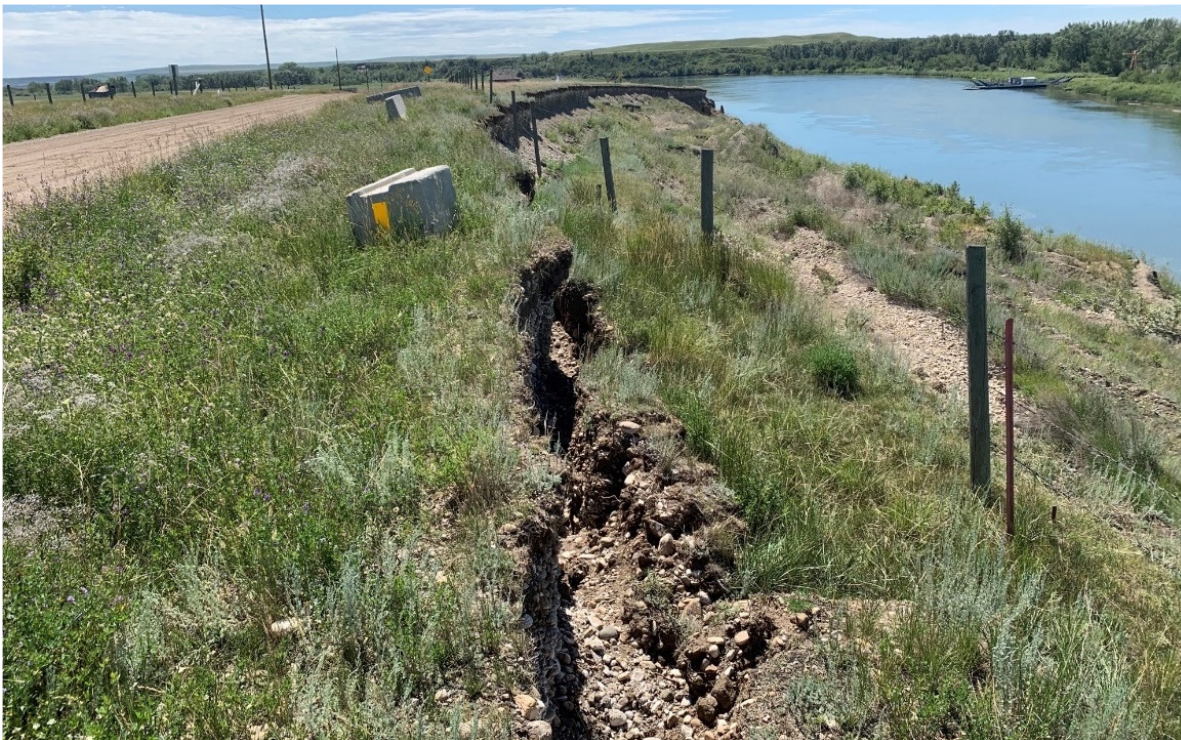
**Photo 4** Six fence posts undermined by sliding. Photo taken near south end of slide facing south on July 15, 2020.
