SITE NUMBER AND NAME: <b>S032 Crowfoot Ferry</b>		HIGHWAY & KM: 1:14, 60.855	PREVIOUS INSPECTION DATE: May 18, 2022	INSPECTION DATE: <b>May 29, 2024</b>
LEGAL DESCRIPTION: 10-24-21-20 W4M 14-24-21-20 W4M 15-24-21-20 W4M	NAD 83 COORDINATES: UTM Northing Easting 12 5629086 383958		RISK ASSESMENT: PF: 9 CF: 3 TOTAL: 27	
AVERAGE ANNUAL DAILY TRAFFIC (AADT): 60 (south) (Reference No. 110170)			CONTRACTOR MAINTENANCE AREA (CMA): 30

PROJECT  
 SOUTHERN REGION GEOHAZARD RISK MANAGEMENT PROGRAM

TITLE  
 Site Plan  
 S032 - Crowfoot Ferry (BF 13129)  
 Hwy 1:14, km 60.855

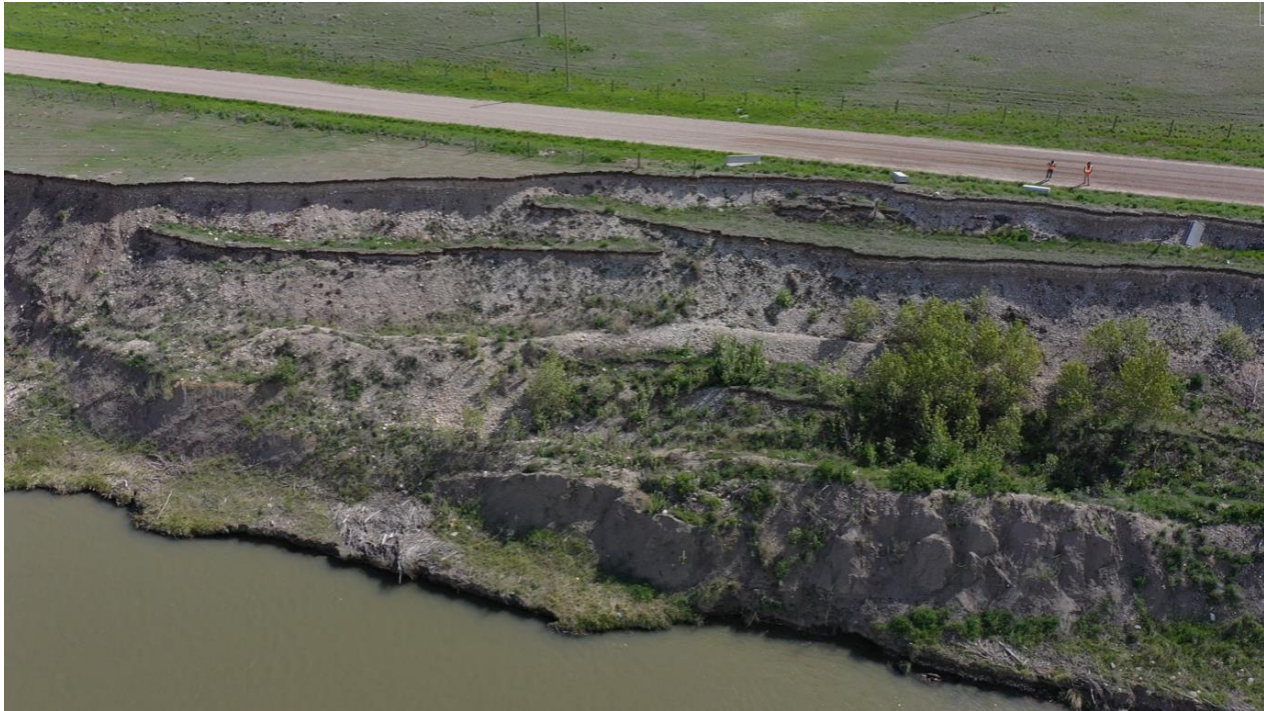
**Photo 1** North end of slide area near road. Photo taken facing east on May 29, 2024, facing east.

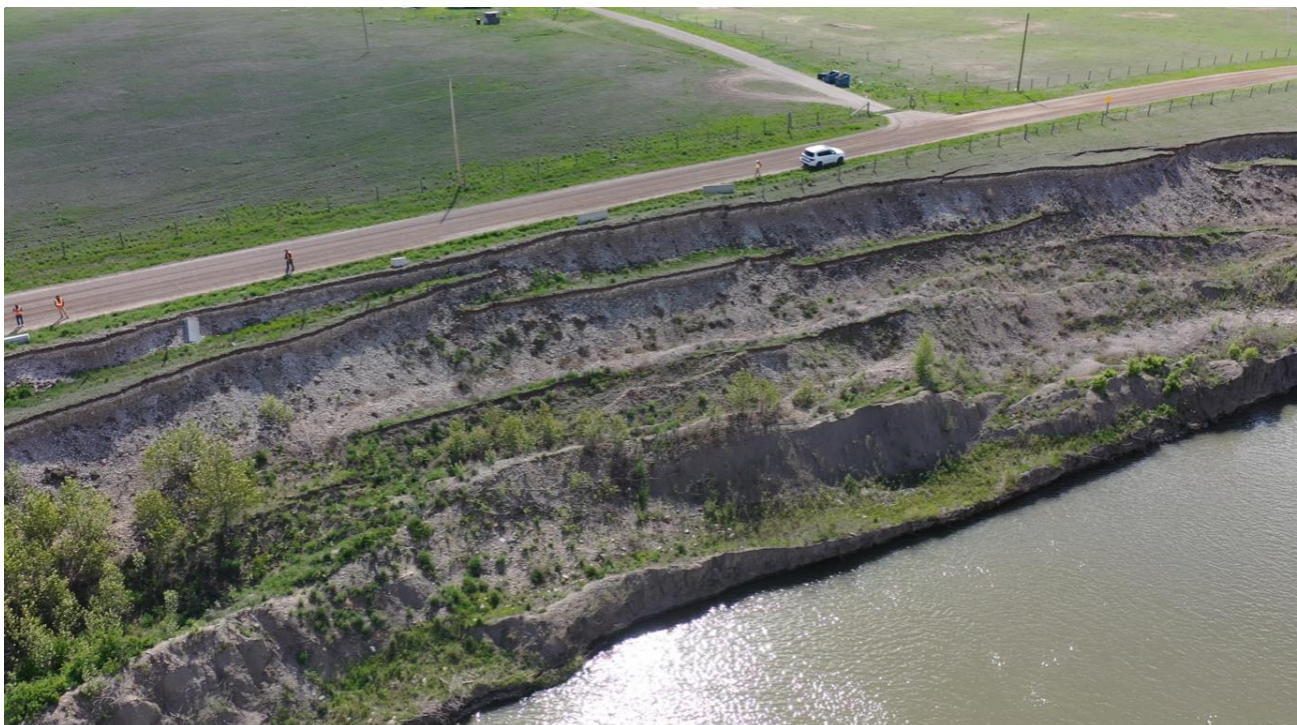
**Photo 2** Middle of slide area. Photo taken facing east on May 29, 2024, facing east.

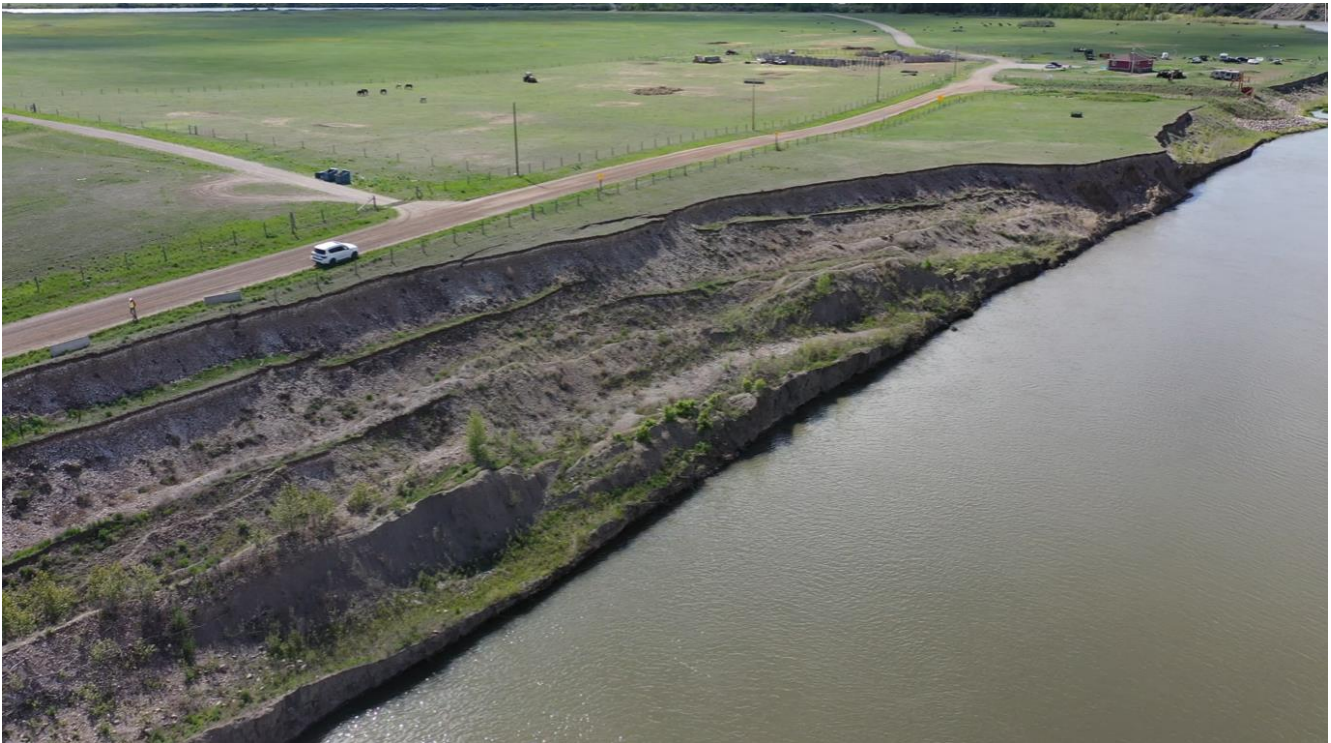
**Photo 3** South end of slide area. Photo taken facing east on May 29, 2024, facing southeast.

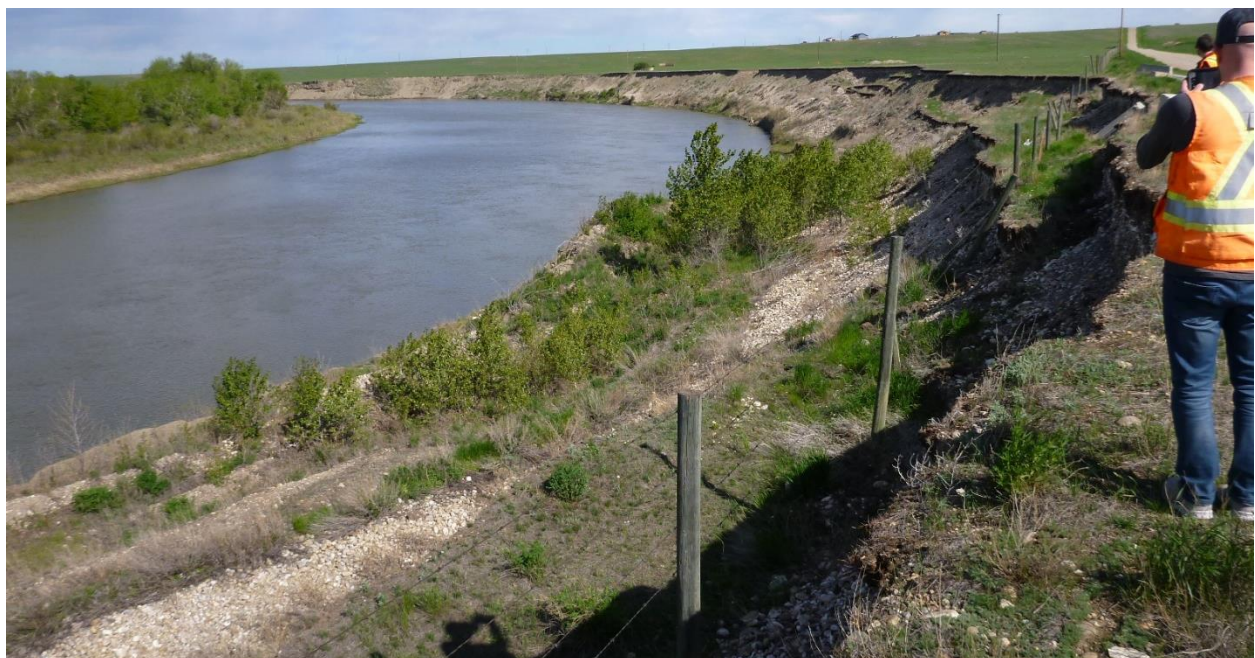
The head scarp of the slide is approximately 3 m to 4 m from the west edge of the highway. The head scarp has not retrogressed significantly between the 2022 and 2024 inspections.

Tension cracks up to 1 m in depth have been observed at the head of the slide.

**Photo 4** The head of the slide is retrogressing towards the highway and is approximately 350 m in length. The head scarp is actively eroding, and material has fallen between the 2022 and 2024 inspections. Photo taken May 29, 2024, facing north.

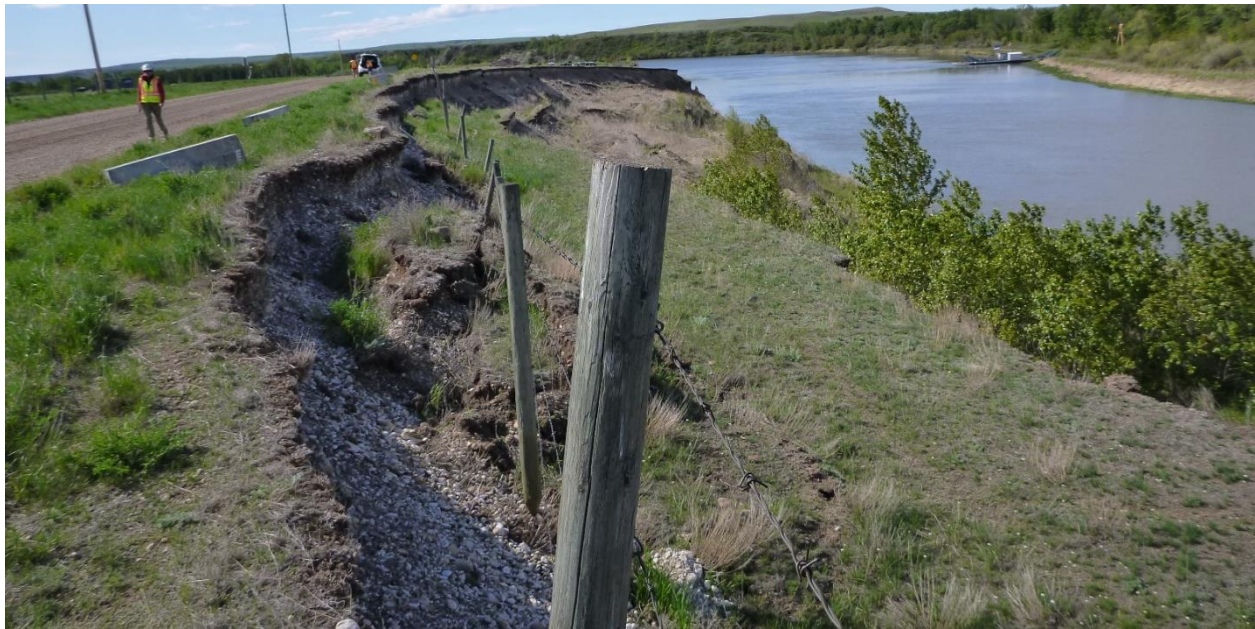
Several concrete lock blocks have been placed adjacent to the highway to keep pedestrians and horseback riders away from the tension cracks. One of the concrete blocks has fallen into the slide area due to slope movement.

**Photo 5** Concrete barriers have been placed along the length of the slide between the head scarp and the highway. Photo taken May 29, 2024, facing southwest.
