SITE NUMBER AND NAME: S032 Crowfoot Ferry		HIGHWAY & KM: 1:14, 60.855	PREVIOUS INSPECTION DATE: July 15, 2020	INSPECTION DATE: May 18, 2022
LEGAL DESCRIPTION: 10-24-21-20 W4M 14-24-21-20 W4M 15-24-21-20 W4M	NAD 83 COORDINATES: UTM Northing Easting 12 5629086 383958		RISK ASSESMENT: PF: 9 CF: 3 TOTAL: 27	
AVERAGE ANNUAL DAILY TRAFFIC (AADT): 60 (south) (Reference No. 110170)			CONTRACTOR MAINTENANCE AREA (CMA): 30

PROJECT SOUTHERN REGION GEOHAZARD RISK MANAGEMENT PROGRAM		
TITLE Site Plan S032 - Crowfoot Ferry (BF 13129) Hwy 1:14, km 60.855		
SCALE 1:4,500	PROJECT No. A05116A03	FIG No. 1

Inspection Photographs

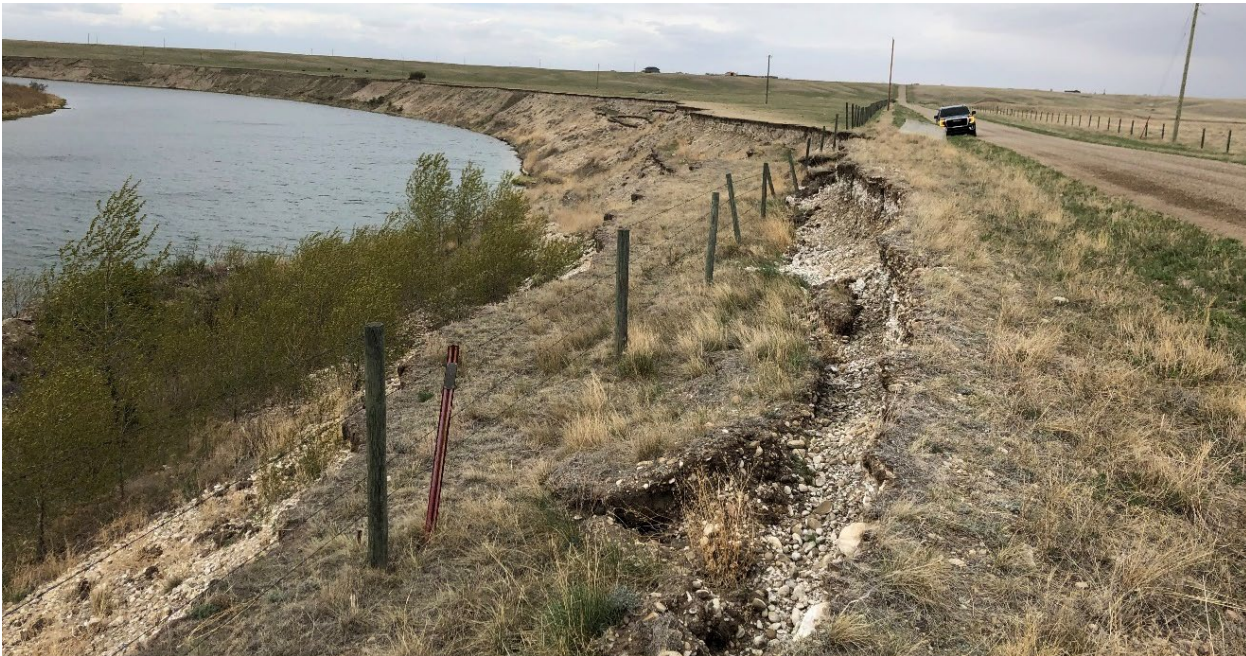
The slide is approximately 350 m long and is impacting approximately 75 m of a private fence. There was a large increase in the number of hanging fence posts between the 2020 and 2022 inspection (increase from six to seventeen) (Photo 1 and 3).

- Photo 1** The head of the slide is retrogressing towards the highway and is approximately 350 m in length. The head scarp is actively eroding, and material has fallen between the 2020 and 2022 inspections. Photo taken May 18, 2022, facing north.

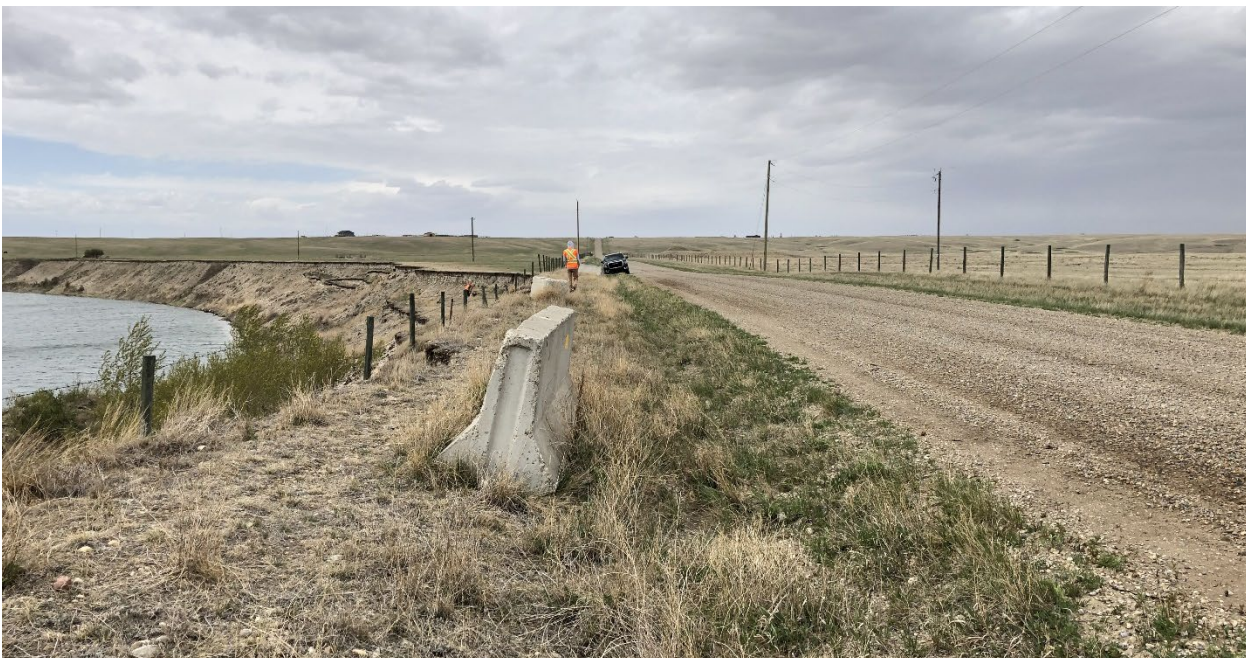
Several concrete lock blocks have been placed adjacent to the highway to keep pedestrians and horseback riders away from the tension cracks (Photo 2).

- Photo 2** Several concrete lock blocks have been placed along the length of the slide between the head scarp and the highway. Photo taken May 18, 2022, facing north.

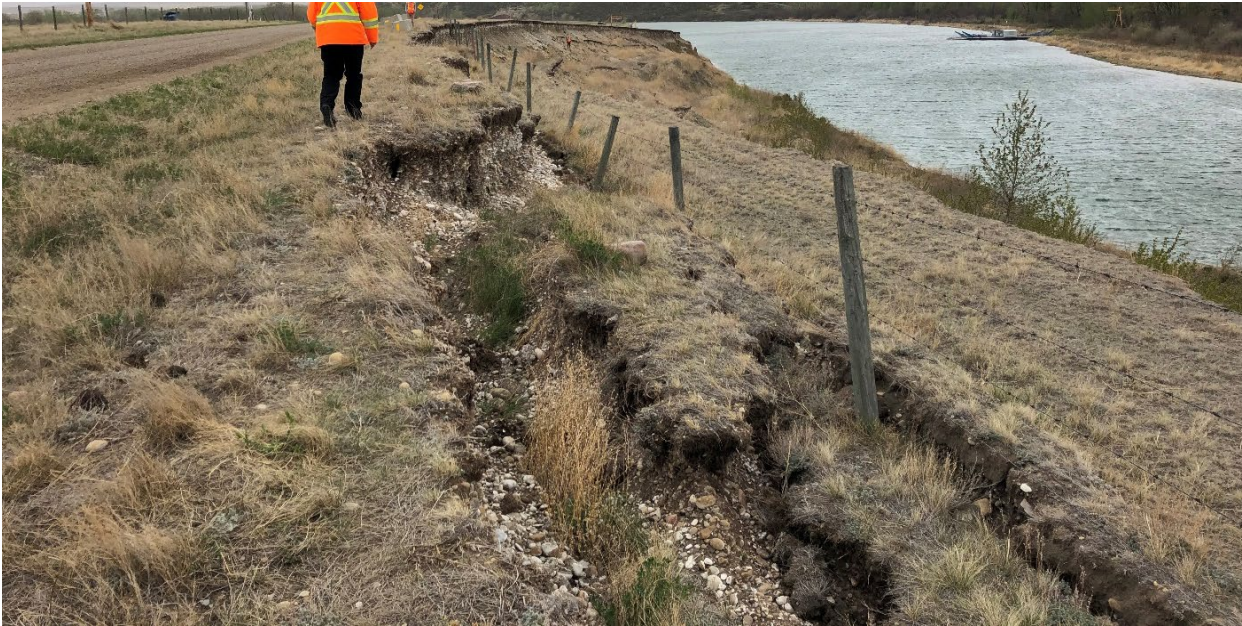
The head scarp of the slide is approximately 3 m to 4 m from the west edge of the highway (Photo 3). The head scarp has not retrogressed significantly between the 2020 and 2022 inspections.

Photo 3 The head scarp has retrogressed towards the highway and has impacted the fence west of the highway (17 fence posts are hanging along the slide). Photo was taken May 18, 2022, facing south.

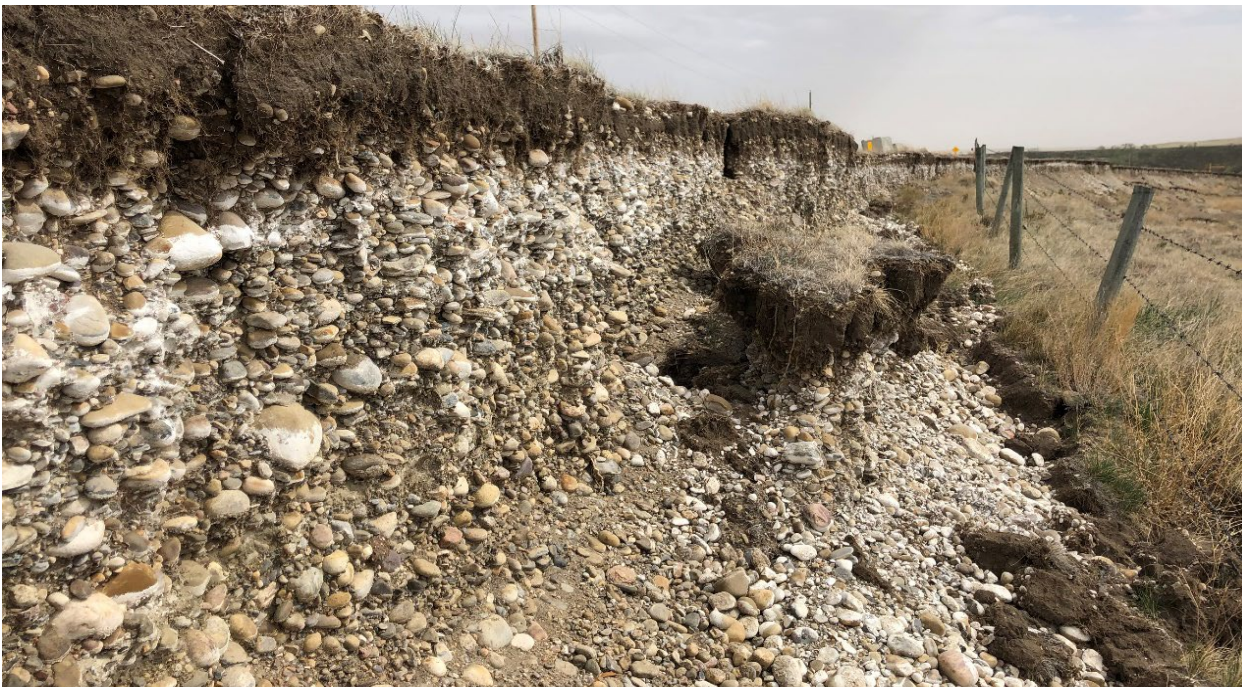
Photo 4 A layer of rounded granular material is exposed at the head of the slide and is approximately 1.0 m to 1.5 m thick. Photo taken on May 18, 2022.
