SITE NUMBER AND NAME: S054 Highwood River Bridge		HIGHWAY & KM: 22:10, 38	PREVIOUS INSPECTION DATE: N/A	INSPECTION DATE: June 8, 2020
LEGAL DESCRIPTION:	NAD 83 COORDINATES: UTM Northing Easting		RISK ASSESMENT: PF: 9 CF: 6 TOTAL: 54	
AVERAGE ANNUAL DAILY TRAFFIC: 2380 (north), 2260 (south), (Ref No. 75150)			CONTRACTOR MAINTENANCE AREA (CMA): 27

PROJECT SOUTHERN REGION GEOHAZARD RISK MANAGEMENT PROGRAM

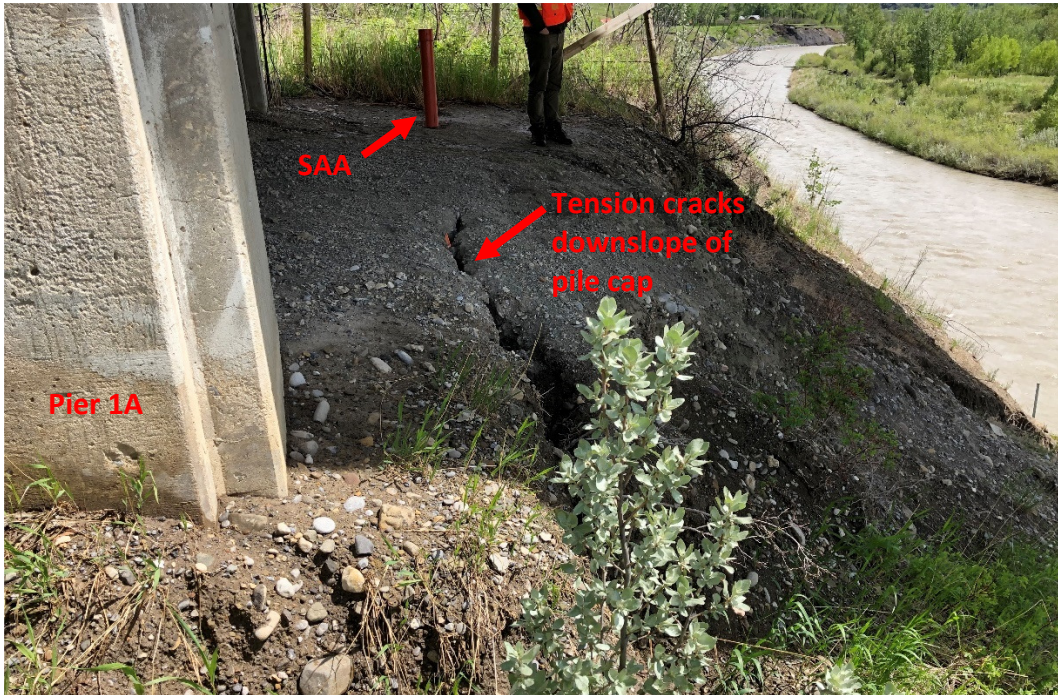
Cracks downslope of the pile cap were 12 to 15 m in length and 60 to 150 mm wide. The downslope tension cracking appeared to be due to near surface sloughing on the steep riverbank slope.

Photo 1 Tension cracking downslope of the Pier 1A pile cap. Photo taken facing east on June 8, 2020.

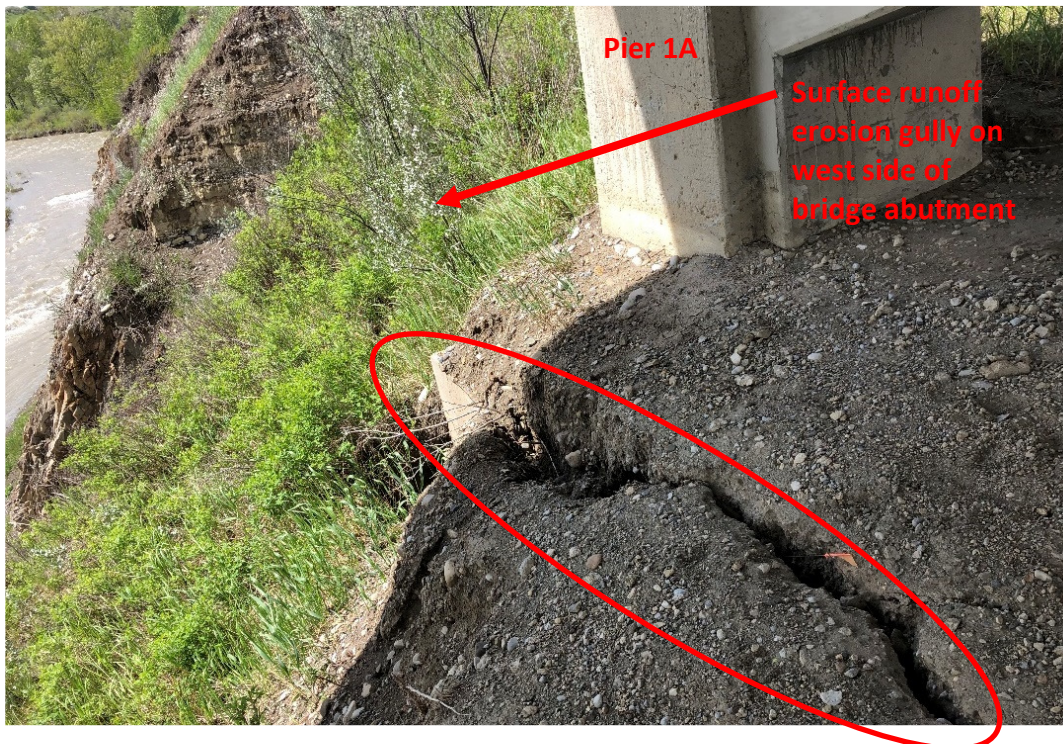
Ongoing erosion is taking place directly west of Pier 1A due to surface water runoff from upslope areas. An erosion gully appears to be removing lateral support for the Pier 1A pile cap and piles. Erosion has exposed the southwest corner of the Pier 1A concrete pile cap.

Photo 2 Tension cracking (60 to 150 mm wide) south (downslope) of the exposed Pier 1A pile cap. Photo taken facing west on June 8, 2020.

- Reduce surface runoff erosion west of Pier 1A by diverting surface water flow away from the bridge abutment;
- Evaluate bridge deck drainage to divert flows away from Pier 1A and reduce runoff onto the north bank;
- Fill the erosion gully west of Pier 1A, including reinforcement and drainage; and
- Continue to monitor instrumentation and survey monuments on the bridge deck, abutment and north bank.

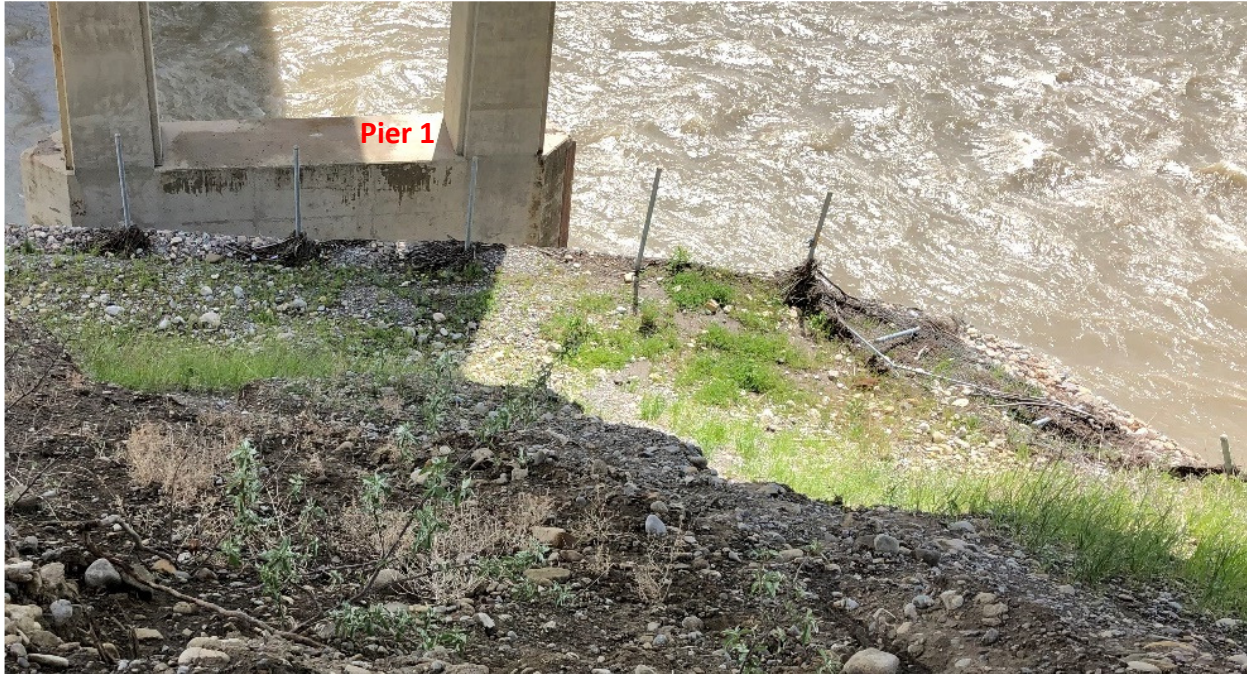
Photo 3 Top view of gabion baskets adjacent to Pier 1. Photo taken on June 8, 2020.

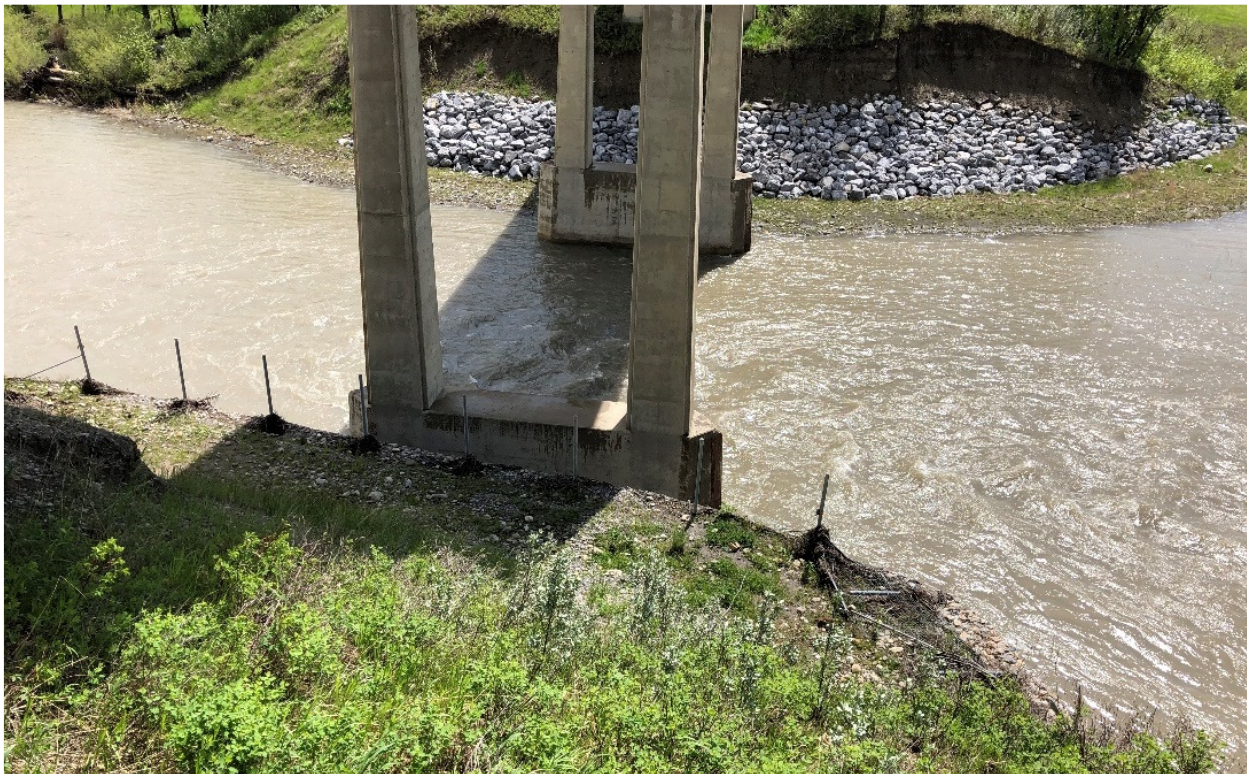
Photo 4 Bridge piers and erosion protection measures in the river channel. Photo taken from southwest of Pier 1A facing south on June 8, 2020.
