November 30, 2022

**CON0022161 Southern Region GRMP Instrumentation Monitoring
Site S054; H22:10, km 37.817 Longview Bridge
Section C – 2022 Fall Readings**

PROJECT SOUTHERN REGION GEOHAZARD RISK MANAGEMENT PROGRAM		
TITLE Site Plan S054 - Longview Bridge Hwy 22:10, km 37.817		
SCALE 1:2,000	PROJECT No. A05115A03	FIG No. 1

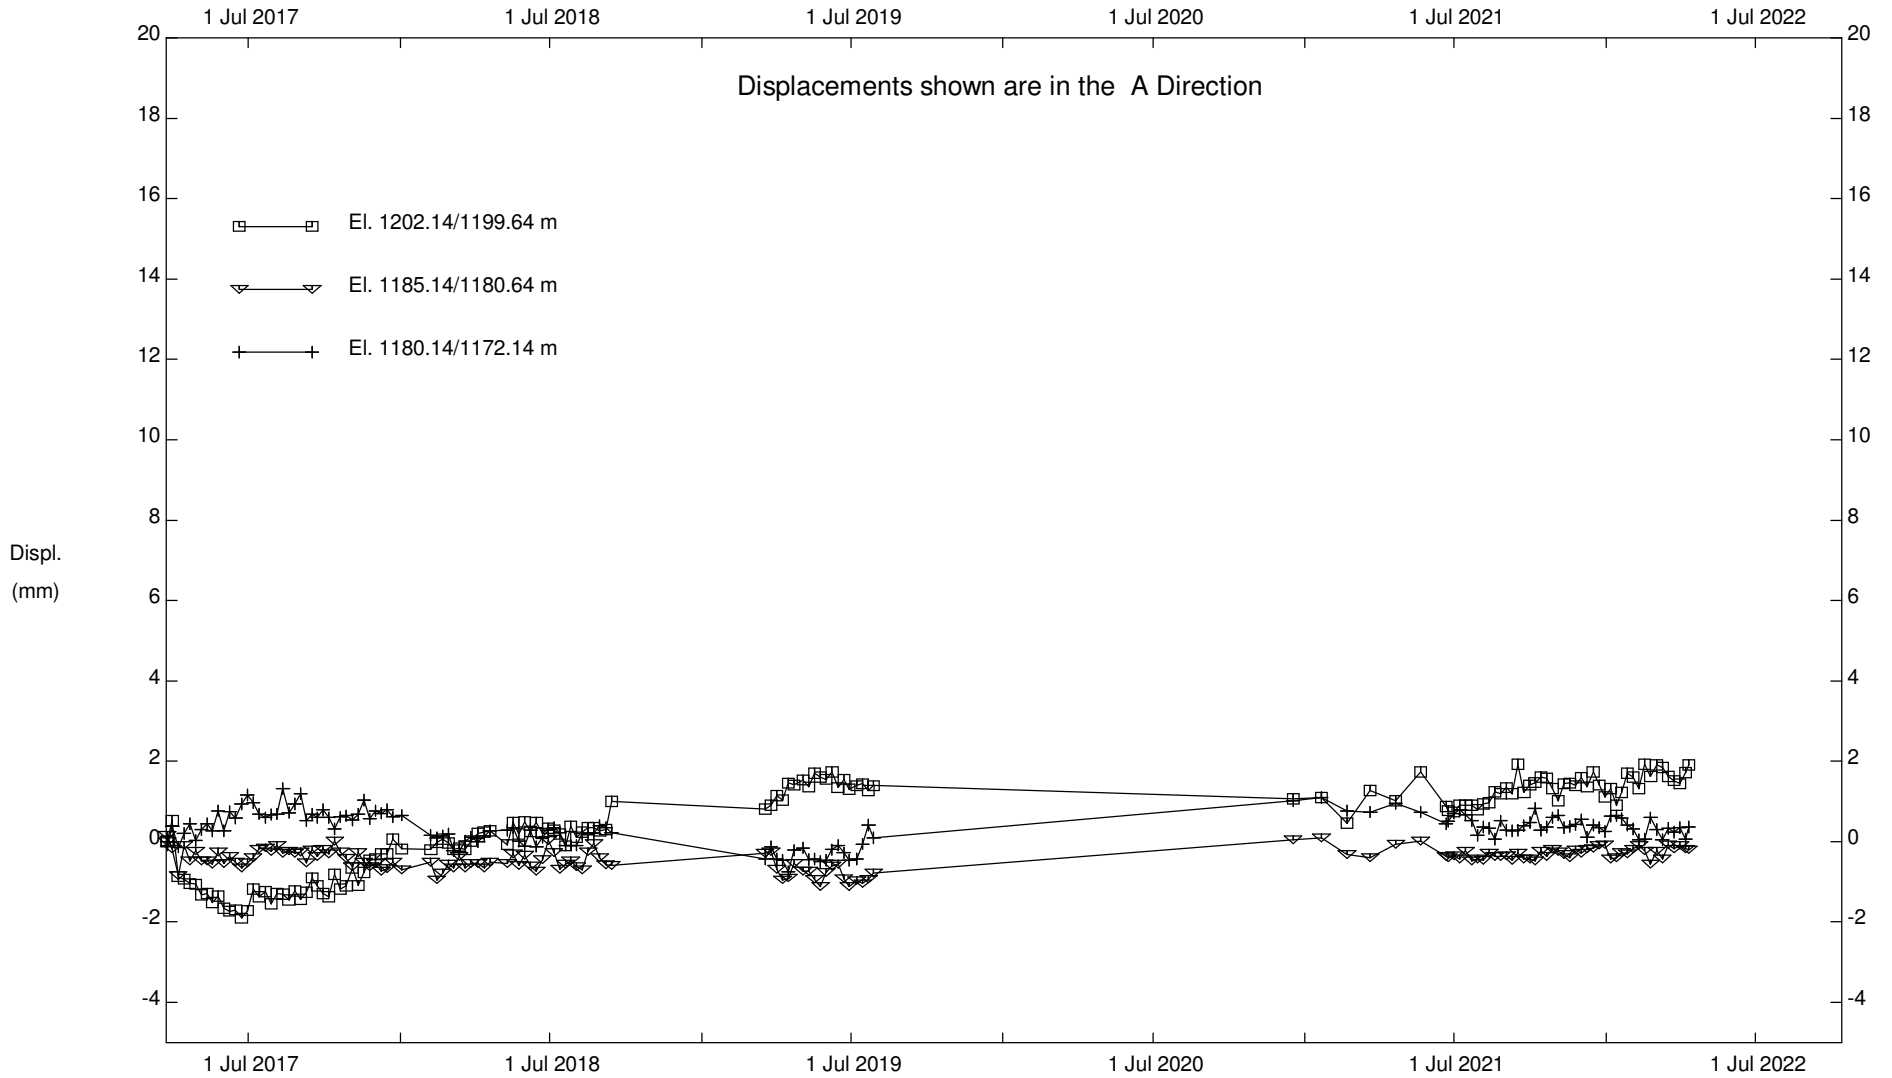
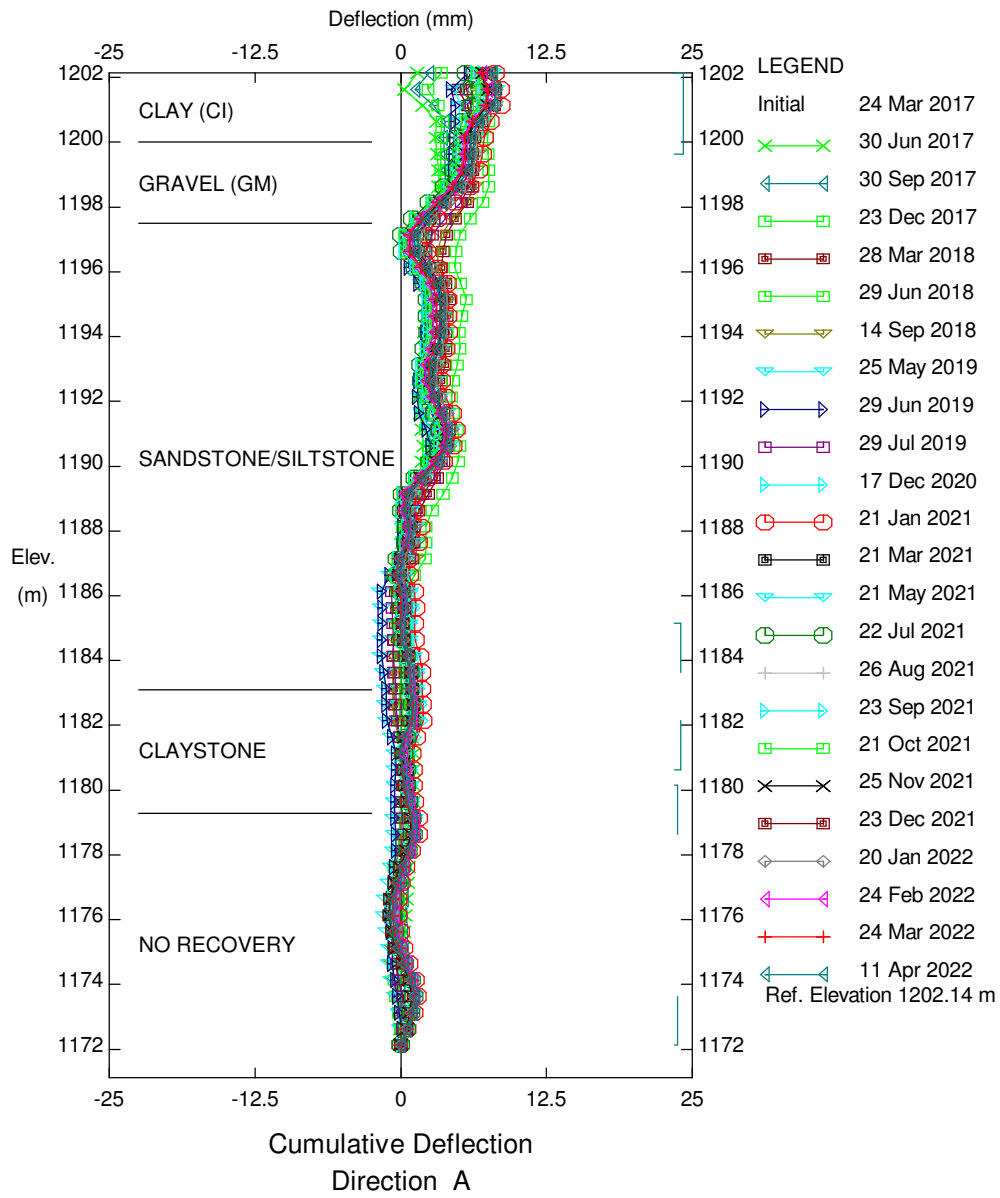
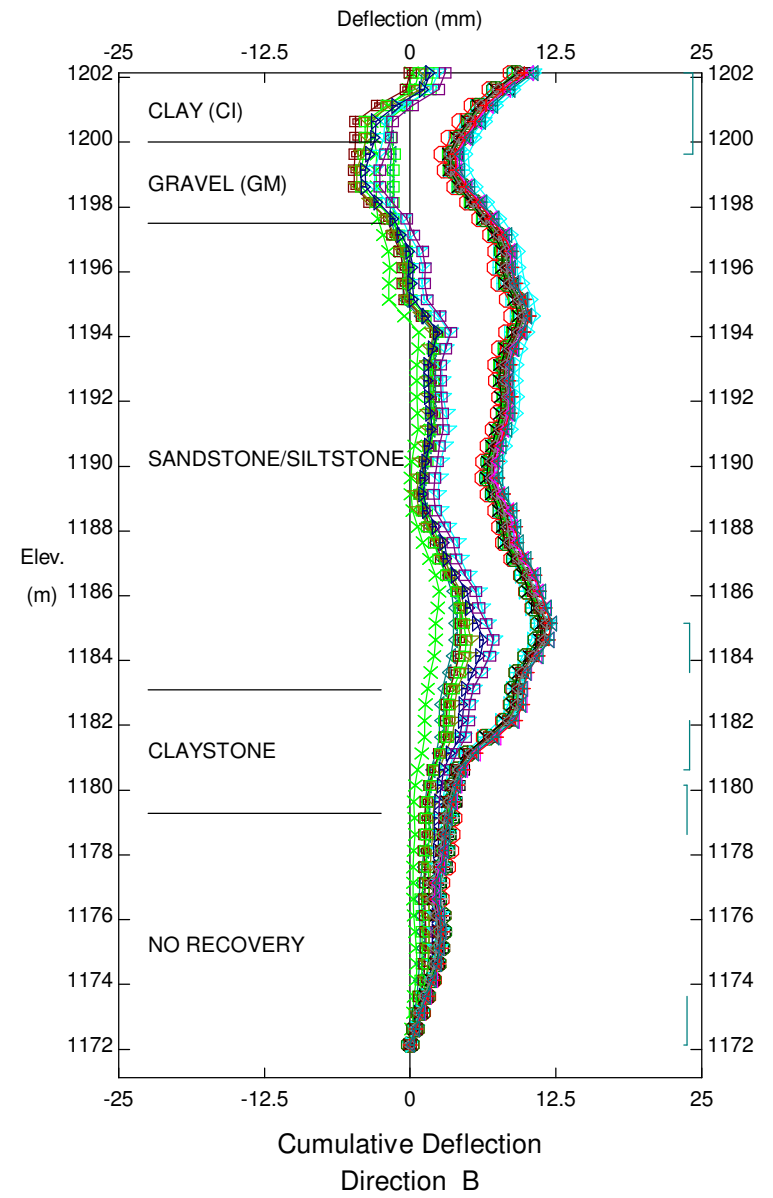
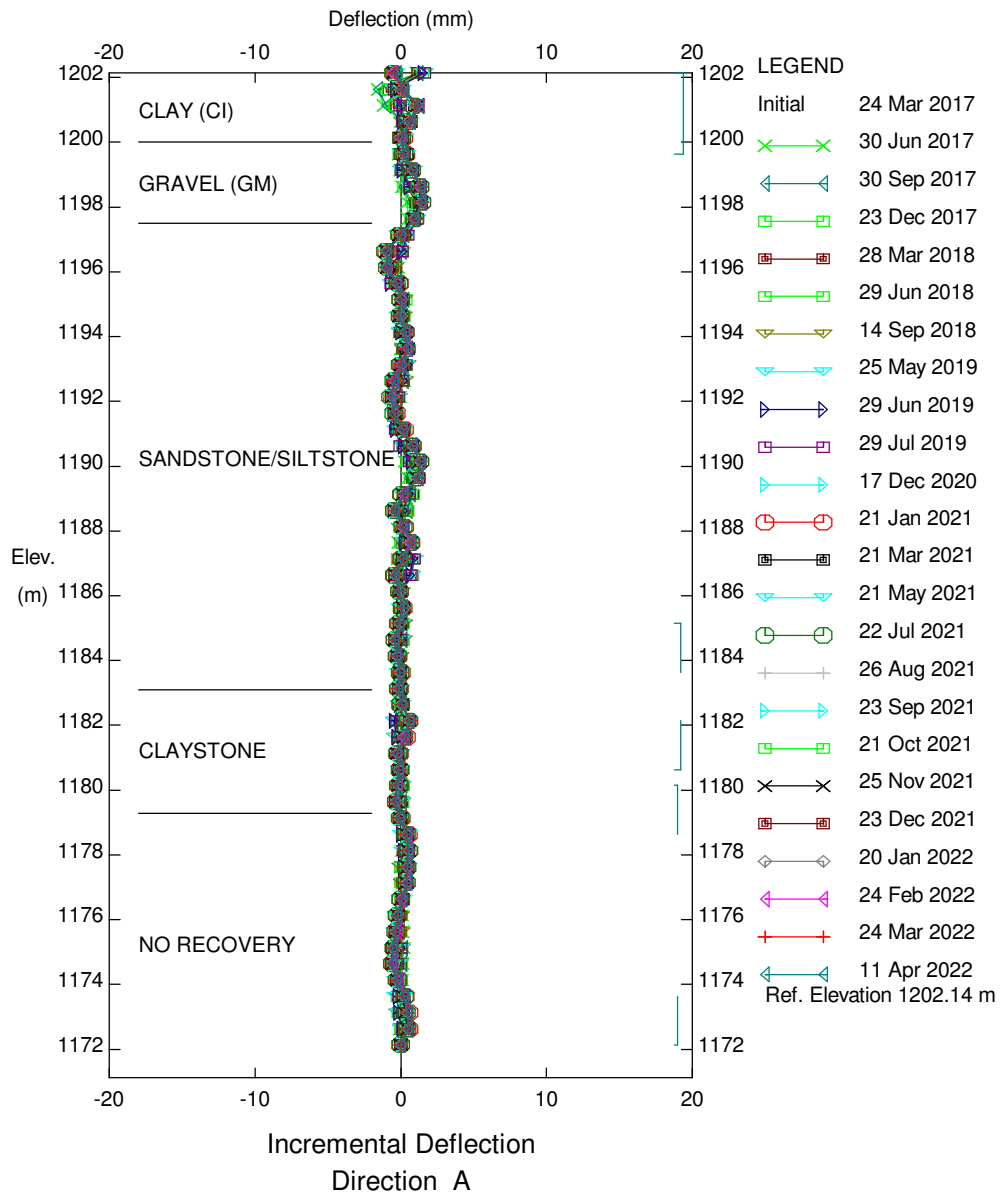
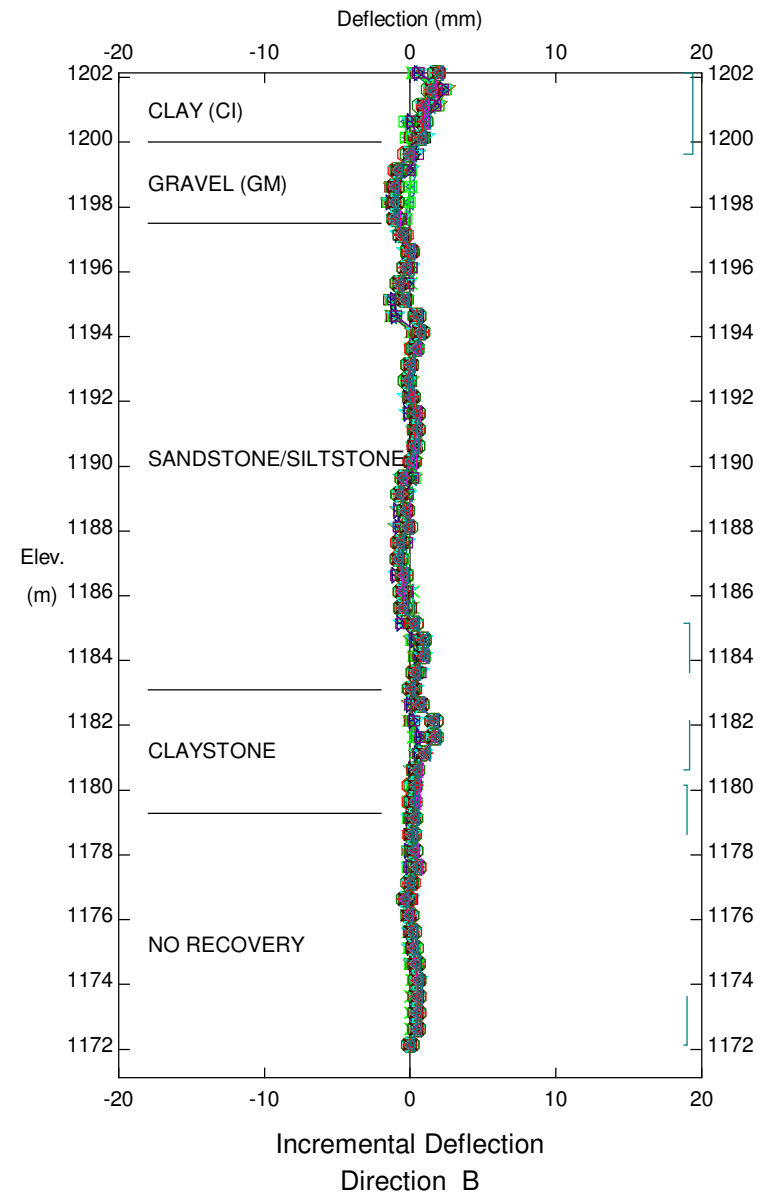
S054; H22:10 Longview Bridge, Inclinator SAA17-02

There are three zones of distributed movement being recorded in SAA17-02, which include:

- a shallow zone from ground surface to an approximate depth of 2.5 m below ground surface, in the medium plastic clay; and
- a deeper zone from an approximate depth of 17.0 m to 21.5 m below ground surface, at the base of the sandstone/siltstone unit and into the underlying claystone; and
- the deepest zone from an approximate depth of 22.0 m below ground surface to near the base of the instrument, from the base of the identified claystone unit to a lower unidentified unit.

Since December 2020, a negligible rate of movement (less than 2 mm/year) has been recorded in SAA17-02. Overall, based on the September 2022 data obtained from this instrument:

- in the upper monitoring zone approximately 7 mm of distributed movement has been recorded in the medium plastic clay, with the majority of the movement occurring shortly after installation.
- In the middle monitoring zone approximately 8 mm of distributed movement has been recorded from near the base of the sandstone/siltstone until to the base of the claystone unit, with the majority of the movement occurring shortly after installation.
- In the lower monitoring zone approximately 3.5 mm of distributed movement has been recorded from near the base of the claystone unit to the base of the instrument, with the majority of the movement occurring shortly after installation.

As previously discussed with AT, a comprehensive slope stability and bridge deck monitoring plan should be developed for this site, including upgrading SAA17-02 with a long-term solution, including a new battery and a permanent power supply (e.g., installation of a solar panel and mount).
