SITE NUMBER AND NAME: <b>S037 Springhill Creek</b>		HIGHWAY & KM: 533:02, 21.962 & 22.336	PREVIOUS INSPECTION DATE: May 2, 2018	INSPECTION DATE: <b>May 10, 2019</b>
LEGAL DESCRIPTION: 09/10/16-32-015-29 W4M	NAD 83 COORDINATES: UTM Northing Easting 12 5576818 290160		RISK ASSESMENT: PF: 8 CF: 3 TOTAL: 24	
AVERAGE ANNUAL DAILY TRAFFIC (AADT): 1380 (east), 1250 (west), (Ref No. 83120)			CONTRACTOR MAINTENANCE AREA (CMA): 27

PROJECT SOUTHERN REGION GEOHAZARD RISK MANAGEMENT PROGRAM		
TITLE Site Plan S037 - Springhill Creek Hwy 533:02, km 22.336		
SCALE 1:2,000	PROJECT No. A05115A03	FIG No. 1

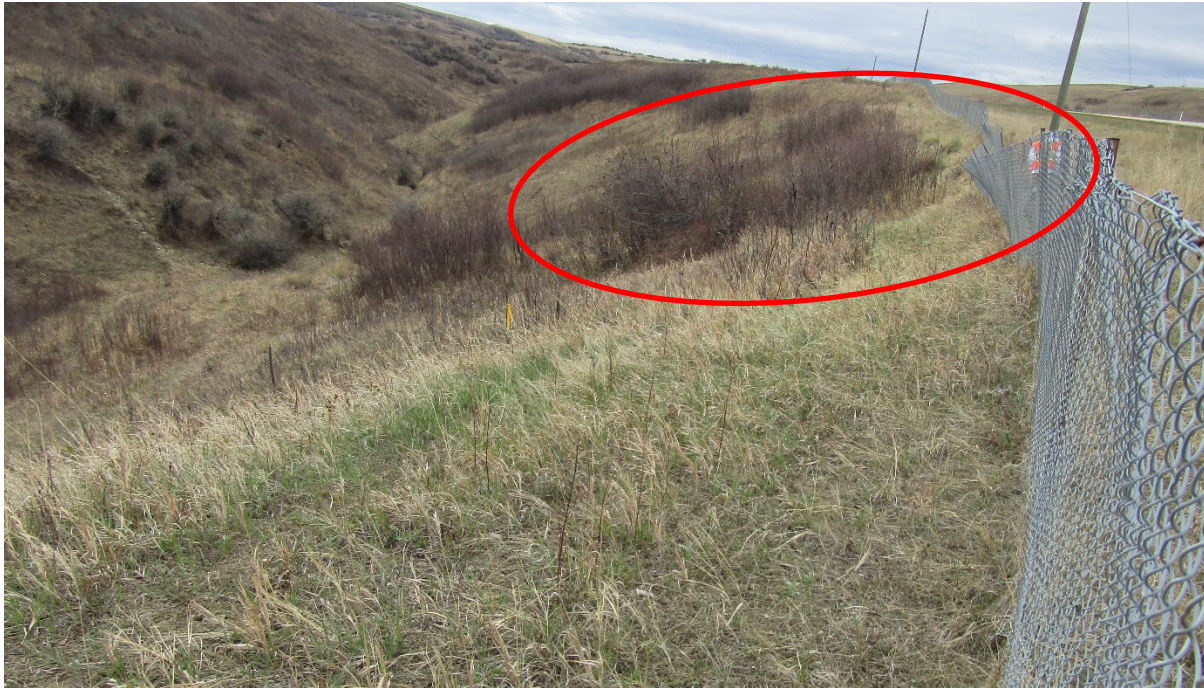
**PRIMARY SITE ISSUE:** 3 earth (embankment) slides on the south side of highway (west to east = 1, 2 & 3), Slide 1 - On south slope but not affecting road surface. Inlet of half culvert (flume) displaced by erosion causing drainage to flow onto slide surface and exacerbate slide movement.

**Photo 1** Slide 1 - Slide not affecting road surface. Some fence displacement in downslope direction at the head scarp (red circle). Power pole leaning downslope. Photo taken facing southwest on May 10, 2019.

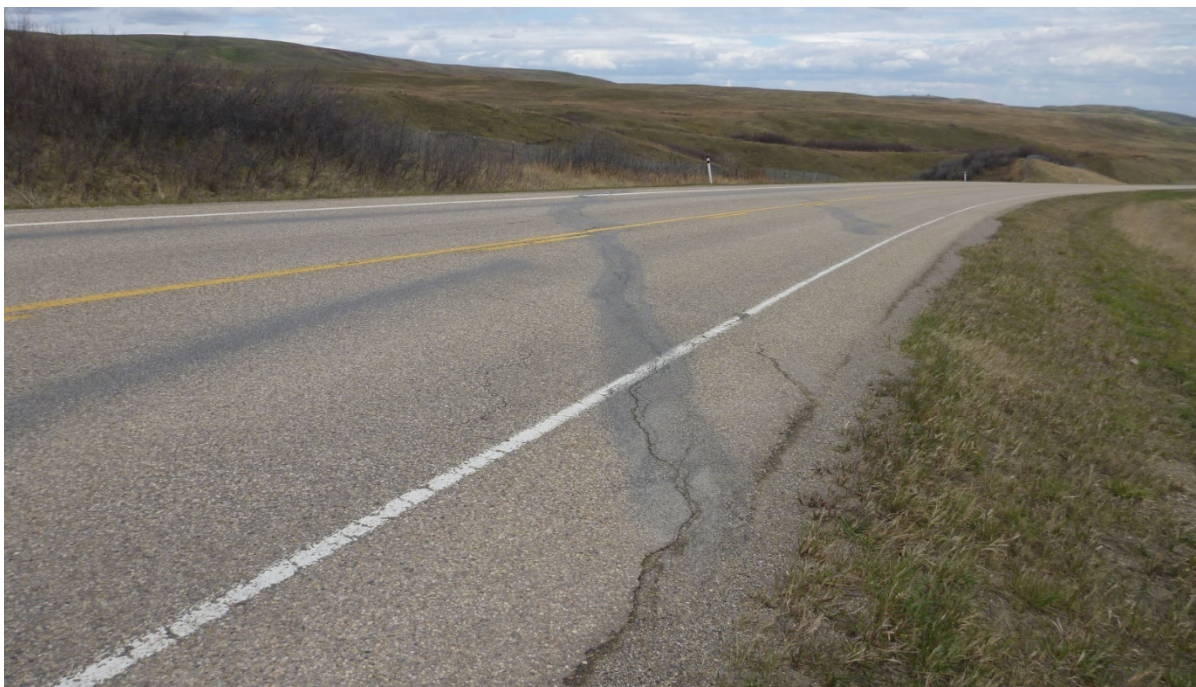
Slide 2 – Patched arc shaped cracks in pavement across both lanes, slump block downslope of fence on south slope.

**Photo 2** Sealed cracking on highway surface located approximately above the slide 2 location. Photo was taken facing north on May 10, 2019.

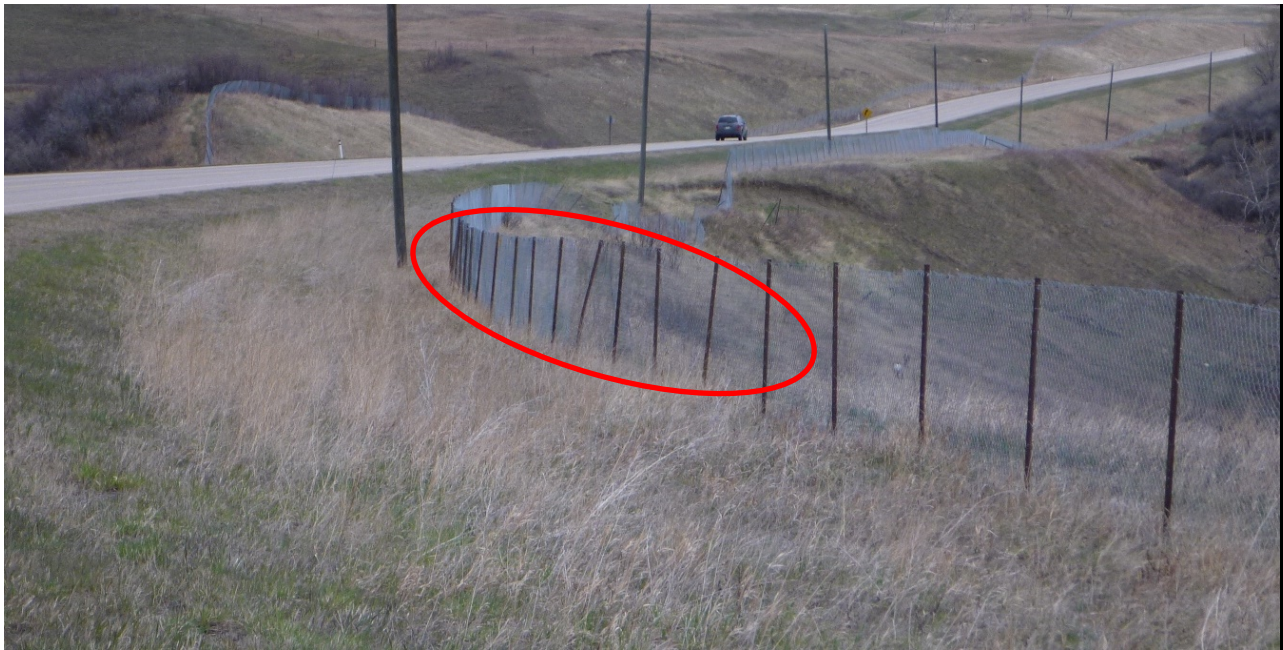
<p>Slide 2:</p> <ul style="list-style-type: none"> <li>- Two arc shaped patched pavement cracks indicative of right flank of rotational landslide.</li> <li>- Slump block on south slope, head scarp downslope of fence.</li> <li>- Earth slides are shallow and may involve seepage erosion and sloughing.</li> <li>- Drainage from road surface and seepage likely trigger for incremental movements.</li> <li>- Power pole standing at an angle of 5.6° in the downslope direction. Fence is displaced downslope.</li> </ul>
<p>Slide 3:</p> <ul style="list-style-type: none"> <li>- Slide is located on south slope of embankment, affecting the fence line but not the road. Power pole in slide area leaning approximately 5° in the downslope direction (no change since 2018), but the anchor cable was slack.</li> <li>- Trees leaning back at toe of slope, appears to be toe of slide.</li> <li>- Relatively fresh scarps were noted on the slide mass near the head scarp in 2016. Additional movement noted in subsequent inspections and further settlement of crest area noted during 2019 inspection.</li> <li>- Head of slide appears to have widened. Estimated as 80 m wide in 2019 inspection.</li> <li>- No cracks on the road surface.</li> <li>- Offset from the head scarp to the road edge, measured slightly west of the power pole, remains 4.2 m (no change since 2018).</li> <li>- Drainage from road surface and seepage likely trigger for incremental movements.</li> </ul>

**Photo 3** Slide 2 – Fence displacement at the head scarp (red circle). Pole in slide area leaning approximately 5.6° downslope. Photo was taken facing north on May 10, 2019.

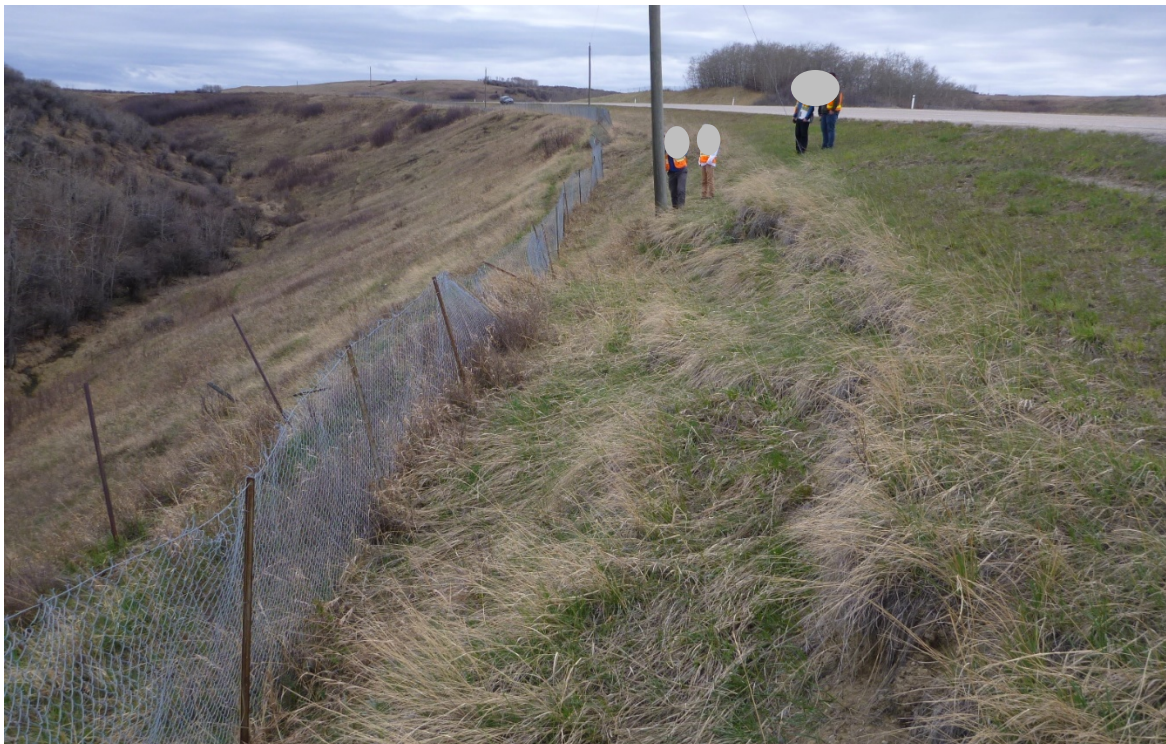
Slide 3 – Largest slide, affecting fence but approximately 4 m from pavement, inward leaning trees are an indication of toe bulge at toe of embankment slope.

**Photo 4** Slide 3 – Back scarp measured to be 4.2 m from asphalt (no change from 2018). Fence displacement down slope. Pole in slide area leaning approximately 5° downslope. Photo taken facing west on May 10, 2019.
