SITE NUMBER AND NAME: S037 Springhill Creek		HIGHWAY & KM: 533:02, 22.174	PREVIOUS INSPECTION DATE: May 10, 2019	INSPECTION DATE: May 20, 2022
LEGAL DESCRIPTION: 09-32-015-29 W4M 10-32-015-29 W4M 16-32-015-29 W4M	NAD 83 COORDINATES: UTM Northing Easting 12 5576818 290160		RISK ASSESMENT: PF: 8 CF: 3 TOTAL: 24	
AVERAGE ANNUAL DAILY TRAFFIC (AADT): 1380 (east) & 1250 (west), (Reference No. 83120)			CONTRACTOR MAINTENANCE AREA (CMA): 27

PRIMARY SITE ISSUE: Three relatively shallow earth slides (Slide 1, 2, and 3) on the south side of highway embankment. The slides are believed to be caused by an over steepened slope and potential infiltration/erosion.

Inspection Photographs

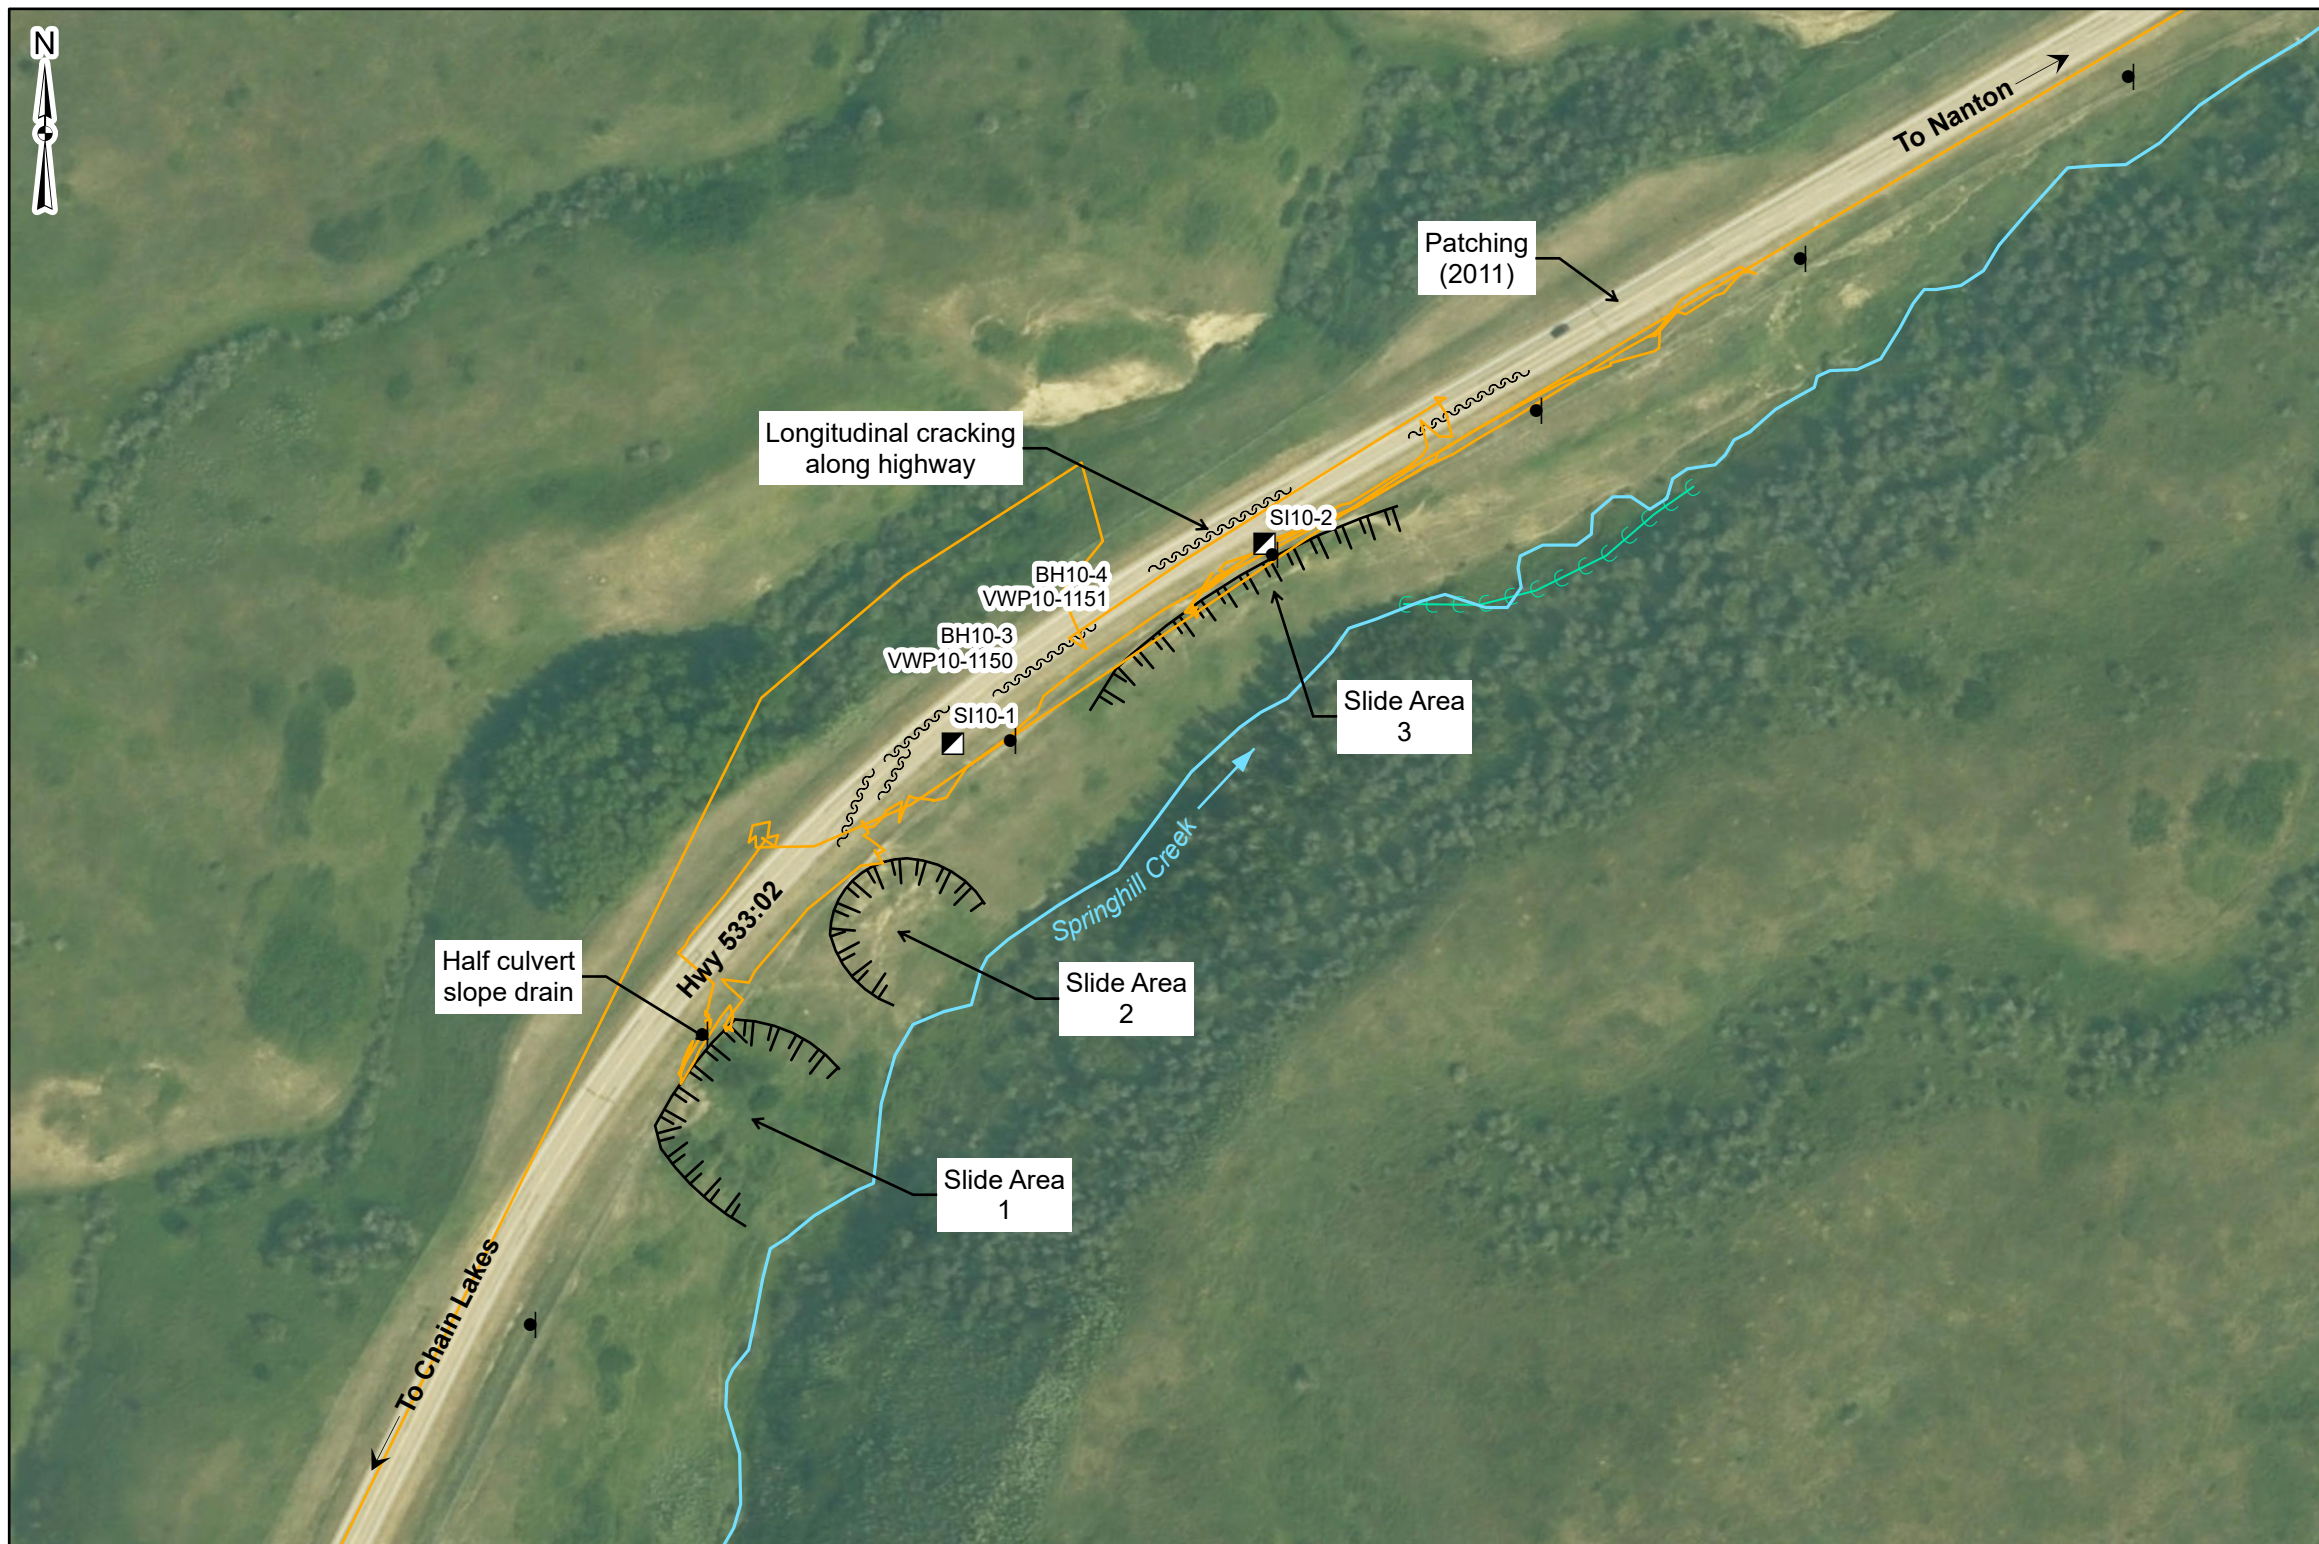
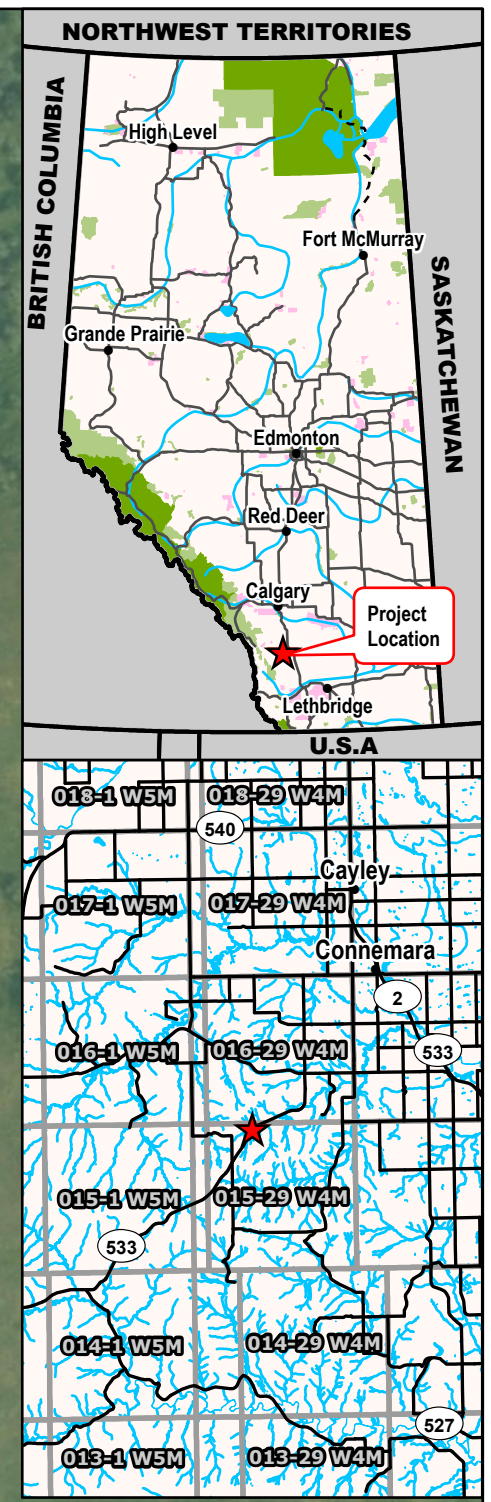
PROJECT SOUTHERN REGION GEOHAZARD RISK MANAGEMENT PROGRAM		
TITLE Site Plan S037 - Springhill Creek Hwy 533:02, km 22.336		
SCALE 1:2,000	PROJECT No. A05115A03	FIG No. 1

APPROXIMATE DIMENSIONS: Three landslide zones located over approximately 500 m of highway. The natural slope to south of highway is sloped at approximately 2H:1V, approximately 30 m high. The sliding beneath the highway has been previously reported/estimated to be a maximum of 5 m deep. Instability of the natural slopes appears to be relatively shallow.

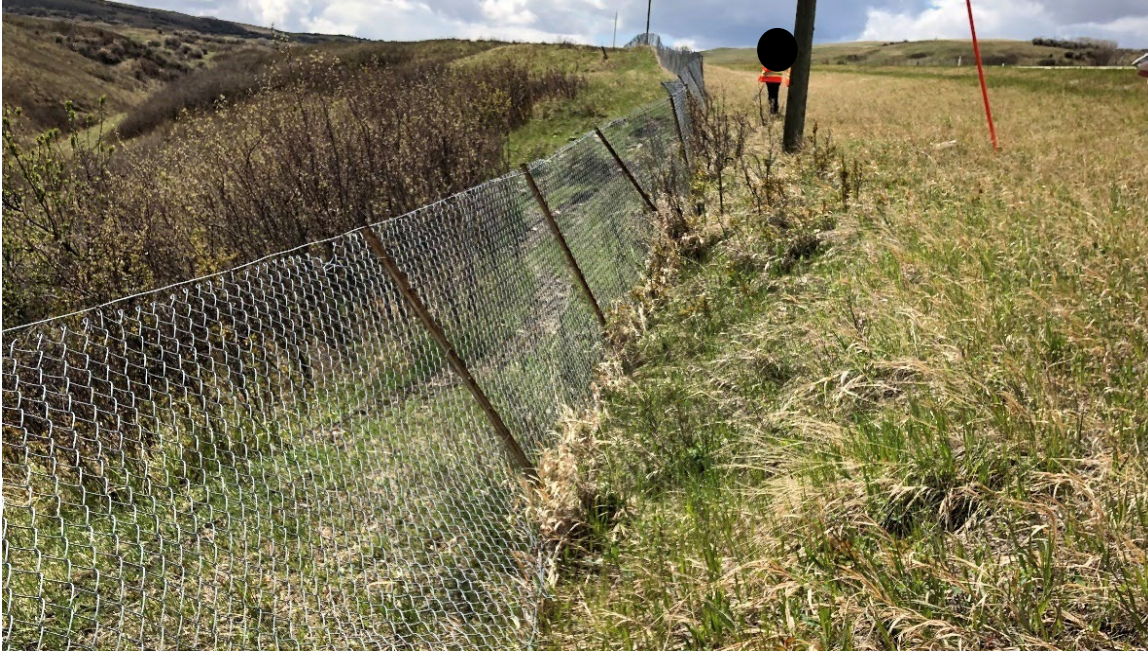
- Ditch and seepage drainage from south side of cut section and surface water runoff from the highway may have contributed to sliding and gullying.
- The fence along the slide zone is leaning downslope and appears to be leaning more since the 2019 inspection (Photo 1). The head scarp has retrogressed towards the edge of the highway and is approximately 1.7 m upslope of the fence along a 15 m length. Where the head scarp is impacting the fence, the ground appears to have settled approximately 0.8 m since the 2019 inspection. The power pole at this slide is near vertical and has no changed since the 2019 inspection.

- Photo 1** The slide at Slide Area 1 is not impacting road surface. The fence posts and power pole are tilting downslope towards the toe of the slope. Photo taken May 20, 2022, facing west-southwest.

- Repair options include slope stabilization and drainage measures.
- Slide stabilization could include excavating slide material and replacing it with geogrid reinforced granular fill; soil nailing; or a combination of geogrid reinforced fill and soil nailing (soil nailing near the lower portion of the slide and geogrid reinforced fill higher up on the slope).

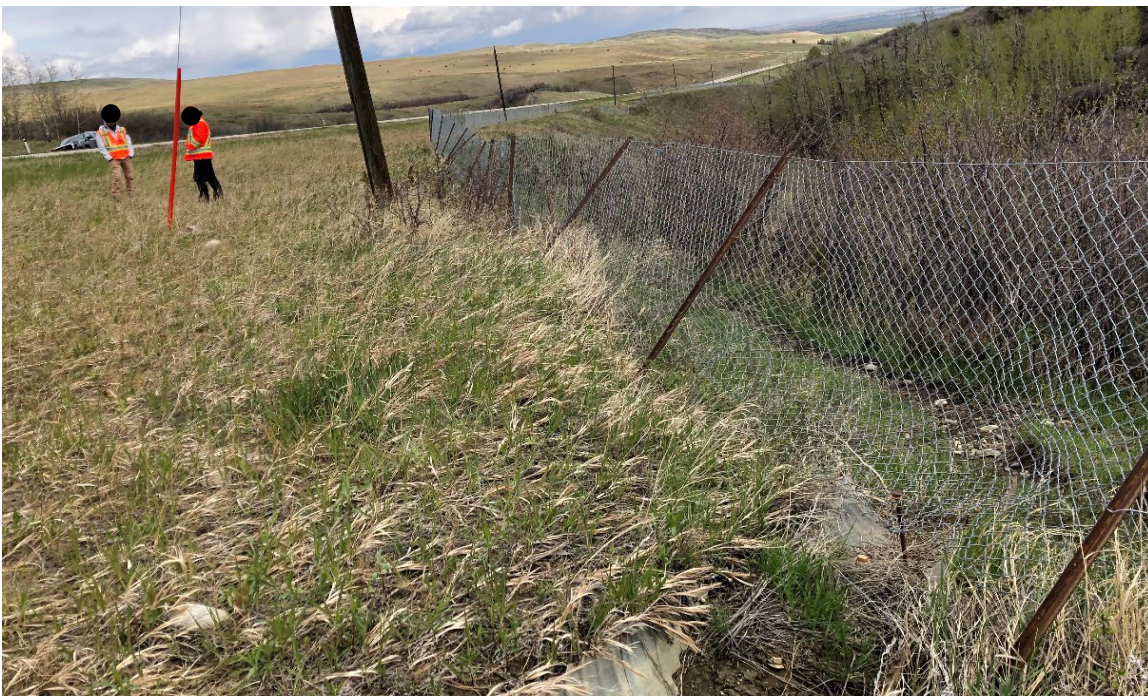
- The CSP slope drain appears to have pulled away from cable anchors and is being undermined by surface water runoff from the south (eastbound) ditch (Photo 2).

- Photo 2** The CSP slope drain at Slide Area 1 is in poor condition and is being undermined by surface runoff from highway ditch. Photo taken May 20, 2022, facing northeast.

- Drainage improvements include repairing the inlets of CSP slope drains so surface water is conveyed to the toe of the slope instead of over the slide area and installing either an asphalt berm at the edge of pavement with HTC/B protection from damage, or a berm/ditch block in the ditch to keep surface water from flowing over the crest of the slope and allow CSP slope drains to convey water to the toe of the slope. Alternatively, directionally drilled subsurface drains could also be located below the failure plane from the flanks of the slide, to drain water seeping into the slope.

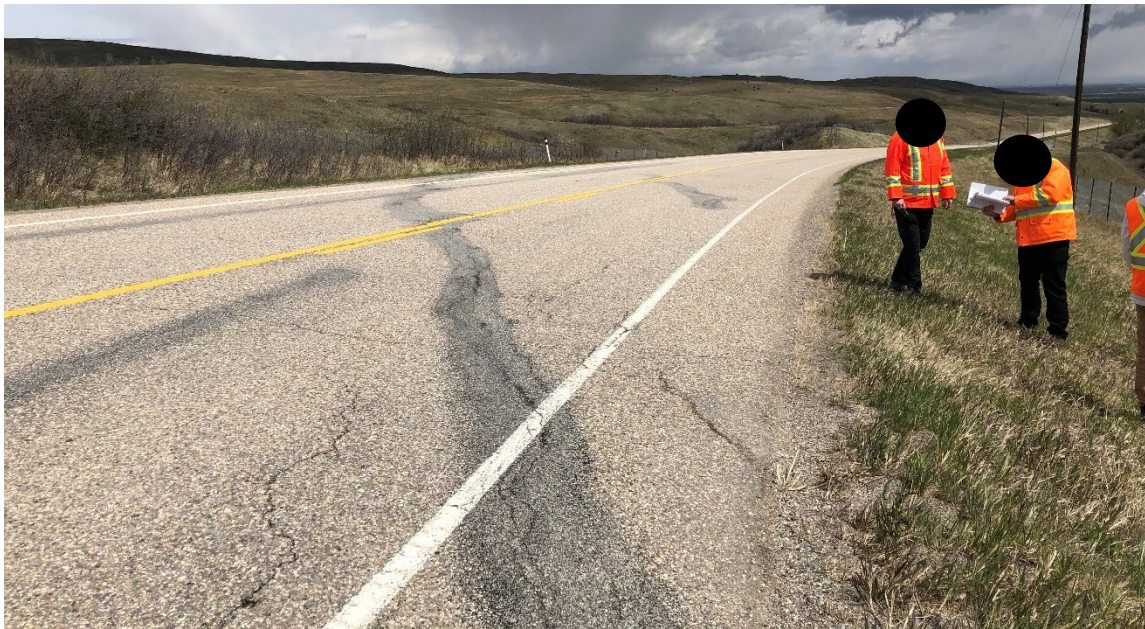
- The slide is believed to be a shallow slide that may be attributed to poor drainage (surface water runoff from highway surface and poor ditch grading) and/or seepage in the embankment/foundation.
- There are two arc shaped pavement cracks upslope of the slide (Photo 3). The pavement cracks could indicate the location of the right (west) flank if a rotational slide. During the 2022 inspection, some secondary cracking was observed in the south (eastbound) lane. However, the extent (i.e., length) of the zone of pavement cracking has not changed since the 2019 inspection.
- Between the 2019 and 2022 inspections, a portion of the fence appears to have been displaced downslope due to slide movement. However, the head scarp has not reached the fence.

Photo 3 Pavement cracking has been sealed near the Slide Area 2 site. Photo taken May 20, 2022, facing north.

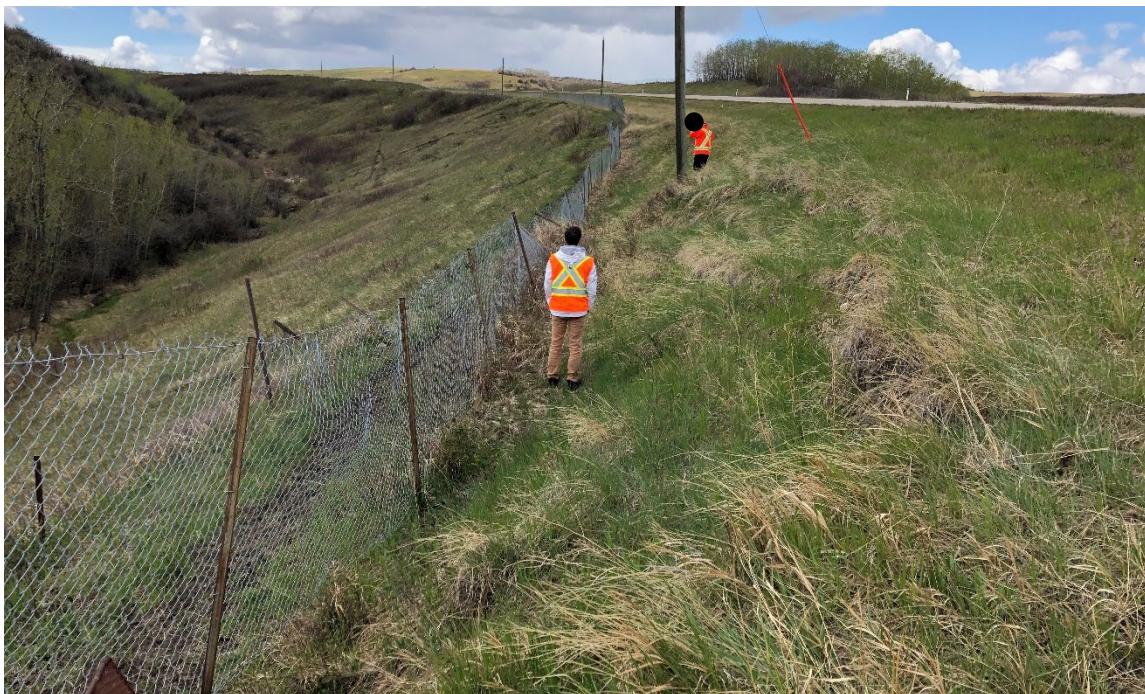
- The slide is located on south slope of embankment and is impacting the fence line but does not appear to be impacting the road surface. The head scarp is less than 5 m from the south (eastbound) edge of the highway (Photo 4).

- The fence is intact but has been displaced approximately 2.5 m downslope and settled approximately 1.5 m since the 2019 inspection. A power pole in the slide area is leaning at an angle of approximately 5° to 6° in the downslope direction and the upslope anchor cable was slack.

- Trees at the toe of the slope are leaning back towards the highway/slope. Slide blocks are actively deforming downslope. Exposed soils in the head scarp were wet and animal burrows were observed during the 2022 inspection. Drainage from road surface and seepage likely trigger for incremental movements.

Photo 4 Slide Area 3 (east end) – The back scarp at Slide Area 3 is approximately 5 m from the south edge of the highway. The fence posts and power pole are leaning downslope towards the toe of the slope. The power pole is leaning at approximately 5° to 6° from vertical. Photo taken May 20, 2022, facing west-southwest.
