September 21, 2022

Alberta Transportation  
2<sup>nd</sup> Floor, 803 Manning Road N.E.  
Calgary, Alberta  
T2E 7M8

**CON0022161 Southern Region GRMP Instrumentation Monitoring  
Site S037; H533:02 km 22.3 to km 21.9 Springhill Creek  
Section C – 2022 Spring Readings**

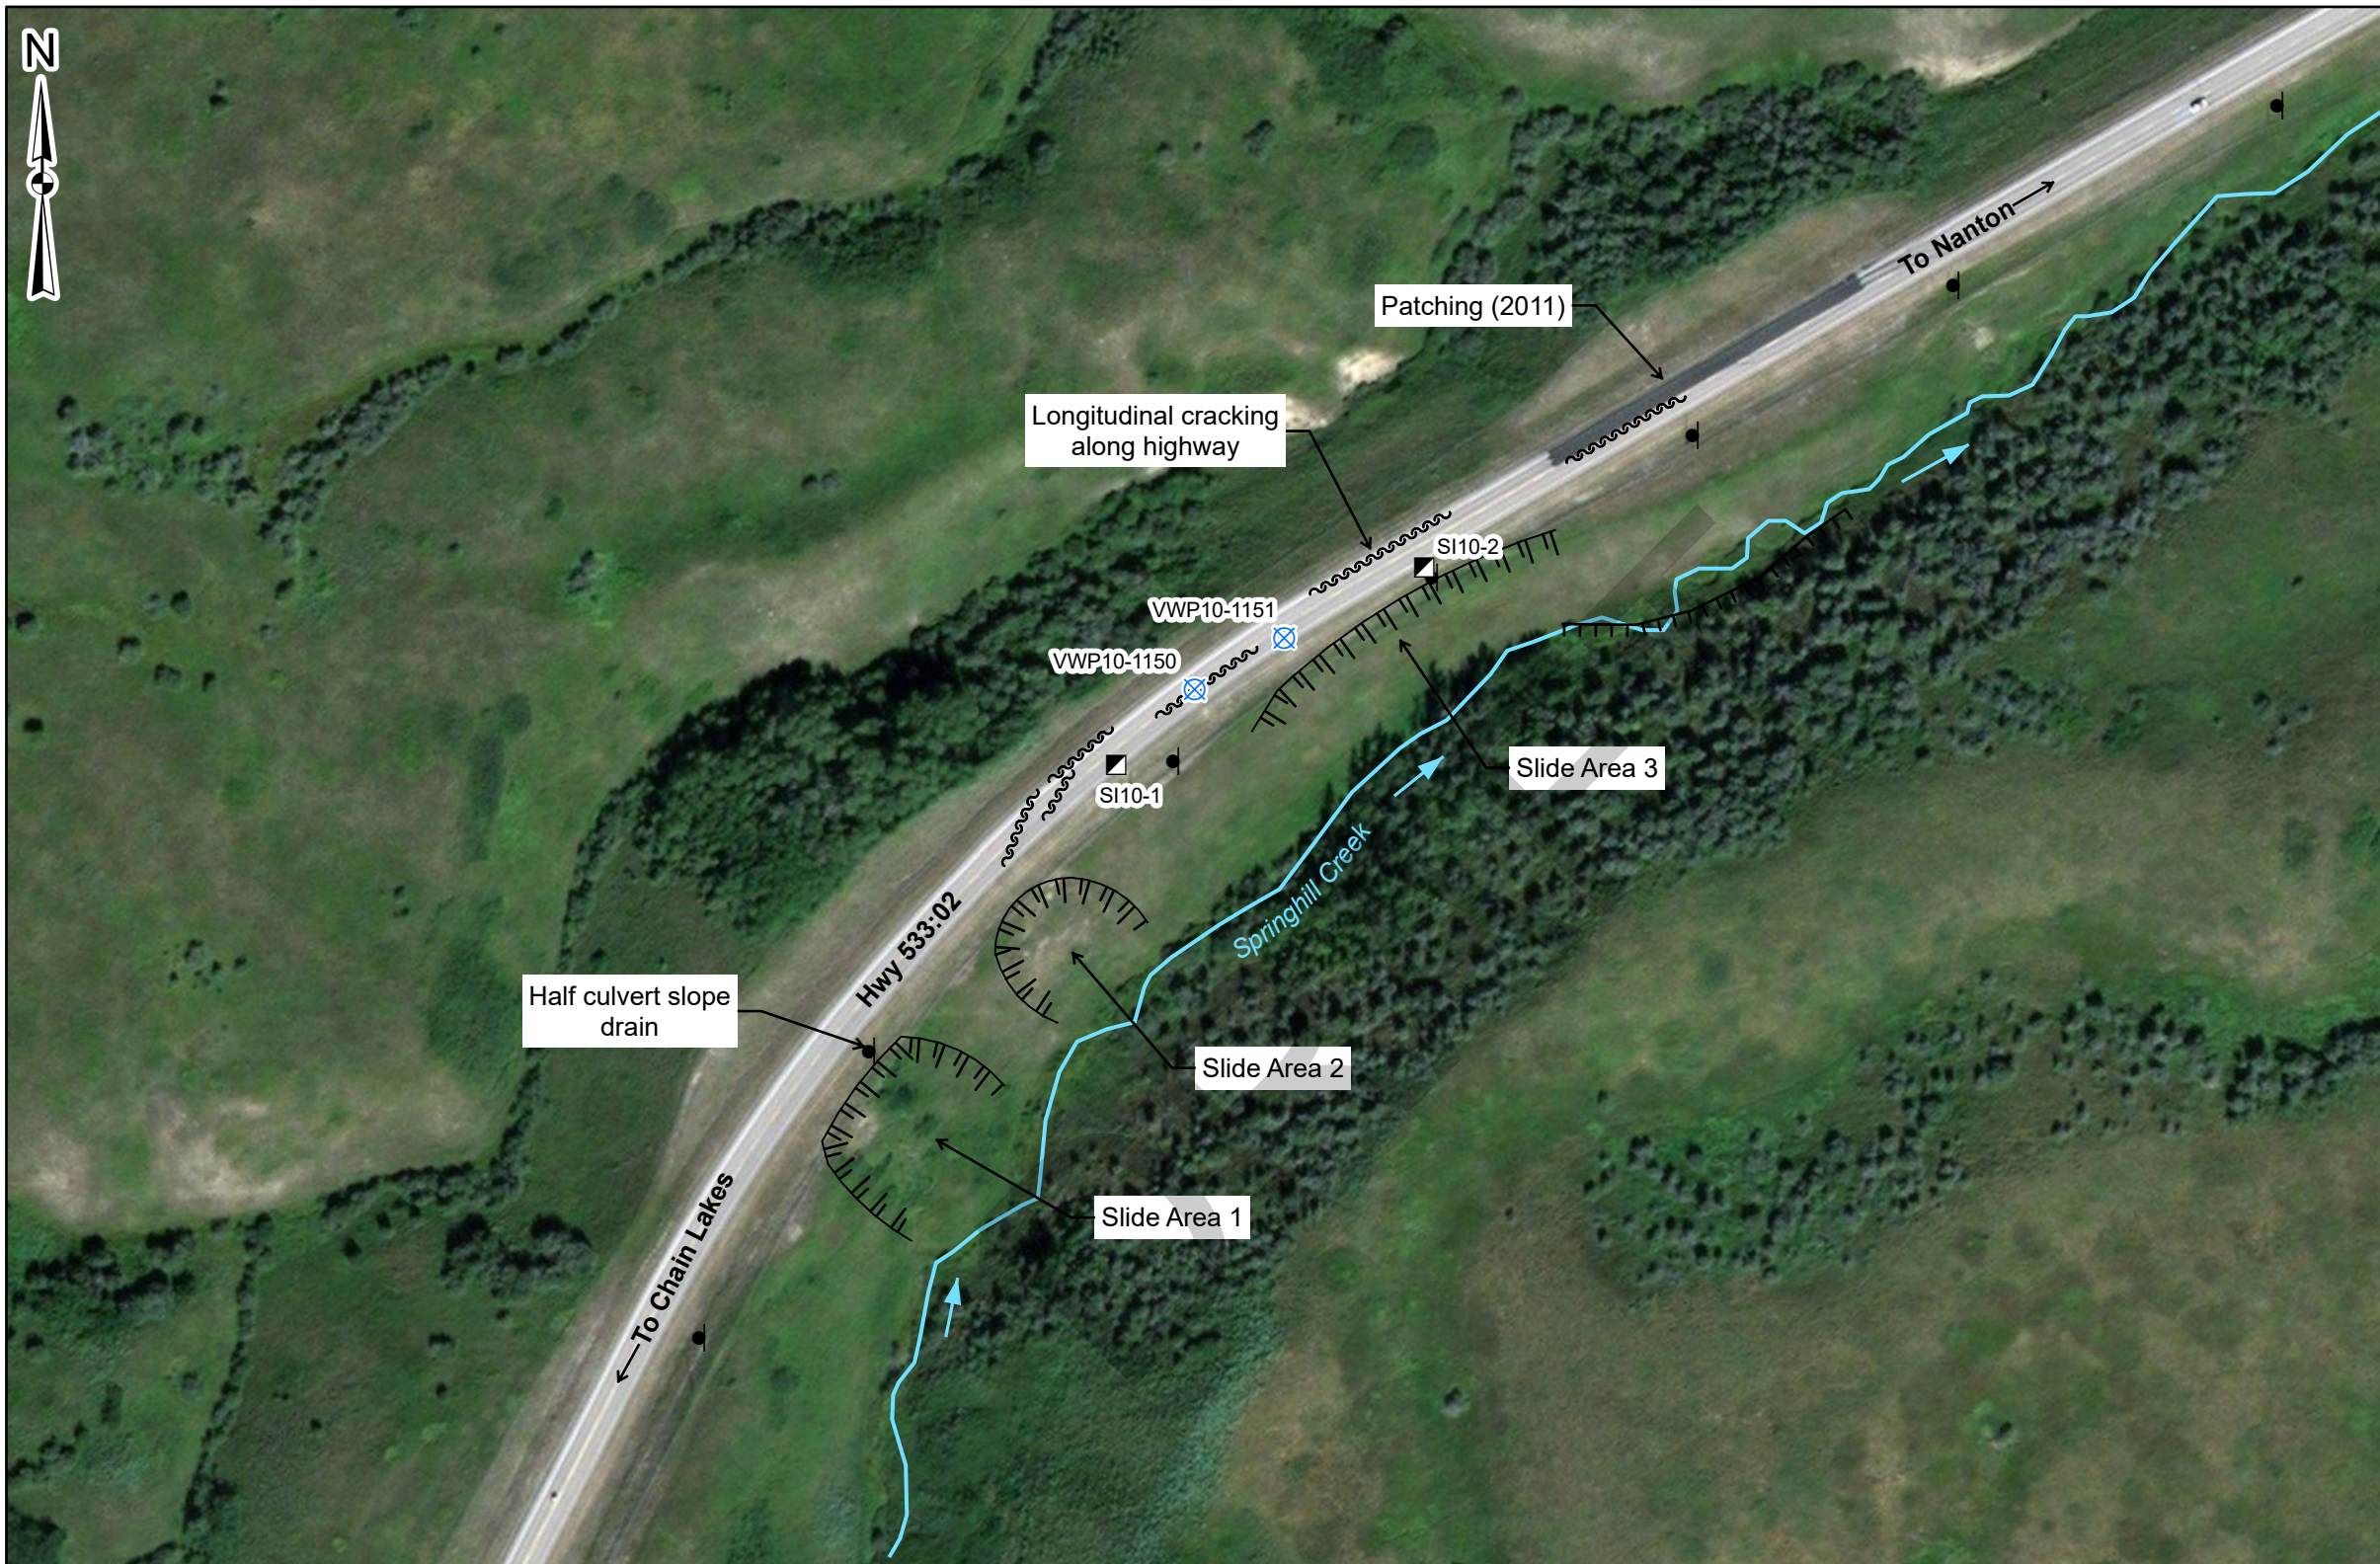
PROJECT SOUTHERN REGION GEOHAZARD RISK MANAGEMENT PROGRAM		
TITLE Site Plan S037 - Springhill Creek Hwy 533:02, km 22.174		
SCALE 1:2,000	PROJECT No. A05116A03	FIG No. 1

The geohazard at the S037 site consists of three adjacent landslides (Slide Area 1 through 3) located along an approximate 400 m length of Hwy 533:02. The landslides are occurring on the natural slope (approximately 30 m high sloped at 3H:1V) between the highway and Springhill Creek. In 2014, a pavement patch was completed above Slide Area 2, and subsequent crack sealing has been completed.

In February 2010, two SIs (SI10-1 and SI10-2) and two VWPs (VWP10-1150 and VWP10-1151) were installed at the site by a previous consultant to monitor movement and groundwater conditions, respectively. SI10-1 is between Slide Area 2 and 3, and the remaining instruments are in or near Slide Area 3. The instruments are installed along the south (eastbound) shoulder of Hwy 533:02 and are protected by flush-mounted casing protectors.

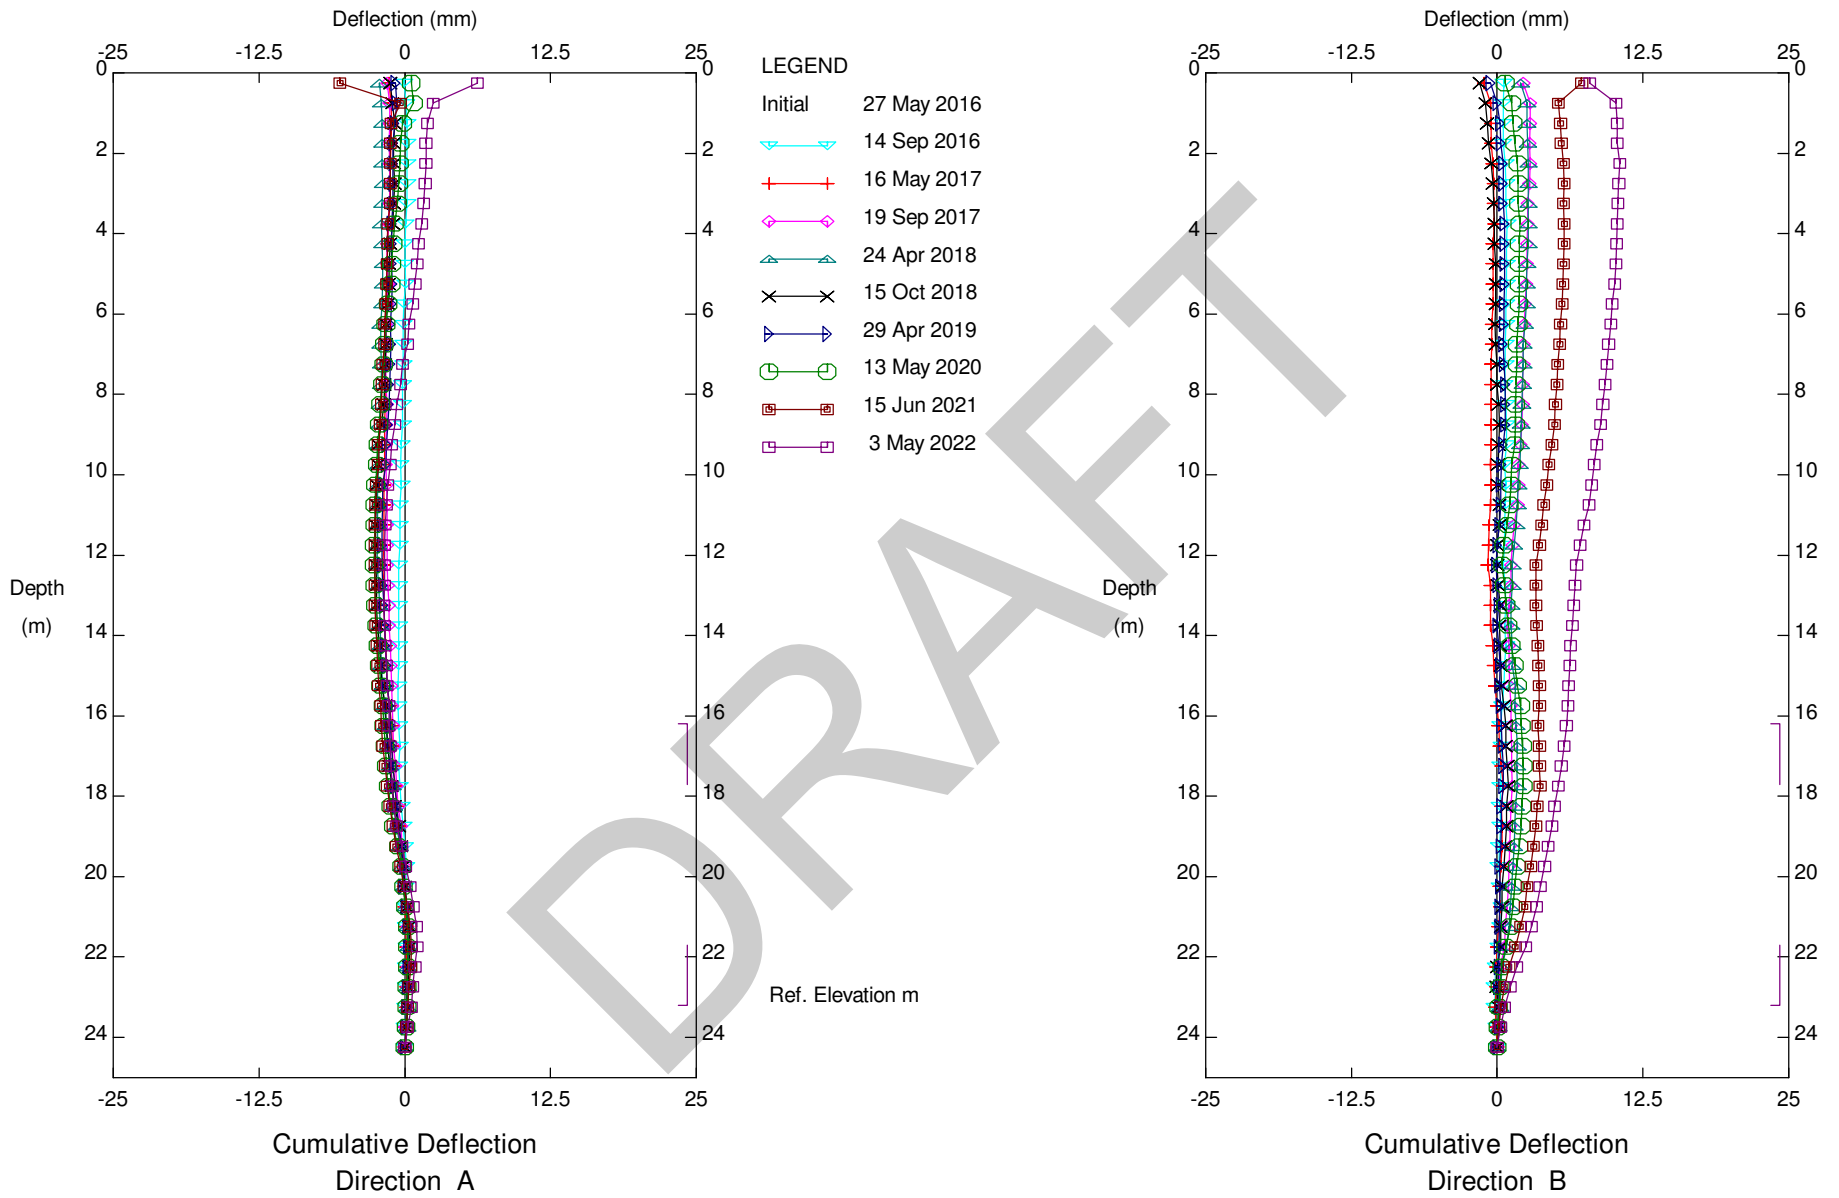
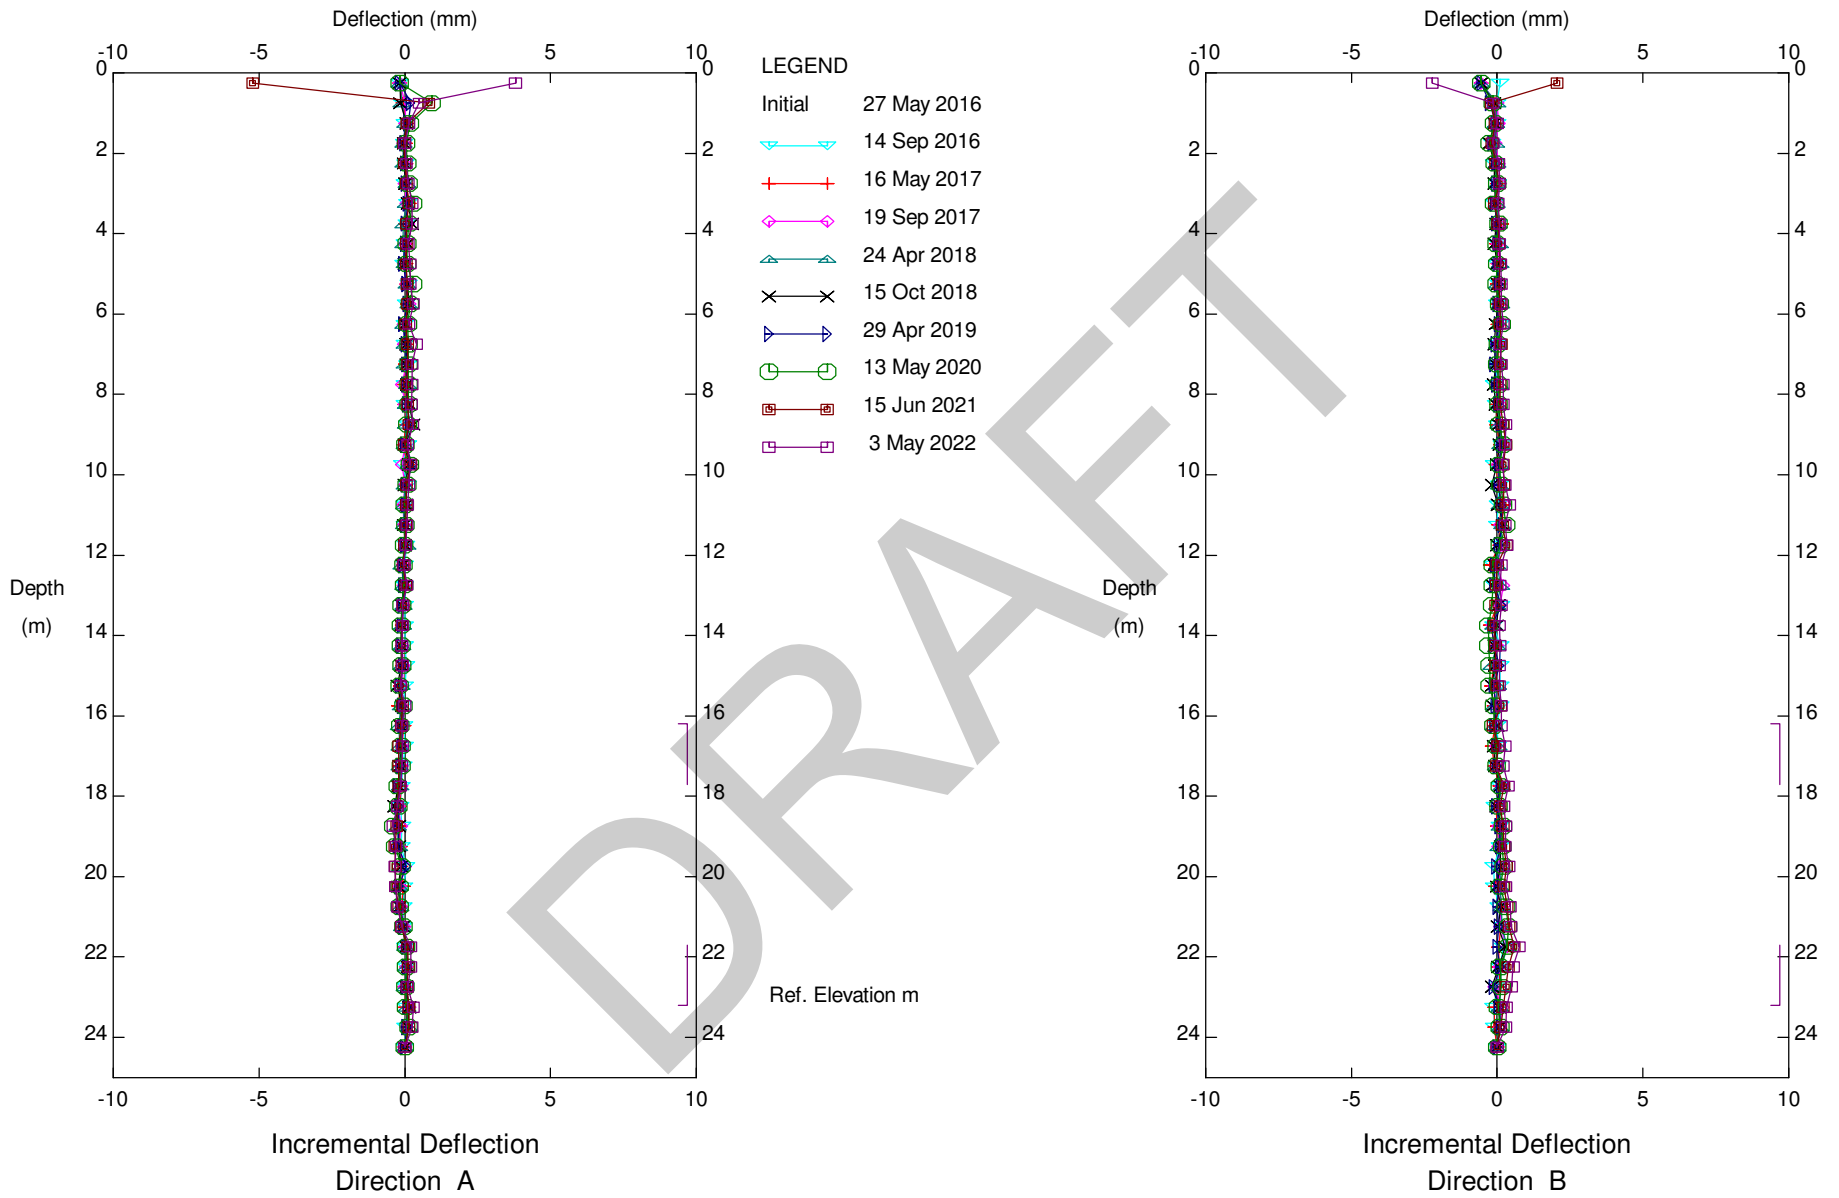
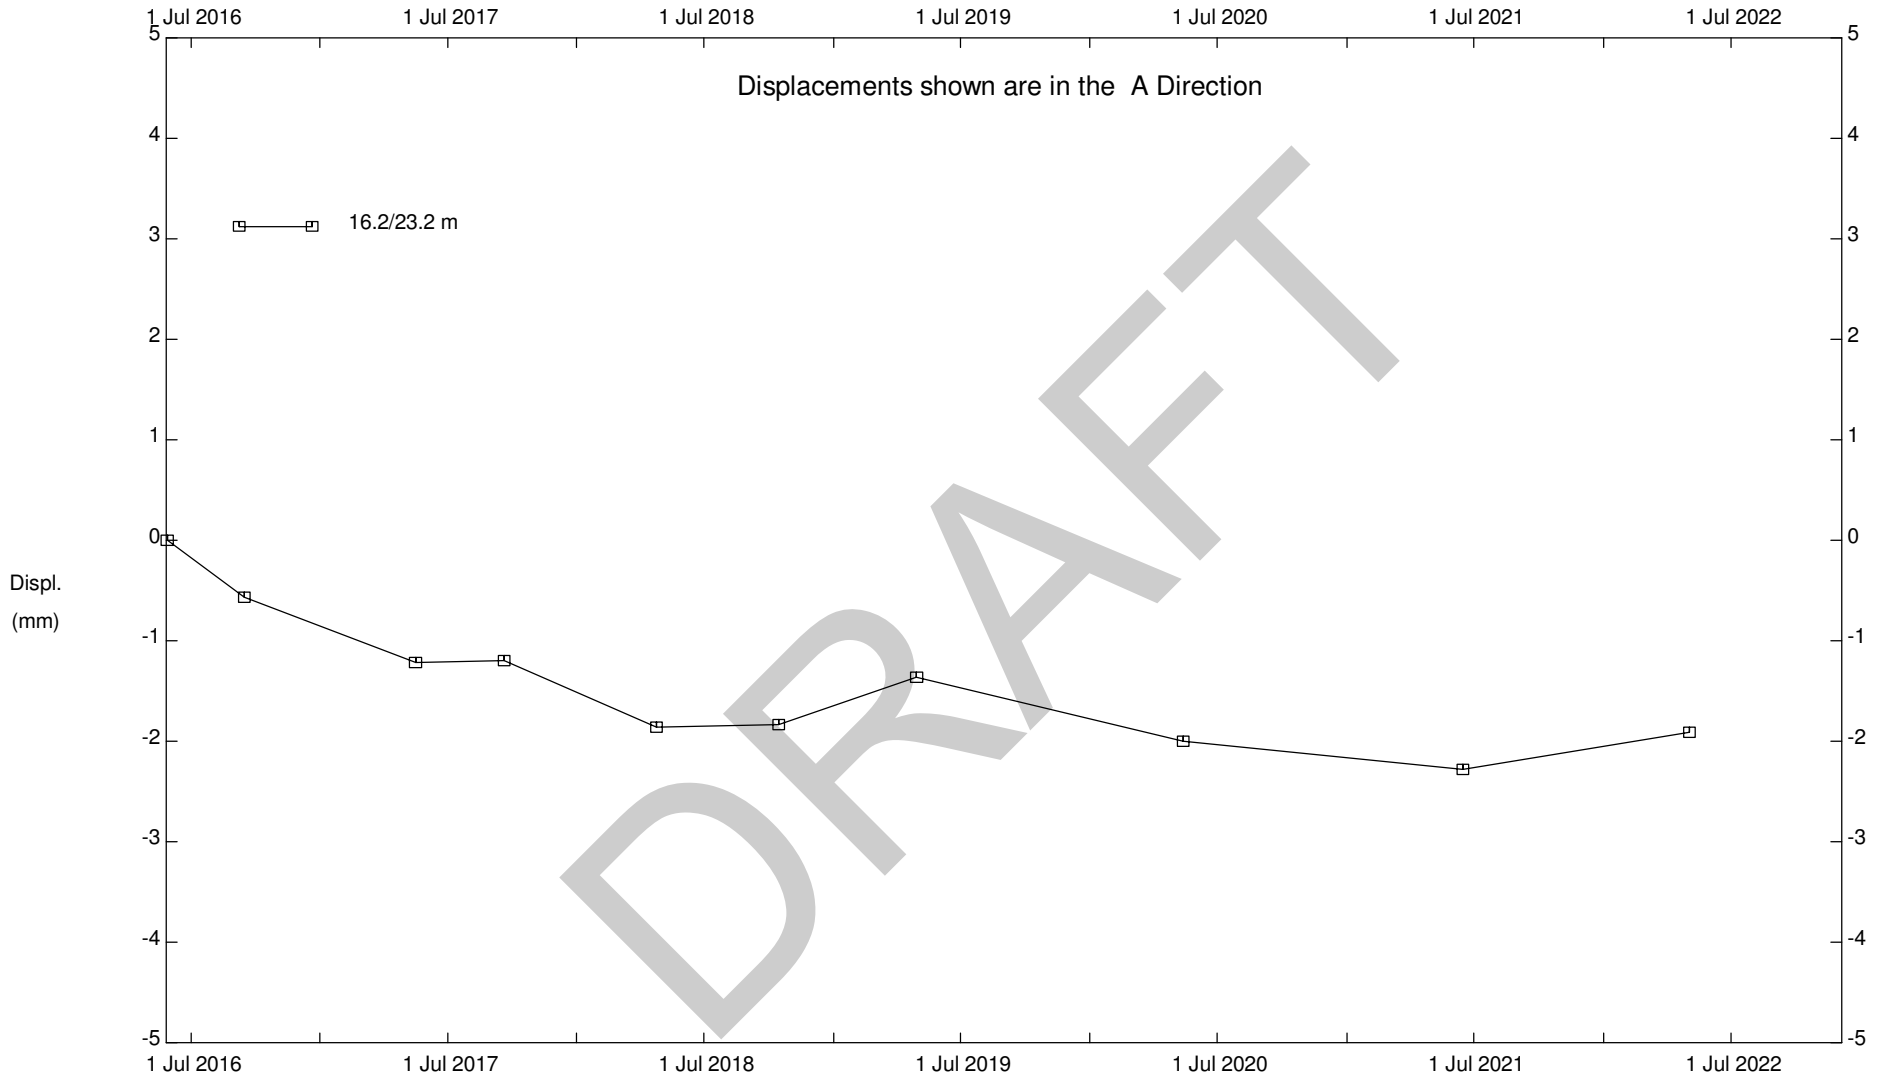
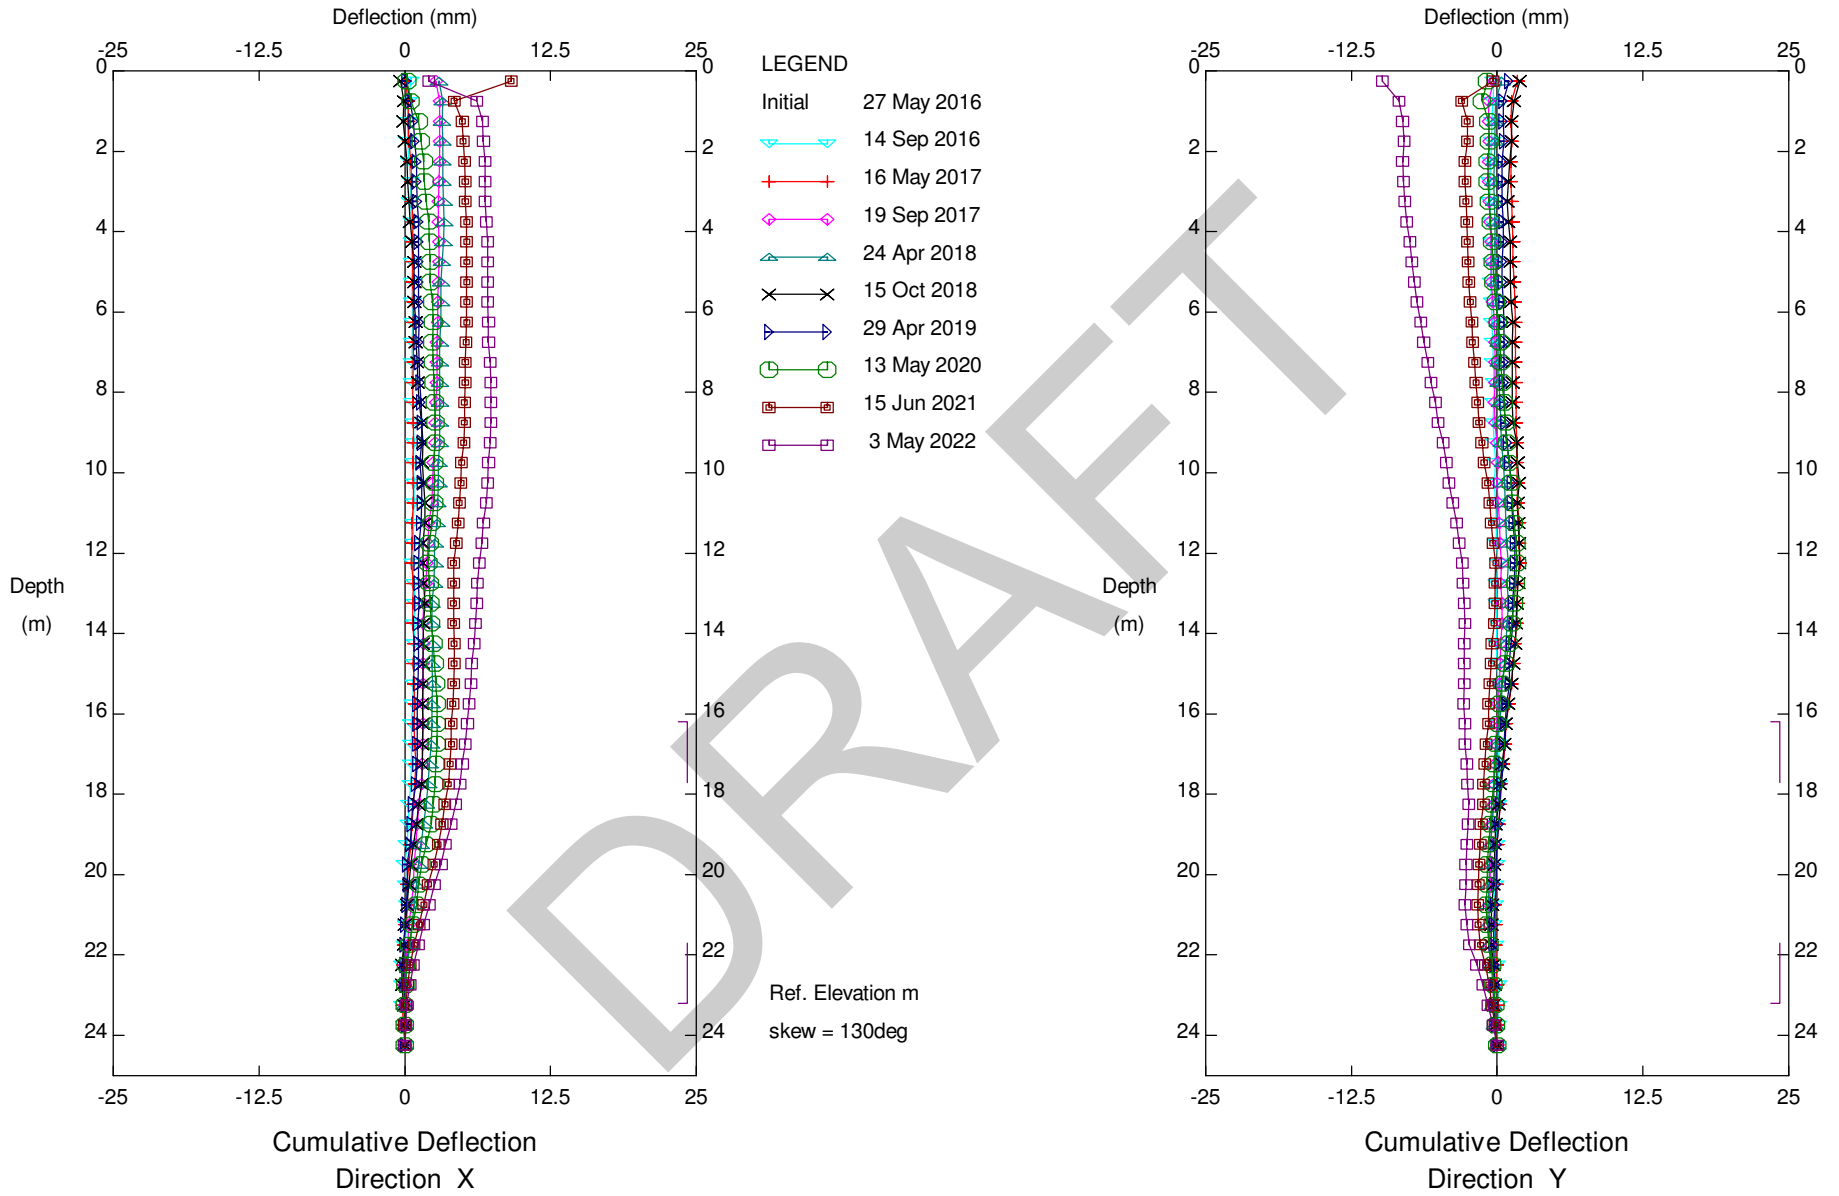
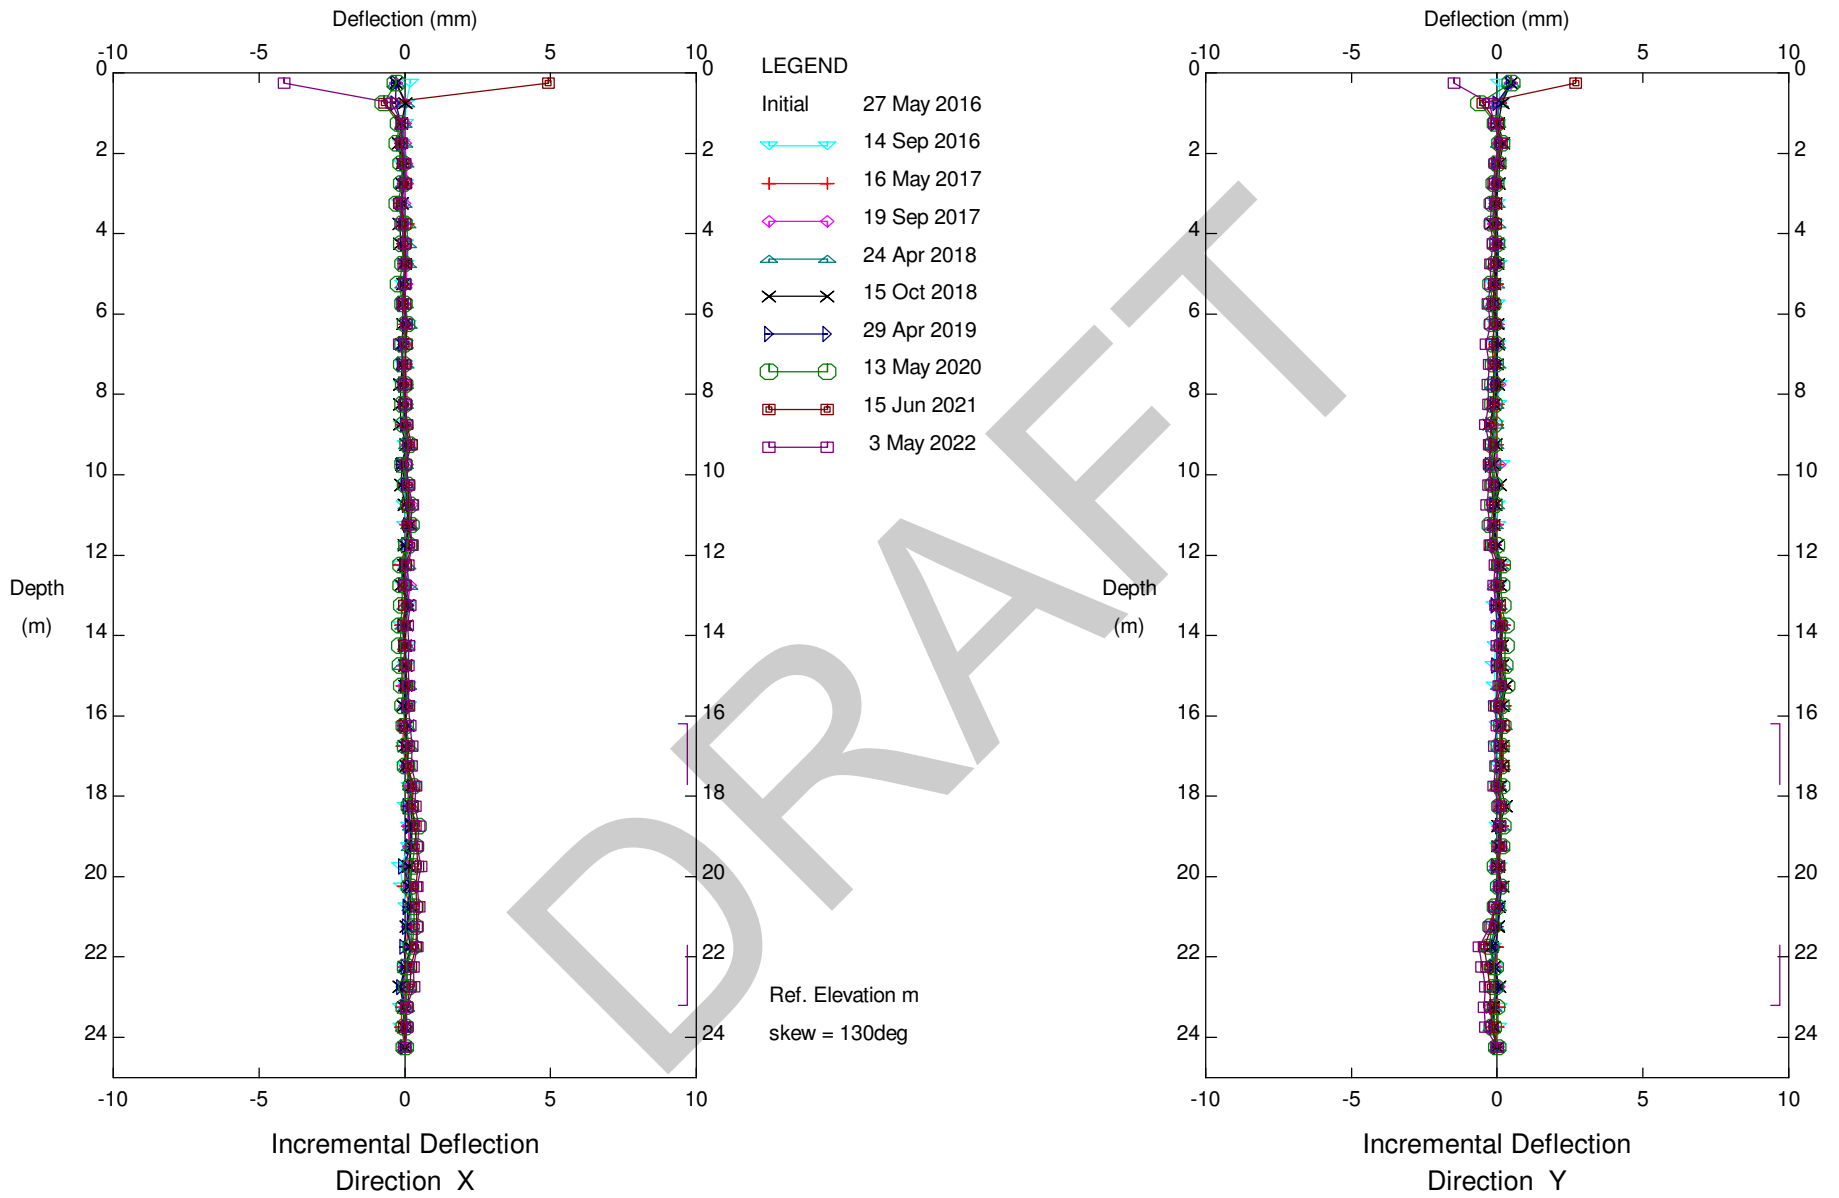
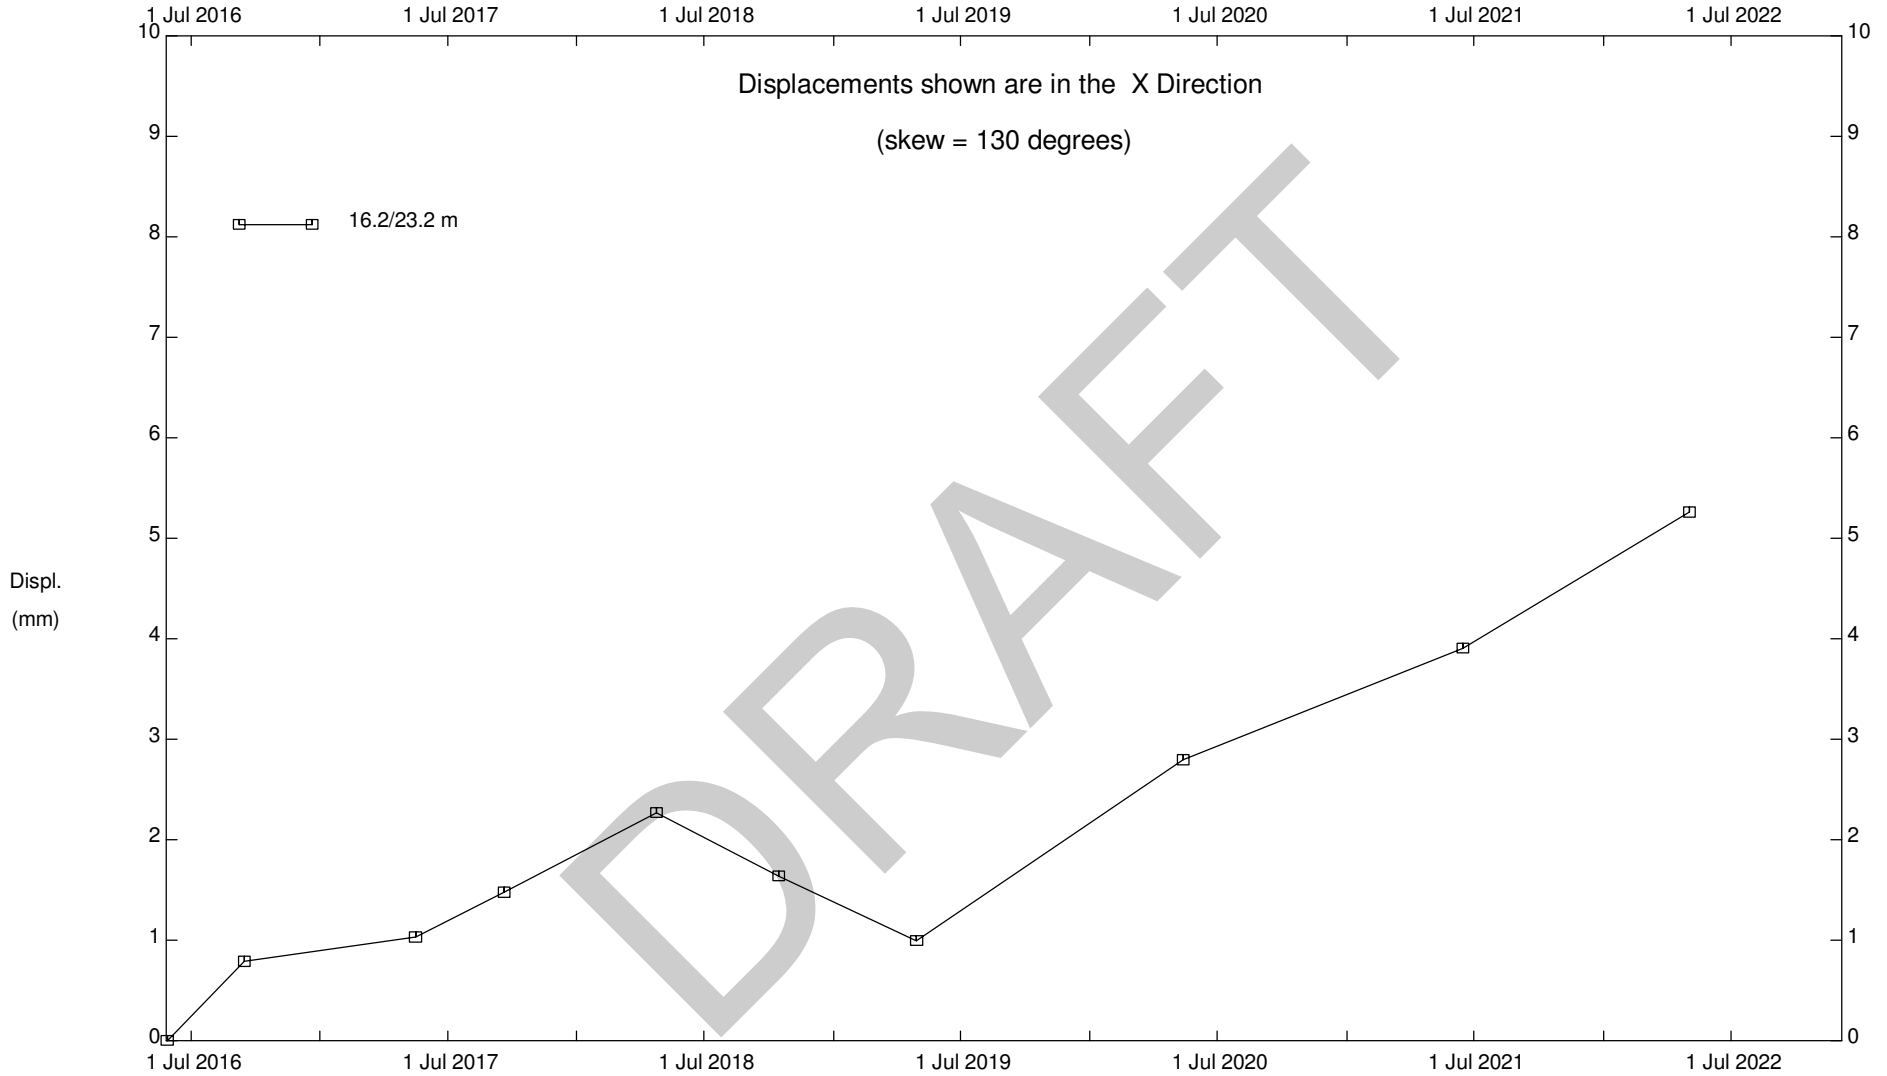
S037; H533:02, Spring Hill Creek, Inclinometer SI10-1  
 Alberta Transportation

Distributed movement has been recorded in SI10-1 and SI10-2 from an approximate depth of 16 m to 23 m and 2 m to 22 m below ground surface, respectively.

Since KCB re-initialized the instruments in 2016, the rate of movement recorded in SI10-1 and SI10-2 has been slow (less than 1 mm/year), except for an increased rate of movement (approximately 10 mm/year) recorded in SI10-2 in the spring of 2022. SI10-2 is located at the crest of Slide Area 3, and SI10-01 is located between Slide Area 2 and 3. Site conditions at the Slide Area 3 appear similar to 2021, so the increased rate of movement is likely due to a small data shift caused by KCB changing the SI reading equipment when the old equipment became inoperable. The small rate of movement being recorded in the SIs makes the data sensitive to changes in equipment. More data is needed to assess.

All operable instruments should continue to be read twice per year (spring and fall).
