September 21, 2022

Alberta Transportation  
2<sup>nd</sup> Floor, 803 Manning Road N.E.  
Calgary, Alberta  
T2E 7M8

**CON0022161 Southern Region GRMP Instrumentation Monitoring  
Site S037; H533:02 km 22.3 to km 21.9 Springhill Creek  
Section C – 2022 Spring Readings**

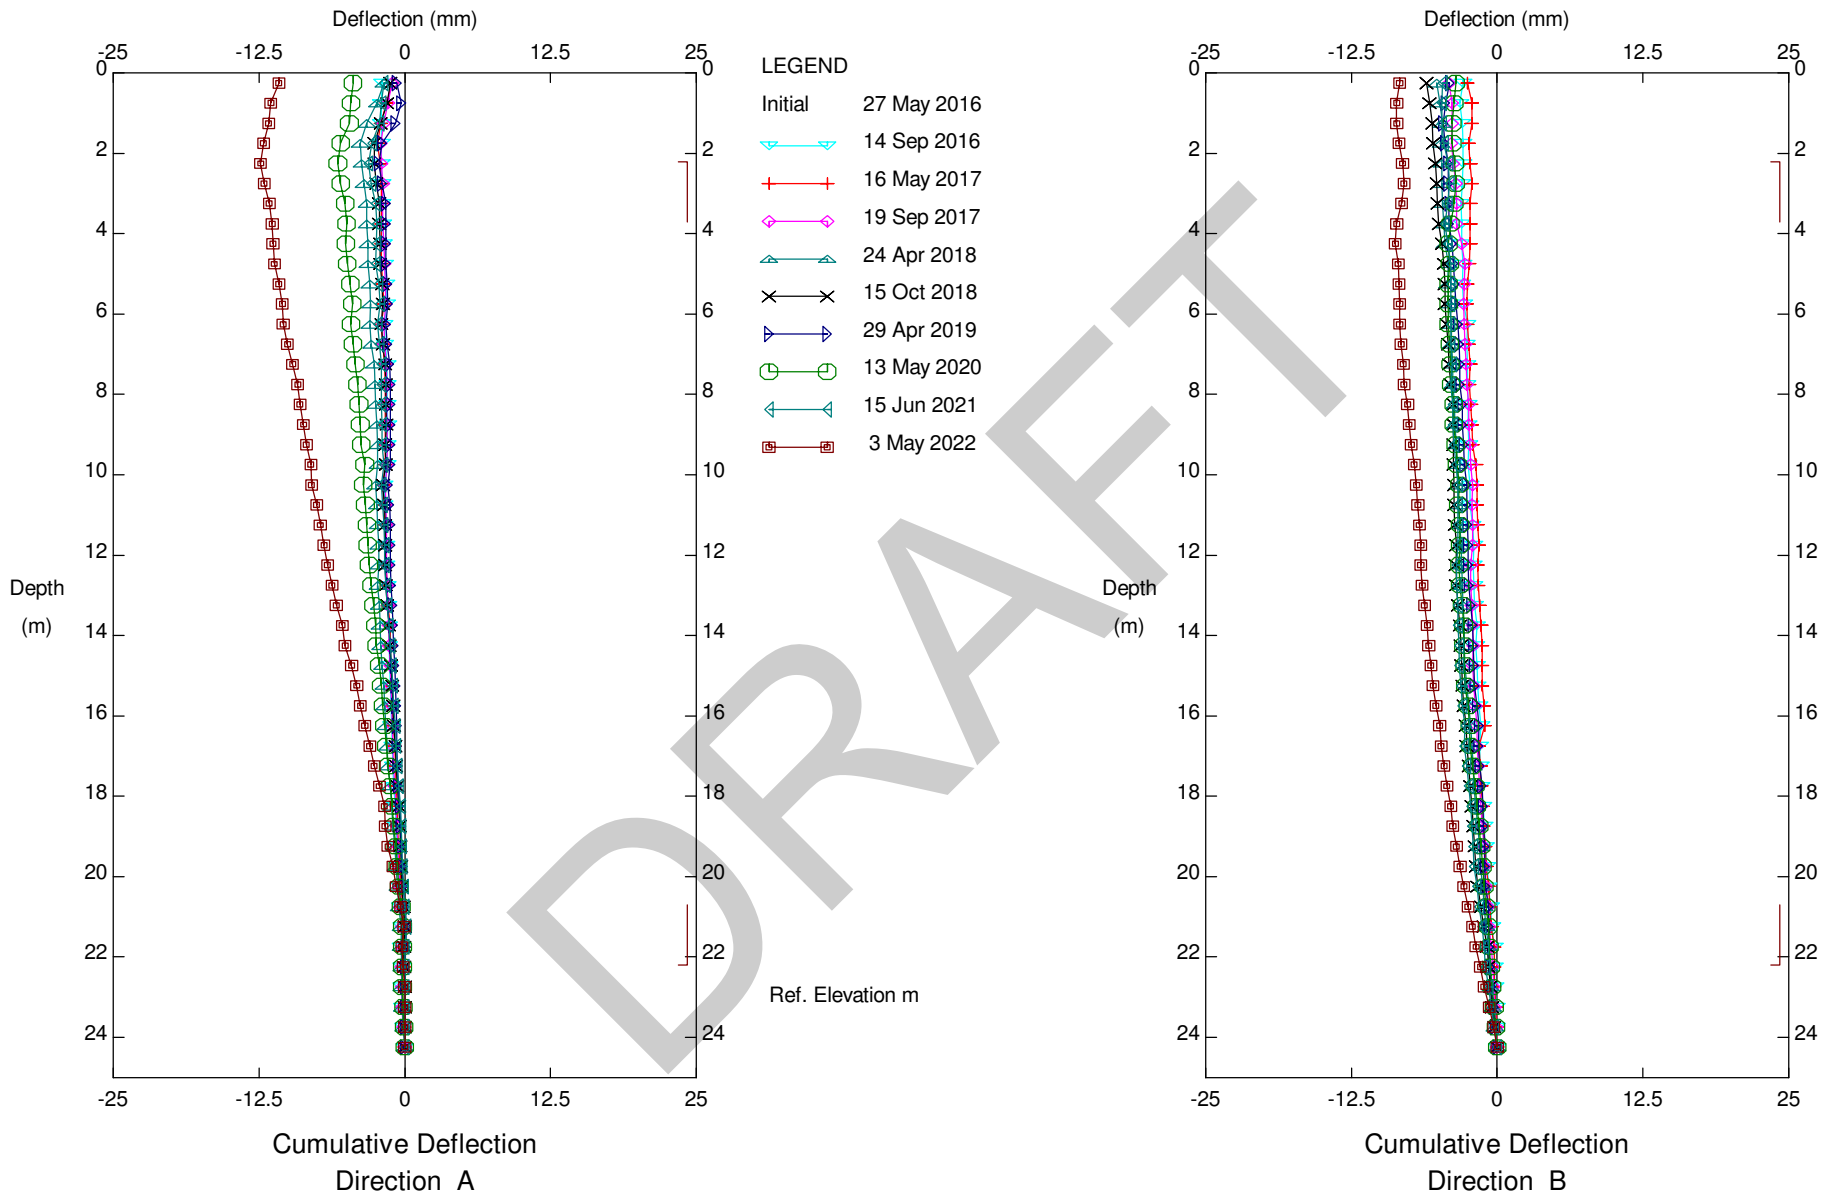
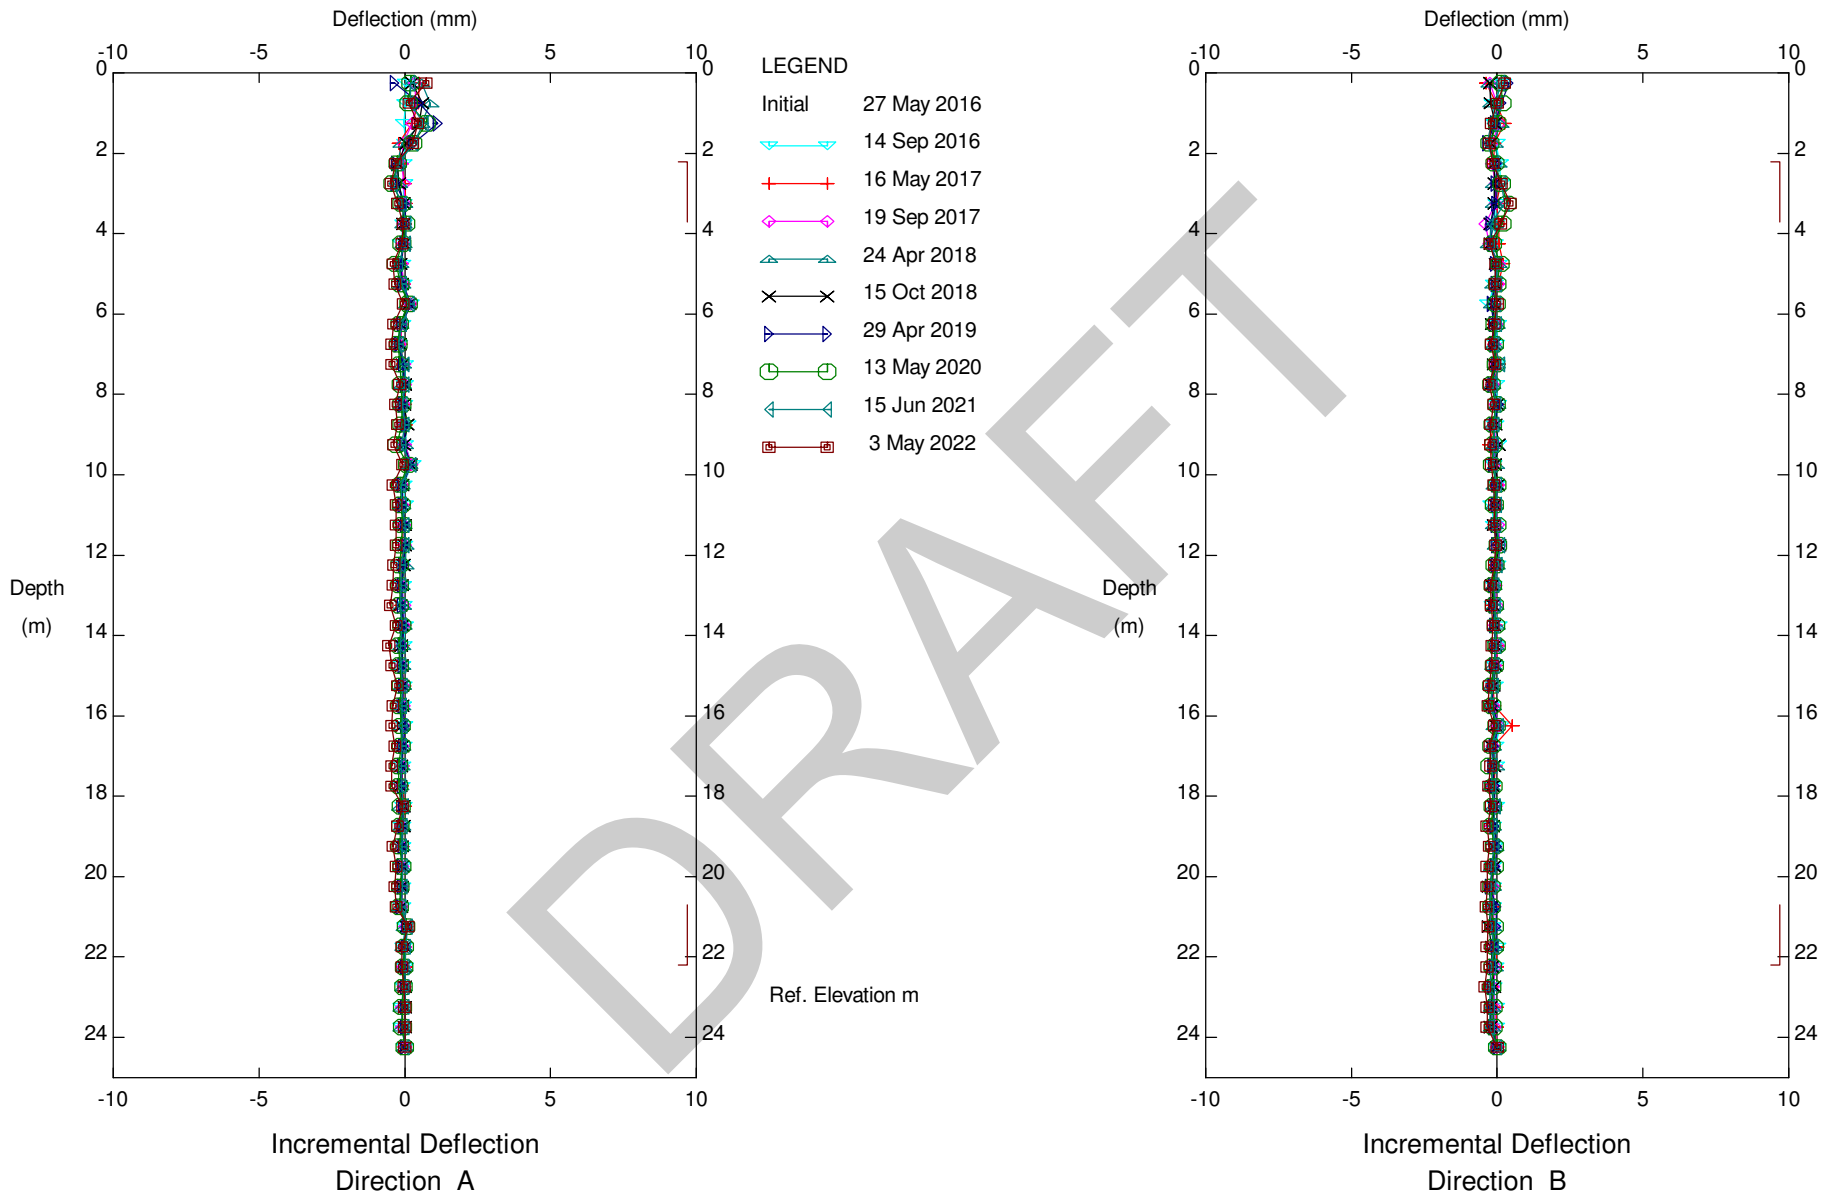
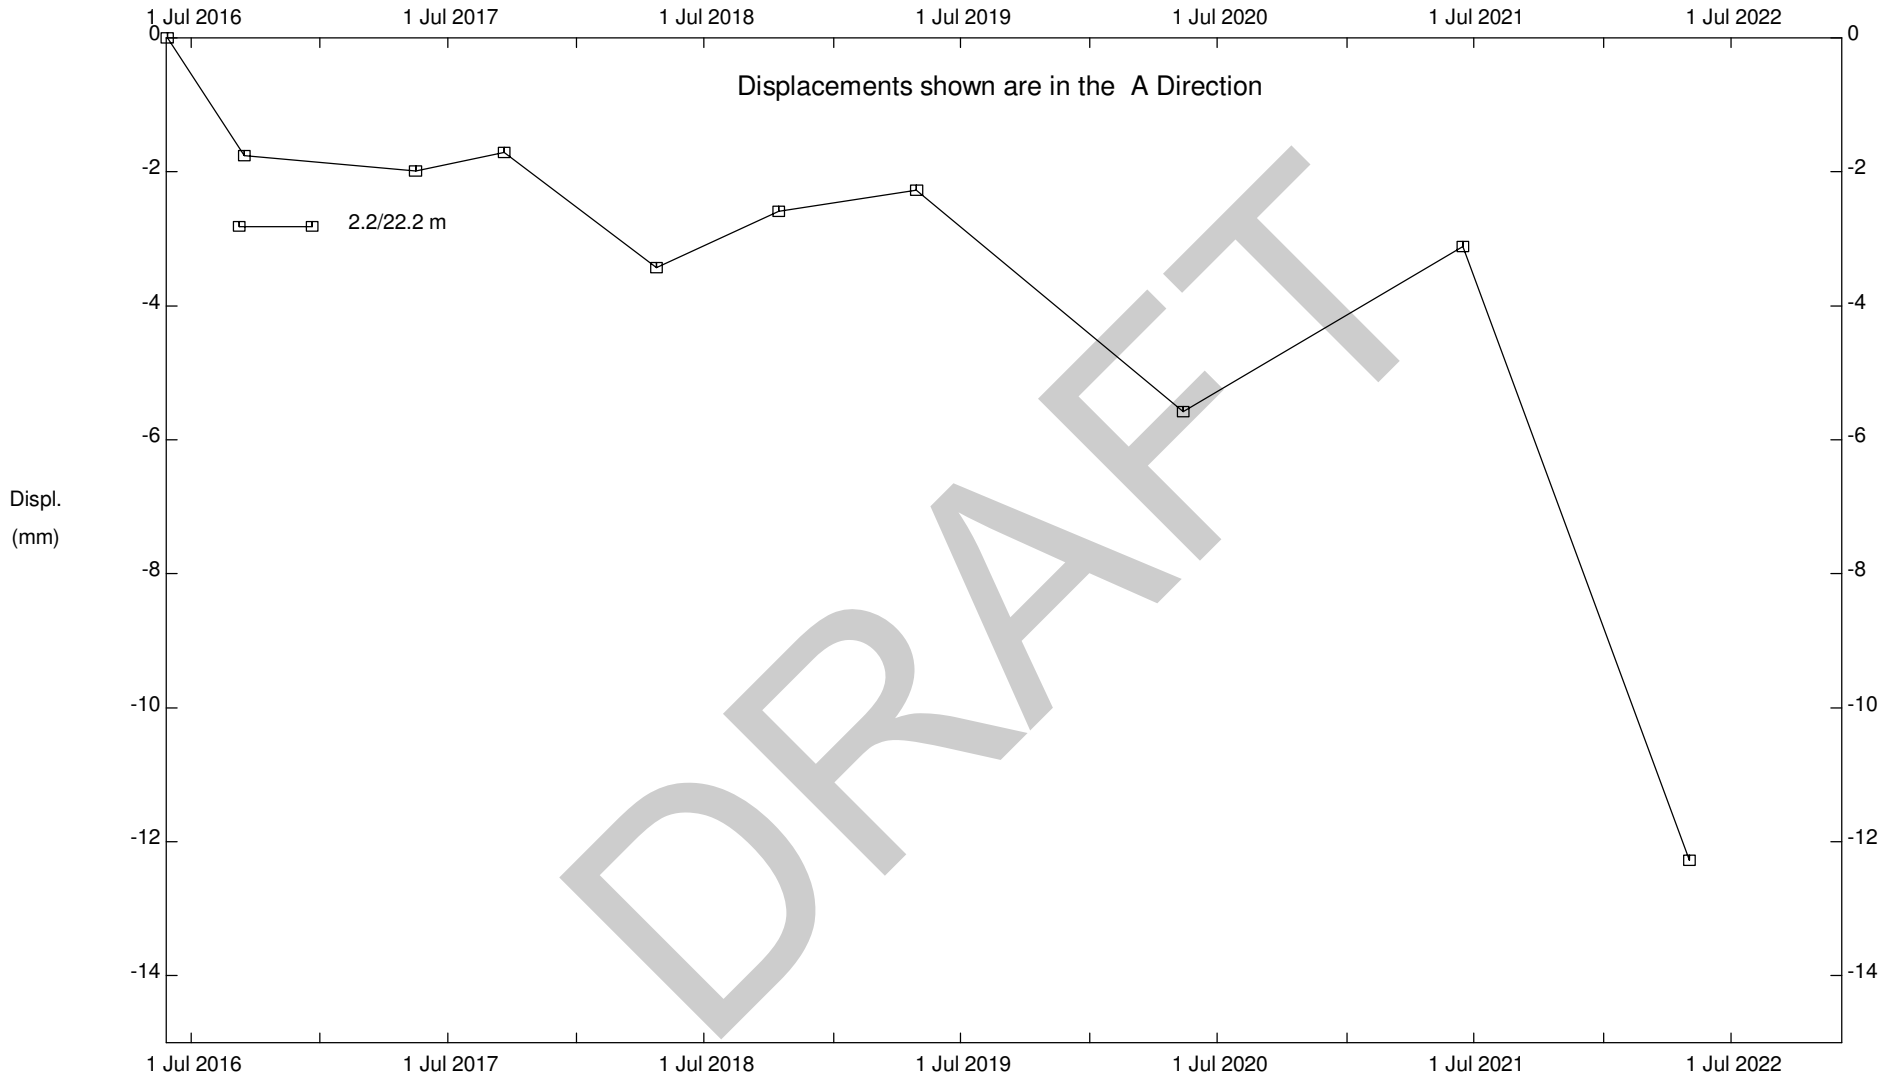
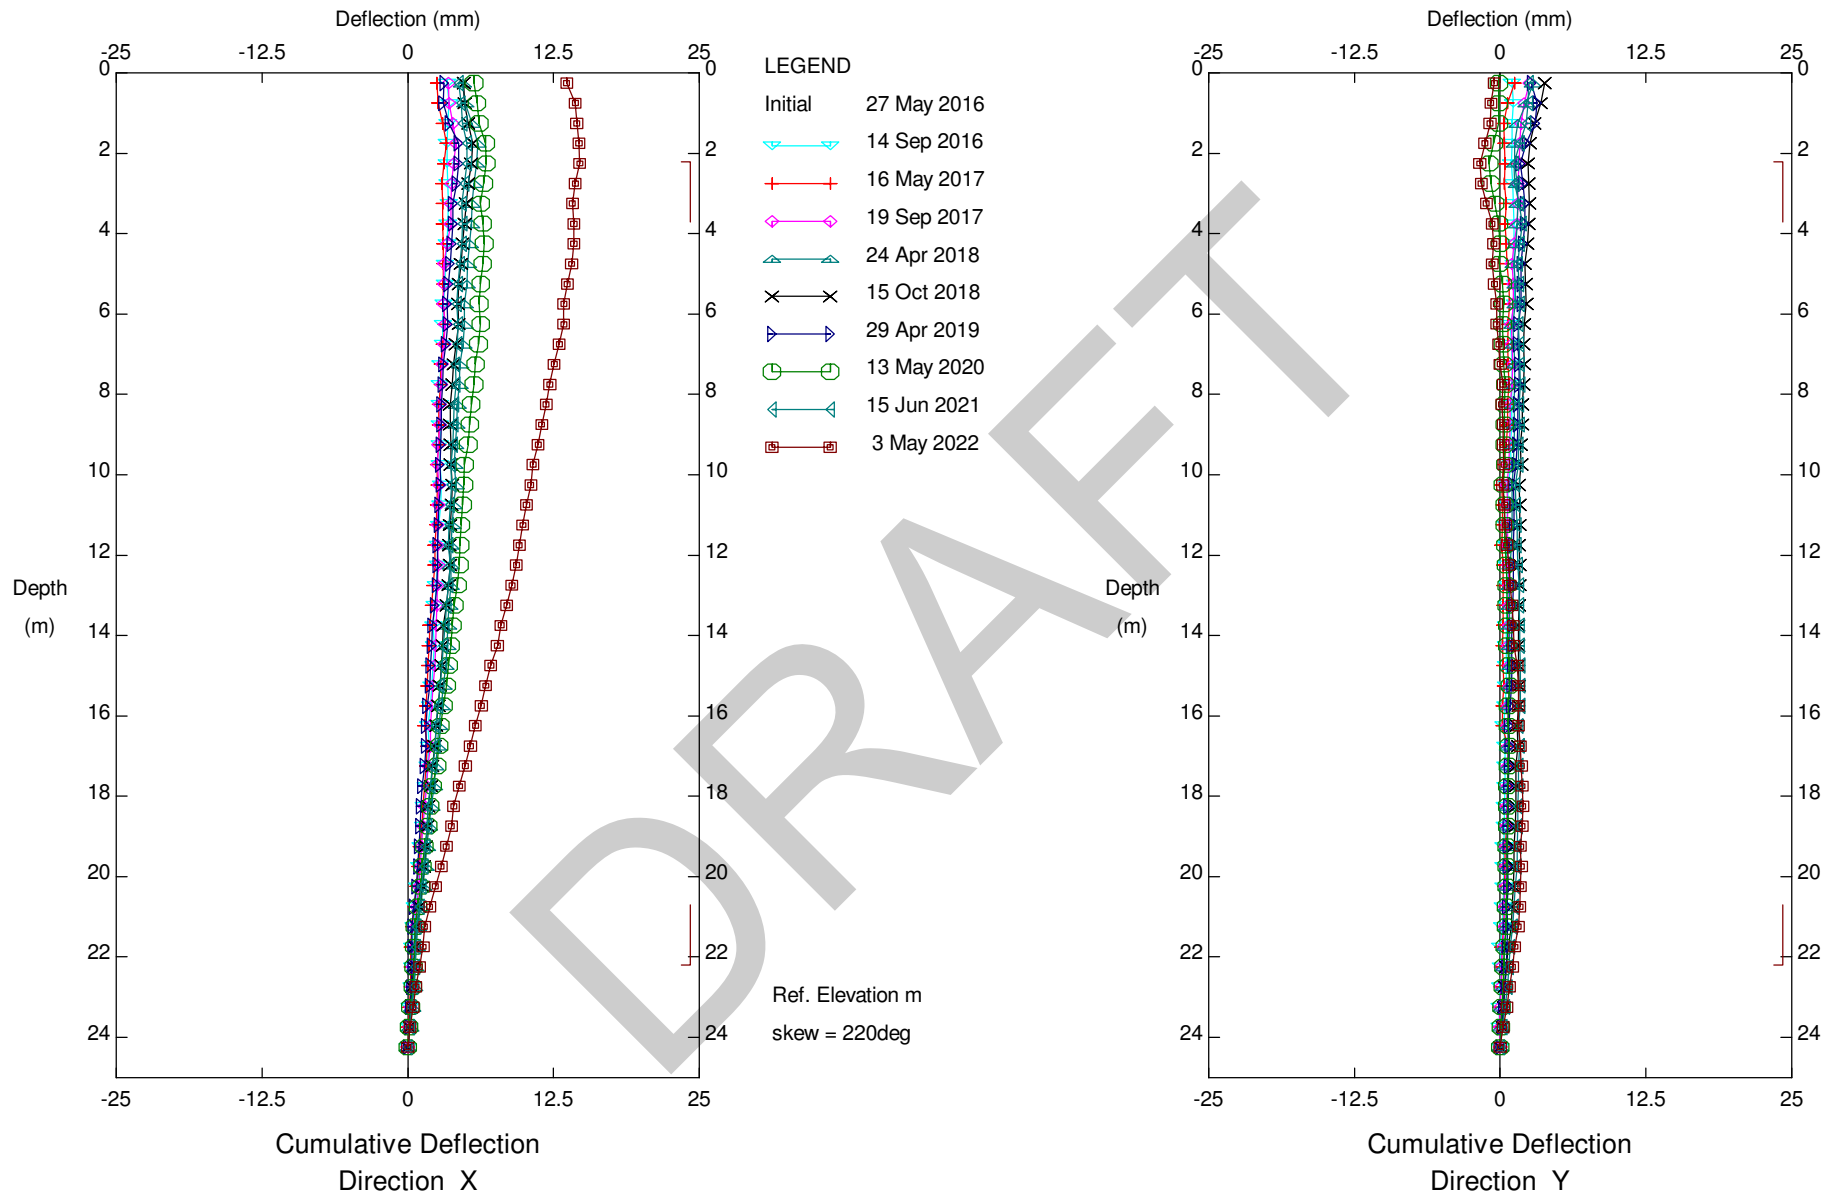
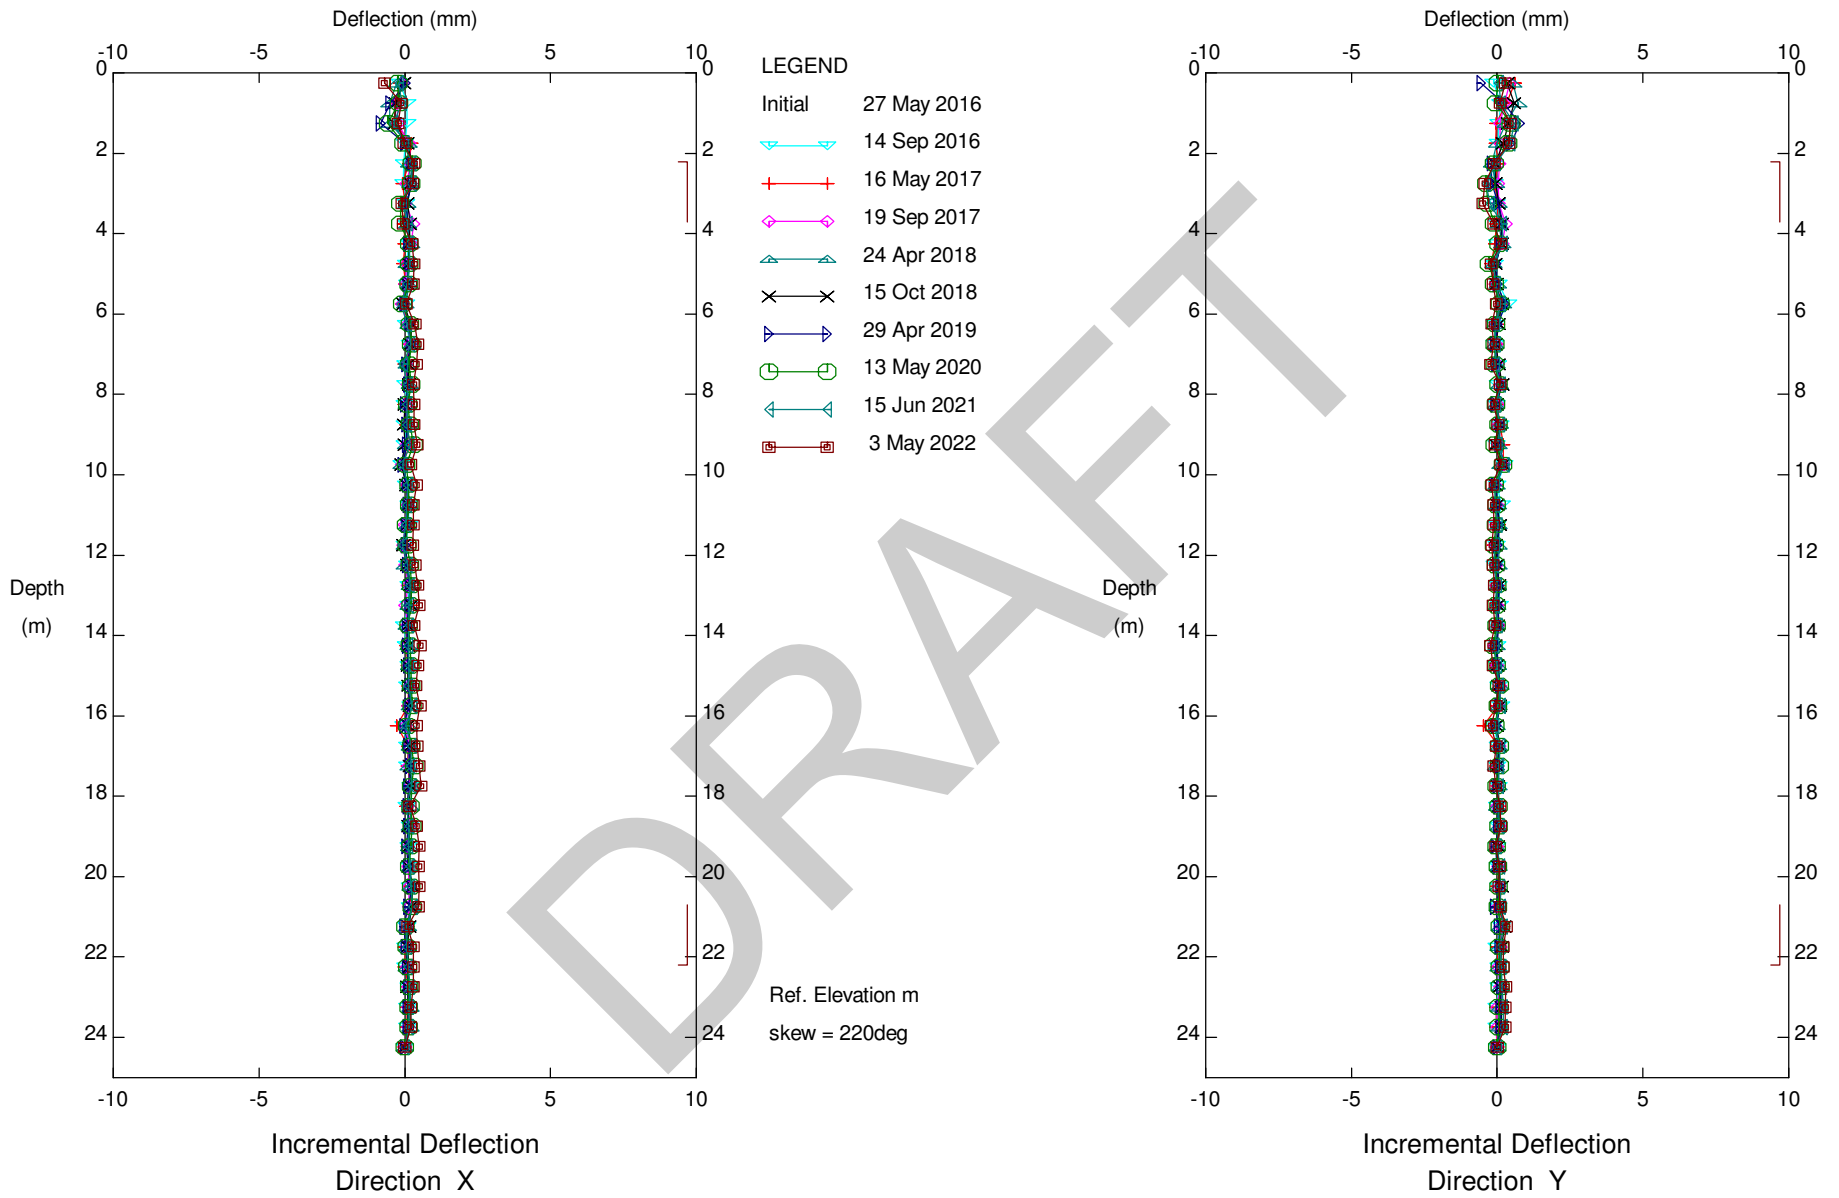
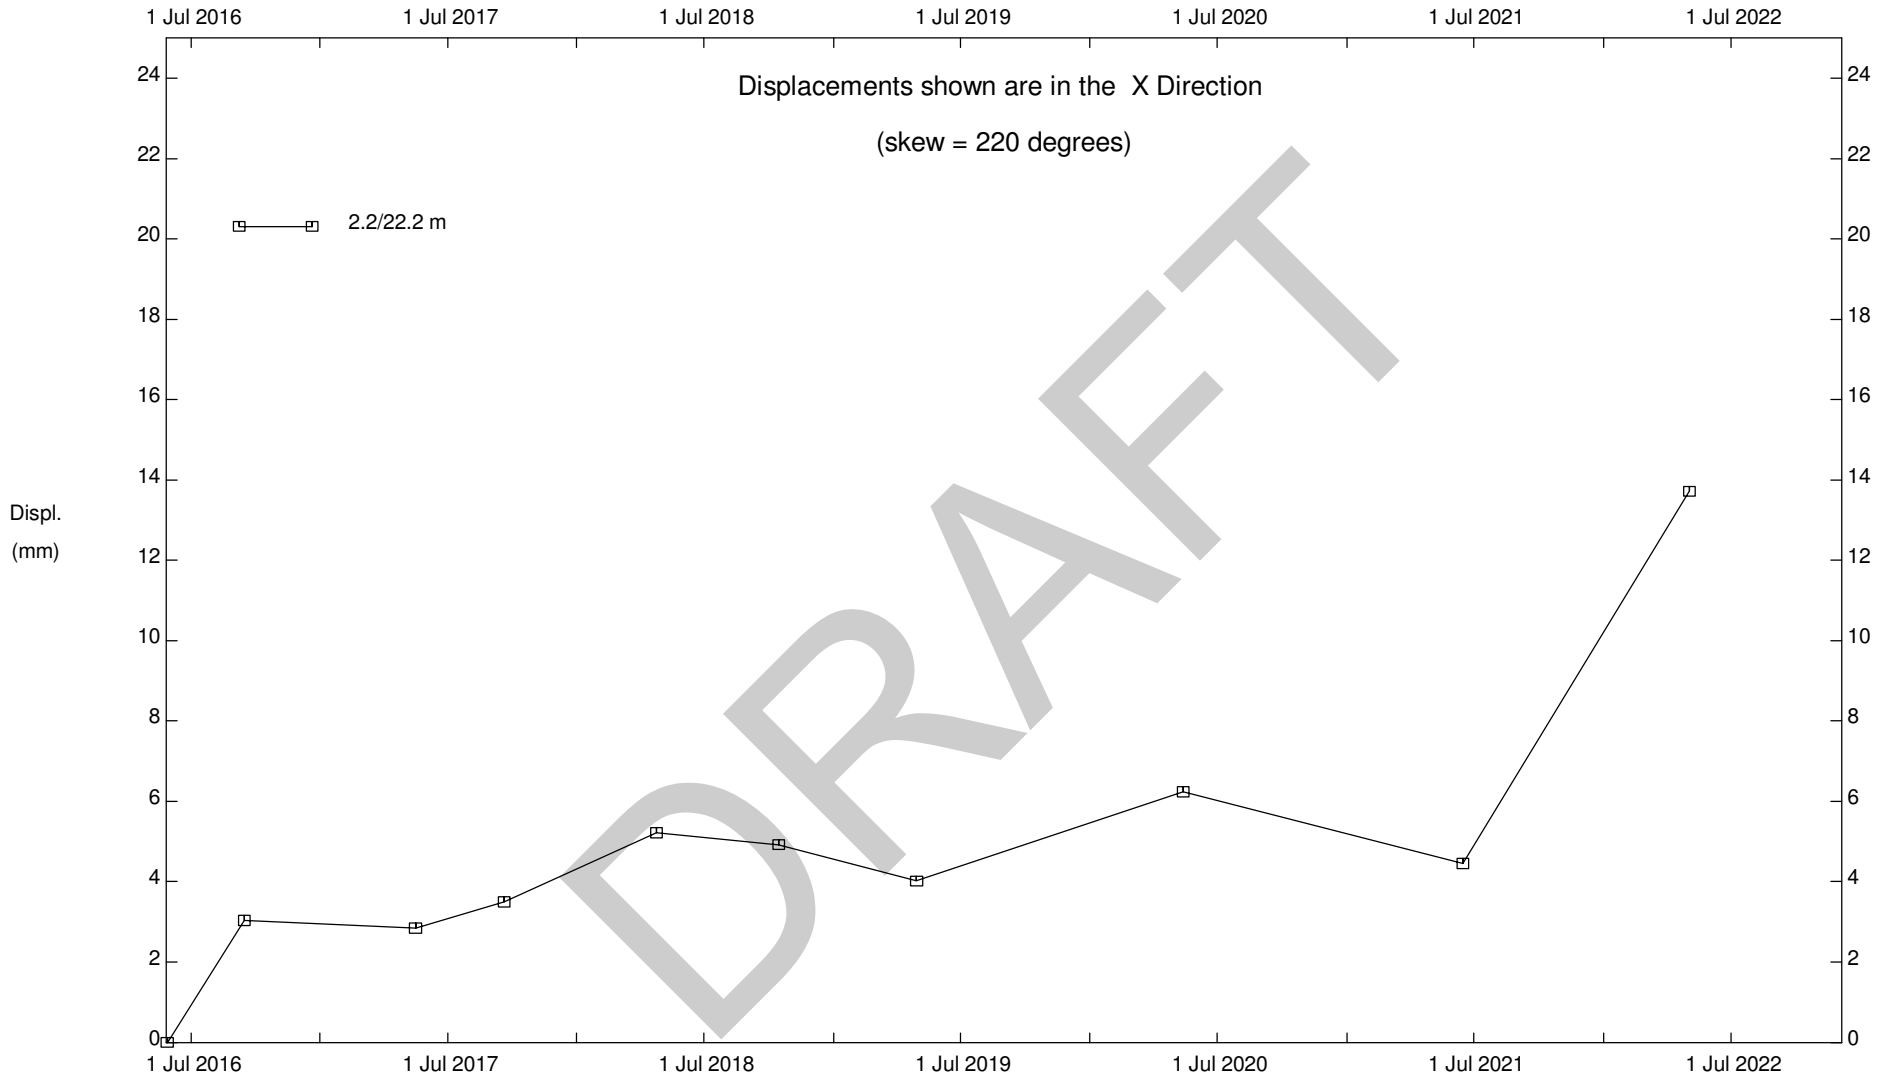
S037; H533:02, Spring Hill Creek, Inclinator SI10-2  
 Alberta Transportation

Distributed movement has been recorded in SI10-1 and SI10-2 from an approximate depth of 16 m to 23 m and 2 m to 22 m below ground surface, respectively.

Since KCB re-initialized the instruments in 2016, the rate of movement recorded in SI10-1 and SI10-2 has been slow (less than 1 mm/year), except for an increased rate of movement (approximately 10 mm/year) recorded in SI10-2 in the spring of 2022. SI10-2 is located at the crest of Slide Area 3, and SI10-01 is located between Slide Area 2 and 3. Site conditions at the Slide Area 3 appear similar to 2021, so the increased rate of movement is likely due to a small data shift caused by KCB changing the SI reading equipment when the old equipment became inoperable. The small rate of movement being recorded in the SIs makes the data sensitive to changes in equipment. More data is needed to assess.

All operable instruments should continue to be read twice per year (spring and fall).

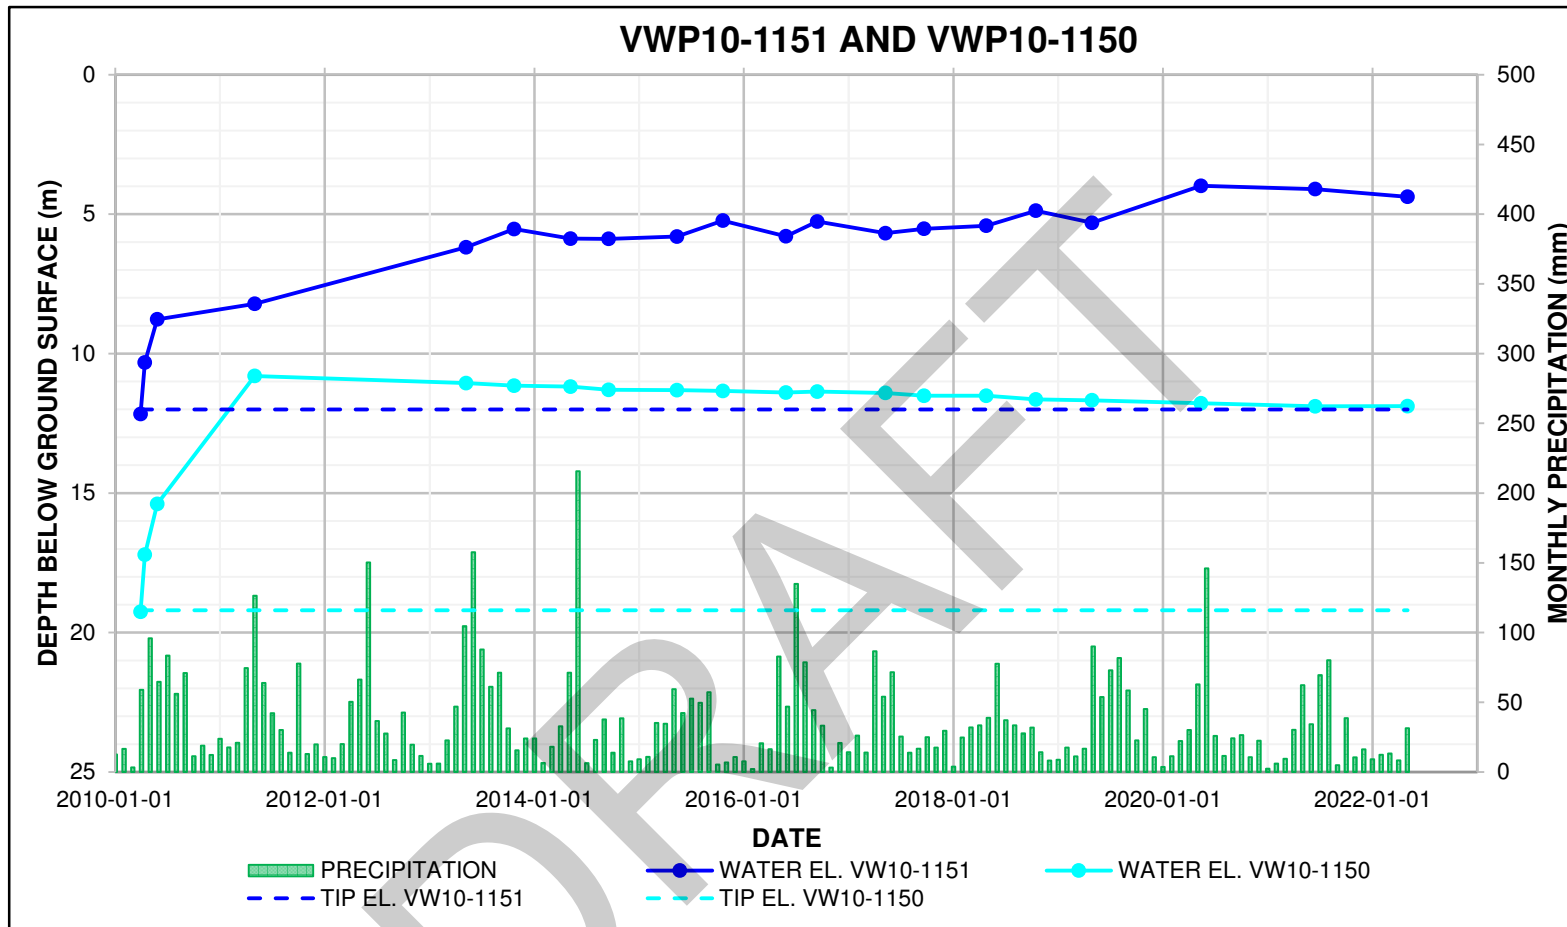
Piezometer Data  
S037 - Spring Hill Creek  
Hwy 533:02, km 21.9 to 22.3

Since May 2011, the water level recorded in VWP10-1050 has slowly decreased. In total, a 1.9 m and 0.3 m decrease has been recorded since May 2011 and the spring 2021 reading, respectively.

The water level recorded in VWP10-1051 steadily increased between May 2010 and October 2013 (increased of approximately 3.3 m) before being relatively unchanged (fluctuations of approximately 0.1 m) between October 2013 and April 2019. A large increase of approximately 1.3 m was recorded between April 2019 and May 2020. Since May 2020, the water level has decreased relatively steadily (overall decrease of 0.4 m).

It appears that VWP10-1051 may respond to increased levels of precipitation, as higher-than-average precipitation was recorded between 2010 and 2013 (in particular 2013) and in 2019 (preceded by two years of less-than-average precipitation).
