## BIM Supplemental Binder Index

84	Metric Conversion Table
85	Crane Signals
87	Working Limits from Power Lines
88	Ice Strengths

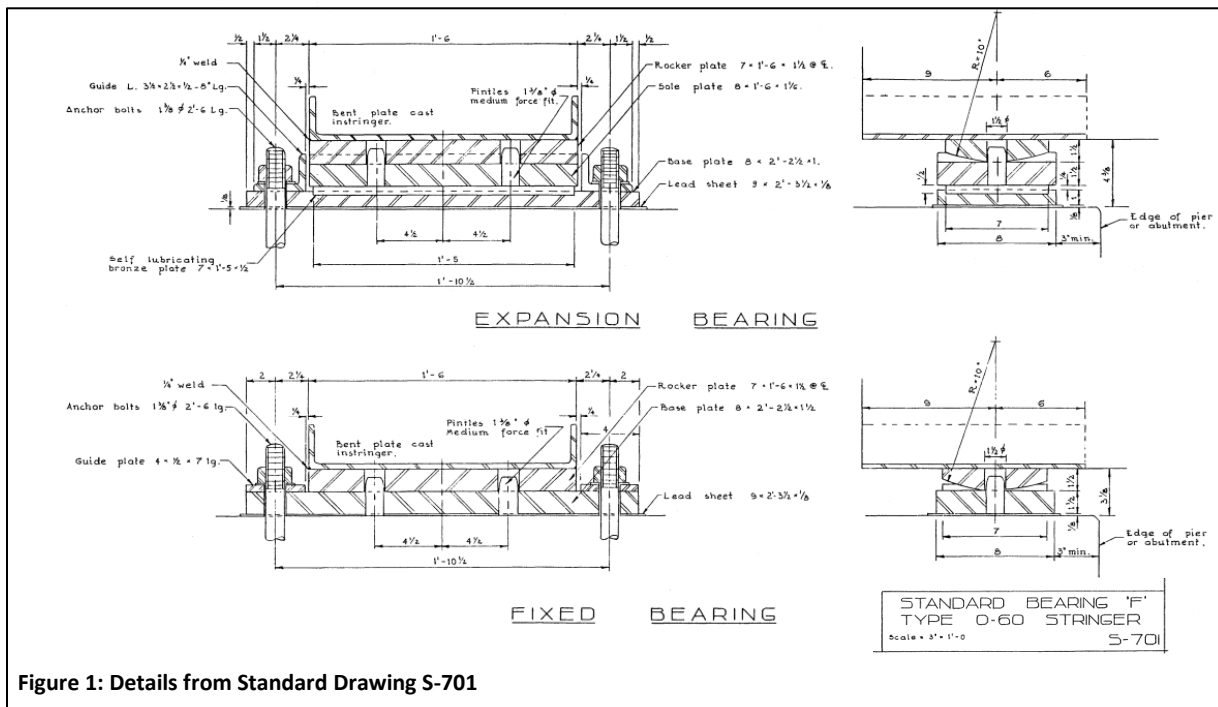
Figure 1: Details from Standard Drawing S-701

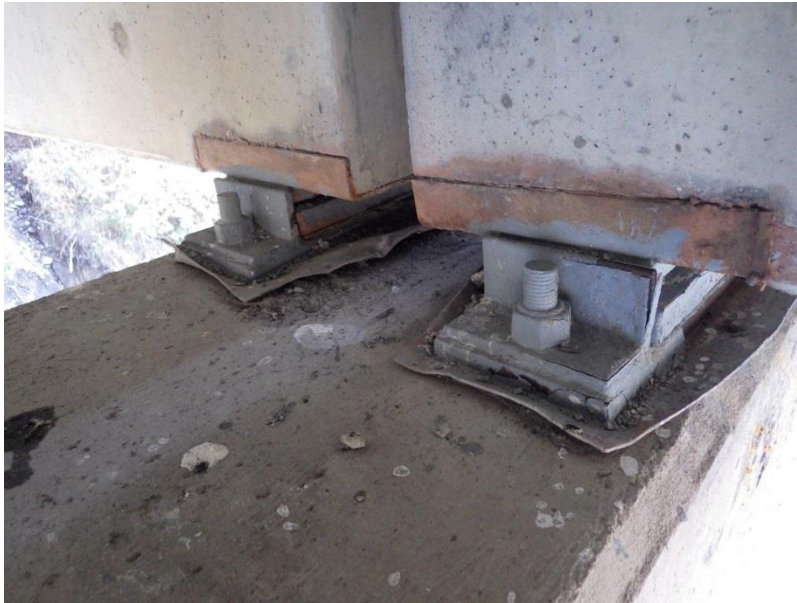
Figure 2: Steel sliding plate expansion bearings with self-lubricating bronze plates

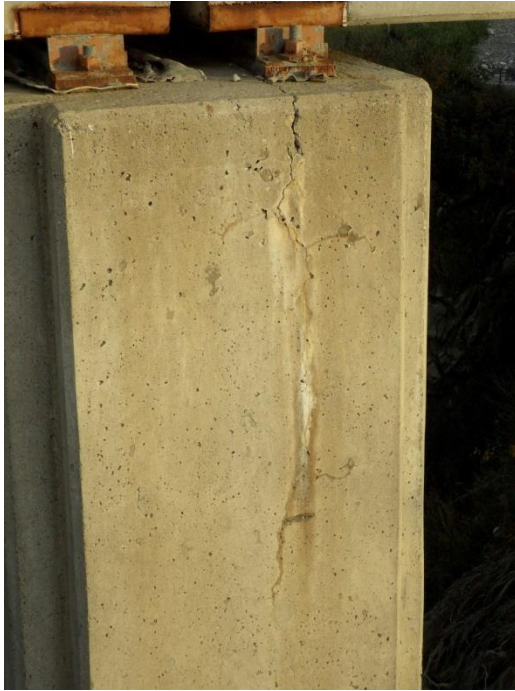
Figure 4: Wide crack in concrete cap at expansion bearing with staining.

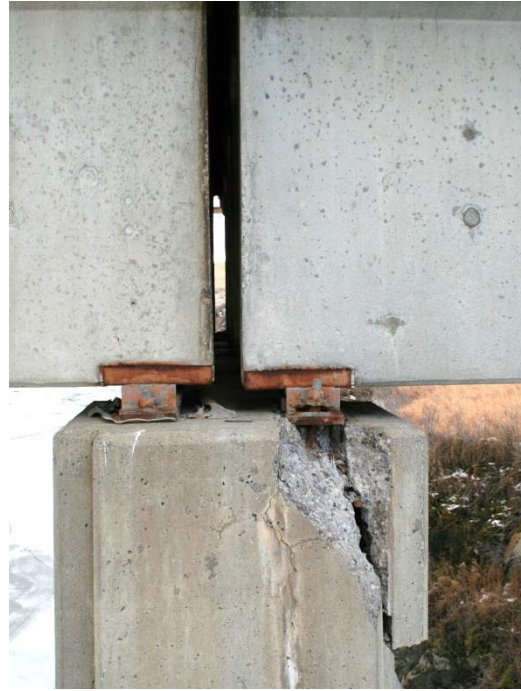
Figure 5: Concrete cap failure with girder drop in elevation.

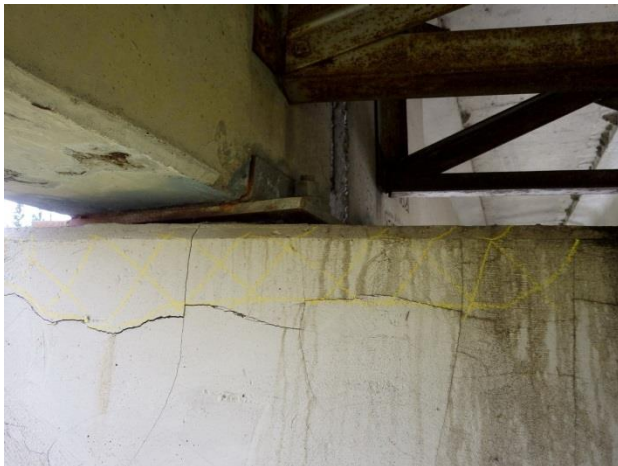
Figure 5: Wide cracks and concrete delamination in concrete S3G6 – P3. Pier cap and expansion bearing rated 3.

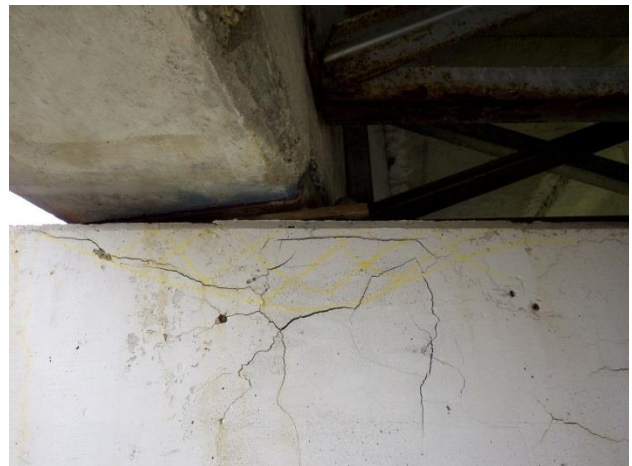
Figure 6: Wide cracks and delamination in bearing area of concrete cap at S2G1 - P2. Pier cap and fixed bearing rated 3.

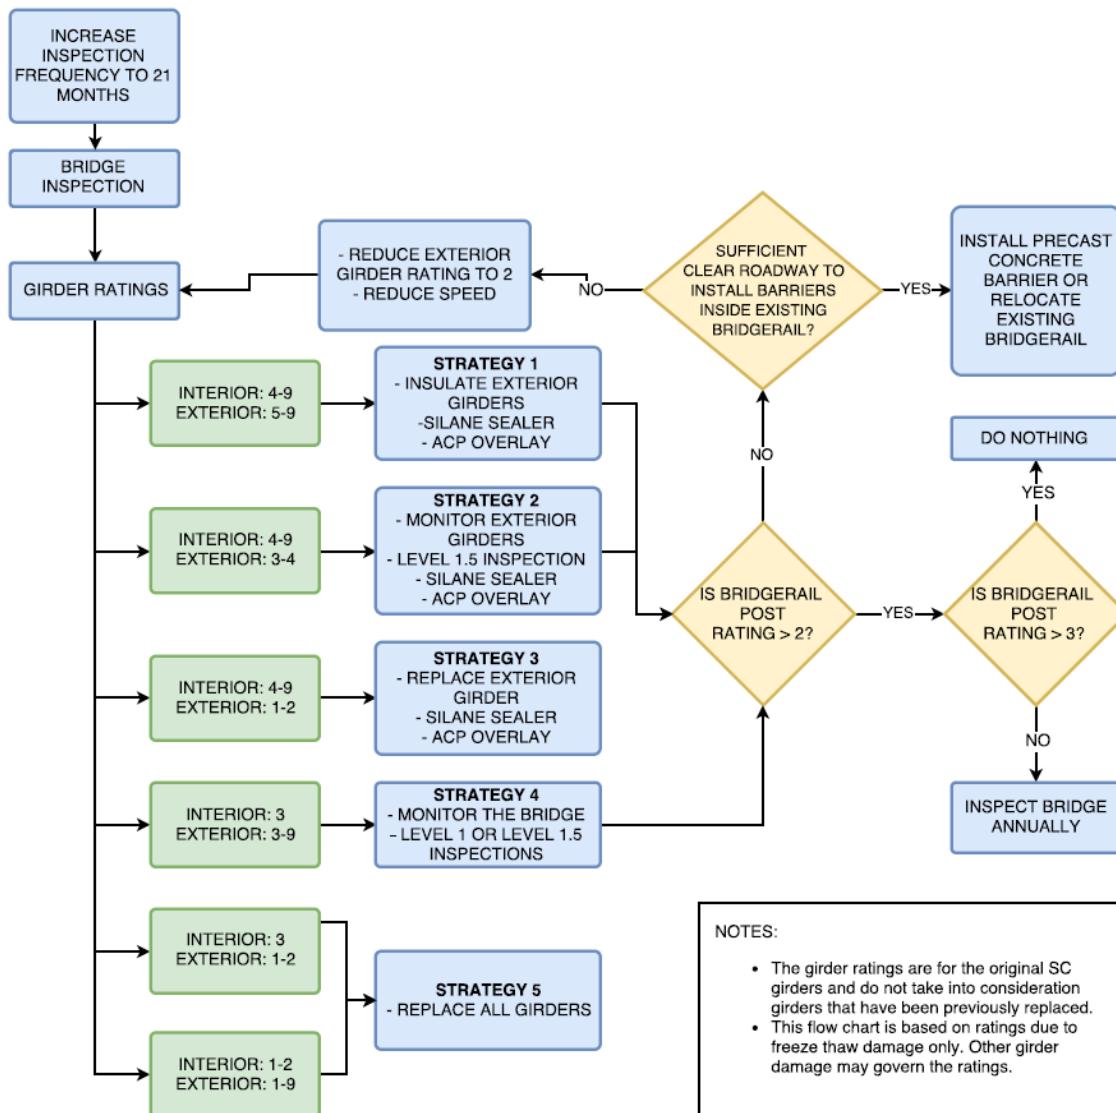
Figure 1: Management Strategy Flow Chart

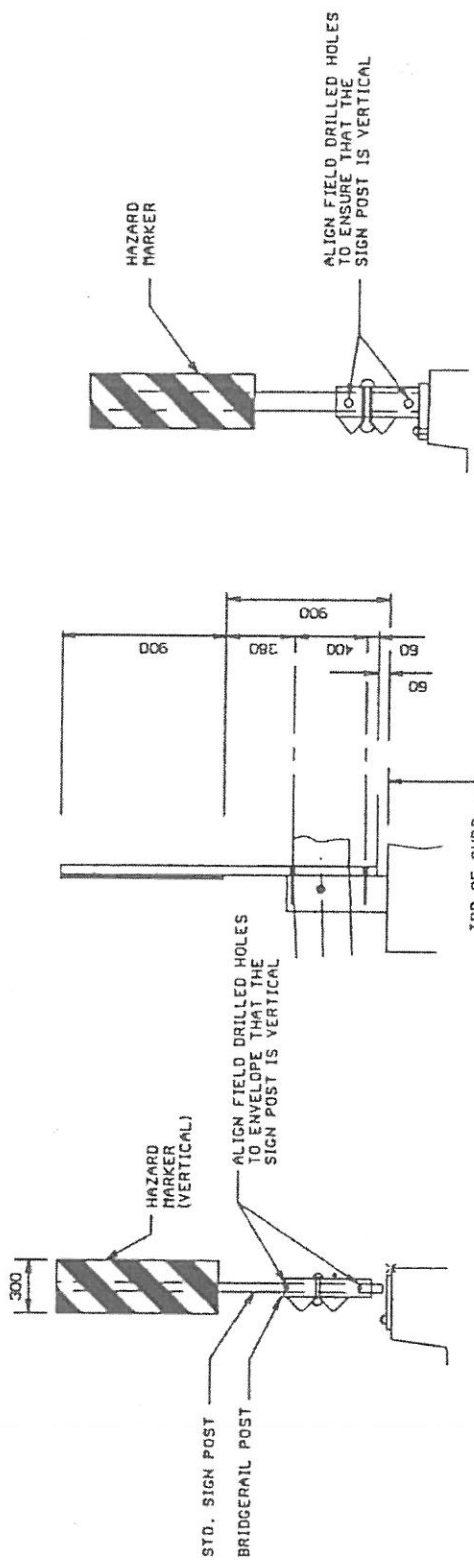
CONCRETE GIRDERS AND TREATED TIMBER (T.T.) SUBSTRUCTURE  
SPILL THROUGH TYPE ABUTMENT (LESS THAN 1.0 m HIGH)

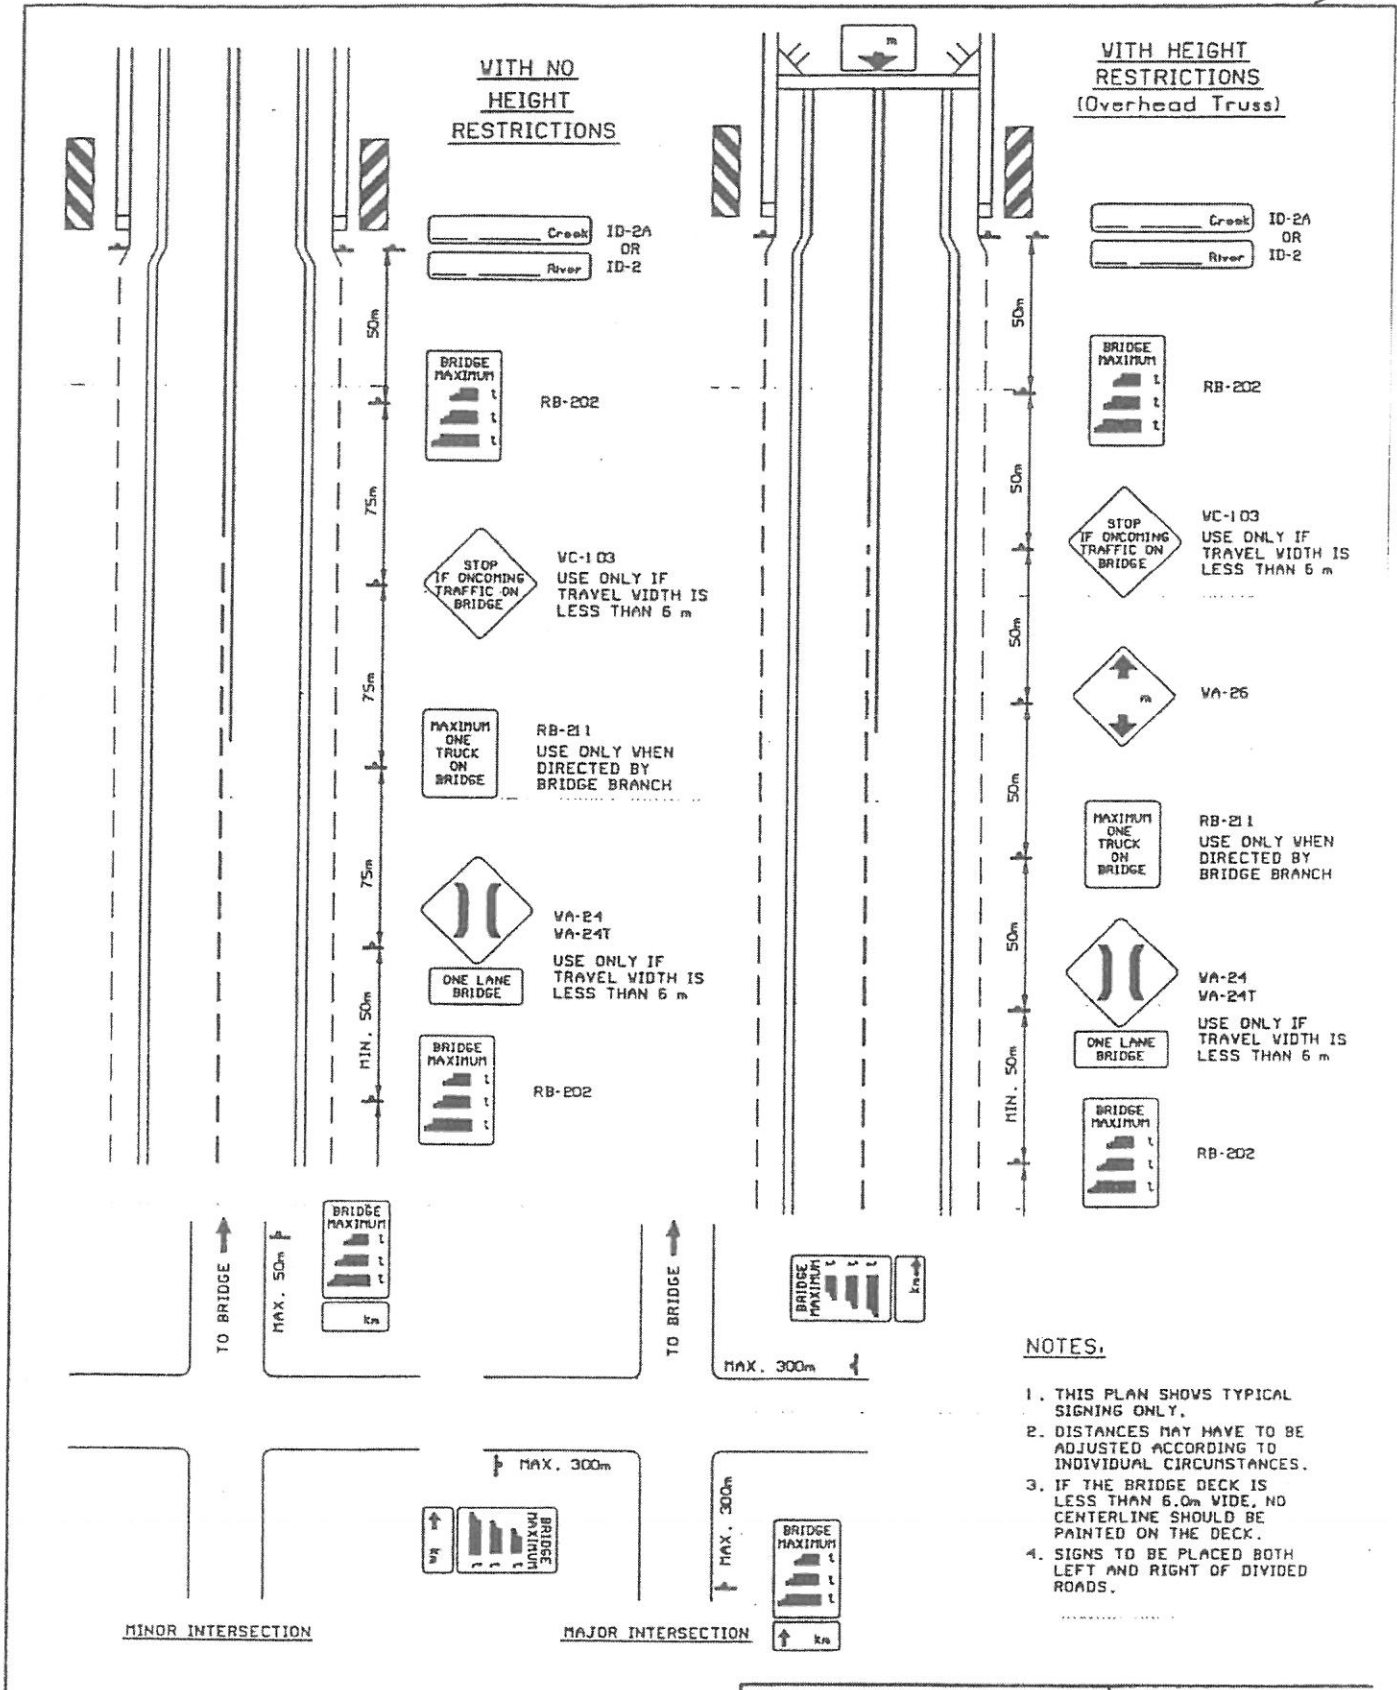
**WITH NO  
HEIGHT  
RESTRICTIONS**
