Central Region Landslide Assessment Site C18 SH837:02 River Scour @ km 1.9 May 2003 Emergency Inspection Report

ALBERTA TRANSPORTATION CENTRAL REGION Site C18 Emergency Inspection Report

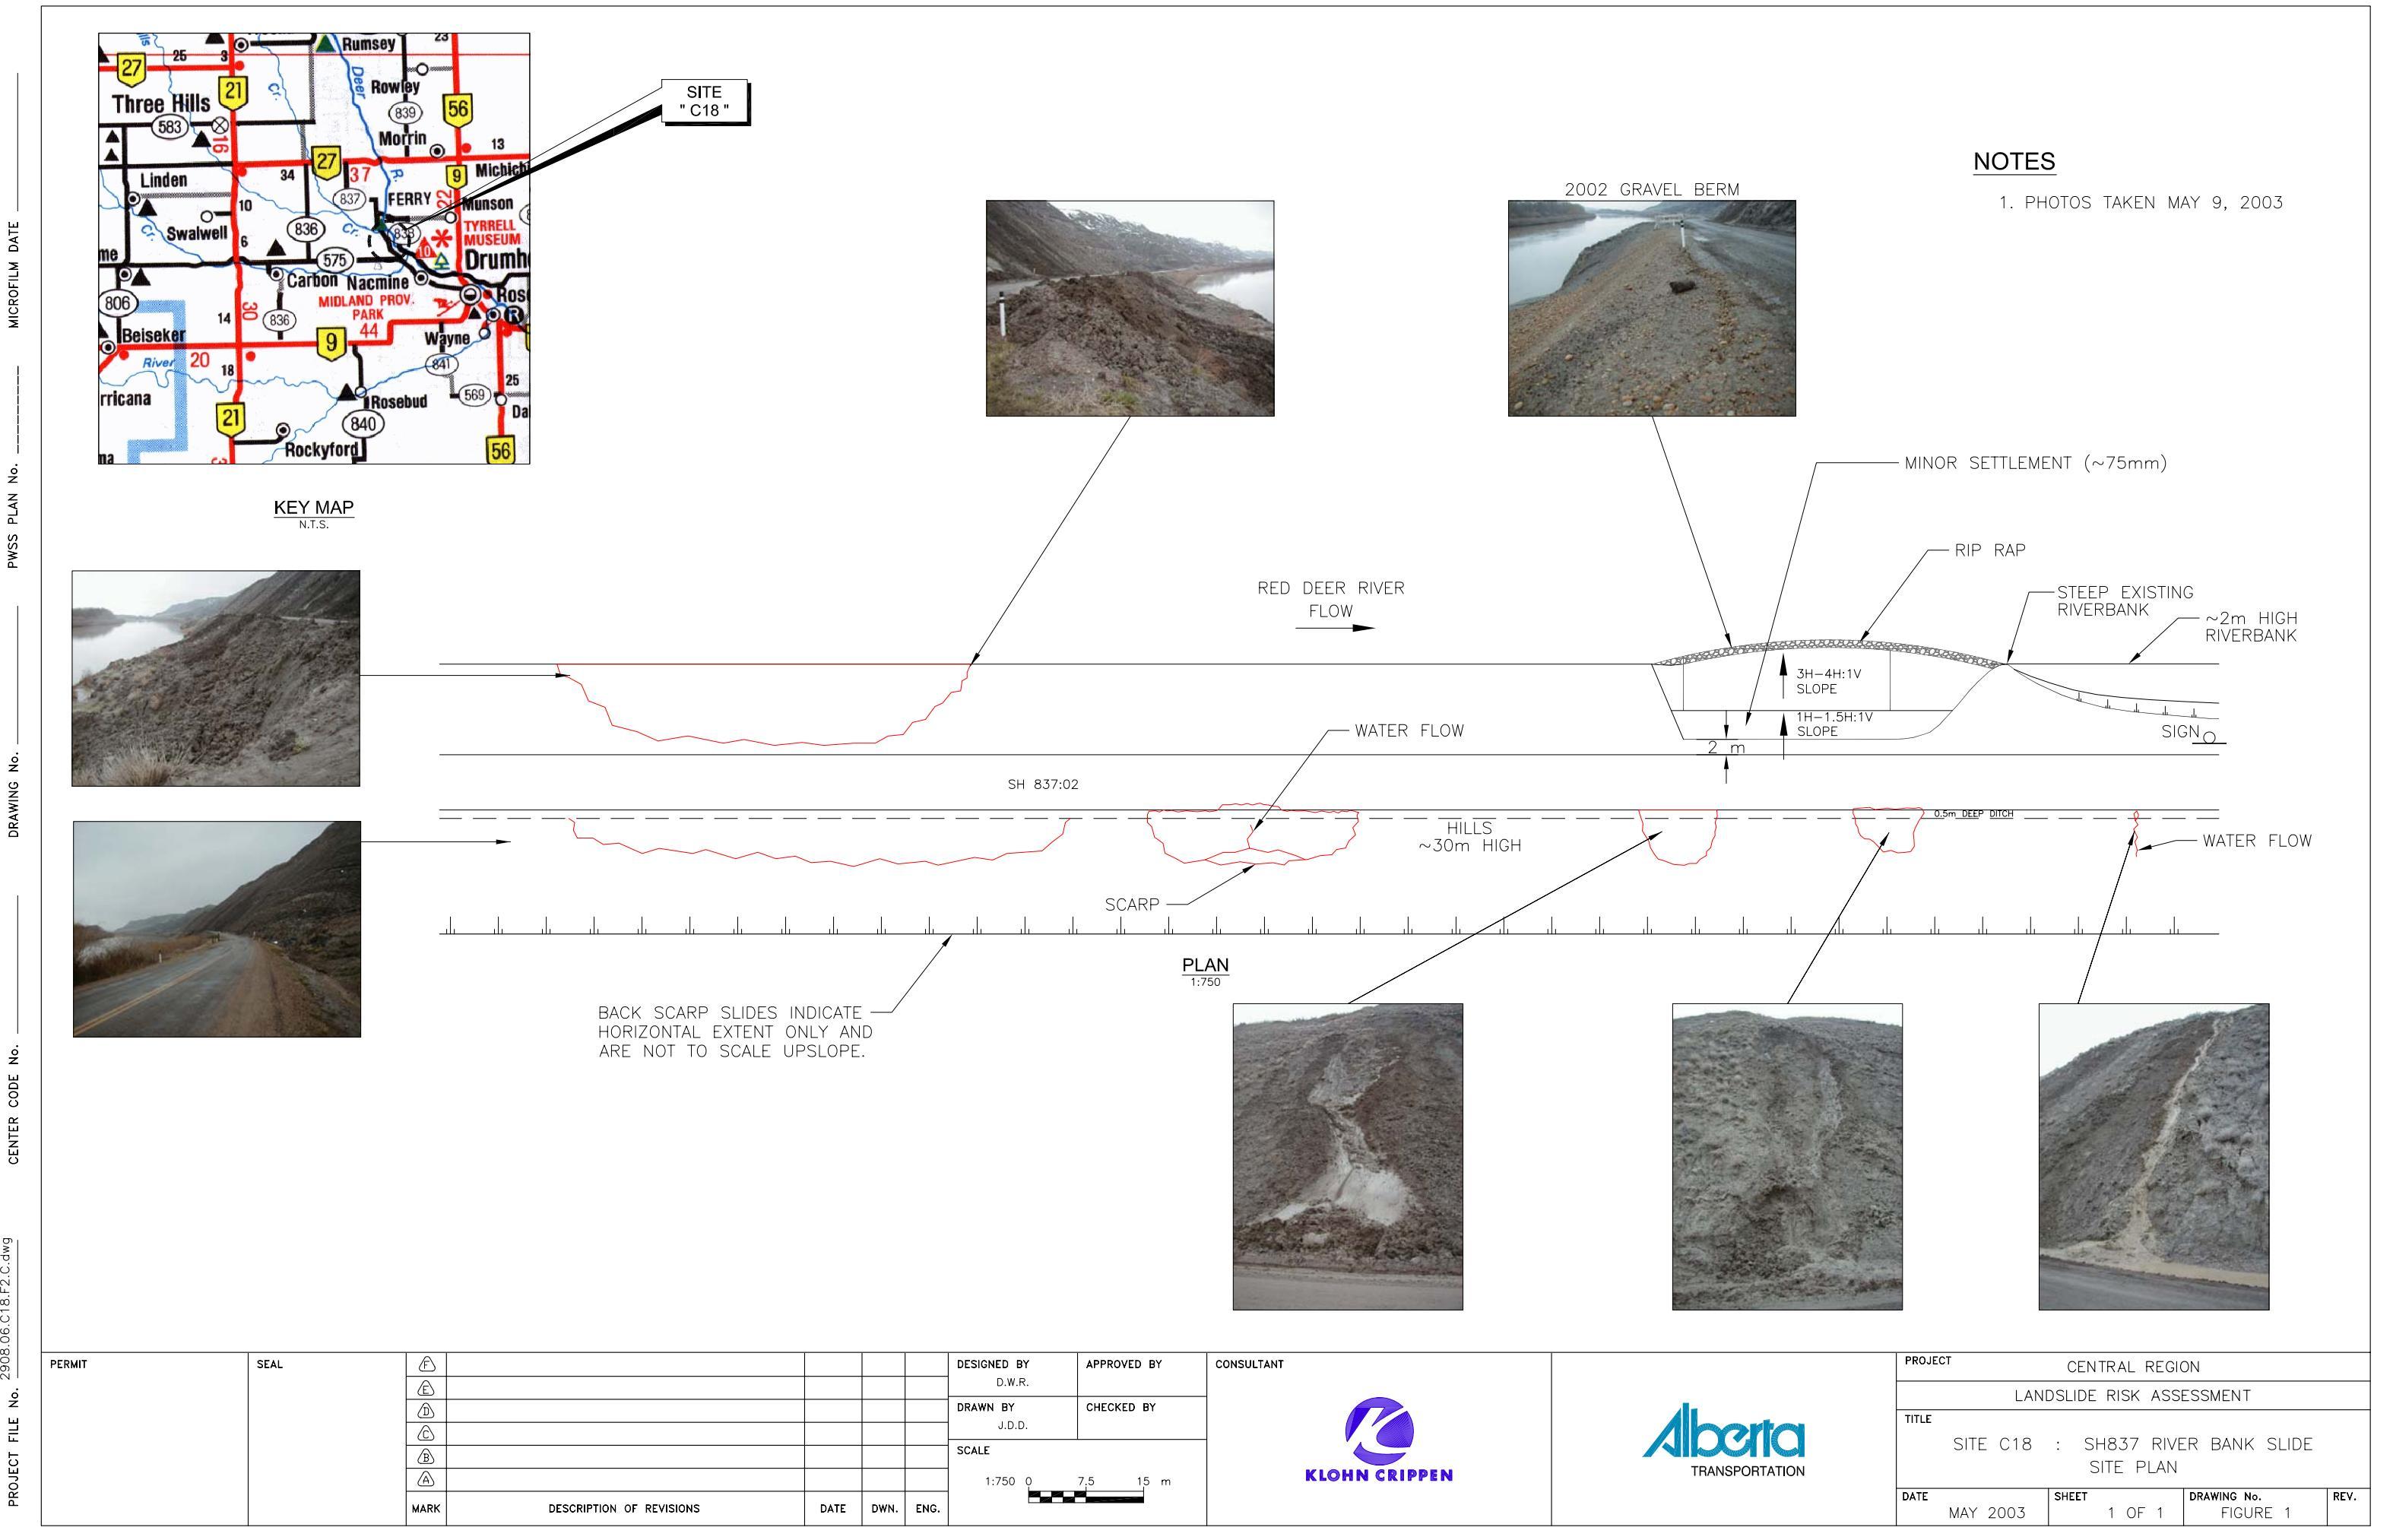
FIGURE

The current features of the site are illustrated in Figure 1 and in the attached photographs.

A series of surficial slides has occurred on the steep high backslopes above the highway. The slides are typically about 10 m wide and extend about 10 m to 15 m up the slope. The slides are very shallow, less than about 200 mm thick, and comprise a "peeling off" of the softened upper layer of the slope surface. The slide mechanism is consistent with the observation that the Horseshoe Canyon Formation bedrock material is highly

About 100 m upstream from the previous riverbank slide, another slide has occurred. This slide extends for about a length of 50 m and is similar to the previous slide, except that in this location the riverbank (distance from the road edge to the river) is wider. At present, the scarp of the slide is at least 2 m from the highway edge.

The repaired riverbank has performed well over the first winter post-construction. A small amount of settlement has occurred at the crest of the gravel berm (about 75 mm) and is likely related to the lower degree of compaction of the top portion of the slope. Riprap is visible at the upstream toe and the upstream and downstream riverbanks in the near vicinity appear to be stable.

It is recommended that the highway section be inspected daily while the slope material is wet and runoff is following down the slope. The number of inspections can be reduced as the slope dries out and stabilizes. The site should be inspected following any significant rainfall event.

The ditch should be cleaned out regularly to permit the flow of water. At the present time, only the minimal amount of material should be removed to prevent more material slumping into the ditch. The existing slump material and newly excavated material should be placed at the lower level of the riverbank for stability purposes. Slump material may be placed in the riverbank slide area, provided it is placed at the bottom and does not load the crest of the slide. The crest of the riverbank slide should be monitored for regression towards the highway edge.

A thin layer of gravel should be placed at the top of the 2002 gravel berm to remove the drop in the shoulder caused by the settlement.
