ALBERTA TRANSPORTATION LANDSLIDE RISK ASSESSMENT

SECTION A: GEOTECHNICAL FILE REVIEW NORTH CENTRAL REGION SITE NC83: West of Wildhay River

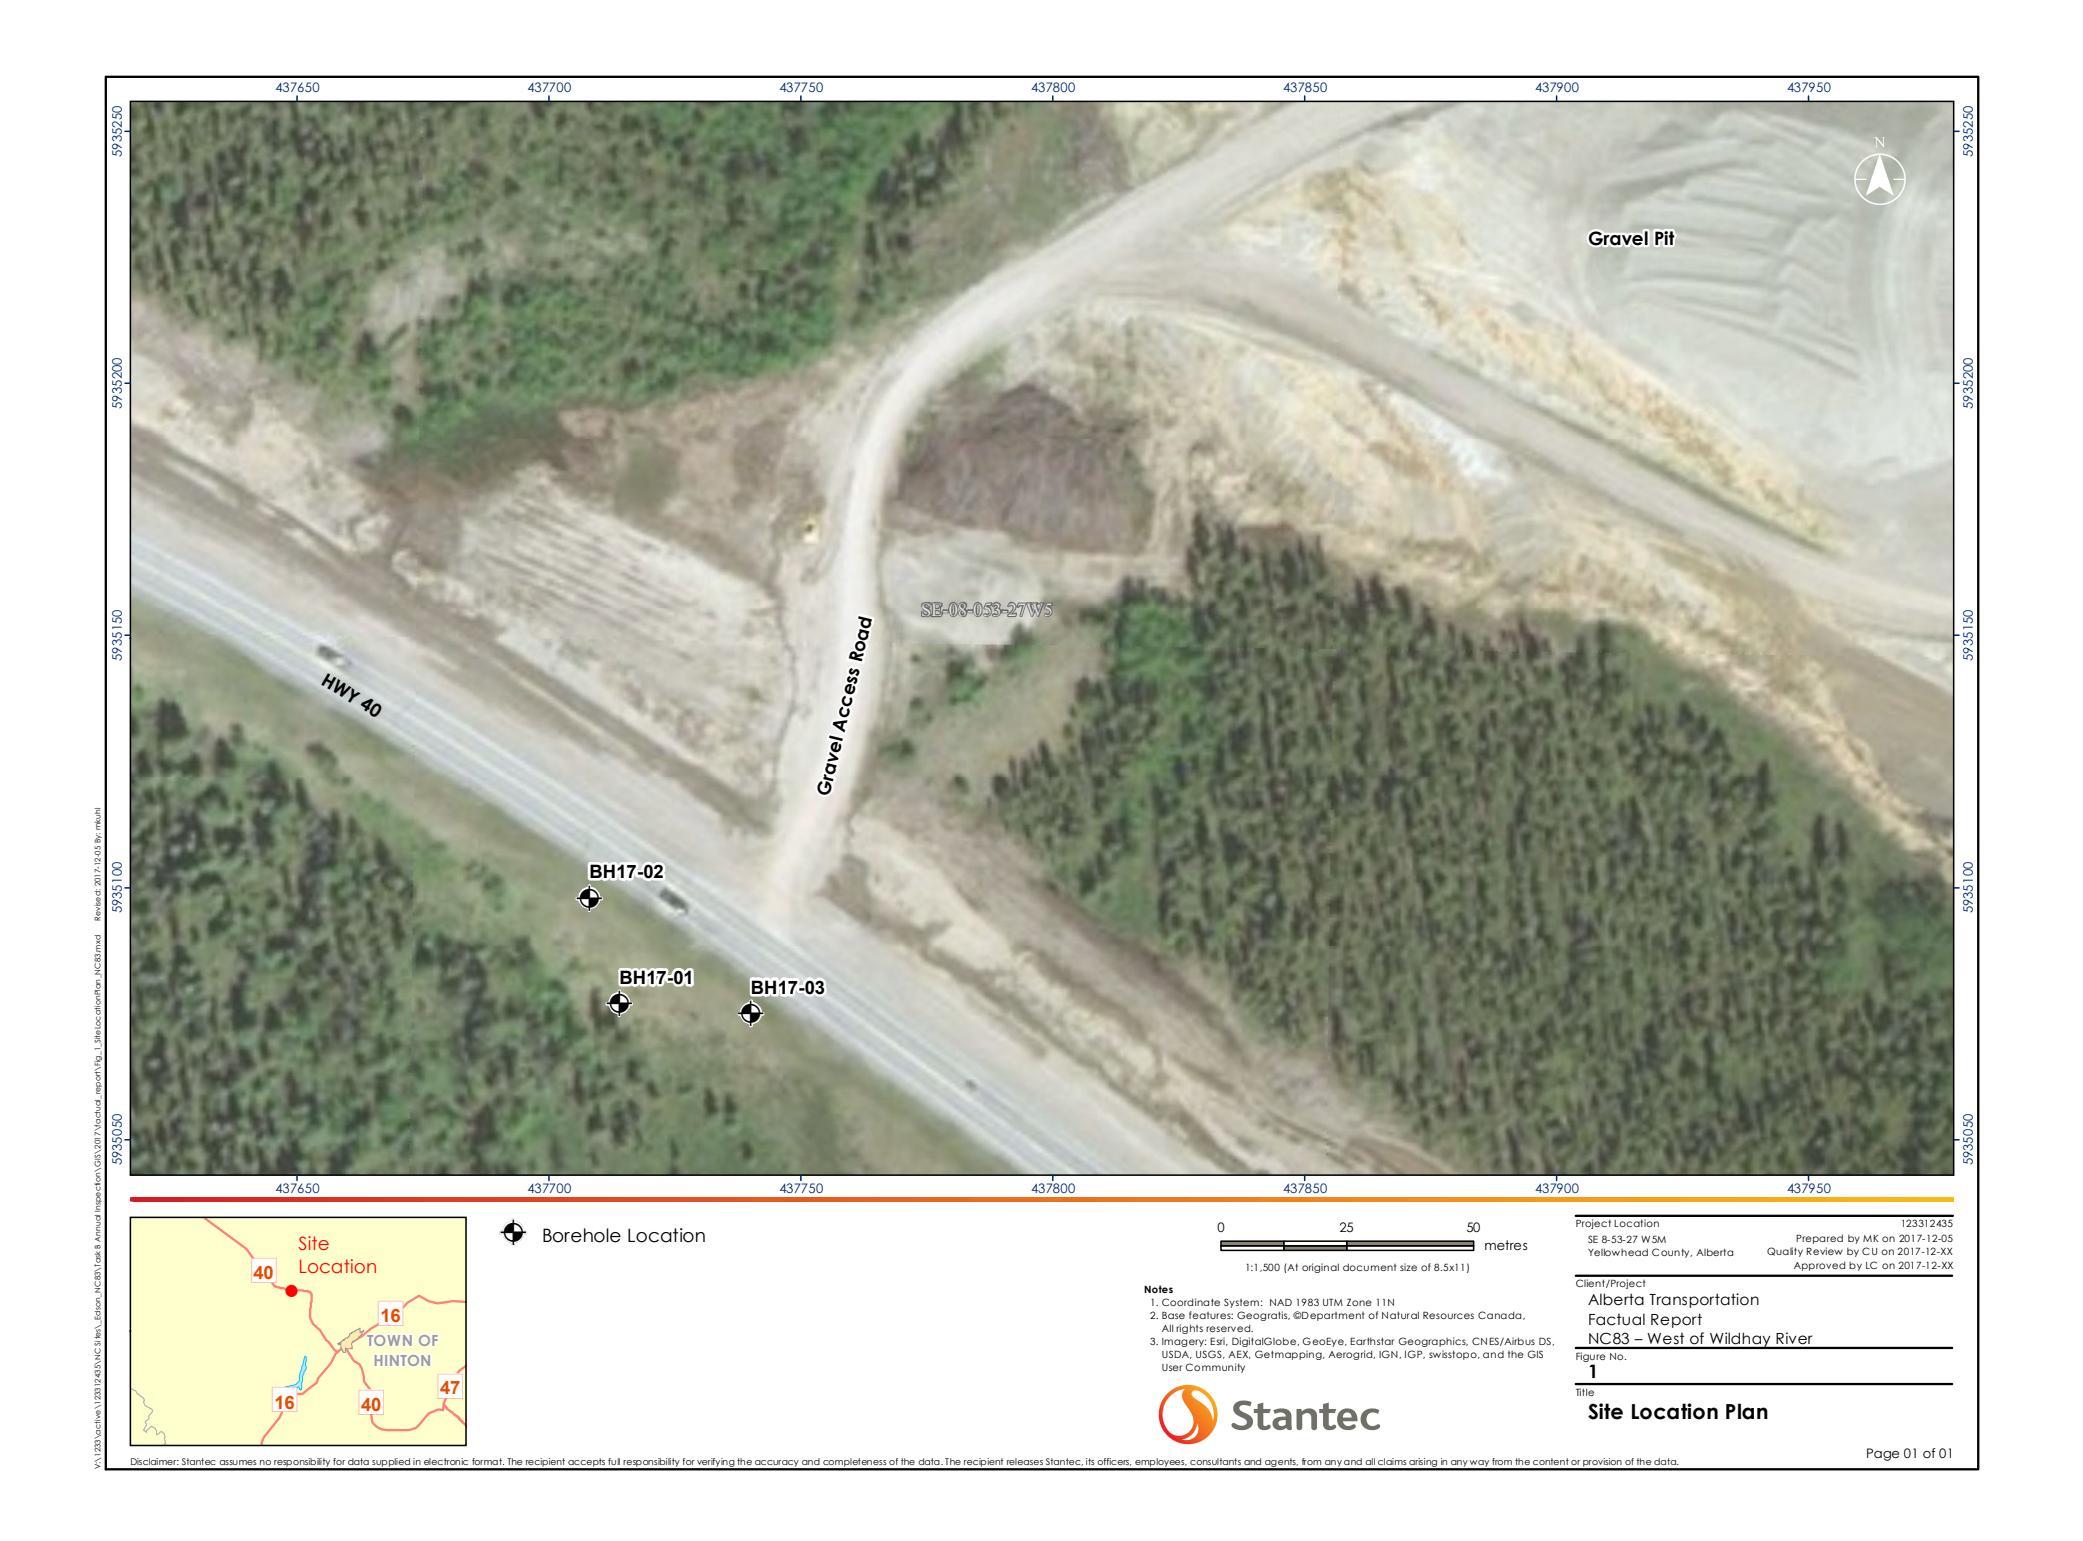
Three (3) slope inclinometers and three (3) vibrating wire piezometers were installed at the site to monitor ground movements and groundwater levels in 2017. The location of these instruments is shown on **Figure 1**.
