December 2, 2024

CON0022166 Peace Region (Grande Prairie District – South) GRMP Instrumentation Monitoring Site GP042; H40:36, km 37.524 Wanyandie Creek Embankment Slide Section C – 2024 Fall Readings

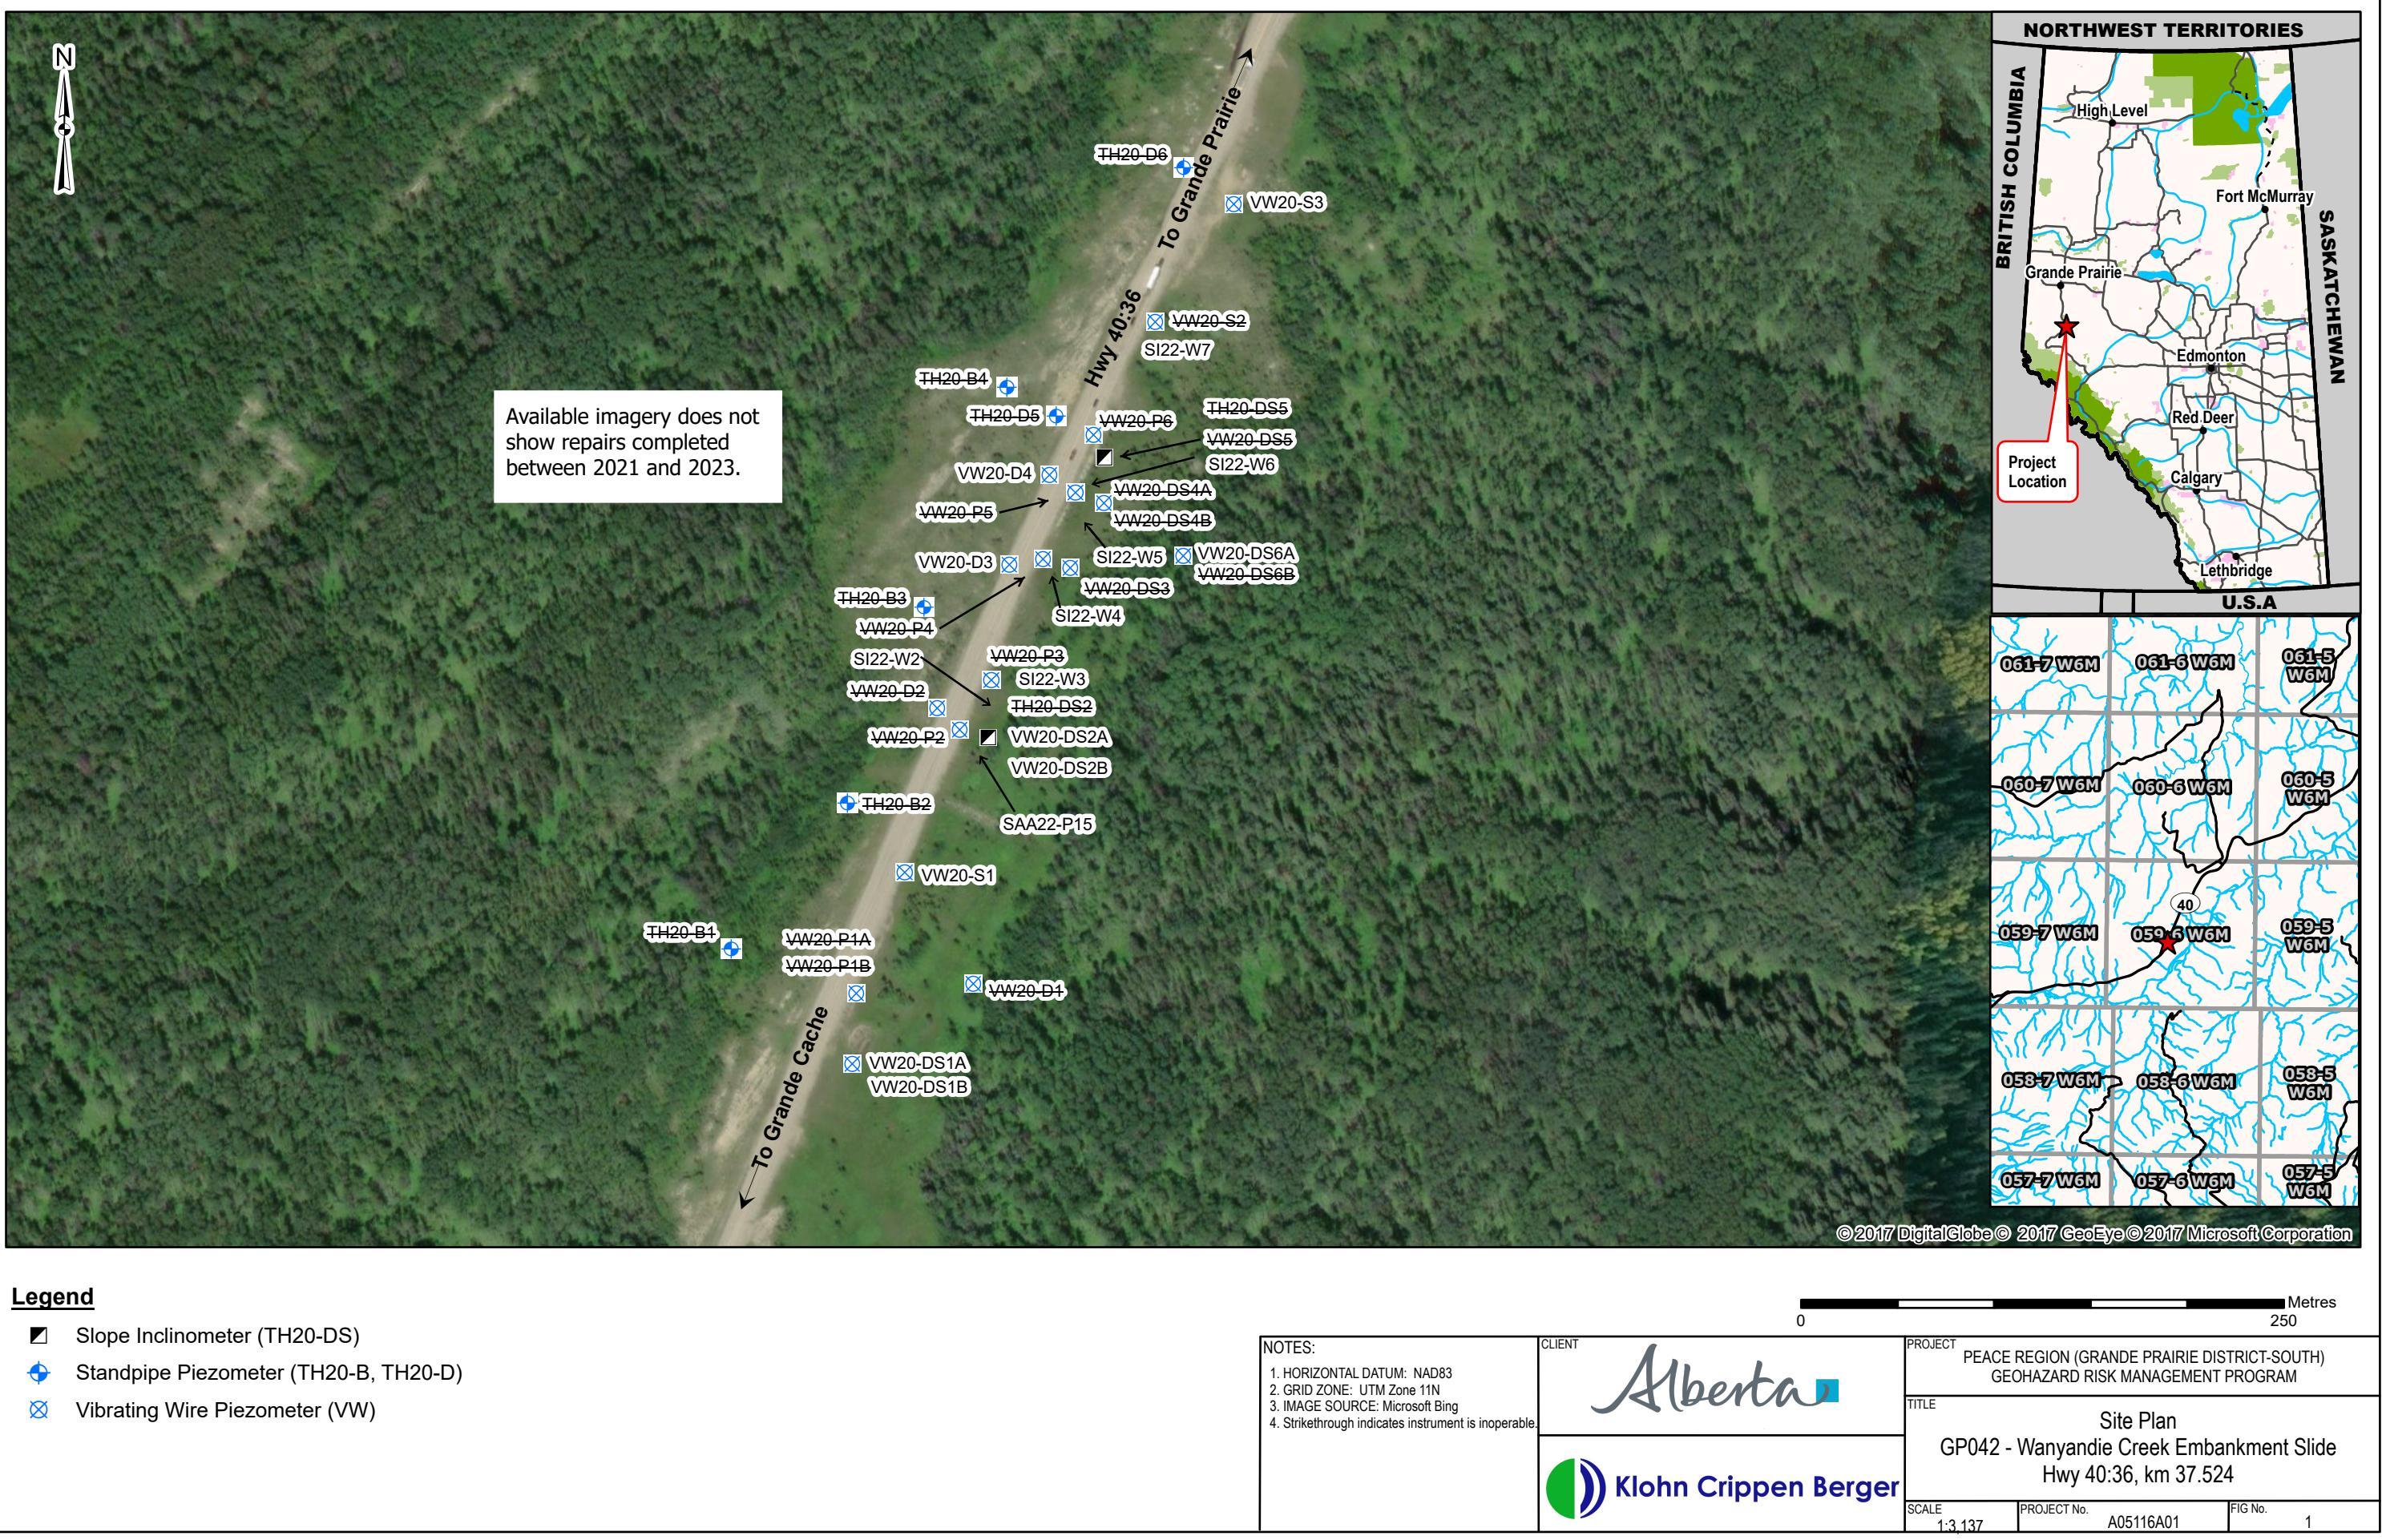
Six slope inclinometers (SIs) (SI22-W2 through W7), nine vibrating wire piezometers (VWPs) (VW20-S1/S3, VW20-D3/D4, and VW20-DS1A/1B/2A/2B/6A), one shape accelerometer array (SAA) (SAA22-P15), and seven vibrating wire load cells (load cells) (Anchor 3U, 5L, 15U/L, 27U/L, and 37U) were read at the GP042 site (includes the GP050 site as well) in the Peace Region (Grande Prairie District – South) (GP South Region) on October 17, 2024, by Courtney Mulhall, P.Eng. and Min Hou, E.I.T. of Klohn Crippen Berger Ltd. (KCB). These instruments were read as part of the GP South Region Geohazard Risk Management Program (GRMP). The site is located on Hwy 40:36, km 37.524. The approximate site coordinates are 5996853 N, 379884 E (UTM Zone 11, NAD 83). A site plan is presented on Figure 1.

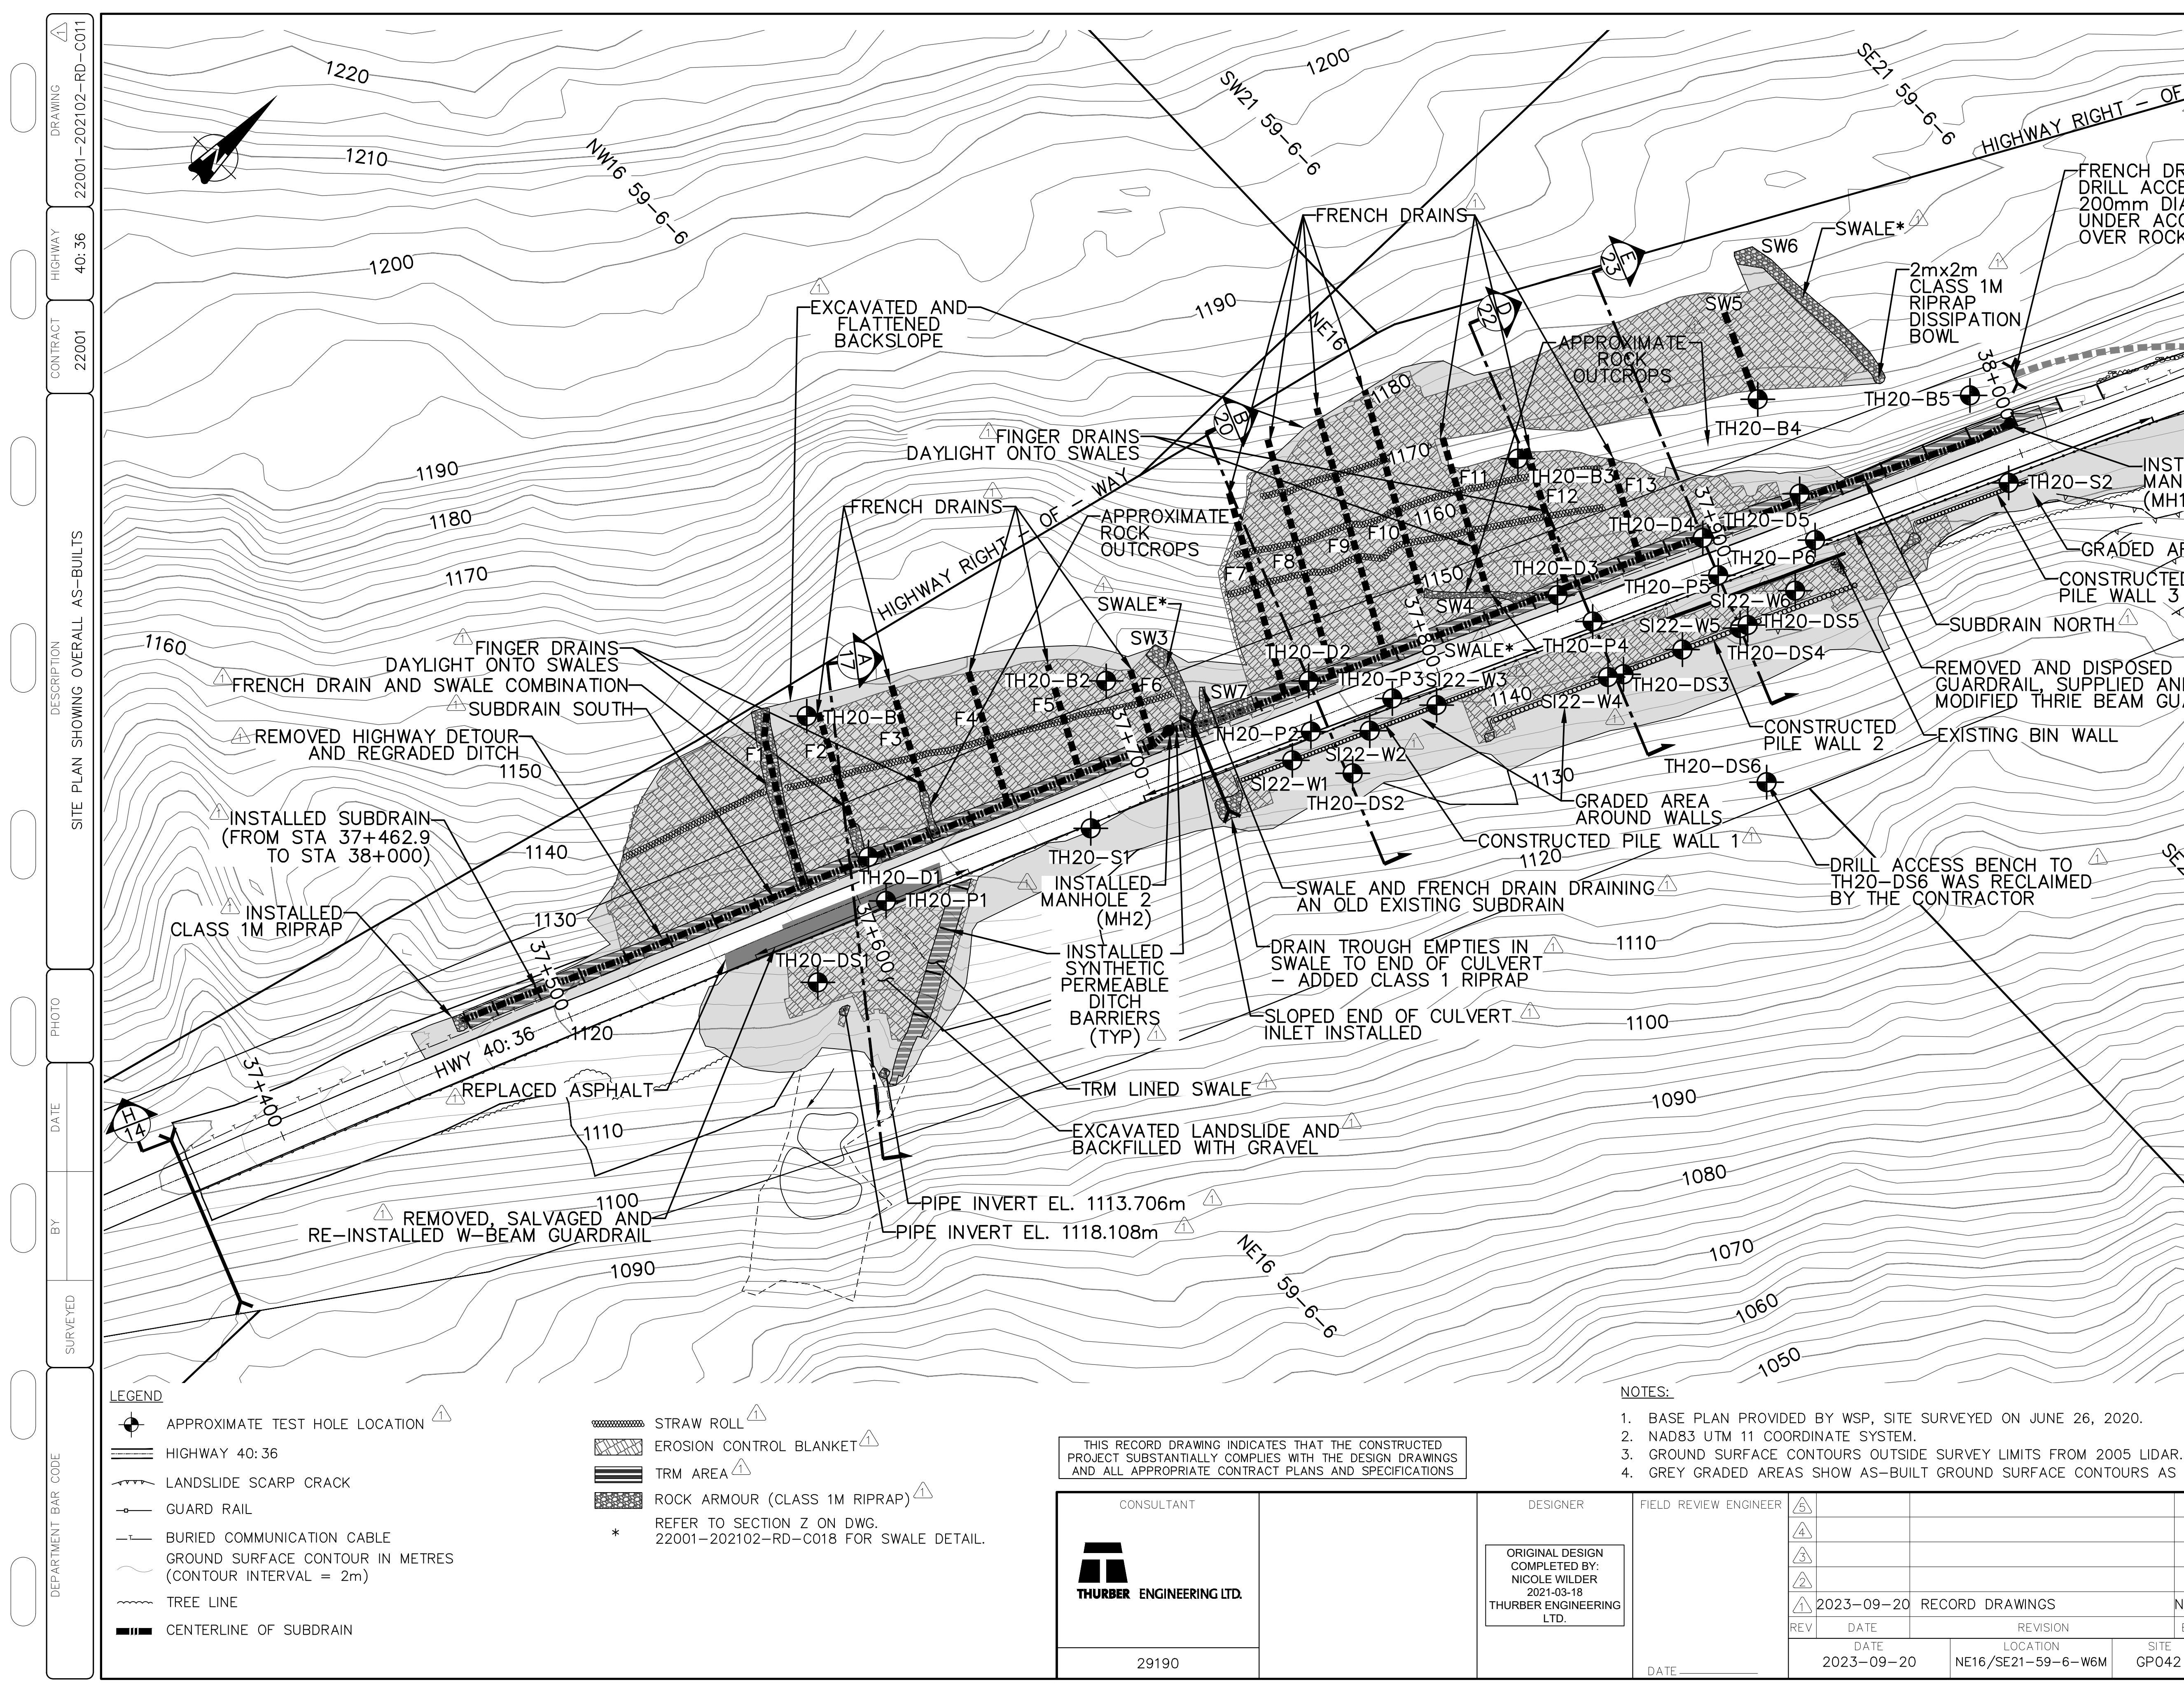
This remedial work is shown on Figure 2 prepared by Thurber Engineering Ltd. (Thurber) but is shown in the available imagery shown on Figure 1.
