# ALBERTA TRANSPORTATION AND ECONOMIC CORRIDORS GRMP (CON0022164) PEACE REGION (PEACE RIVER DISTRICT) INSTRUMENTATION MONITORING RESULTS – FALL 2023

# SITE PH080: HWY 688:02 McKINNEY CREEK SLIDE (KM 15.4) - BF72477

# ALBERTA TRANSPORTATION AND ECONOMIC CORRIDORS GRMP (CON0022164) PEACE REGION (PEACE RIVER DISTRICT) INSTRUMENTATION MONITORING RESULTS

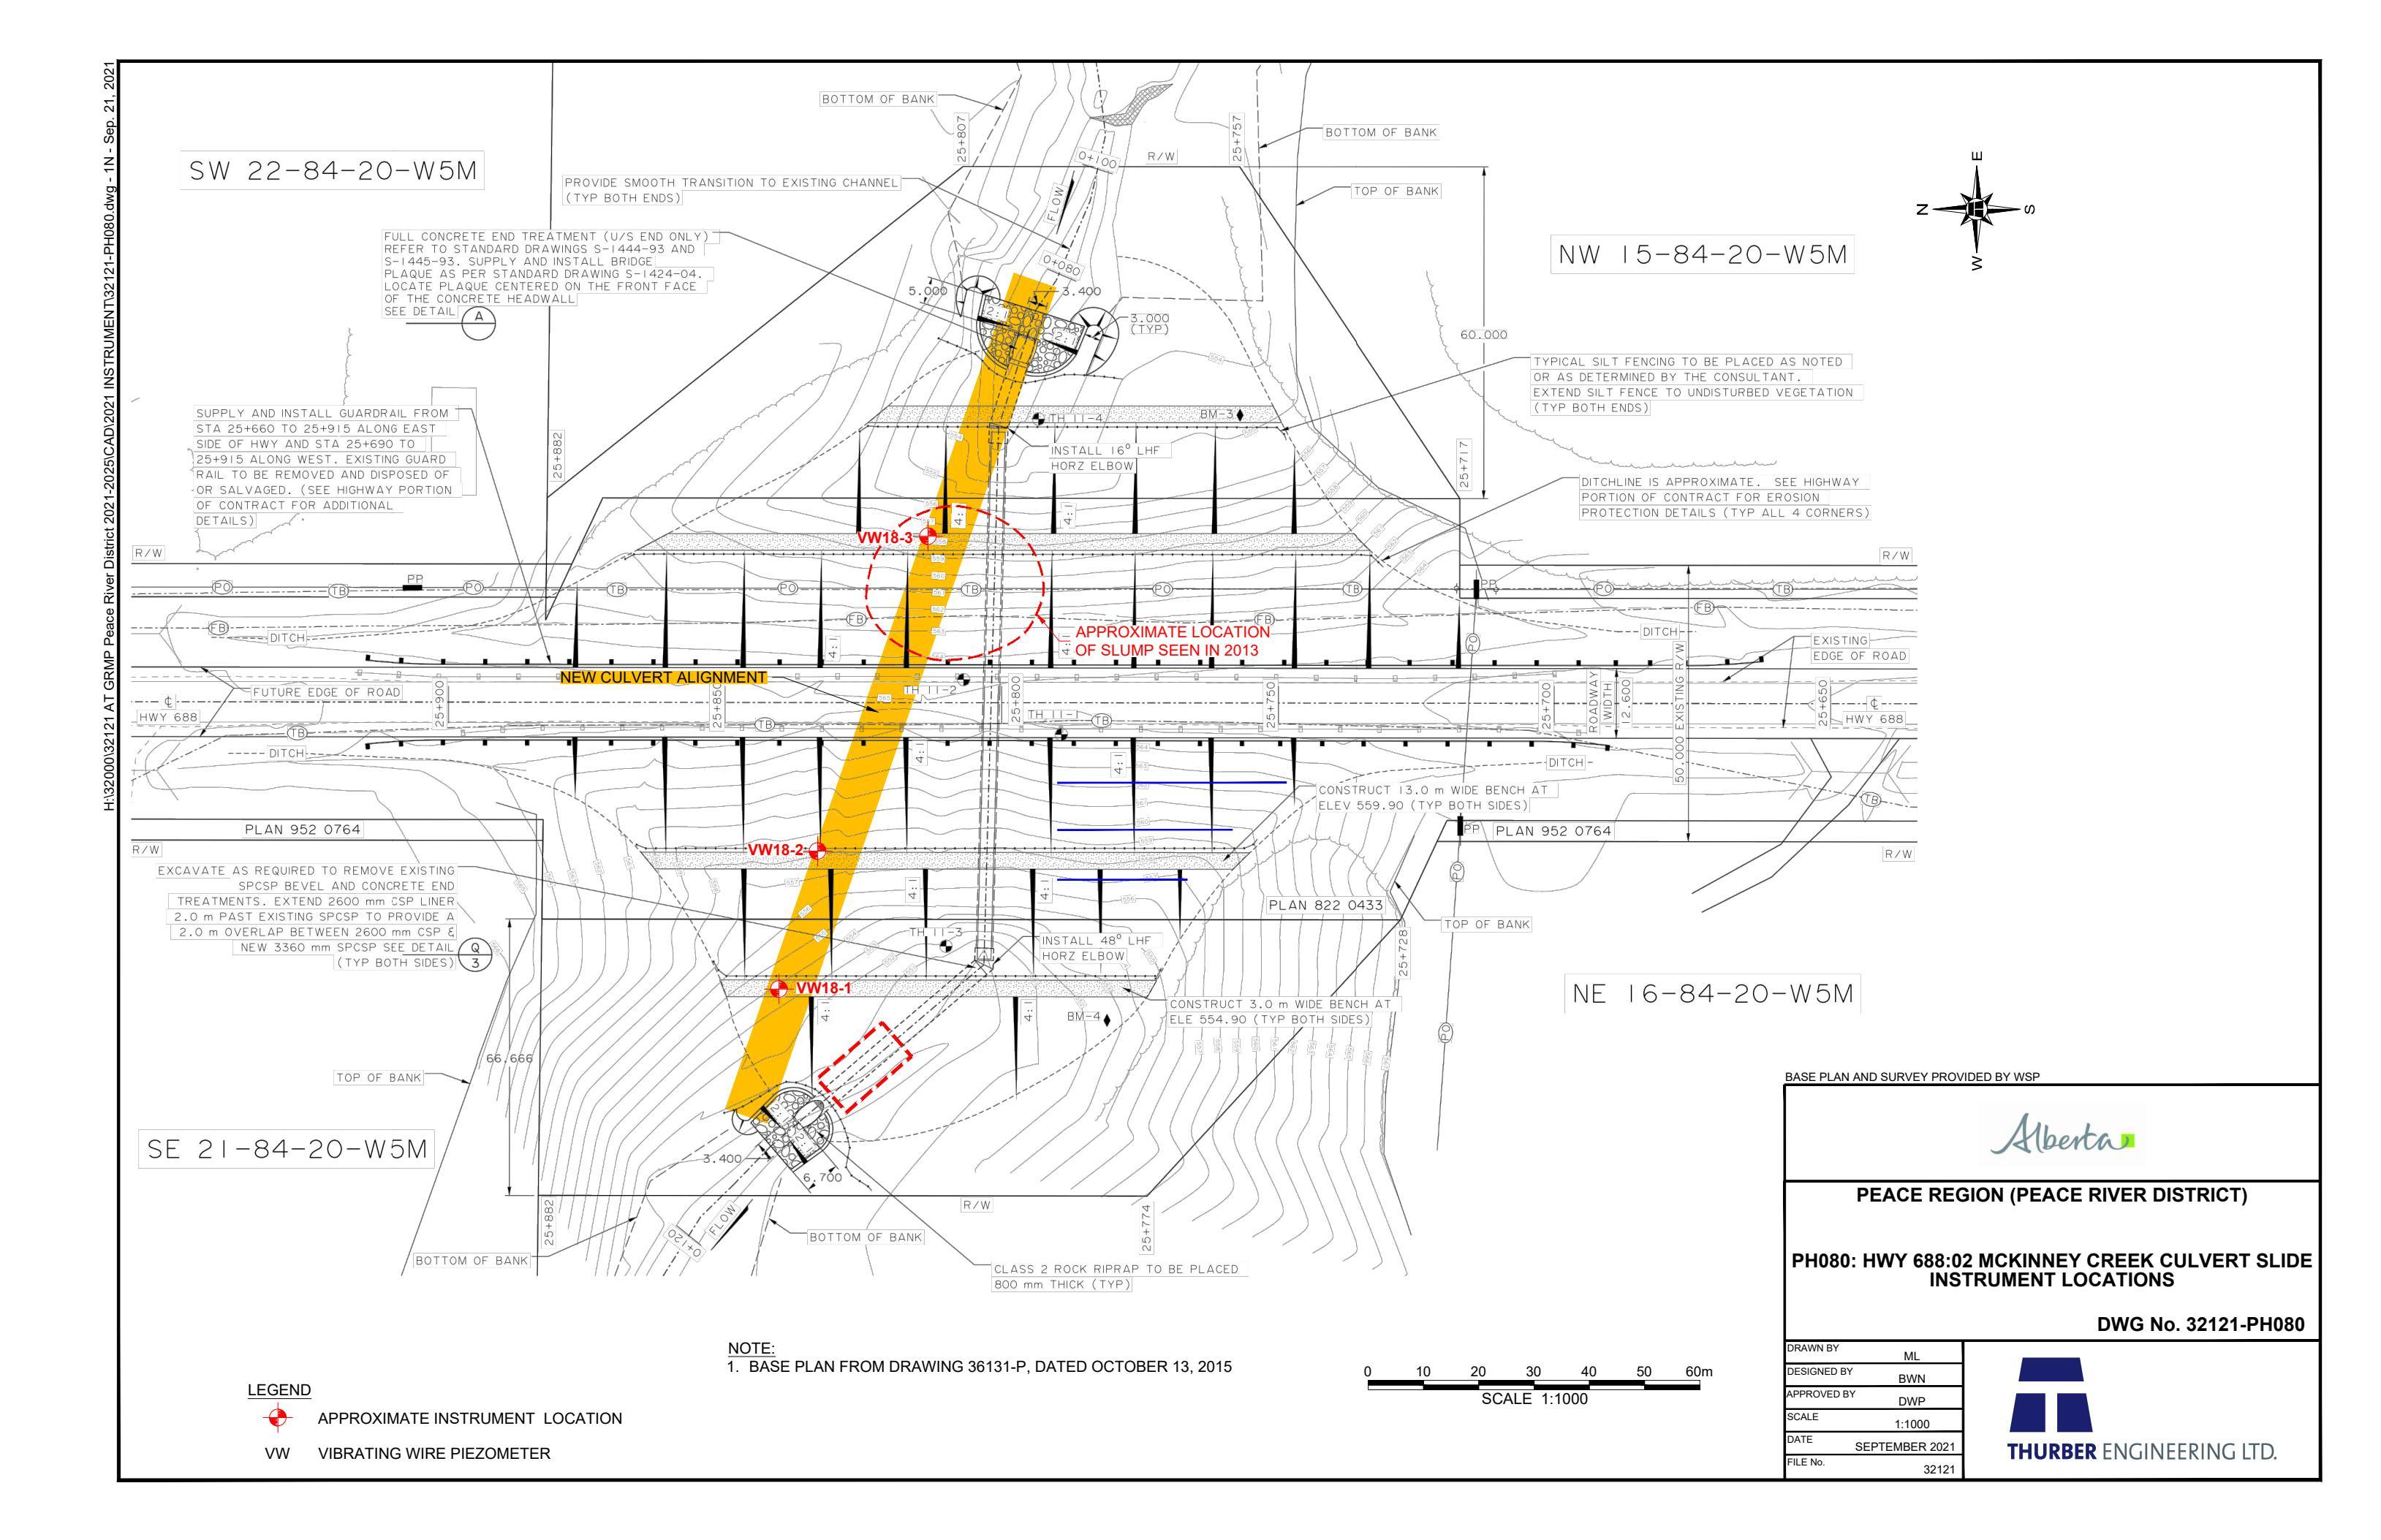
VW18-1 and VW18-2 cables are west of the highway, north of the culvert outlet near the bush line. VW18-3 cable is east of the highway, north of the creek near the crest of the hill VW 18-1,18-2 and 18-3 needs stickup protector or enclosure box. Currently the wires are lying on ground. See photographs

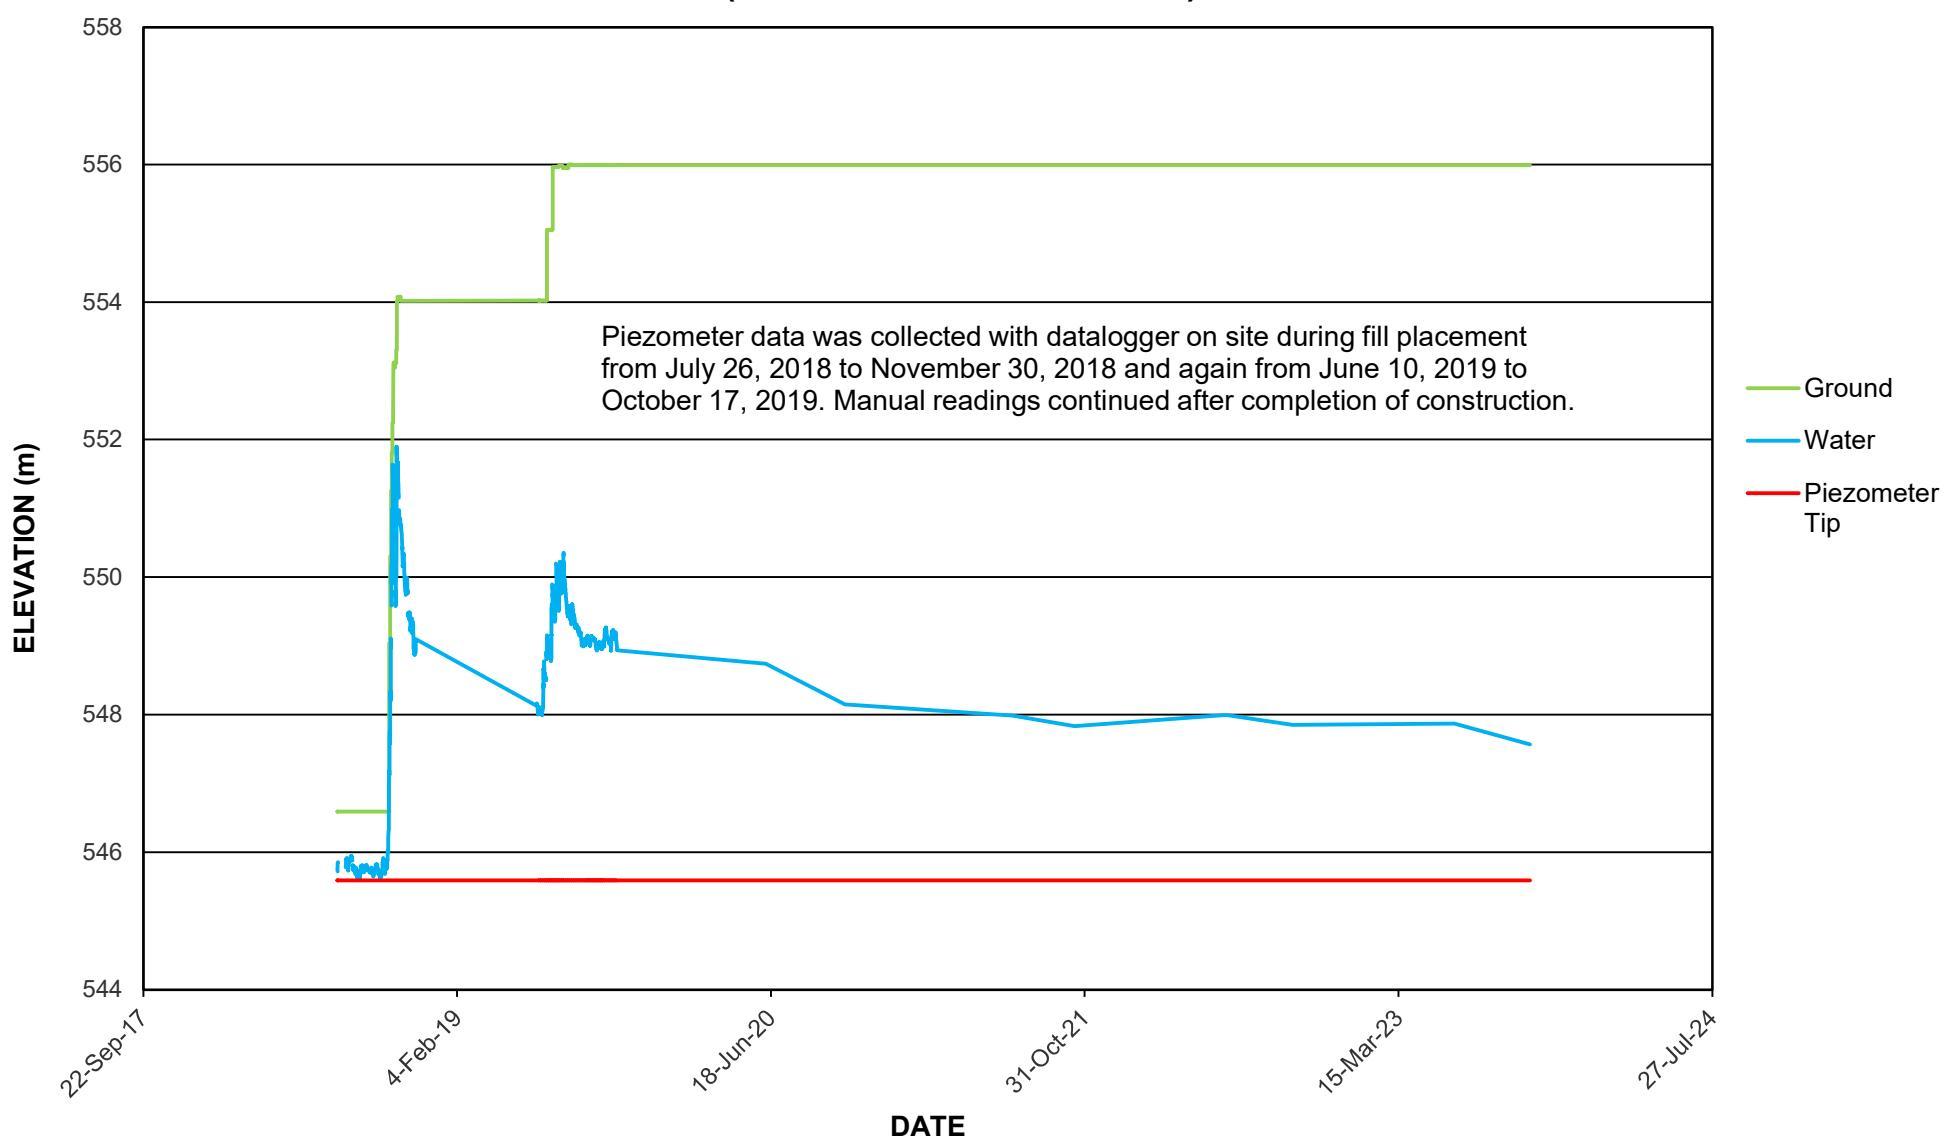
# FIGURE PH080-1 HWY 688:02 McKINNEY CREEK CULVERT SLIDE - VW18-1 (WEST SIDE OF CULVERT)

Vibrating wire piezometers VW18-1 and VW18-2 showed decreases in groundwater level of 0.31 m and 0.15 m, respectively, since the spring of 2023 readings. VW18-3 showed an increase in groundwater level of 0.04 m since the spring of 2023 readings. VW18-1 and VW18-3 showed a prior trend of diminishing groundwater levels since the completion of construction and the groundwater levels at these instrument locations appear to have levelled out. The piezometers had all previously shown their highest groundwater levels during construction as fill was placed at their respective locations.

Figures PH080-1, PH080-2 and PH080-3 show the response of each of the piezometers relative to fill height during construction, as well as the subsequent decrease in pore water pressure. Figure PH080-4 shows a combined plot of the groundwater elevations of all three vibrating wire piezometers.

The instruments should be read again in the spring of 2024.
