SITE NUMBER AND NAME: S043 Pine Ridge		HIGHWAY & KM: 6:04, 10.000	PREVIOUS INSPECTION DATE: June 1, 2017	INSPECTION DATE: May 2, 2018
LEGAL DESCRIPTION: 02-09-003-29 W4M	NAD 83 COORDINATES: UTM Northing Easting 12 5452673 292619		RISK ASSESMENT: PF: 8 CF: 4 TOTAL: 32	
AVERAGE ANNUAL DAILY TRAFFIC (AADT): 353 (north), 328 (south), (Ref No. 60060410)			CONTRACTOR MAINTENANCE AREA (CMA): 26

PROJECT SOUTHERN REGION GEOHAZARD RISK MANAGEMENT PROGRAM		
TITLE Site Plan S043 - Pine Ridge Hwy 6:04, km 10.000		
SCALE 1:1,000	PROJECT No. A05115A03	FIG No. 1

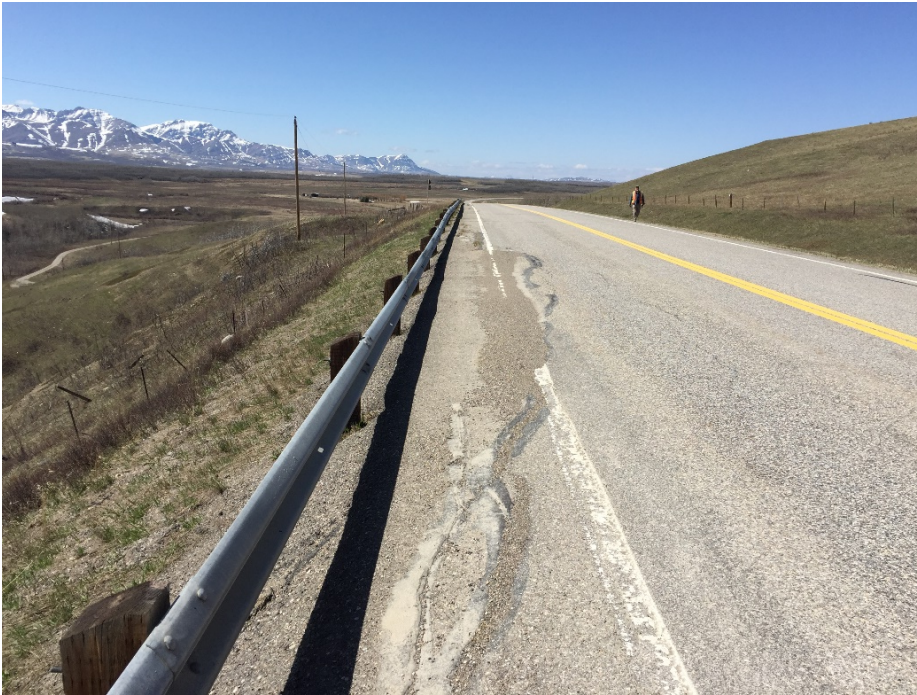
COMMENTS
There is an existing draw feature at the site that was likely filled in as part of the highway construction works.
Cracks up to 50 to 75 mm wide at southern extent of the failure area, with up to 50 mm of settlement. The cracking extends to the middle of the southbound lane. The extent of cracking in the middle of the southbound lane has not changed since 2017.
The guard rail above the failure zone on the highway has dropped and a dip is apparent.
Ponding water is occurring in the upslope ditch opposite the slide zone with infiltration into the slide mass. Standing water in ditch at the time of the inspection.
Up to 1 to 1.2 m of asphalt was observed at various points along the highway shoulder on the crest of the downslope embankment. However, this could be overspill from the last overlay.
A high density of vegetation was observed at the fill-natural soil contact at the toe of the embankment downslope of the highway. The density of vegetation could indicate seepage at the fill-foundation contact.

Photo 1 Cracks at south end of failed area extending to middle of southbound lane. Photo was taken facing northwest on May 2, 2018.

- The drainage ditch should be regraded to allow water to pass through this area without ponding and assess if movements cease. If not, the ditch should be lined with a geomembrane to limit infiltration into the embankment fill. Additional stabilization measures such as a pile wall may be required if current rates of movement accelerate significantly.
- The AT pavement LiDAR data could be reviewed at this site to assess if long term deformation is occurring at this site. This site is an ideal location to assess the use of the pavement LiDAR data for change detection due to the relatively long period since the last overlay which predates AT's use of pavement LiDAR.

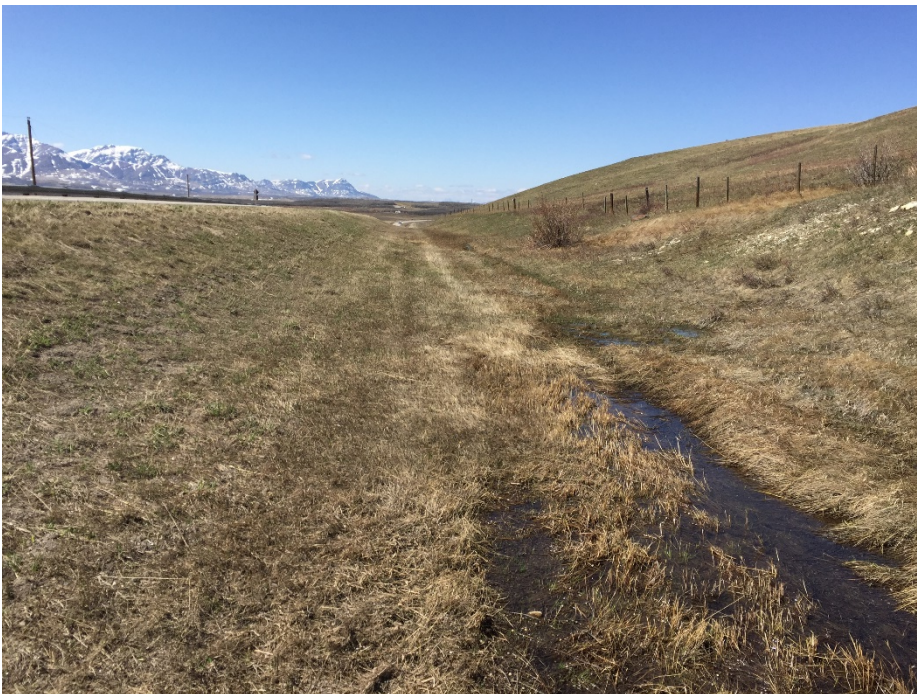
The embankment failure appears to be due to groundwater seepage and seepage from the adjacent drainage ditch leading to instability downslope. The ponding water in the drainage ditch is allowing water to infiltrate into the adjacent highway embankment. It may also be possible that any organic material present beneath the embankment was left in-situ or drainage not included to drain springs as was a common highway construction practice in the past.

Photo 2 Drainage ditch on upslope side of site. Ponded water observed in the poorly graded ditch. Photo was taken facing northwest on May 2, 2018.
