SOUTHERN REGION GRMP SITE INSPECTION FORM

SITE NUMBER AND NAME	E: HIGHWAY & KM:	PREVIOUS	INSPECTION DATE:
S005 Chin Coulee	36:02, 37.101	INSPECTION DATE:	May 11 2023
		May 9, 2019	May 11, 2020
LEGAL DESCRIPTION:NAD 83 COORDINATES:10-36-007-17 W4MUTM Northing Easting115495465414771		RISK ASSESMENT: PF: 9 CF: 2 TOTAL: 18	
AVERAGE ANNUAL DAIL 720 (north), 900 (south), Re	/ TRAFFIC (AADT): ef No. (70000182)	CONTRACTOR MAINTENANCE AREA (CMA): 24

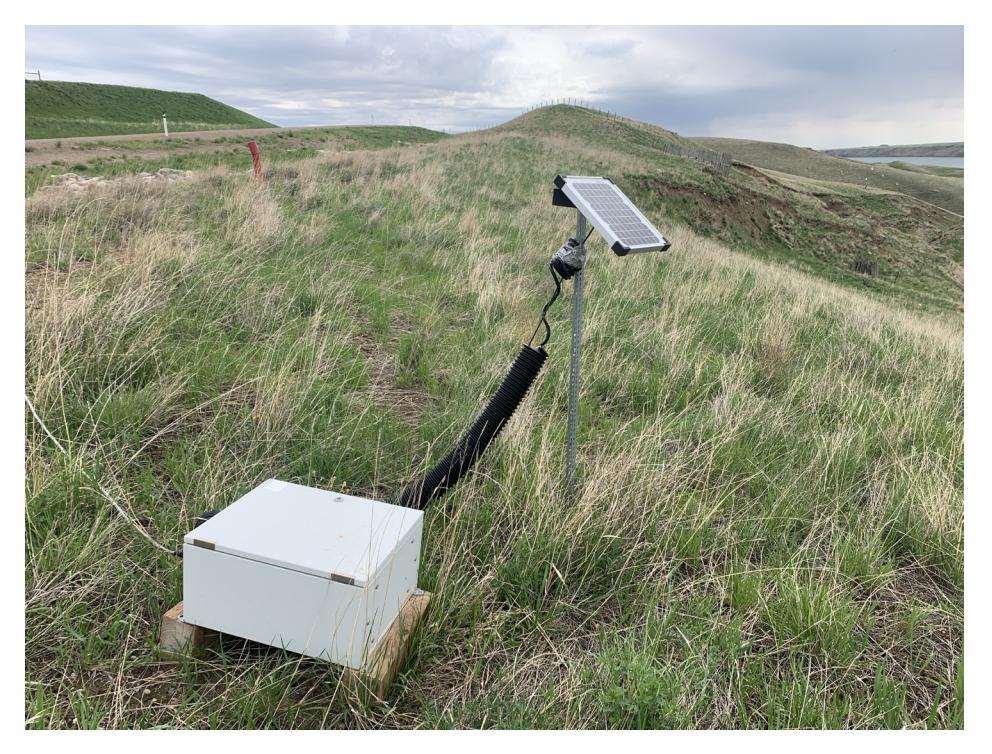
Photo 1 Geocube installed at crest of slope between highway and slide area. Photo taken facing east on May 11, 2023.

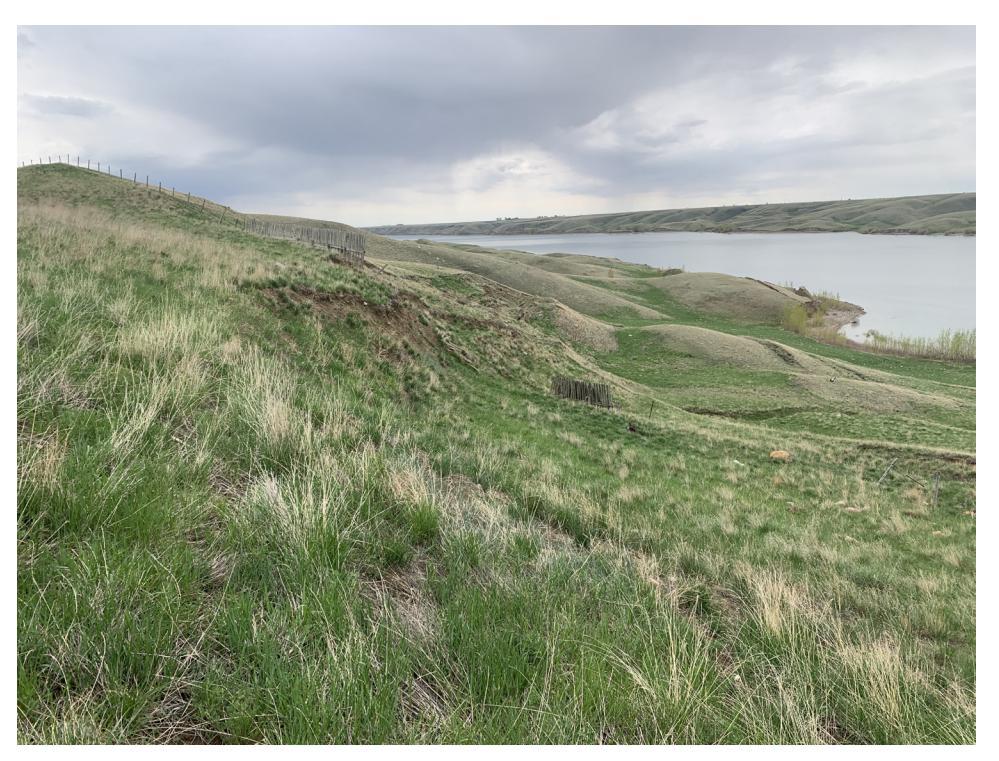
The slide is large with multiple back scarps and reverse grabens. The size of this slide infers a deep-seated translational failure mode on a sub-horizontal weak layer. Toe of slide is below the fluctuating reservoir level, which may influence slide mobilization.

Photo 2 Slope failure downslope of highway. Photo taken facing southeast on May 11, 2023.

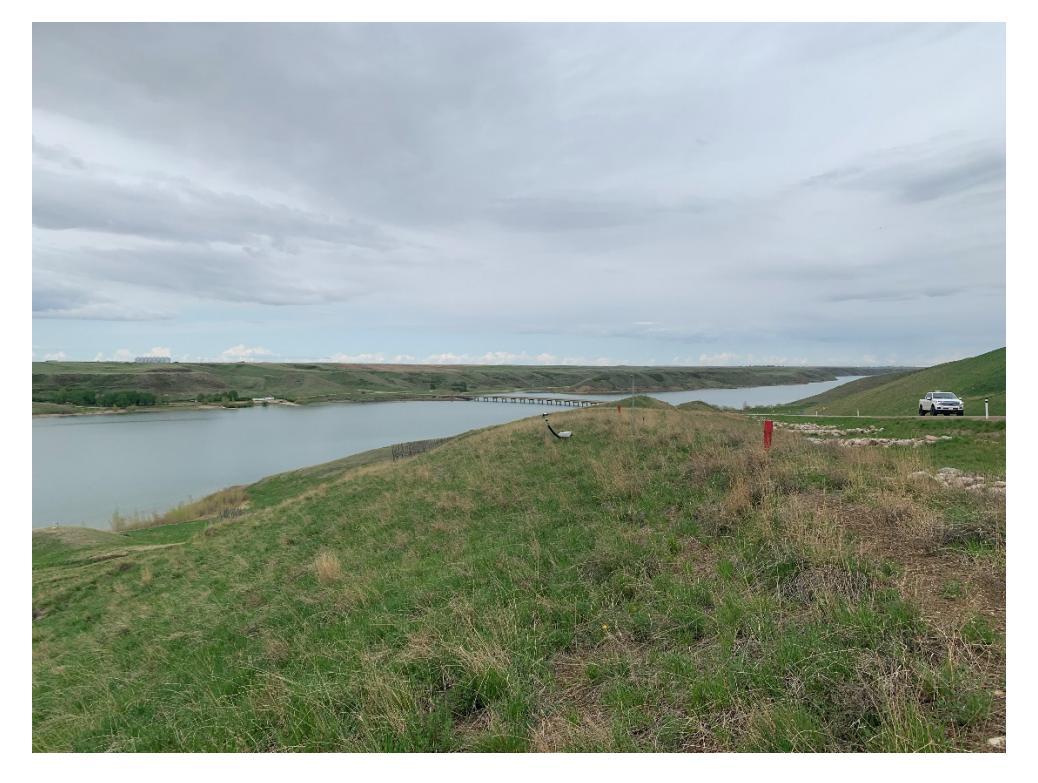
Photo 3 Crest of slope, downslope of highway. Photo taken facing west on May 11, 2023.

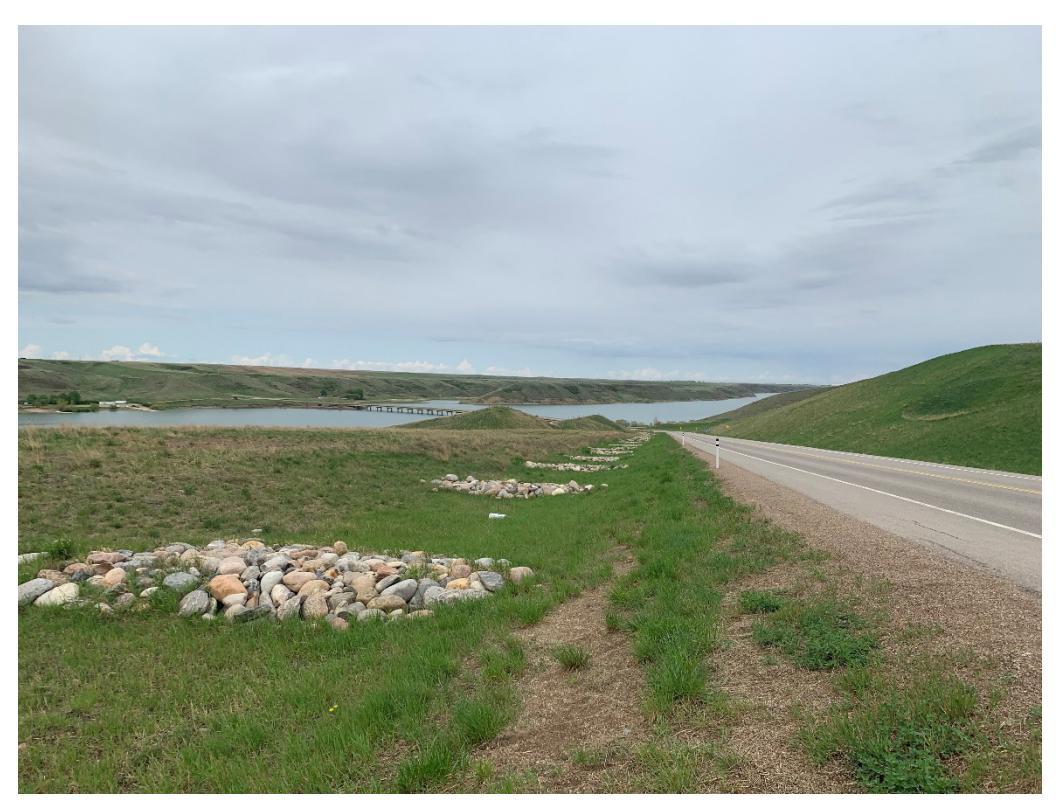
Check dams in ditches have too steep of an upstream slope and may constitute a traffic hazard if a car leaves the highway.

Photo 4 Ditch check dams. Photo taken facing west on May 11, 2023.
