August 28, 2009

CG25309.B

**Re: Southern Region Geohazard Assessment Program
Highway 40, Limestone Mountain Cut Slope
June 2009 Inspection Report**

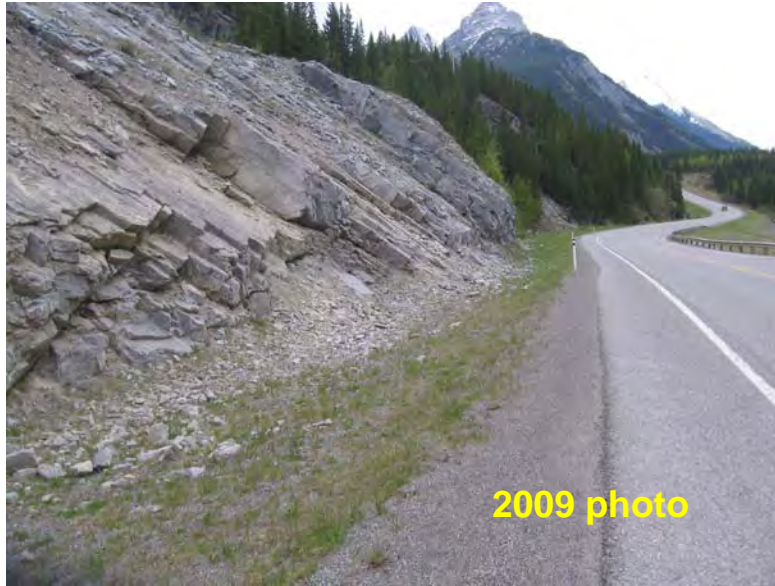
Photo 1 (top) – June 2009

- There was an accumulation of gravel to cobble-sized rockfall debris along the toe of the cut slope and extending into the central portion of the ditch, as shown in Photo 1.
- The boulder-sized debris noted along the ditch during the 2005 inspection (see Photo 2) had been cleaned out at some point since 2005, and no additional boulder-sized rocks have subsequently fallen into the ditch.
- There was no rockfall debris along the edge of the paved road surface at the time of the June 2009 inspection.

Facing south along the east highway ditch adjacent to the cut slope. The rockfall debris from this cut slope is contained within the existing ditch.

No further work is recommended for this site aside from cleaning of accumulated rockfall debris from the ditch as required to keep the ditch reasonably close to maximum capacity.

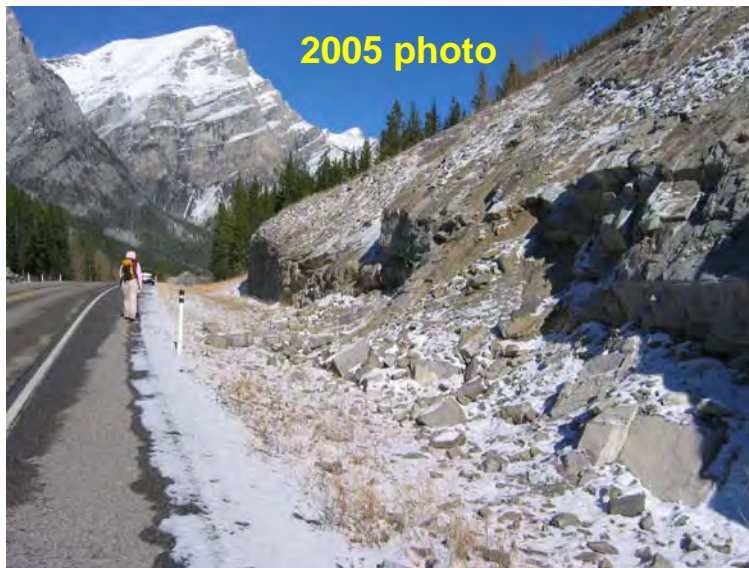
Photo 2 (bottom) – 2005

Facing north along the east highway ditch, across the same area shown in Photo 1. At the time of the 2005 inspection there was a significant accumulation of up to boulder-sized rockfall debris along the ditch.
