SOUTHERN REGION GRMP SITE INSPECTION FORM

SITE NUMBER AND NAME:	HIGHWAY & KM:	PREVIOUS	INSPECTION DATE:	
S045-I West Fisher Creek	549:02, 10.704	INSPECTION DATE:	June 8, 2020	
		May 6, 2019		
LEGAL DESCRIPTION:	NAD 83 COORDINATES:	RISK ASSESMENT:		
16-08-021-03 W5M	UTM Northing Easting	PF: 11 CF: 4 T	OTAL: 44	
	11 5626463 683084			
AVERAGE ANNUAL DAILY TR	RAFFIC (AADT):	CONTRACTOR MAINTENANCE AREA (CMA):		
760 (east), (Ref. No. 65170)		27

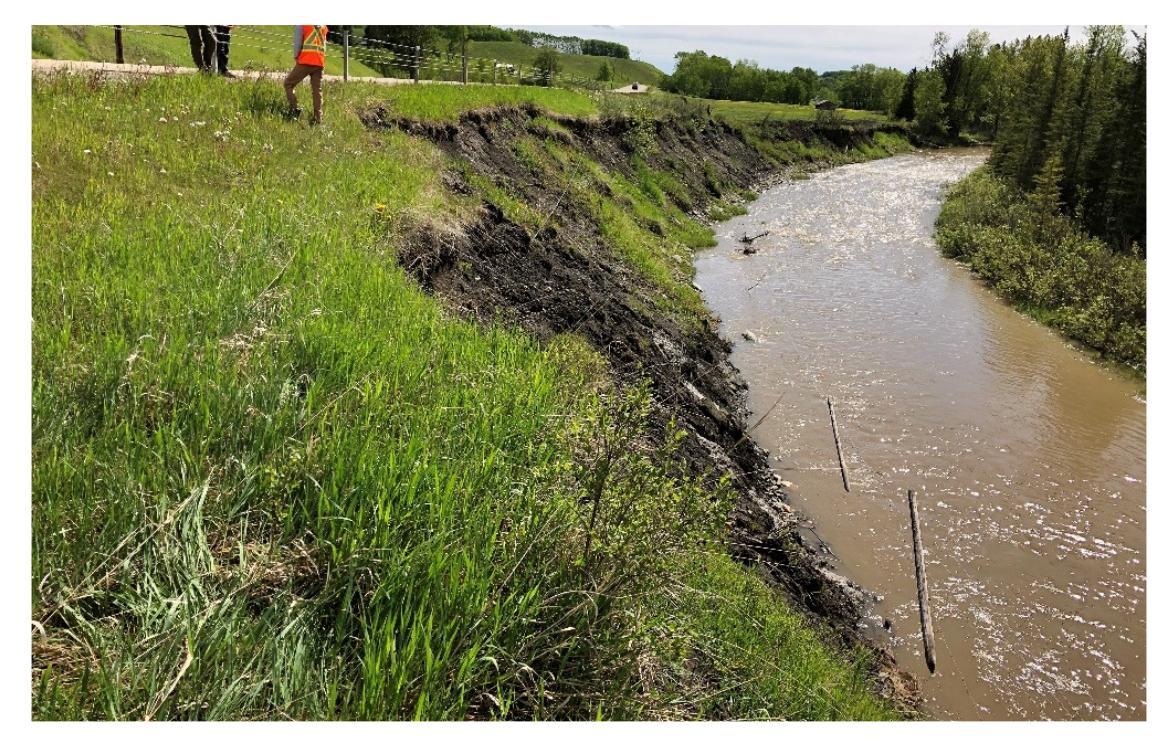
Photo 2 Active slope erosion from creek flow. Photo was taken facing west on June 8, 2020.

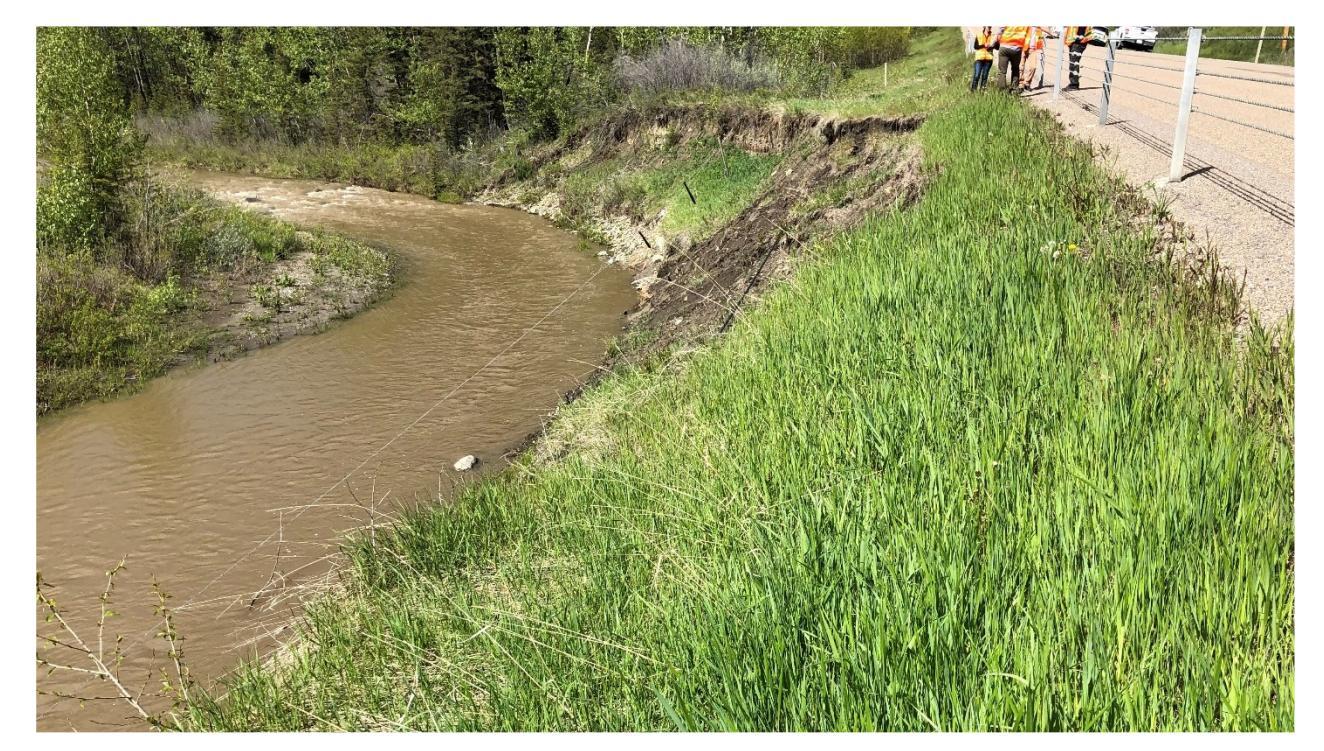
Photo 3 Upstream corner of slope erosion (west end). Photo was taken facing southwest on June 8, 2020.

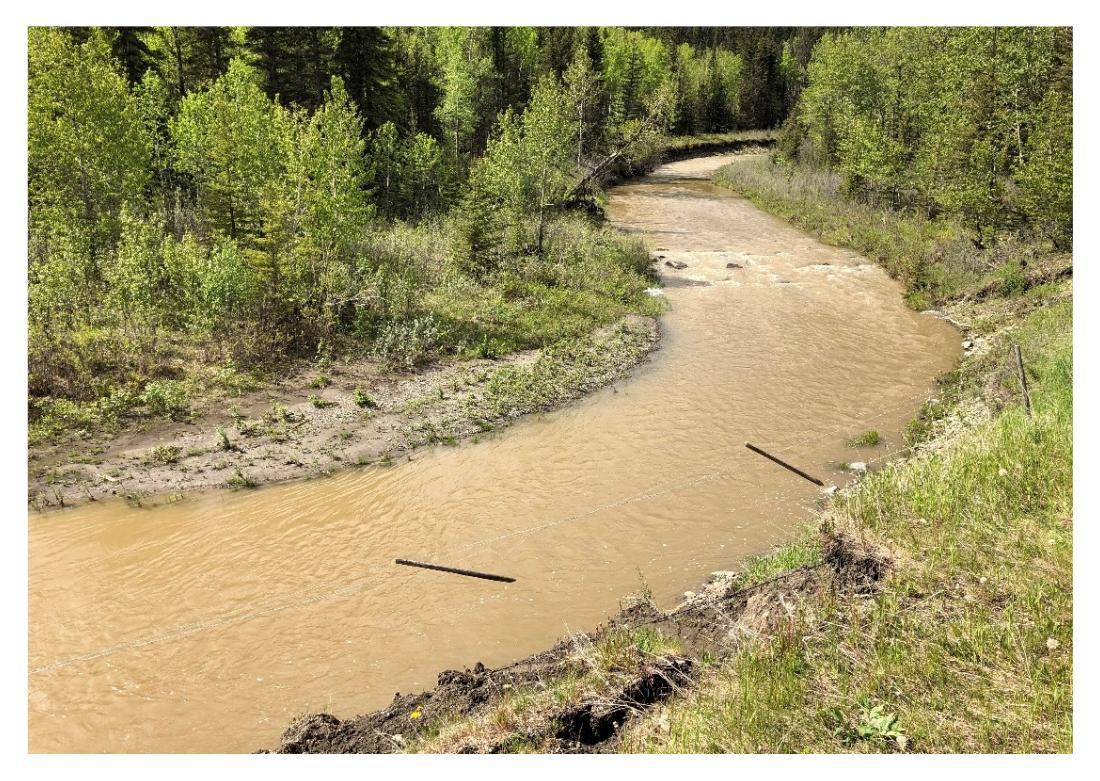
Photo 4 Displaced grass and soil due to surface runoff and ongoing bank erosion from Fisher Creek. Photo taken facing east on June 8, 2020.
