**ALBERTA TRANSPORTATION AND
ECONOMIC CORRIDORS GRMP
NORTH CENTRAL (ATHABASCA AND FORT
McMURRAY DISTRICTS)
INSTRUMENTATION MONITORING- FALL 2024**

Site Number	Location	Name	Hwy	km
NC087	HWY 63:02	Fischer Trail	63:02	km 20.67
Legal Description: 8-22-69-17 W4		UTM Co-ordinates		
		12U E 404181	N	6094051

**ALBERTA TRANSPORTATION AND ECONOMIC CORRIDORS
 NORTH CENTRAL REGION - ATHABASCA AND FORT McMURRAY DISTRICTS
 INSTRUMENTATION MONITORING FIELD SUMMARY (NC087)
 FALL 2024**

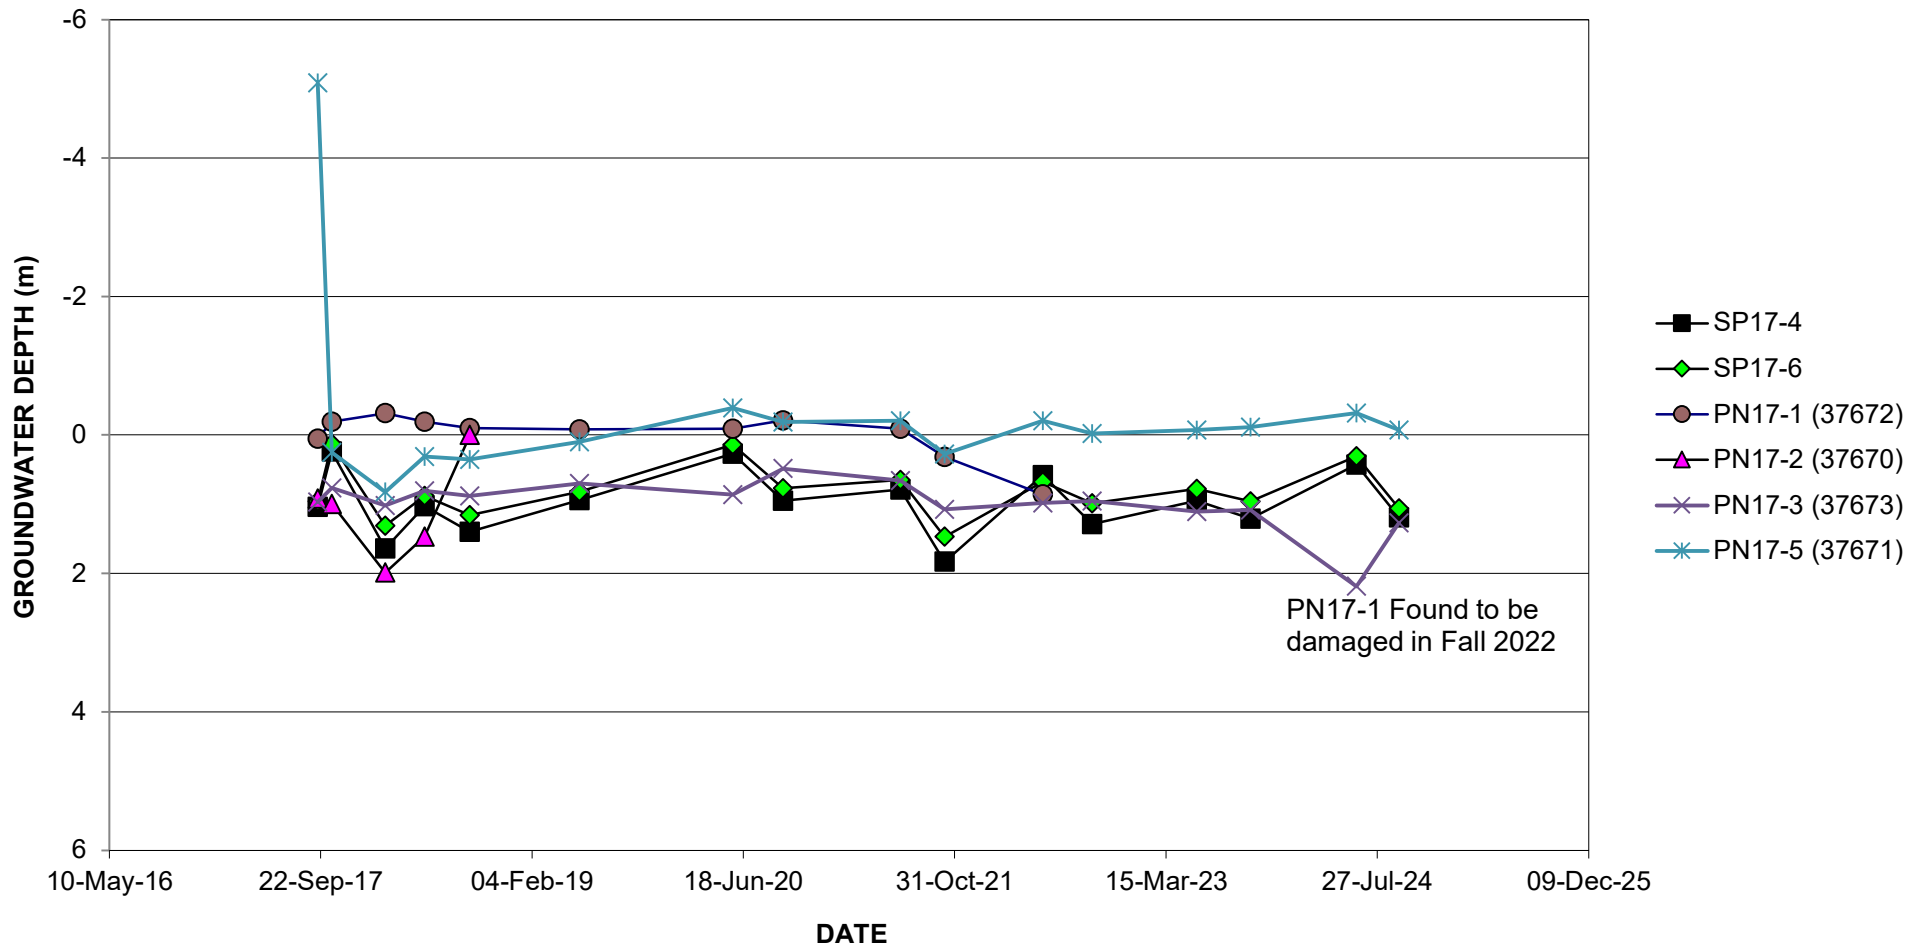
**FIGURE NC087-1
PIEZOMETER DATA FOR HWY 63:02 - FISCHER TRAIL**

Discussion	
Zones of New Movement:	None
Interpretation of Monitoring Results:	The groundwater level increased in PN17-3 by 0.92 m and decreased in PN17-5 by 0.25 m since the spring of 2024 readings. PN17-5 showed an above-ground (artesian) groundwater level of 0.07 m. Standpipe piezometers SP17-4 and SP17-6 showed decreases in groundwater level of 0.76 m and 0.75 m, respectively, since the spring of 2024 readings.
Future Work:	The instruments should be read again in the spring of 2025.
Instrumentation Repairs:	No instrument repairs are required at this time.
Additional Comments:
