**NORTH CENTRAL REGION (ATHABASCA AREA)  
- 2015 GEOHAZARD ASSESSMENT**

**NC14: HWY 661: 02 FORT ASSINIBOINE (km 1.8)  
SITE PLAN SHOWING MID-HILL SLIDE AREA**

**FIGURE NC14-2**

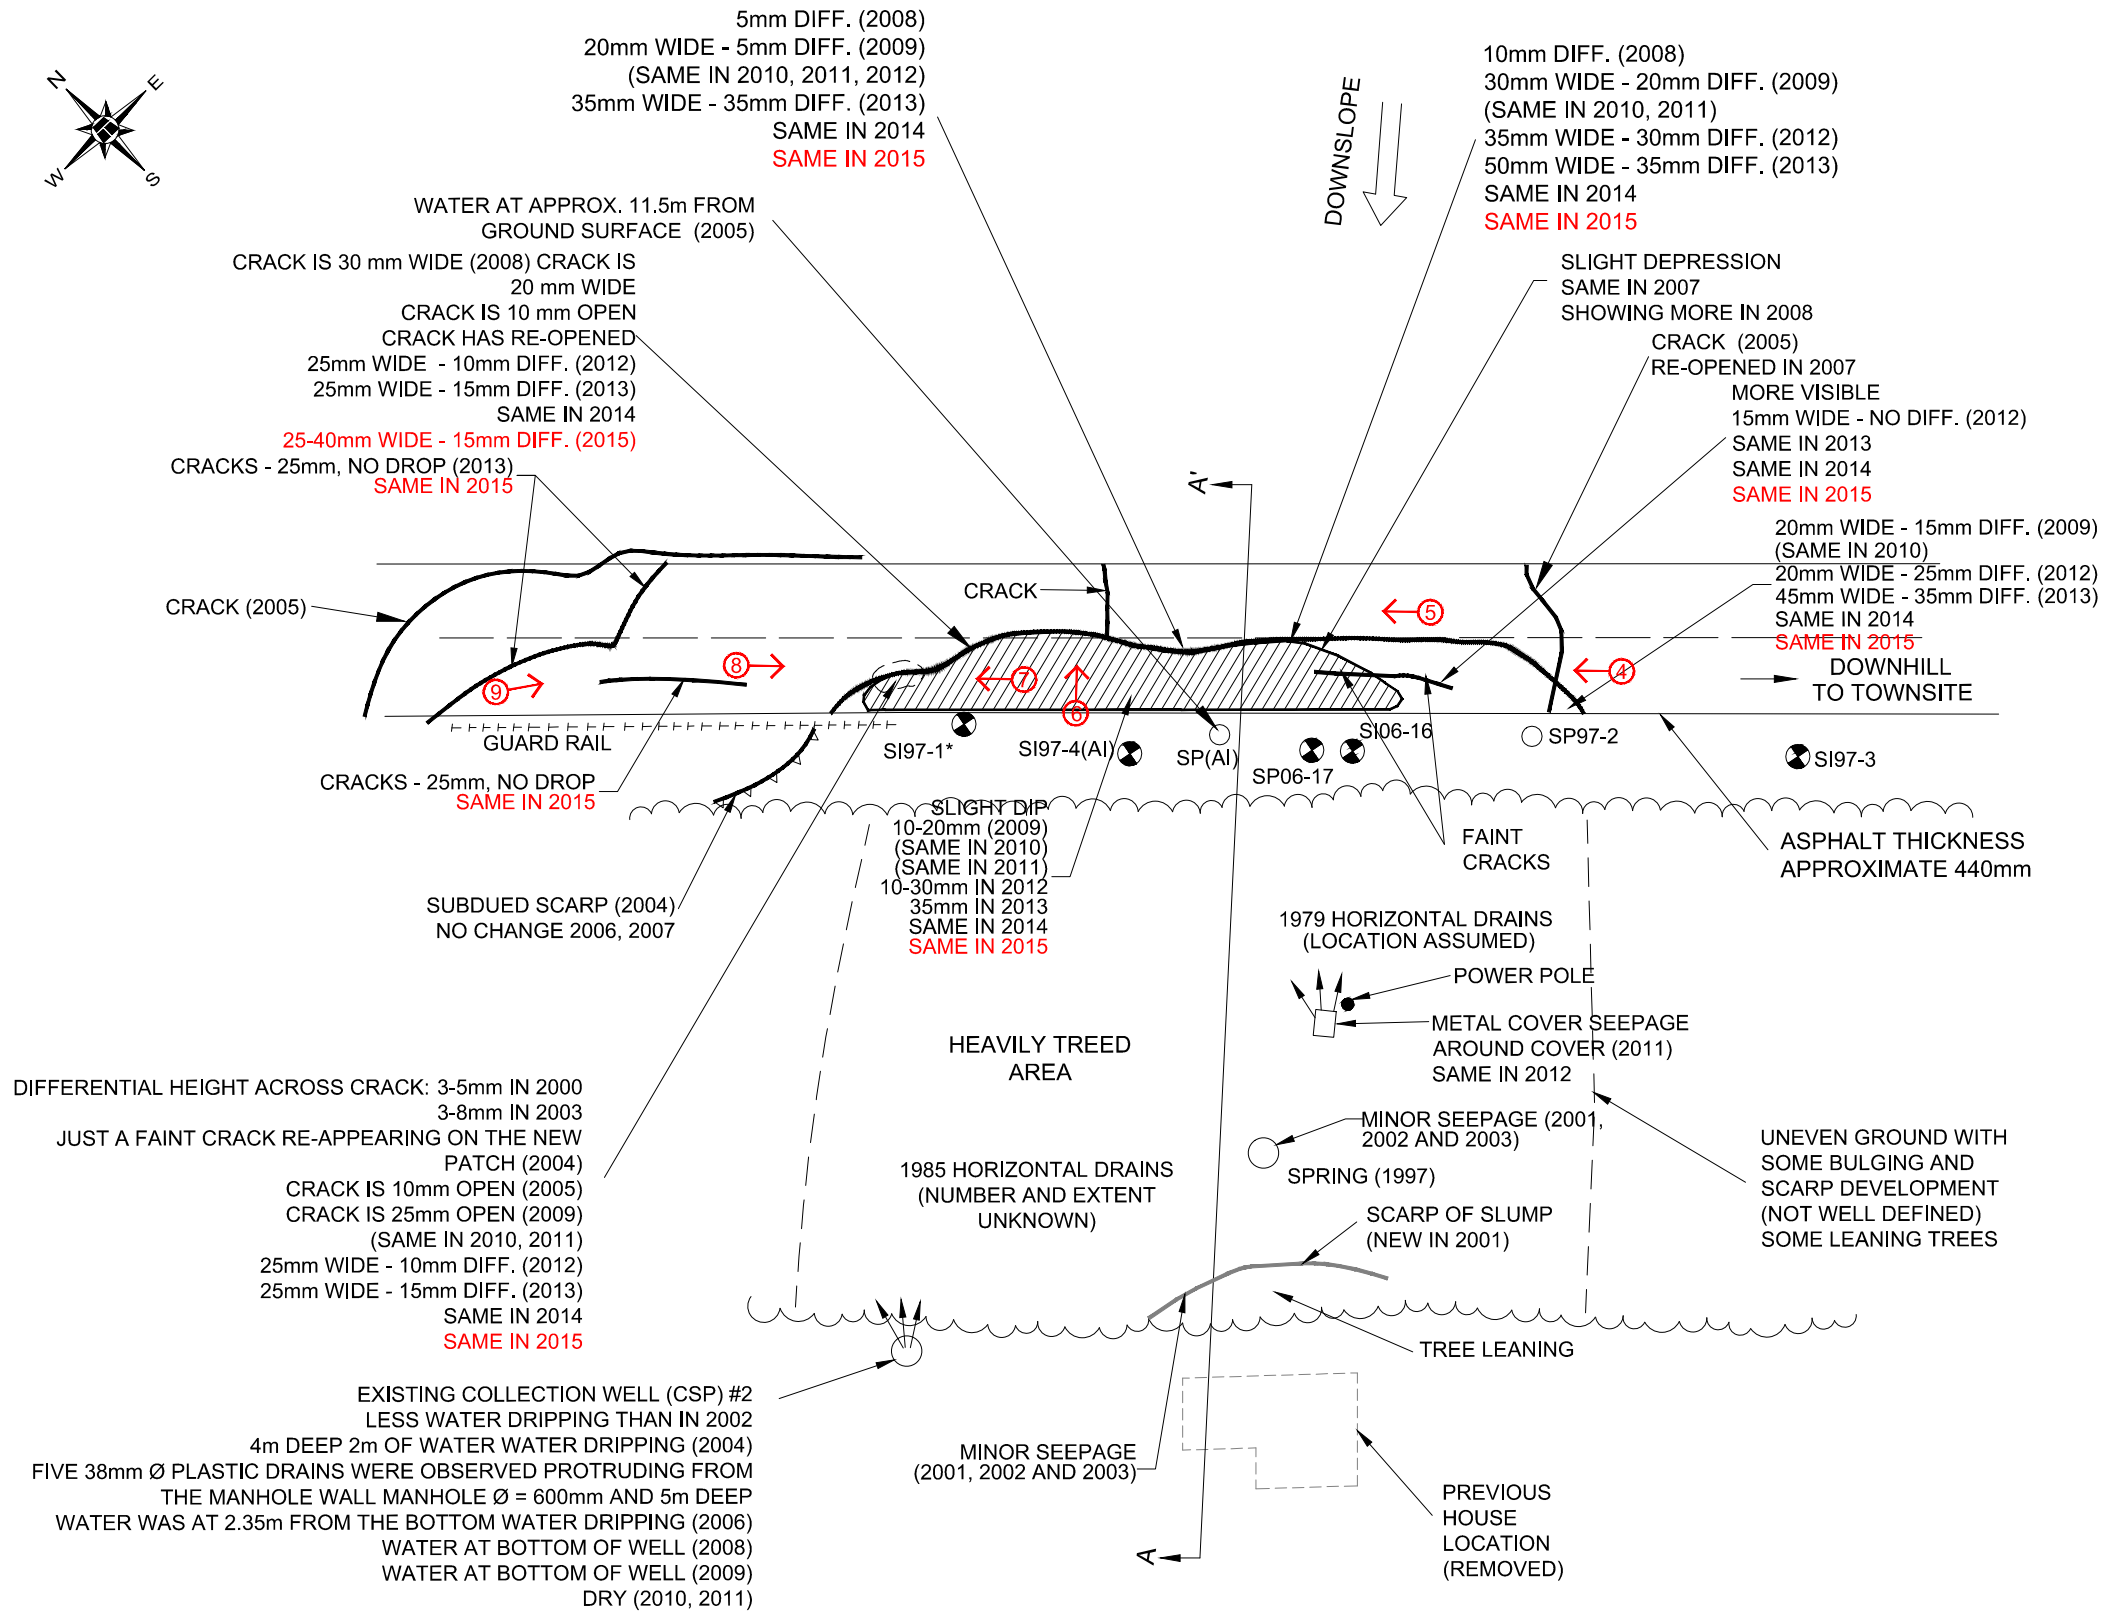
- NOTES :**
1. FEATURE LOCATIONS ARE APPROXIMATE.
  2. PREVIOUS OBSERVATIONS SHOWN IN BLACK
  3. PREVIOUS CRACK PATTERN WAS COVERED BY NEW (2004) ASPHALT PATCH
  4. **MAY 11, 2015 OBSERVATIONS ARE SHOWN IN RED**
- ① PHOTOGRAPH NUMBER, AND APPROXIMATE DIRECTION AND LOCATION

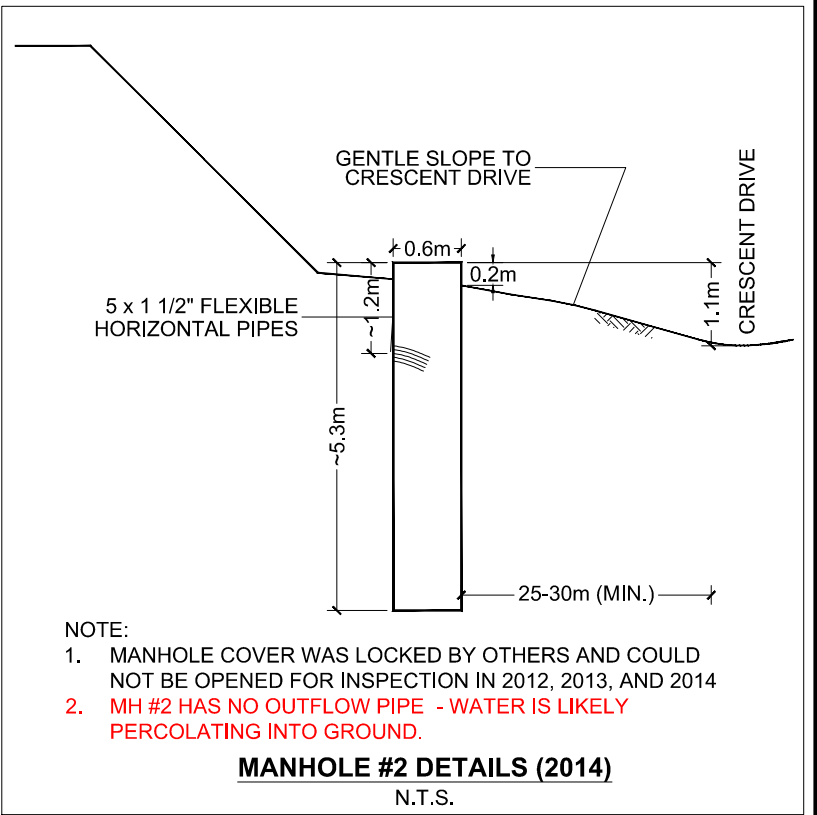
**MANHOLE #2 DETAILS (2014)**  
N.T.S.

- NOTE:**
1. MANHOLE COVER WAS LOCKED BY OTHERS AND COULD NOT BE OPENED FOR INSPECTION IN 2012, 2013, AND 2014
  2. **MH #2 HAS NO OUTFLOW PIPE - WATER IS LIKELY PERCOLATING INTO GROUND.**
