NORTH CENTRAL REGION (ATHABASCA AREA) - 2016 GEOHAZARD ASSESSMENT

NC014-1: HWY 661: 02 FORT ASSINIBOINE (km 1.8) SITE PLAN SHOWING MID-HILL SLIDE AREA

DWG NO. NC014-1-2

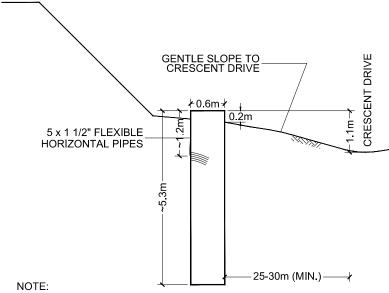
MANHOLE #2 DETAILS (2014) N.T.S.

- 1. MANHOLE COVER WAS LOCKED BY OTHERS AND COULD NOT BE OPENED FOR INSPECTION IN 2012, 2013, AND 2014
- MH #2 HAS NO OUTFLOW PIPE WATER IS LIKELY PERCOLATING INTO GROUND. (2015)
- MINOR FLOW FROM ONE OF SUBHORIZONTAL DRAINS IN 2016.
