**ALBERTA TRANSPORTATION GRMP (CON0022163)
NORTH CENTRAL (ATHABASCA AND FORT McMURRAY DISTRICTS)
INSTRUMENTATION MONITORING RESULTS – SPRING 2022**

SECTION C

SITE NC058 (NC58A): HWY 858:02 SLIDE 45 km NORTH OF HWY 55

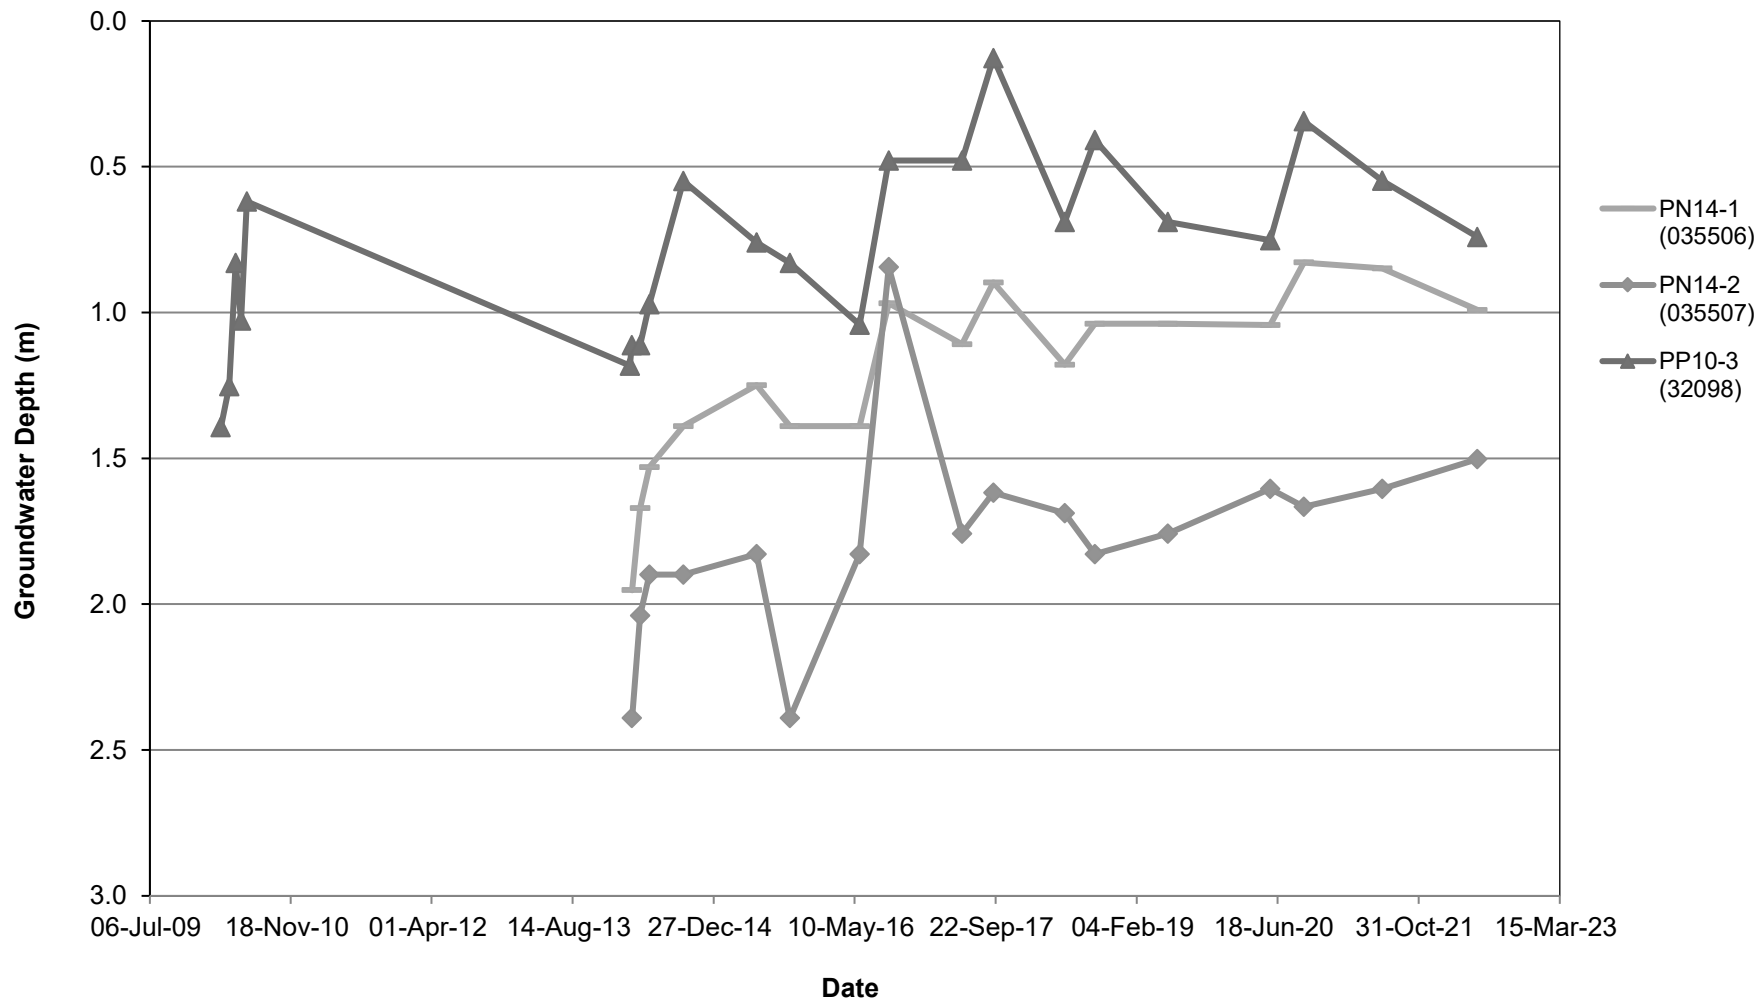
**FIGURE NC058-1
PIEZOMETRIC DATA FOR HWY 858:02 SLIDE 45 km NORTH OF HWY 55**

PP10-3 and PN14-1 showed decreases in groundwater level of 0.19 m and 0.14 m, respectively since the spring of 2021 readings. PN14-2 showed an increase in groundwater level of 0.10 m since the spring of 2021 readings. The pneumatic piezometer readings are summarized in Table NC058-2 and are plotted on Figure NC058-1, included in Appendix A.

The instruments should be read again in the spring of 2023.
