**ALBERTA TRANSPORTATION GRMP (CON0022163)  
NORTH CENTRAL (ATHABASCA AND FORT McMURRAY DISTRICTS)  
INSTRUMENTATION MONITORING RESULTS – SPRING 2022**

**SITE NC025: HWY 646:04 LINDBERGH HILL**

**ALBERTA TRANSPORTATION GRMP (CON0022163)  
NORTH CENTRAL (ATHABASCA AND FORT McMURRAY DISTRICTS)  
INSTRUMENTATION MONITORING RESULTS**

**APPENDIX A  
DATA PRESENTATION AND SITE PLANS**

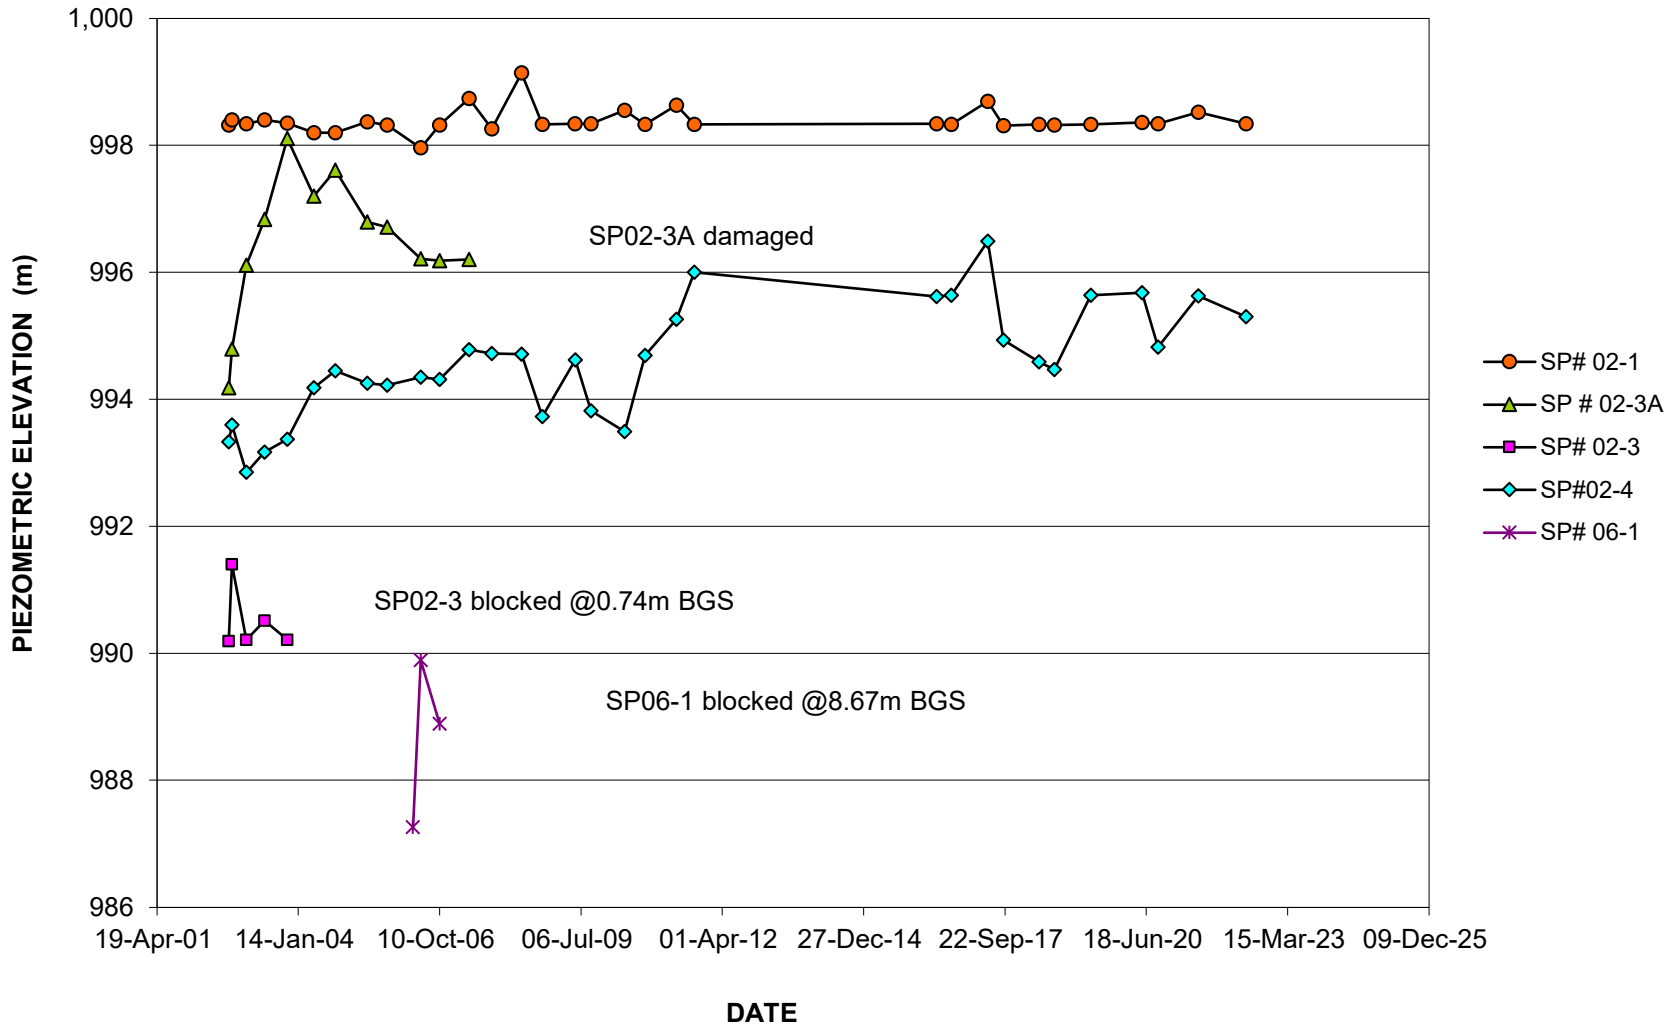
**FIGURE NC025-1**  
**STANDPIPE PIEZOMETER DATA FOR HWY 646:04, LINDBERG HILL**

Standpipe piezometers SP02-1 and SP02-4 showed decreases in groundwater level of 0.18 m and 0.33 m, respectively, since the spring of 2021 readings. The standpipe piezometer readings are summarized in Table NC025-2 are plotted on Figure NC025-1 in Appendix A.

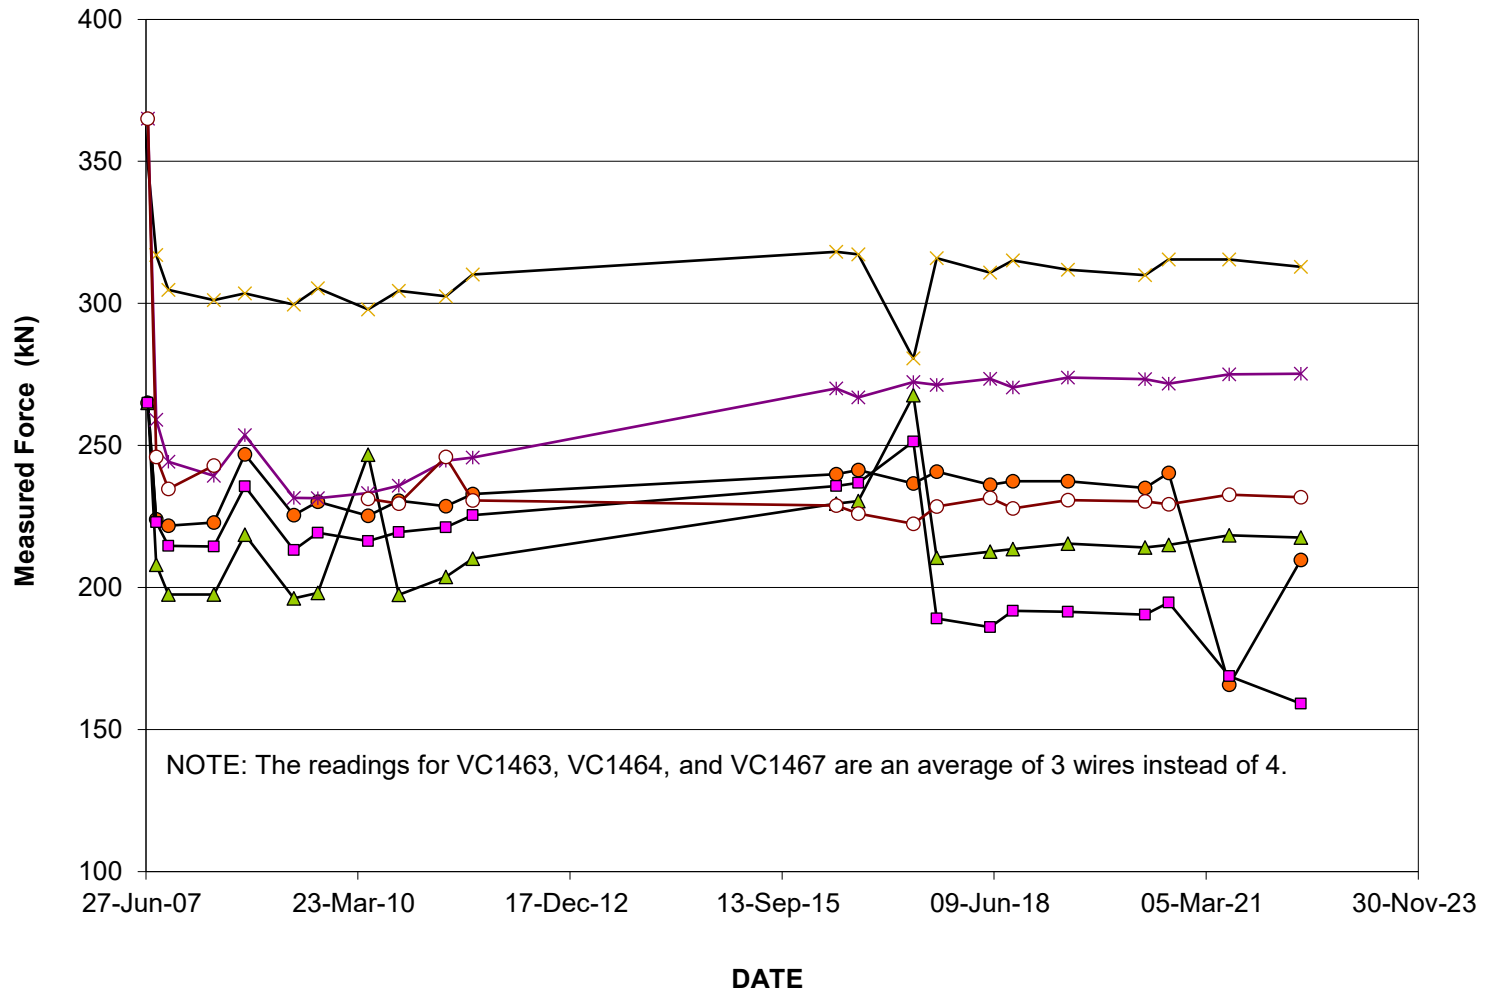
**FIGURE NC025-2  
LOAD CELL DATA FOR HWY 646:04, LINDBERG HILL**

Load cells VC1463 and VC1467 showed increases in measured load of 44.00 kN and 0.18 kN, respectively, since the spring of 2021 readings. The large increase in VC1463 may be from one of the vibrating wires functioning incorrectly. This reading will be confirmed in the spring of 2023 readings.

VC1464, VC1465, VC1466, and VC1468 showed decreases in measured load of 0.73 kN, 9.60 kN, 2.60 kN and 0.86 kN, respectively, since the spring of 2021. VC1463, VC1464 and VC1467 currently have three of the four vibrating wire channels functioning so the measured load is the average of the functioning channels. The load cell readings are summarized in Table NC025-3, and are plotted on Figure NC025-2 in Appendix A.

The instruments should be read again in the spring of 2023.
